# Caesar Apparels Ltd-New

Yakub Synthetic Building, PBA Road, Moijjartak, Shikalbaha,

18<sup>th</sup> December 2016

# Observations

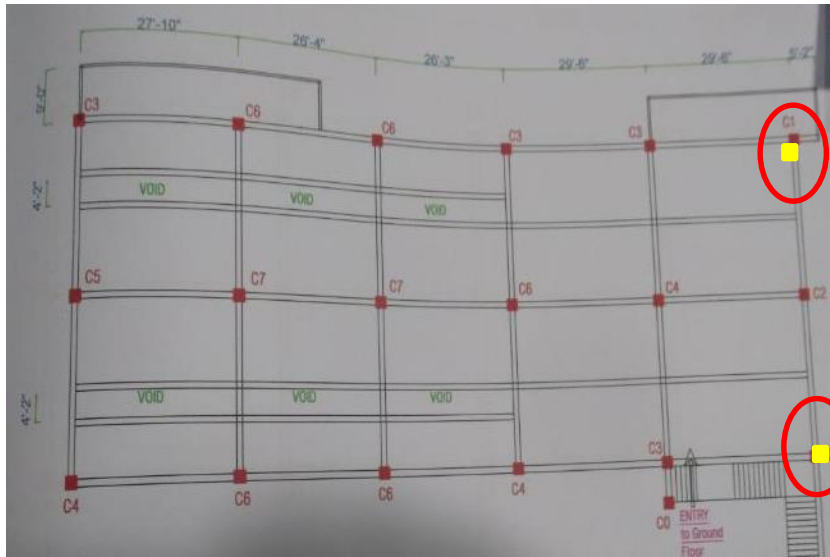
| COLUMN INDEX | COLUMN DIMENSIONS | |
| | UP TO G.B.L. | G.B.L. TO 2ND. FLOOR |
| C1 (24"x24") | <br>27"<br>Main bars: 16 - Ø16 mm | <br>24"<br>Main bars: 16 - Ø16 mm |

During inspection, The highlighted columns(C1) were found under-sized compared to As- Built drawing. In drawings the size of the column is mentioned (24inX24in), but we found (23inX15in)

| Item No. | Observation | Recommended Action Plan | Recommended Timeline |
|---|---|---|---|
| 1 | Inconsistency between Structural Drawing and As-Built Condition | Factory engineer to check, collect information and produce accurate and complete as-built documentation | 6-weeks |

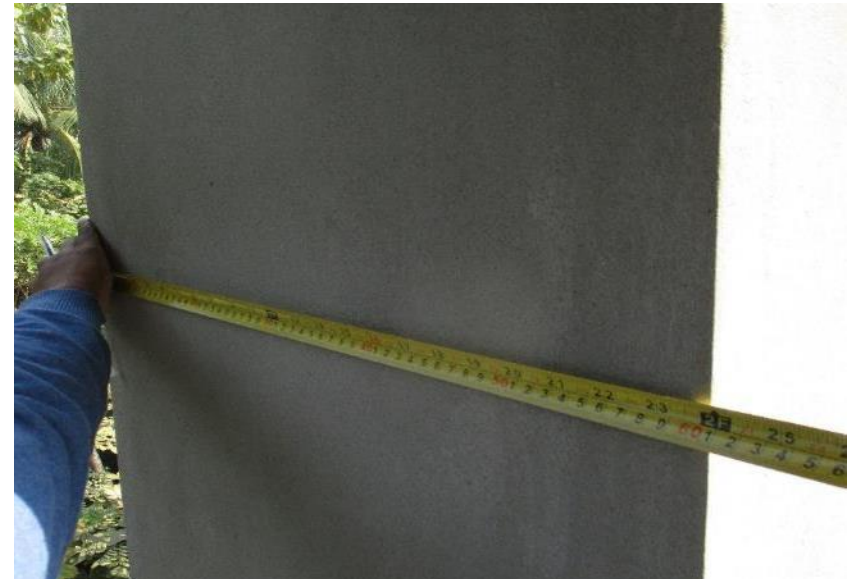
Long Face( C1 column )(23 inch)

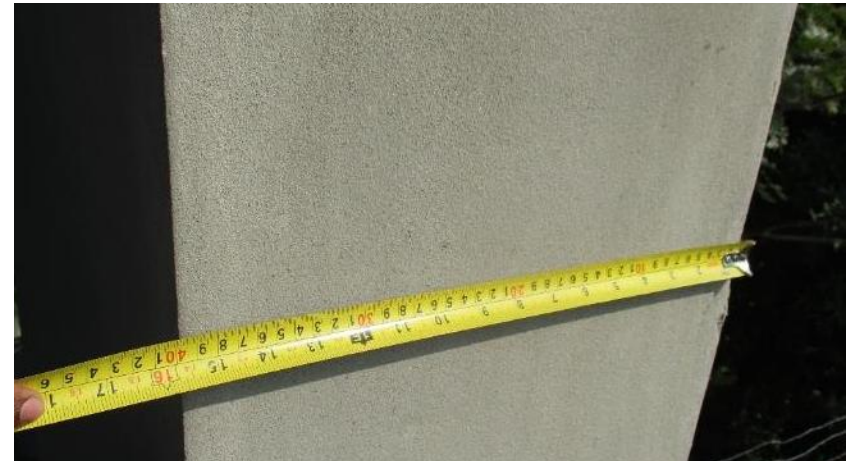
Short Face ( C1 column )(15 inch)

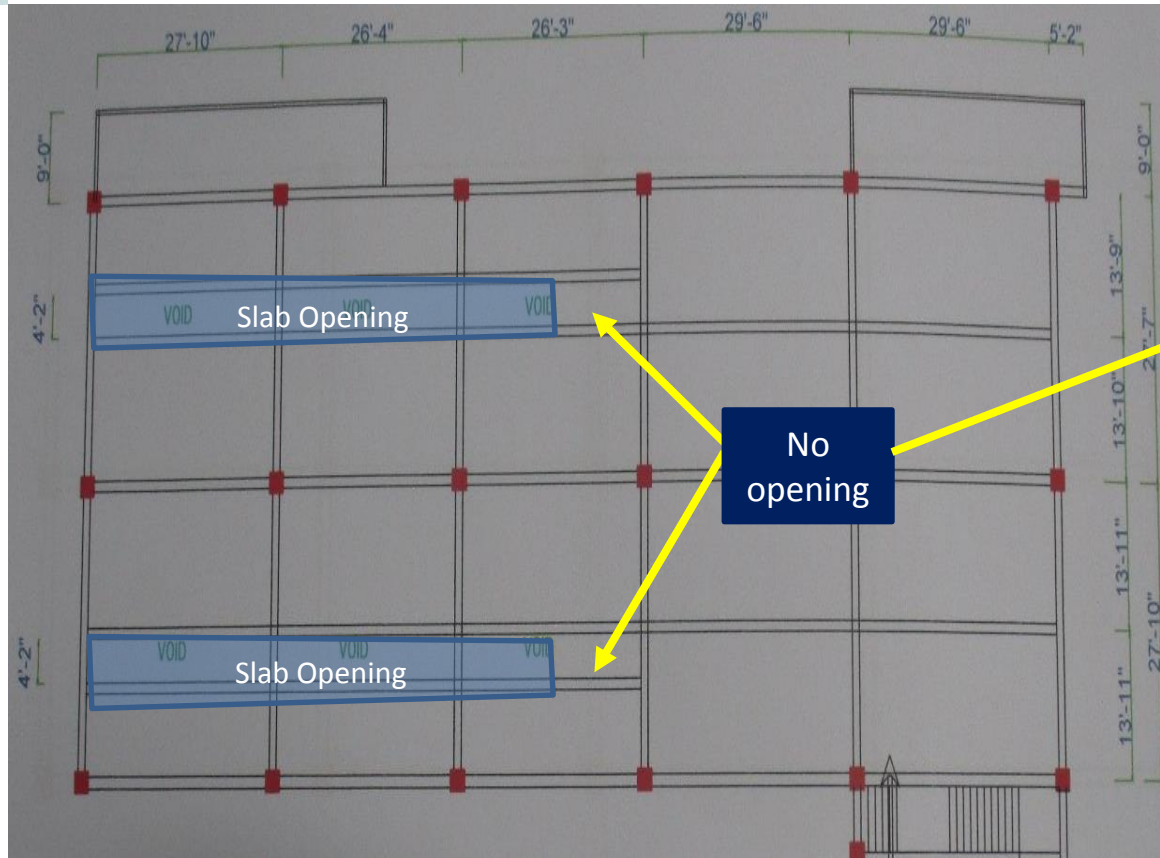
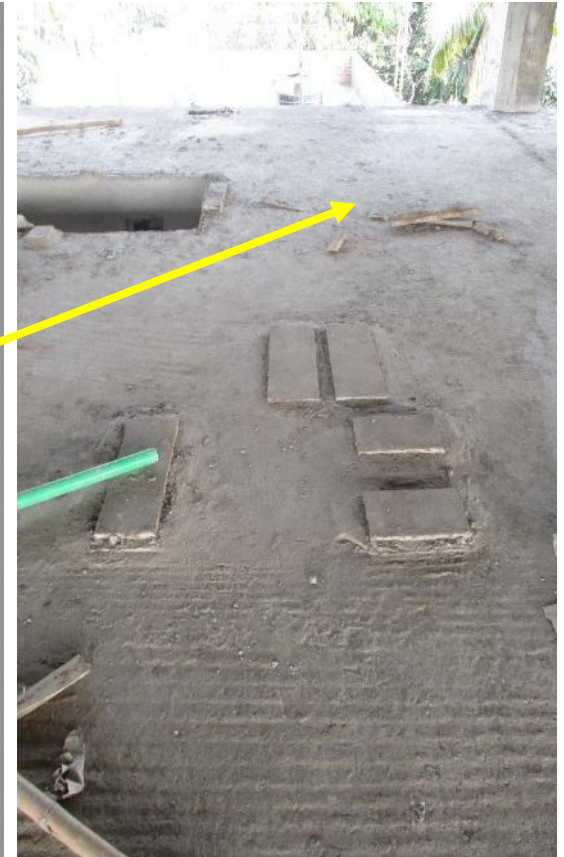
As per as-built drawing ,The slab opening was mentioned on 3 bays but during inspection, no opening was found on the highlighted areas.

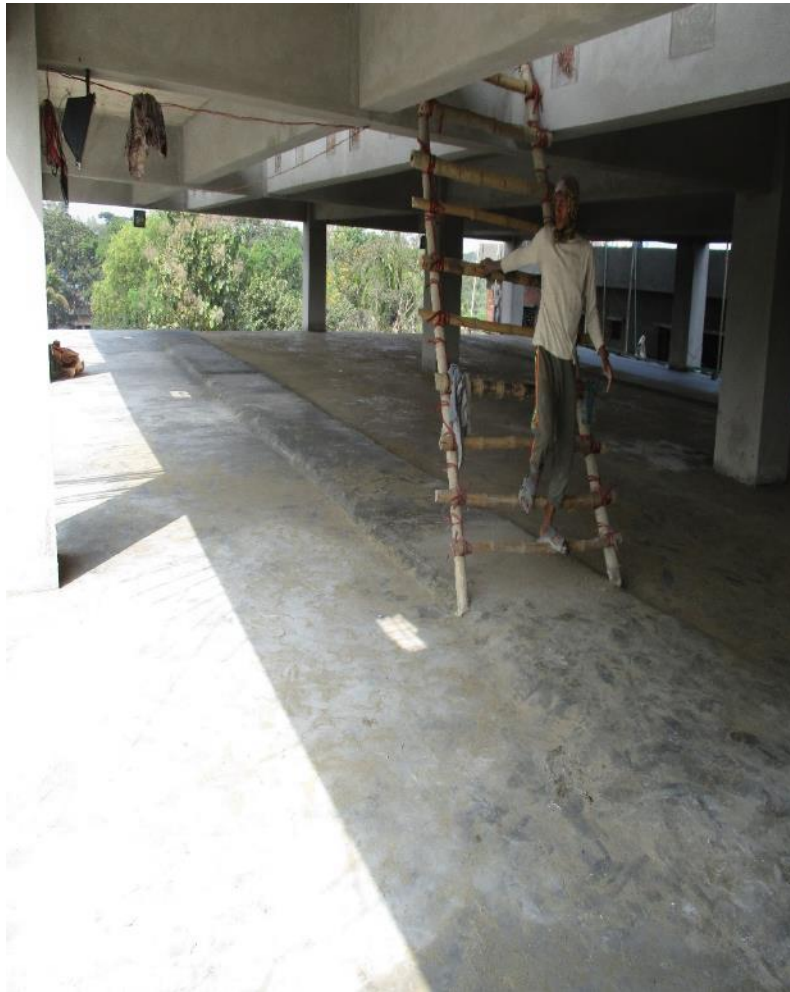
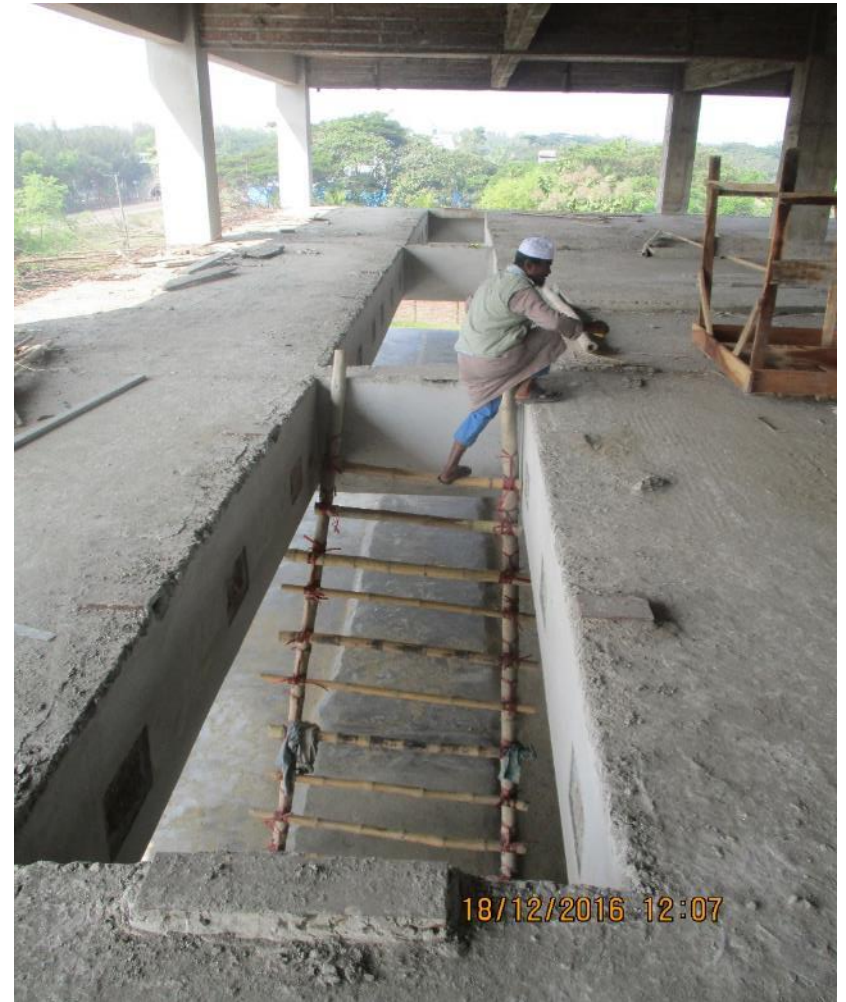
**Bamboo ladder was observed to go upstairs**

During inspection, Bamboo ladder was observed to go upstairs. Although, upper floors were found unoccupied during inspection. Factory Engineer is required to ensure that properly constructed stair is installed before they are being used.

| Item No. | Observation | Recommended Action Plan | Recommended Timeline |
|---|---|---|---|
| 2 | Bamboo ladder was observed to go upstairs | Factory engineer to design and construct proper stair/stairs before occupying upper floors giving consideration to floor capacity and column capacity. | 6-weeks |
| 3 | Bamboo ladder was observed to go upstairs | Construction of stairs to be completed | 6-months |

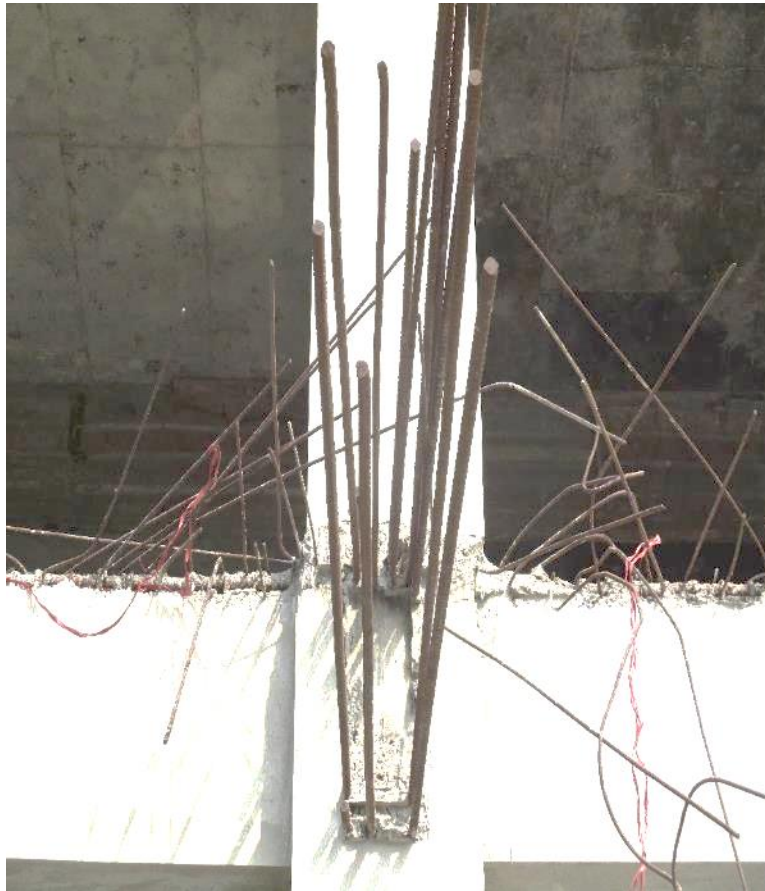
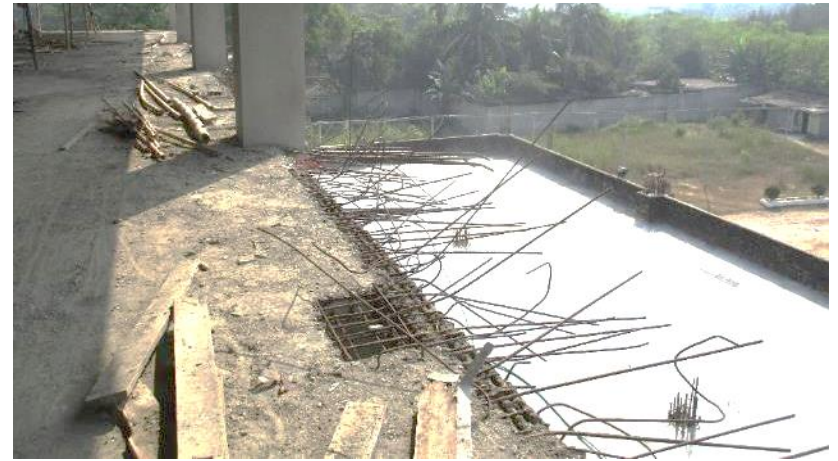
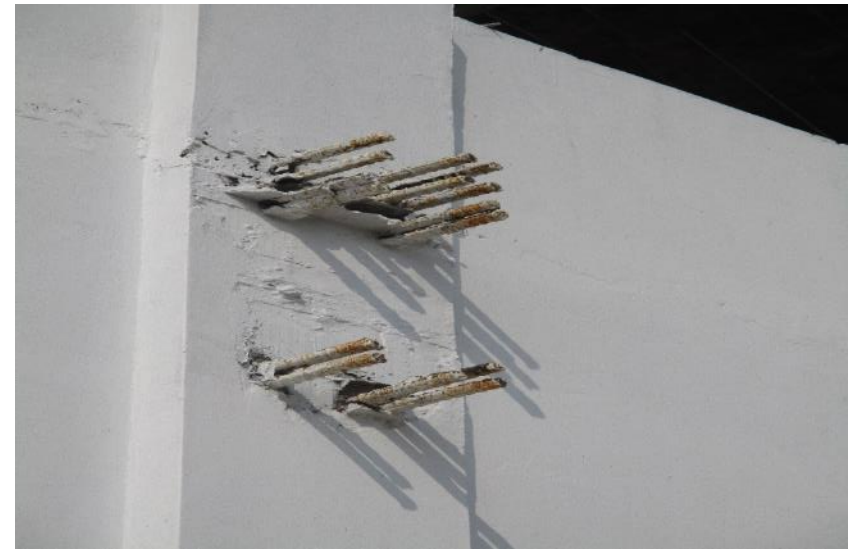
**Exposed rebar was observed**

During inspection, Rebar was found exposed on different places including roof.

| Item No. | Observation | Recommended Action Plan | Recommended Timeline |
|---|---|---|---|
| 4 | Exposed rebar was observed | All exposed rebar is to be protected from corrosion which may cause degradation of the concrete. | 6-weeks |

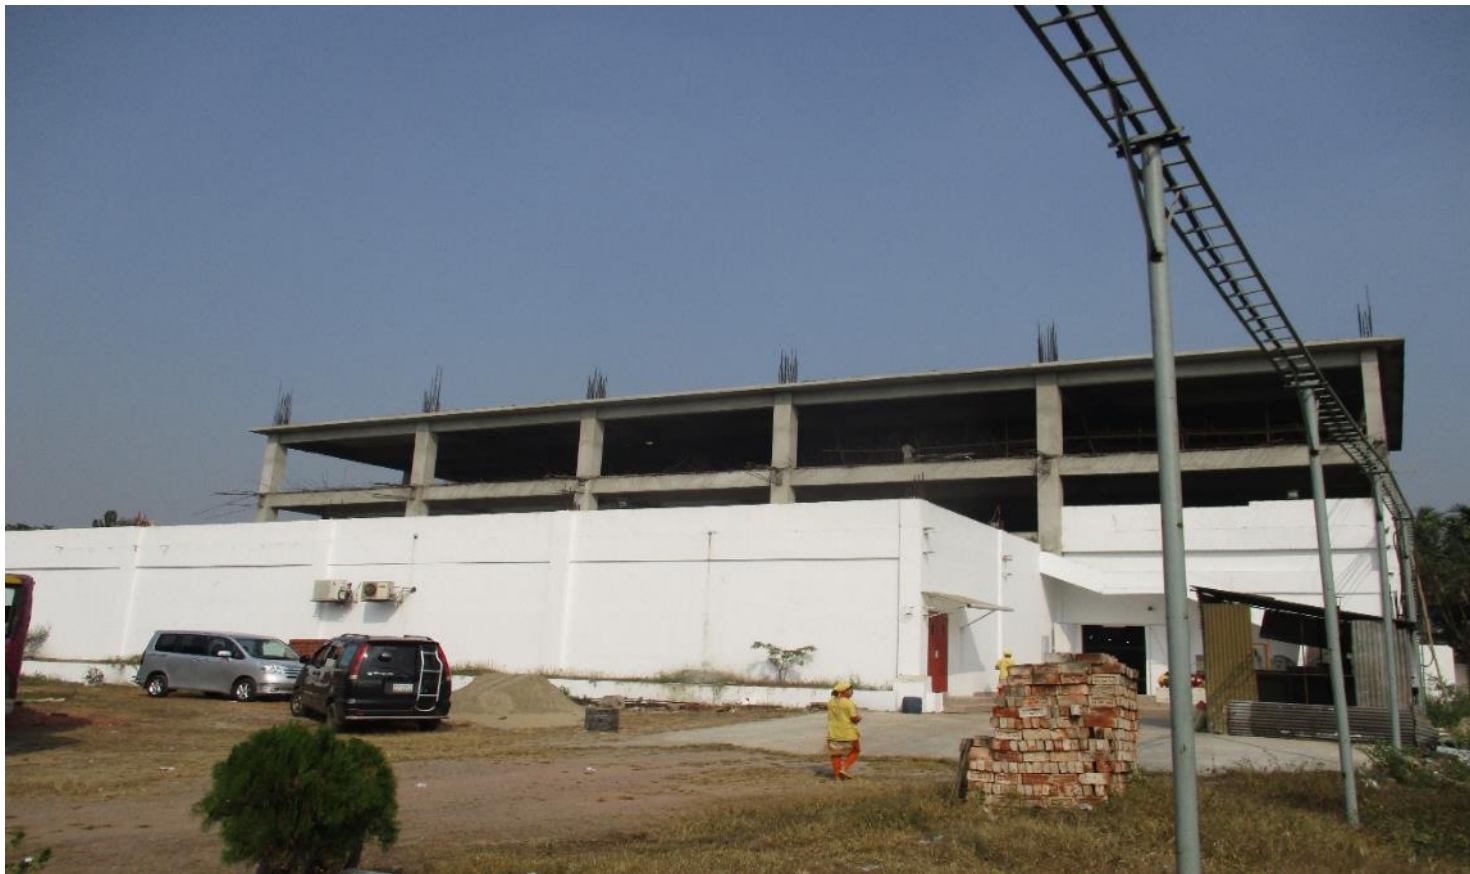
# Future Vertical Extension

As factory has a permit drawing of 3-storied building. So, No further extension is allowed. If factory goes further extension, they must carry out a Detail engineering assessment as per BNBC provision.

| Item No. | Observation | Recommended Action Plan | Recommended Timeline |
|---|---|---|---|
| 5 | Future Vertical Extension | For future vertical extension, Building Engineer is required to analyze the structure following BNBC requirements. | 6-weeks |
| 6 | Future Vertical Extension | Implement strengthening or repairing works if required. | 6-months |
