Knit Horizon Ltd.

Holding: 36/1,Block-E ,Boherarchala , Sreepur , Gazipur
(24.200399N,90.400936E)
28th December 2016

Observations

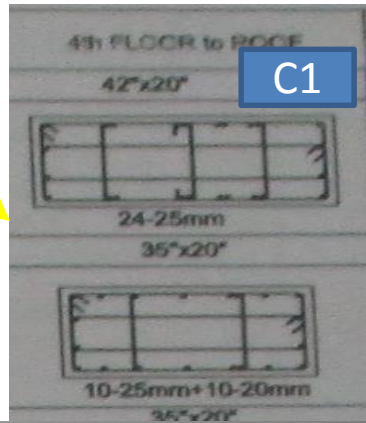
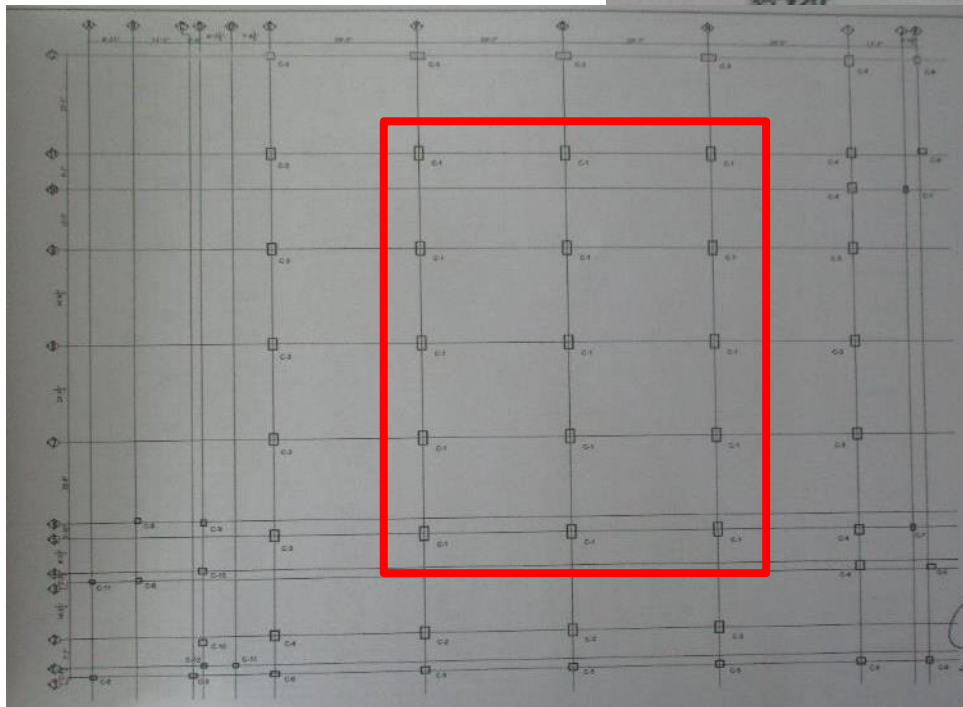
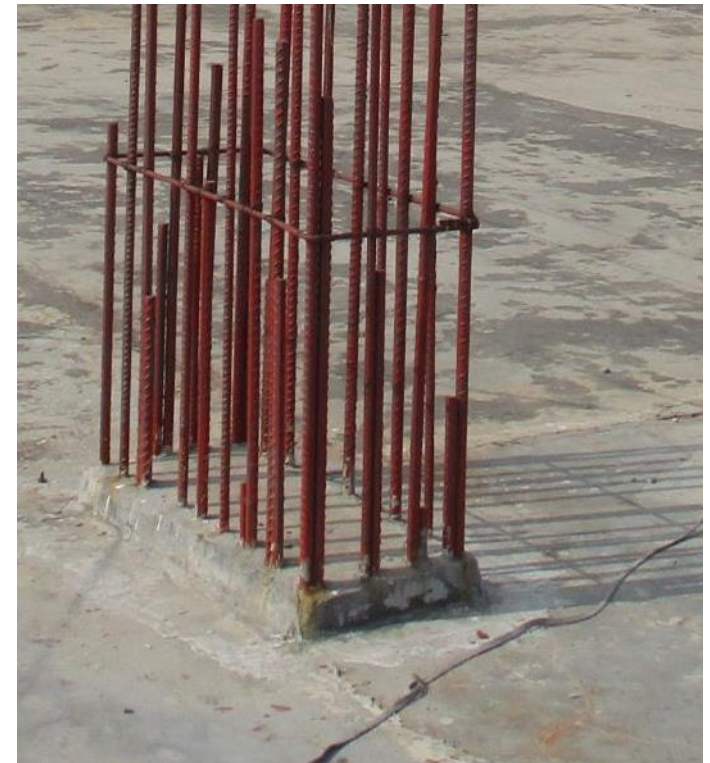
Discrepancy between Structural Drawing and As – Built Condition

Rebar arrangement of C1 Column not match with column schedule. During inspection (17-25mm + 7 – 20mm) rod found instead of 24 – 25mm rod. (Checked on Roof)

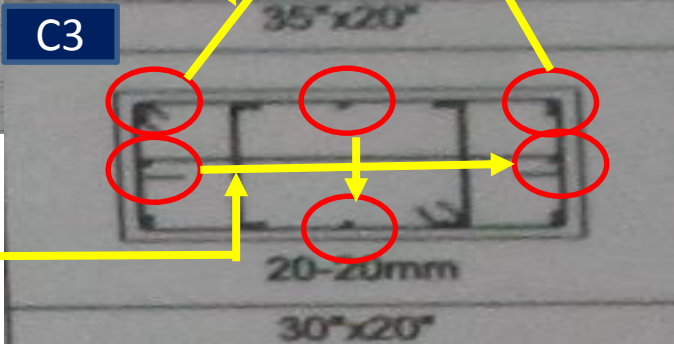
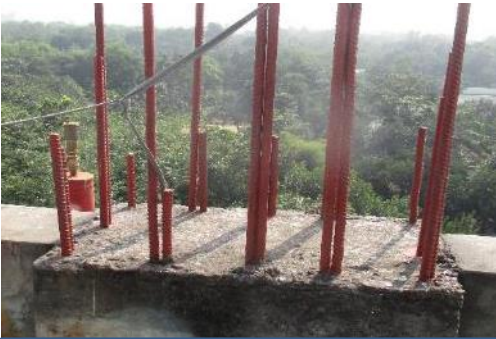
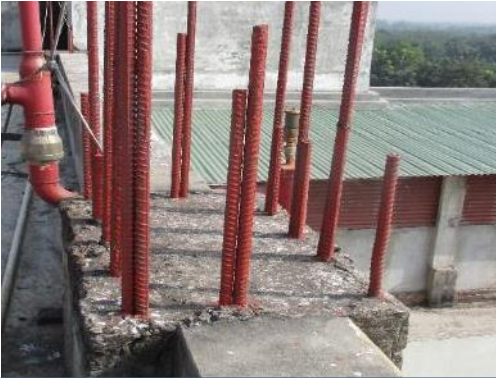
Not Bundled

Bundled

Rebar arrangement of C3 Column not match with column schedule at roof

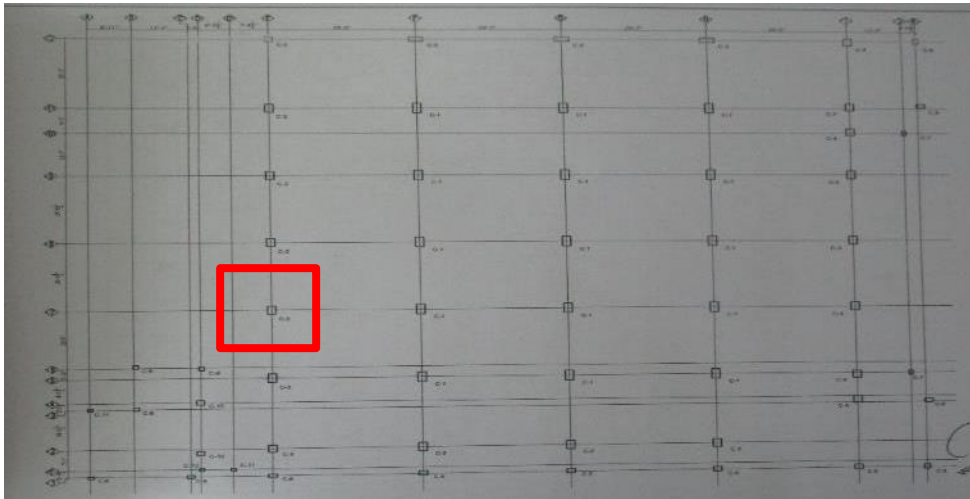
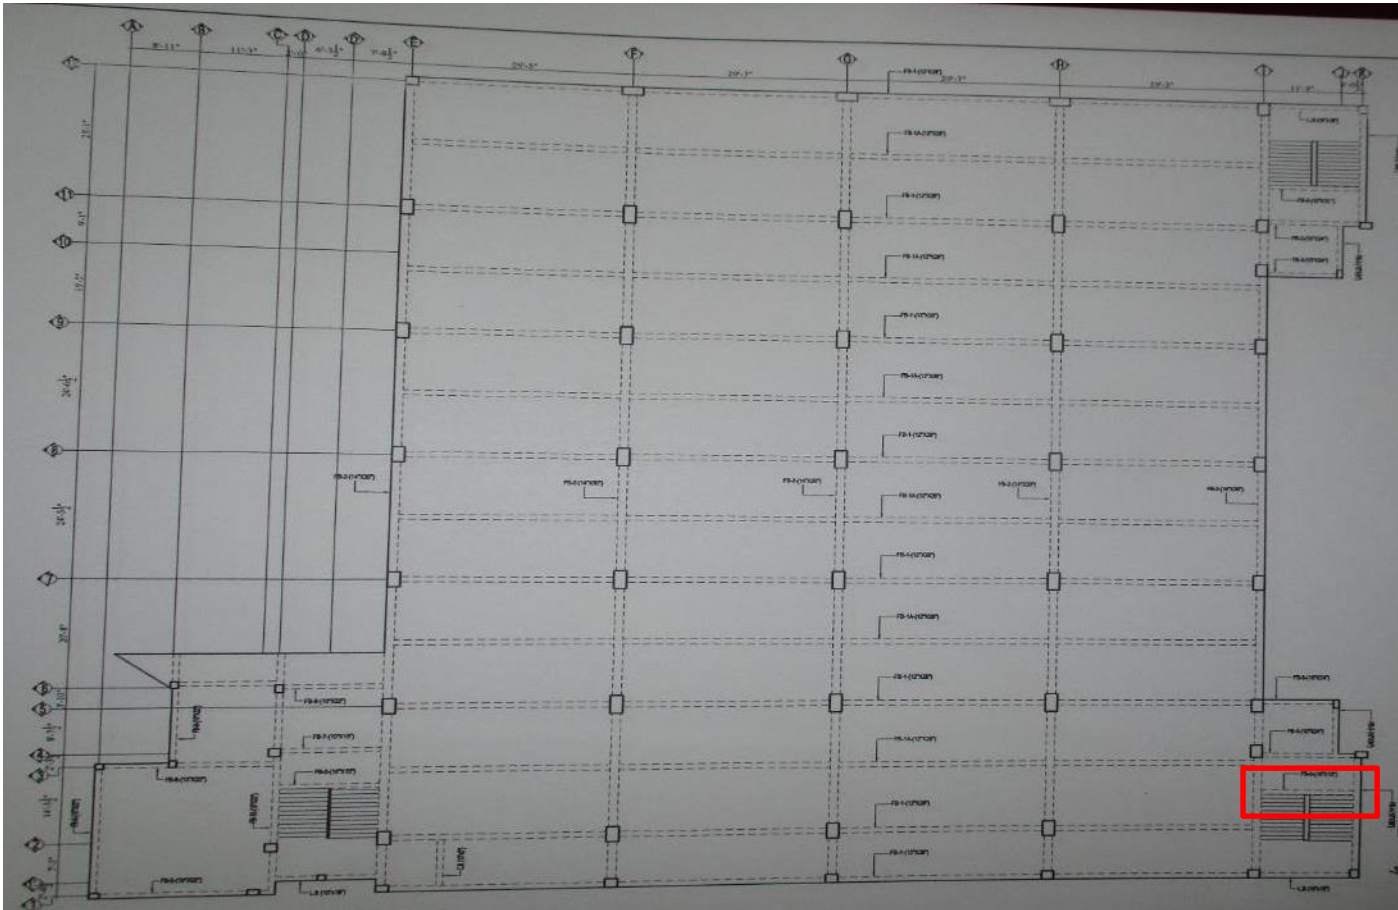
Stair Beam was not found on the highlighted portion on 1st and 2nd floor level

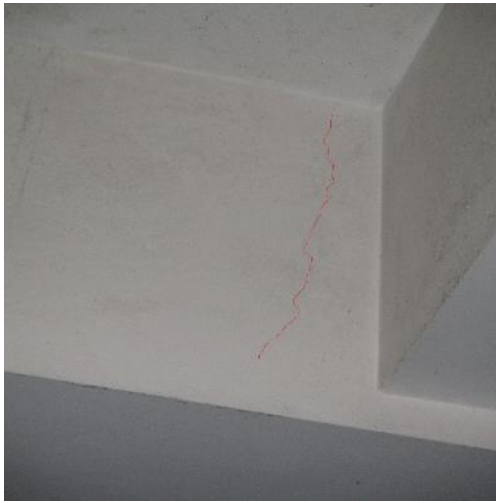
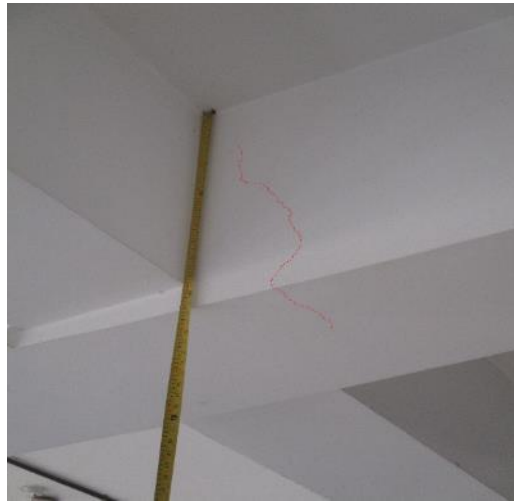
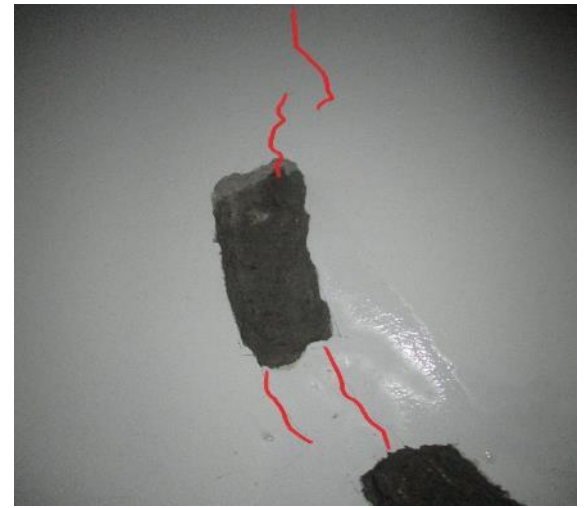
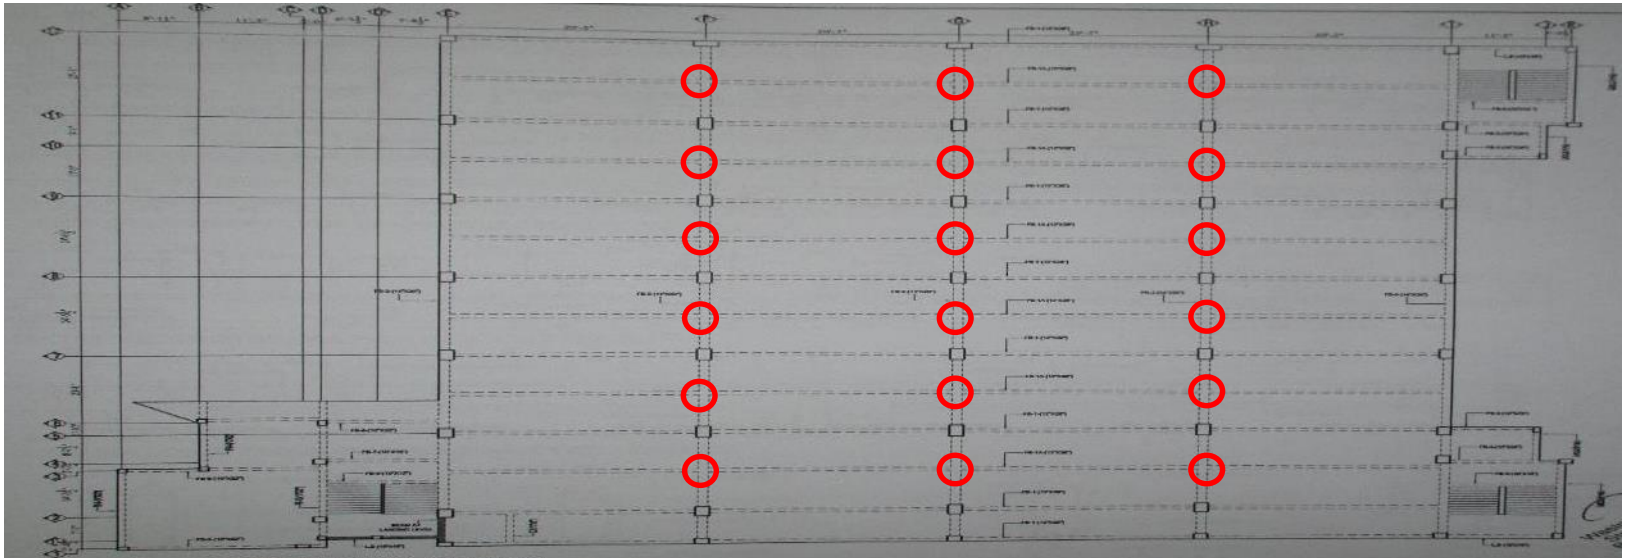
Cracks found on beam to beam joint on every floor above ground.

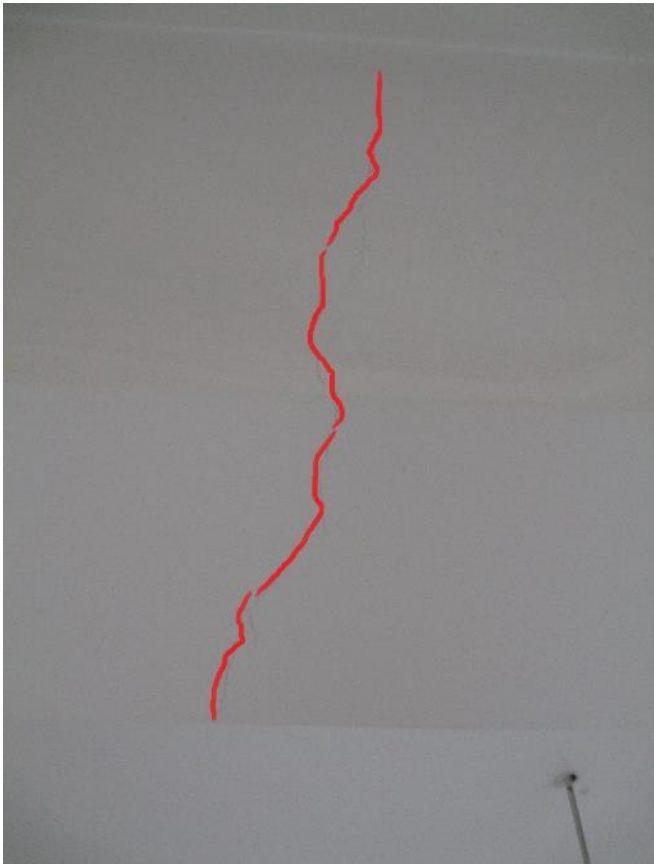
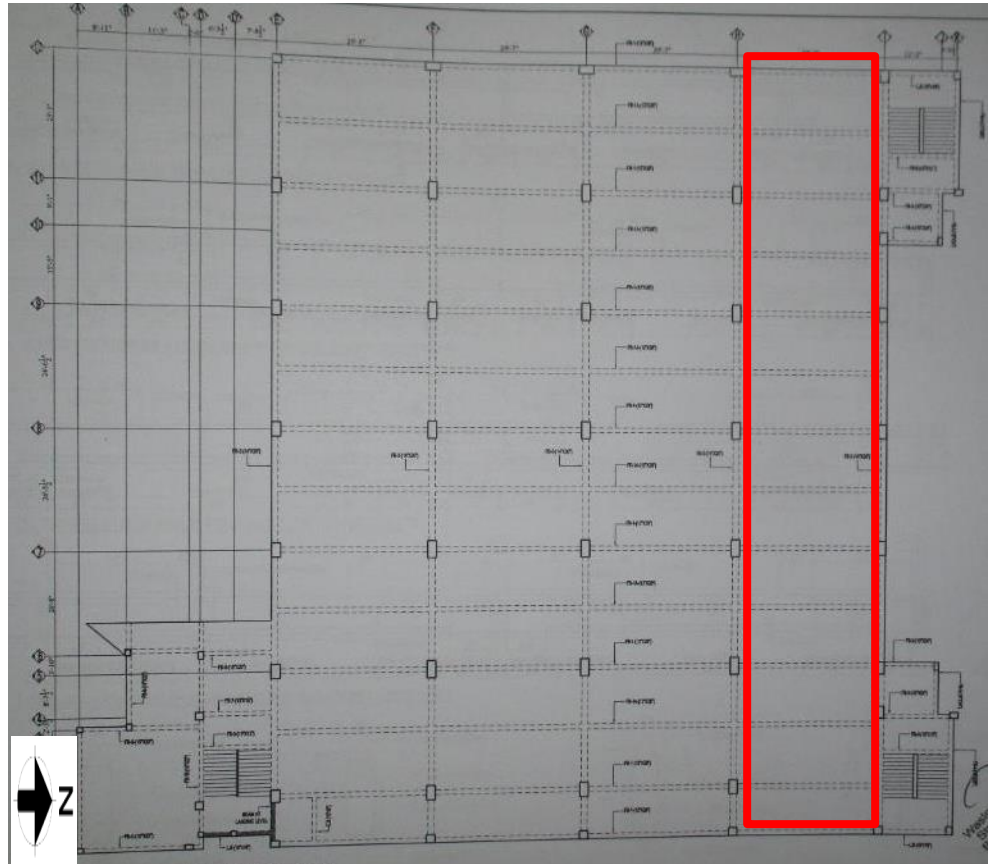
During inspection, cracking was found on mid span of beam of the highlighted bay on several floors.

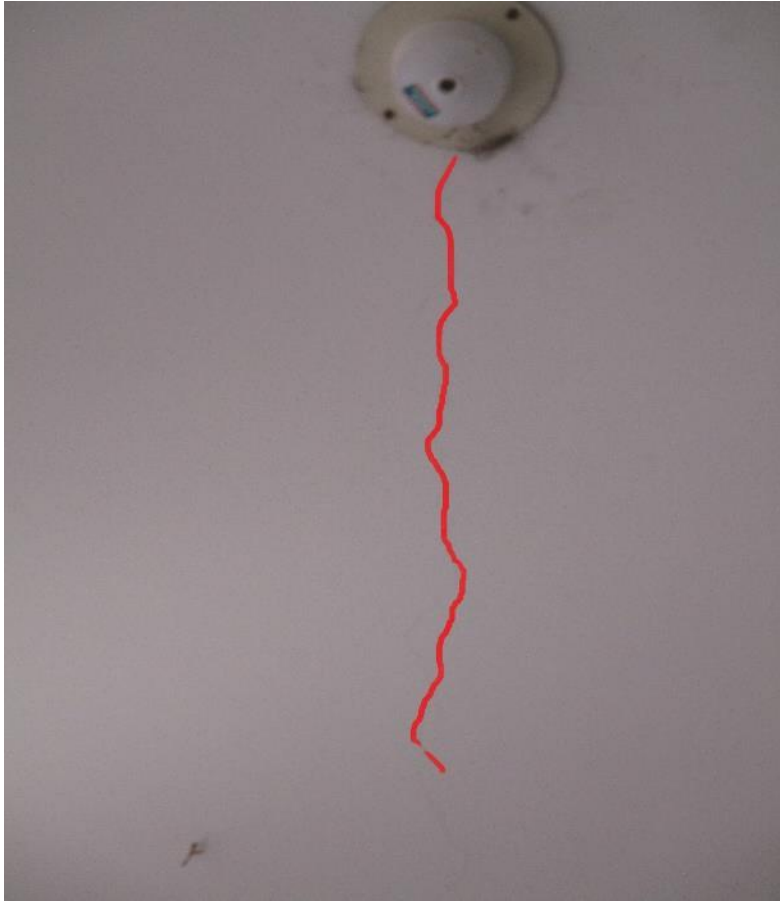
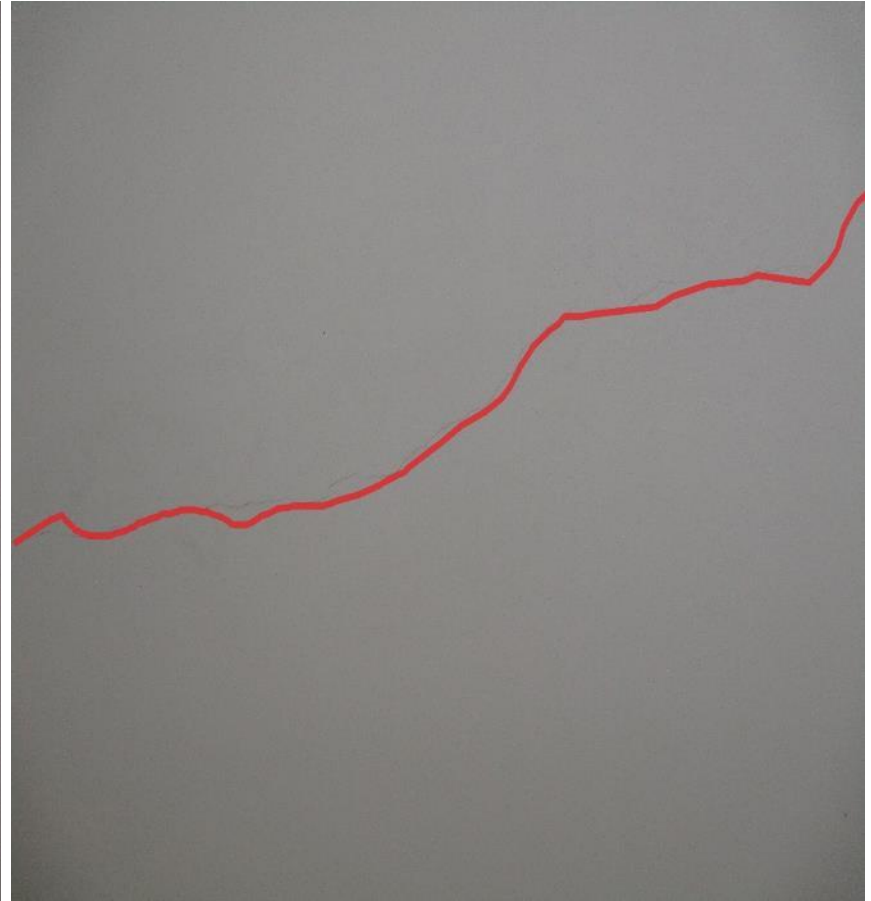
Cracking found on slabs on several panels of different floors.

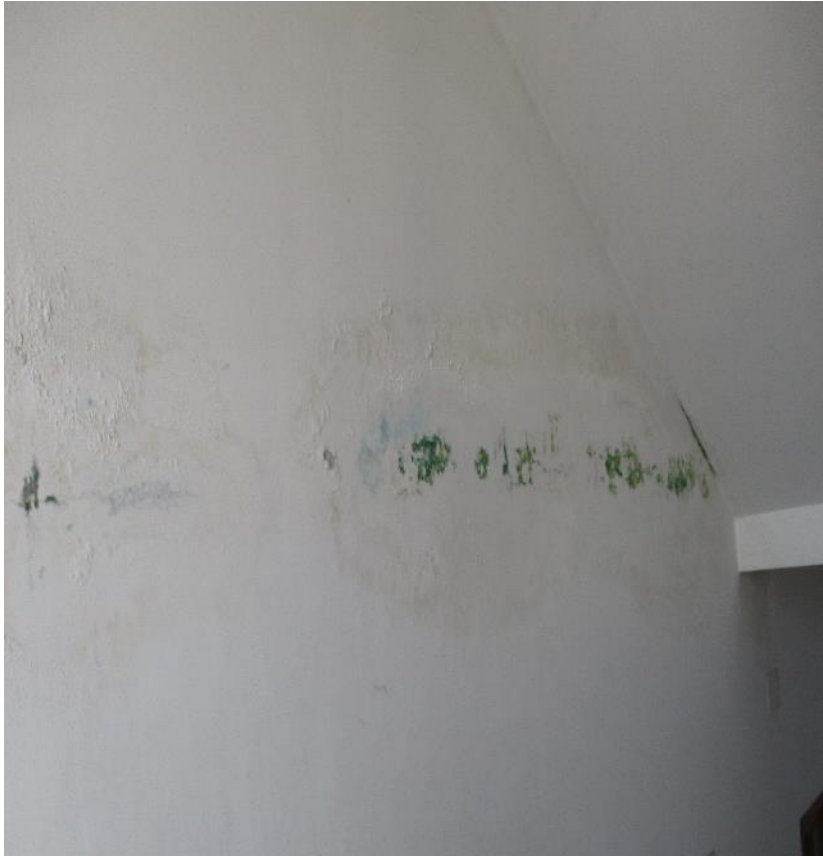
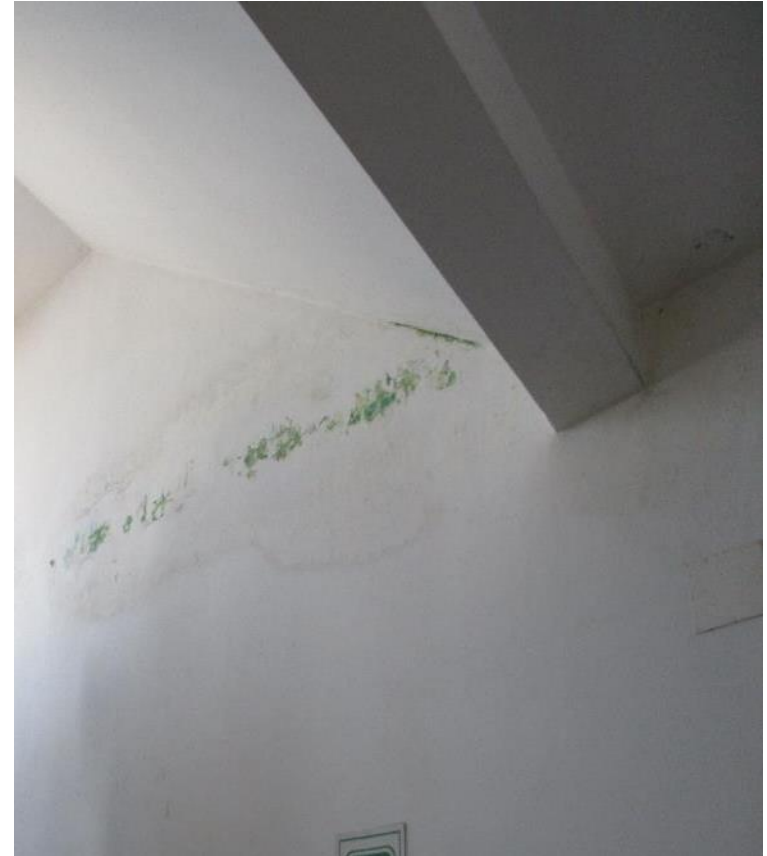
During inspection, dampness was found on wall of the staircase portion beside toilet area.

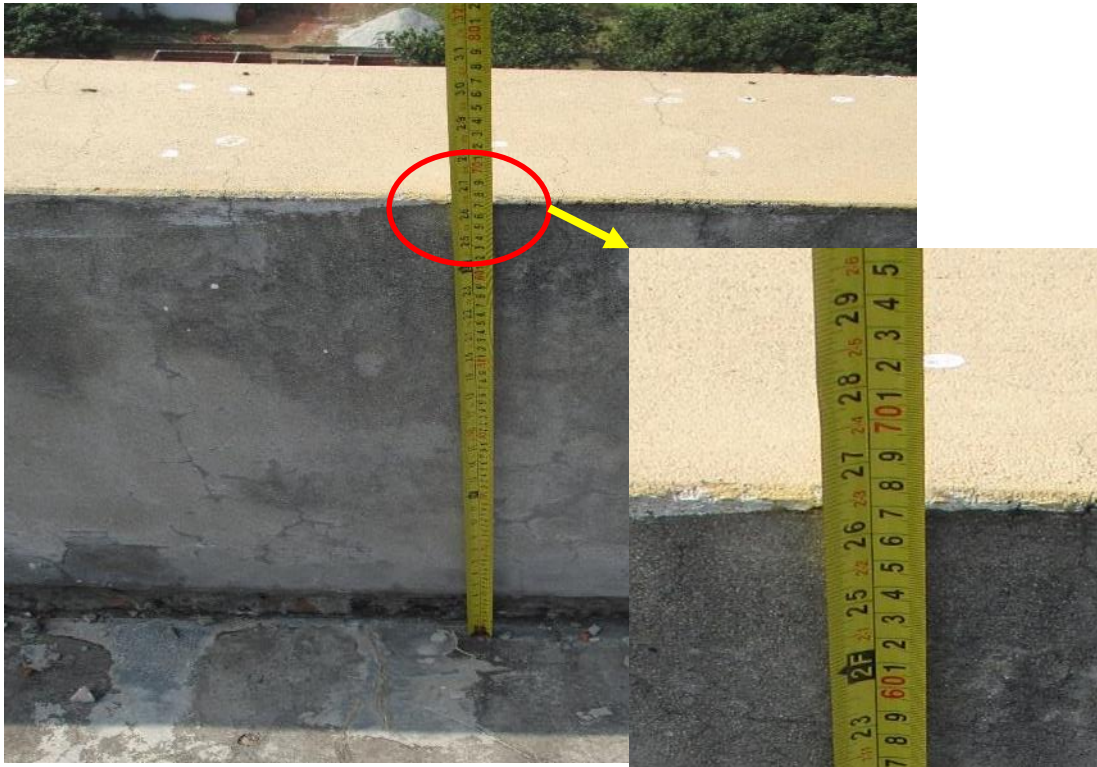
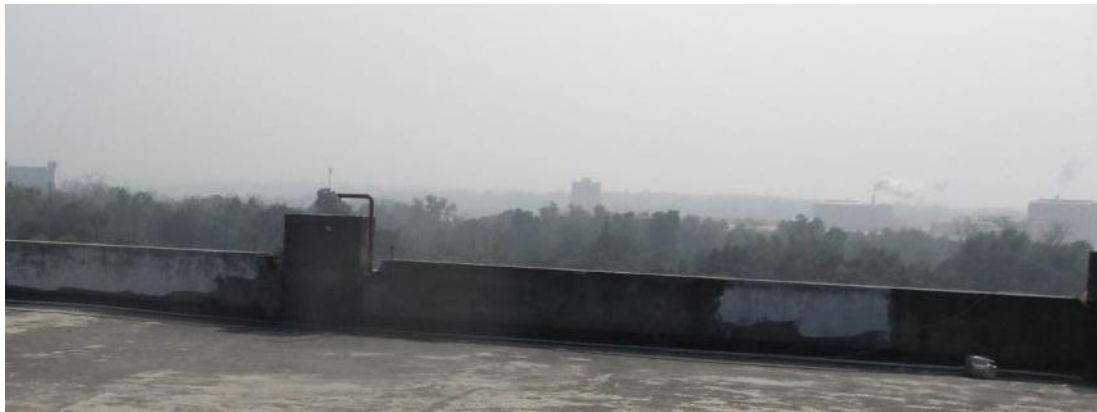
During inspection, Parapet height on roof was not found adequate to avoid falling hazard.

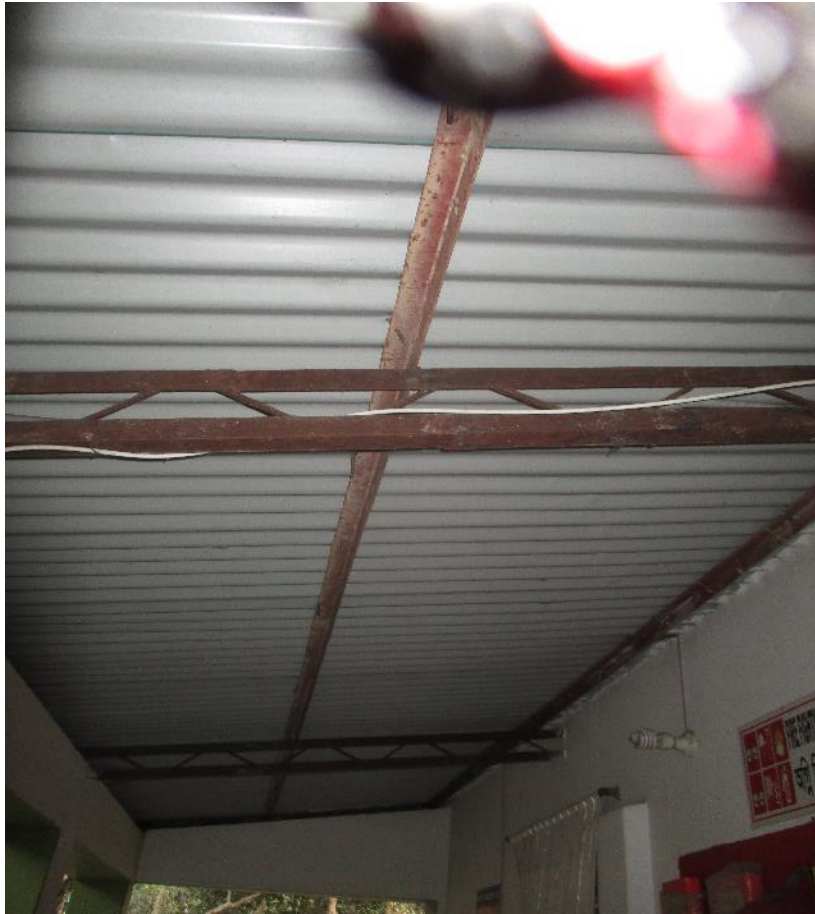
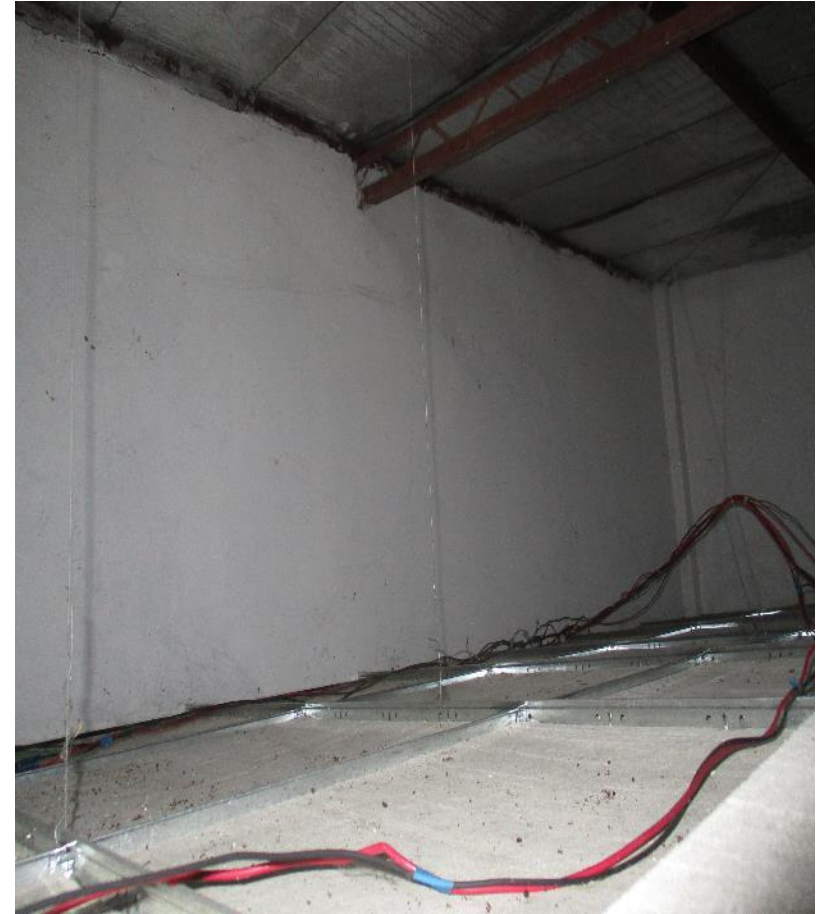
During inspection, Medical room & child care shed and canteen shed were found as non-engineered. Factory Engineer is required to check the adequacy of member and connection against lateral loads.

8	Non-engineered structures were observed	Implement remedial action if required.	6-months
