# Fame Apparels Ltd.

Plot # B- 188, 189, 210,211 BSCIC Hosiery Shilpanagary, Fatulah, Narayanganj, Bangladesh  
(23.626406, 90.481306)

26<sup>th</sup> December 2016

# Discrepancies between provided drawings and on site condition

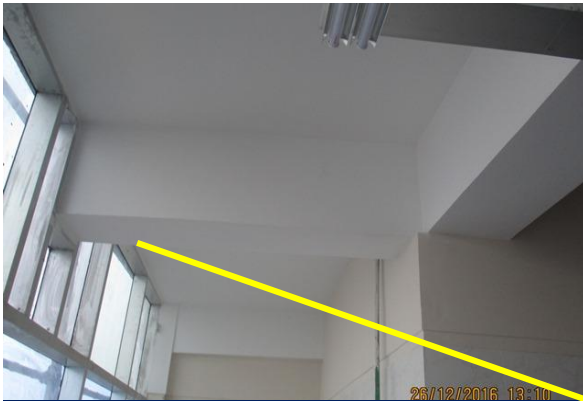
Cantilever beam at north

Cantilever beam at north side not shown in drawings and near south lift core a sub beam shown in as built structural drawings which does not exist. Also mezzanine floor at GF not fully updated in structural drawings.

| Item No. | Observation | Recommended Action Plan | Recommended Timeline |
|---|---|---|---|
| 1 | Discrepancies between provided drawings and on site condition | Building Engineer to survey as constructed building and prepare a set of as-built drawings. | 6-weeks |

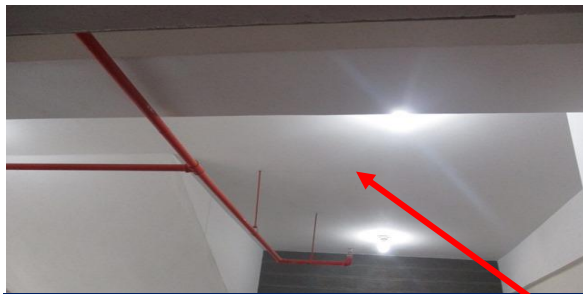
No sub beam at lift core (south)

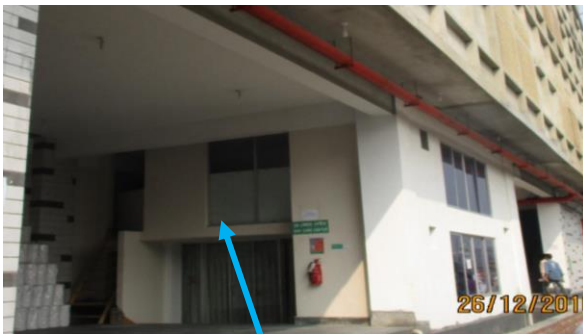
Mezzanine floor

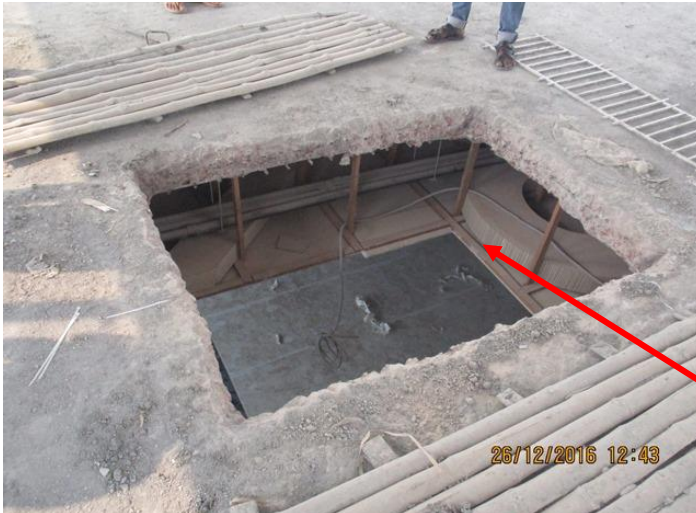
Opening in slab at 9<sup>th</sup> floor

Opening found on 9<sup>th</sup> floor roof slab which is not shown in structural drawing. A beam at same floor was found damaged due to installed hydrant pipe.

| Item No. | Observation | Recommended Action Plan | Recommended Timeline |
|---|---|---|---|
| 2 | Opening in slab and damaged beam found at 9th floor | Factory engineer to investigate damaged beam & the slab opening. | 6-weeks |
| 3 | Opening in slab and damaged beam found at 9th floor | Provide slab and beam adequacy check. | 6-weeks |
| 4 | Opening in slab and damaged beam found at 9th floor | Remedial works to be carried out if required. | 6-months |

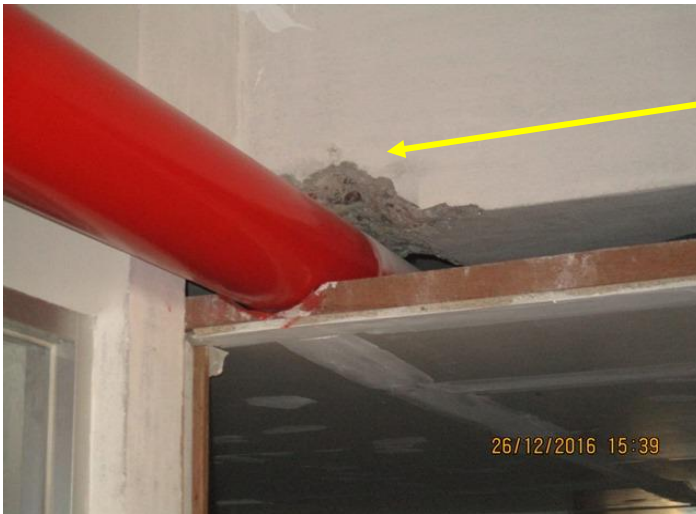
Damaged Beam at 9<sup>th</sup> floor

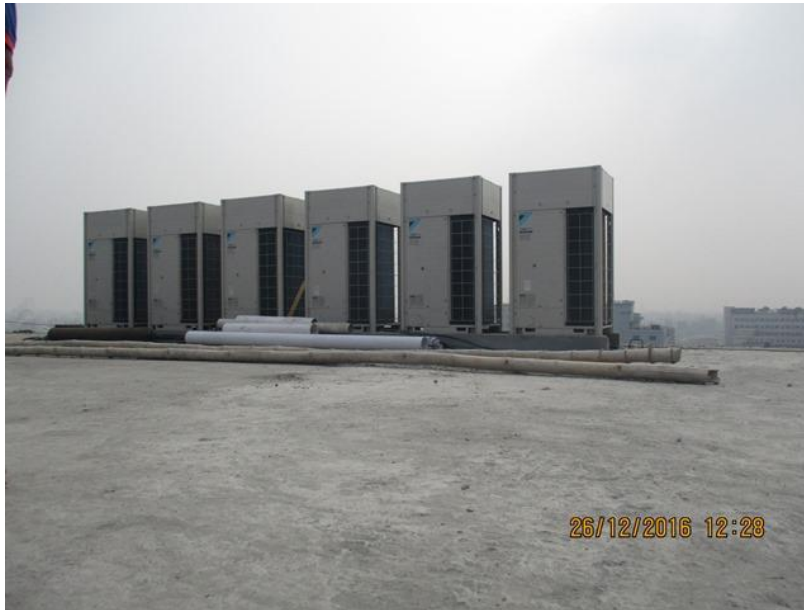
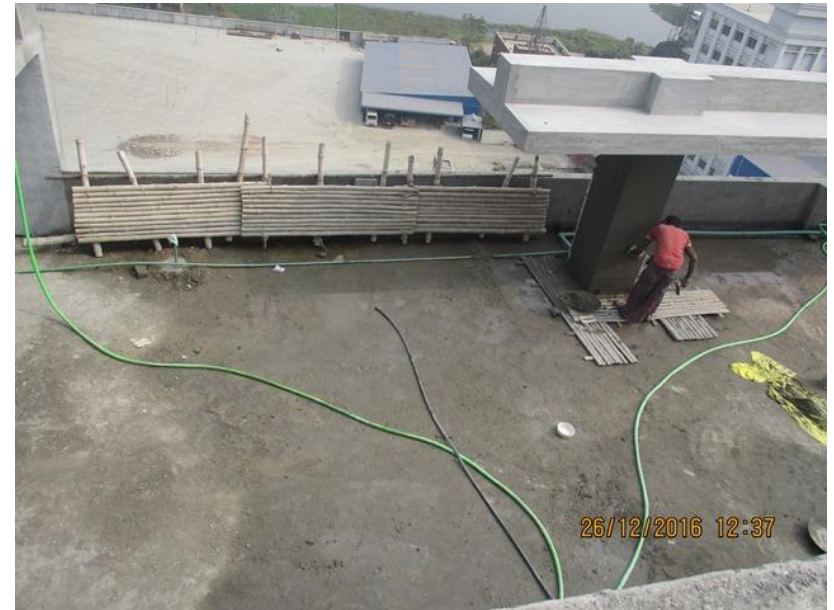
**No water proofing at roof**

During inspection roof top was under construction and no water proofing was observed at roof level.

| Item No. | Observation | Recommended Action Plan | Recommended Timeline |
|---|---|---|---|
| 5 | No water proofing at roof | Waterproofing on the roof slab is to be applied. Moreover the roof slab drainage system should be investigated and improved. | 6-weeks |

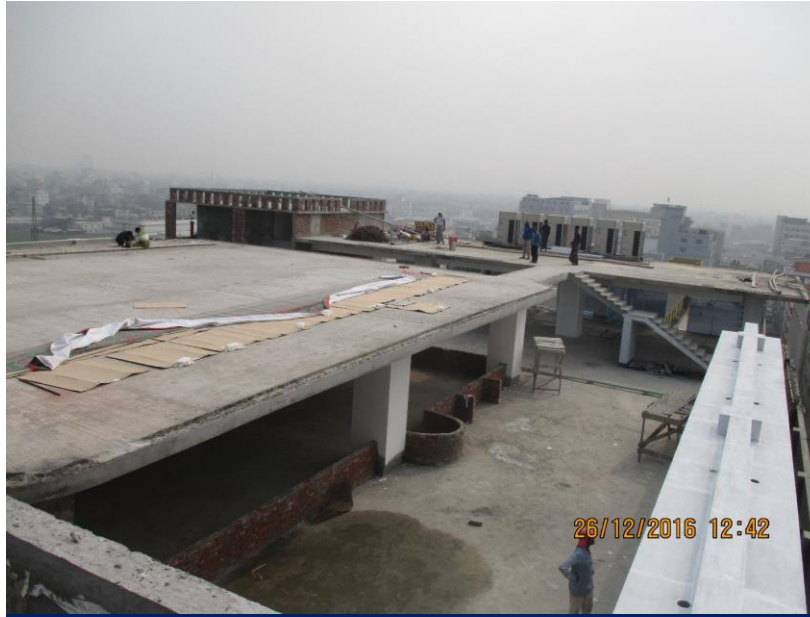
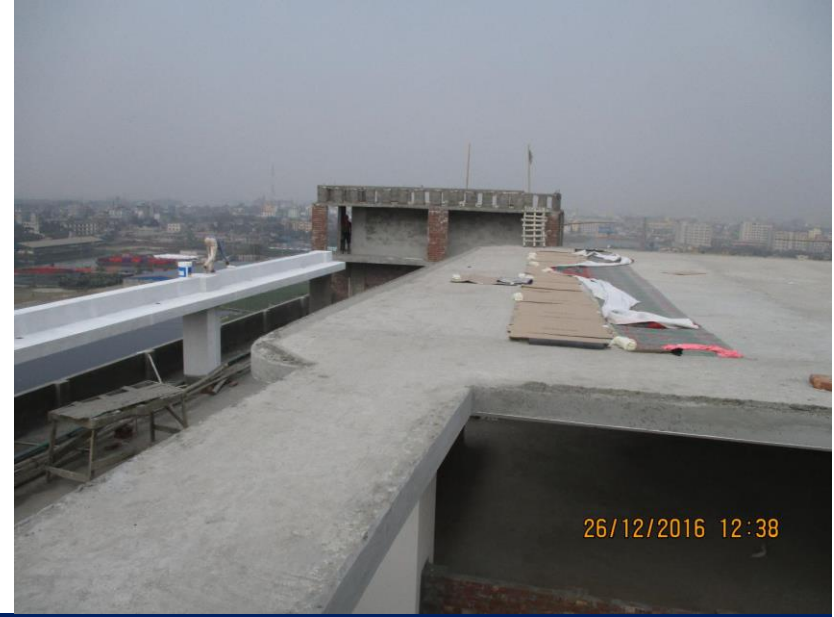
**No edge protection at roof top**

There was no edge protection at roof top.

| Item No. | Observation | Recommended Action Plan | Recommended Timeline |
|---|---|---|---|
| 6 | No edge protection at roof top | Secure constructed area around the perimeter wall to exclude any possible falling hazard. | Immediate - Now |
