# **FIRE SAFETY INSPECTION REPORT**

## **VANCOT LIMITED**

**PLOT 18-20, SECTOR 3, KEPZ, NORTH PATENGA  
EPZ THANA, CHITTAGONG**

June 10, 2014

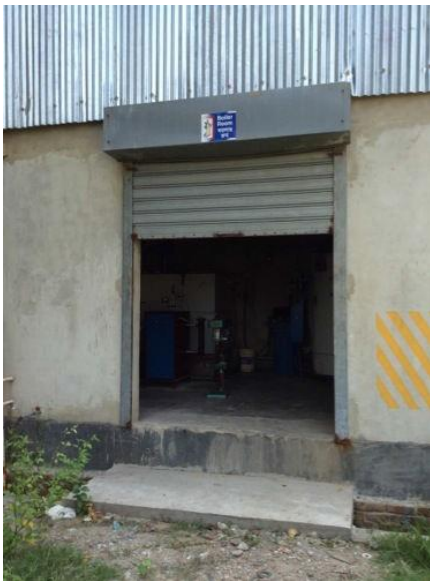
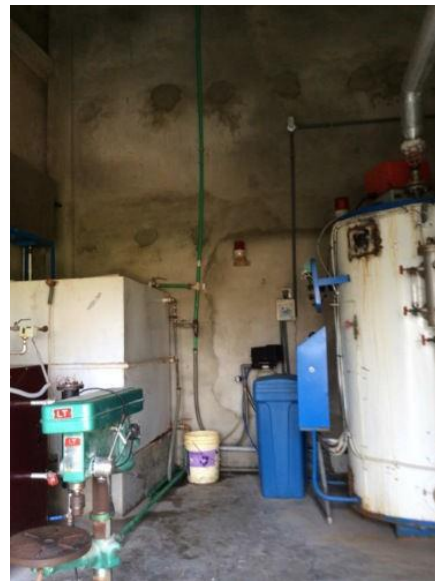
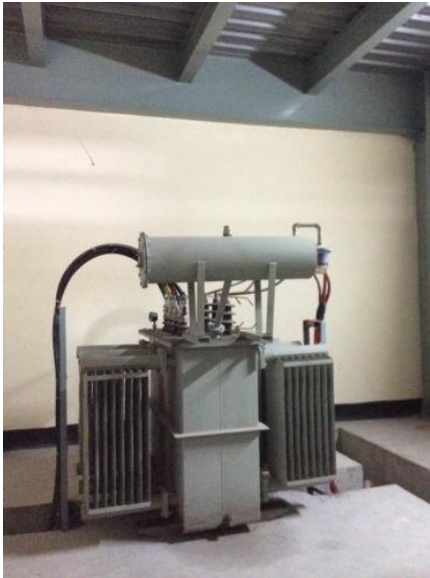
| No . | Category | Findin<br>g | Recommendation | Remediation<br>Timeframe |
|---|---|---|---|---|
| F-1 | Fire Rated Construction | The boiler, and transformer rooms are not separated by fire-rated construction that is openings, non-rated doors, penetration on ground floor south side of the factory. | Separate the boiler and transformer rooms by a minimum 2-hr fire-rated construction. Seal and/or protected all openings to maintain the required fire separations | Within 3 months |

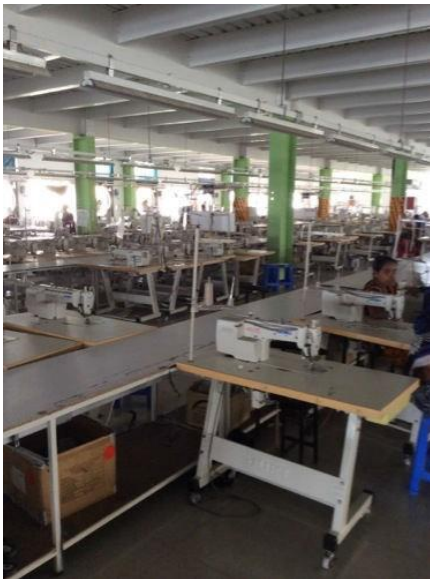
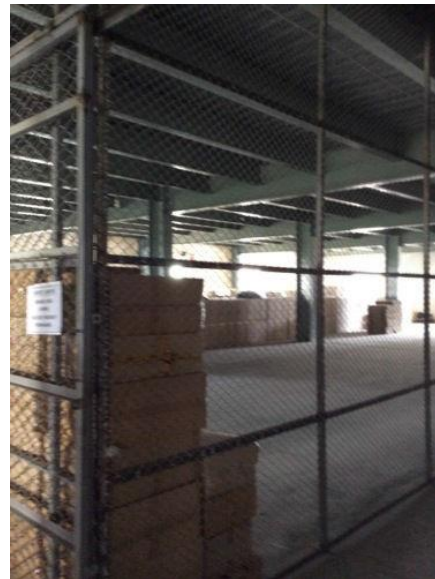
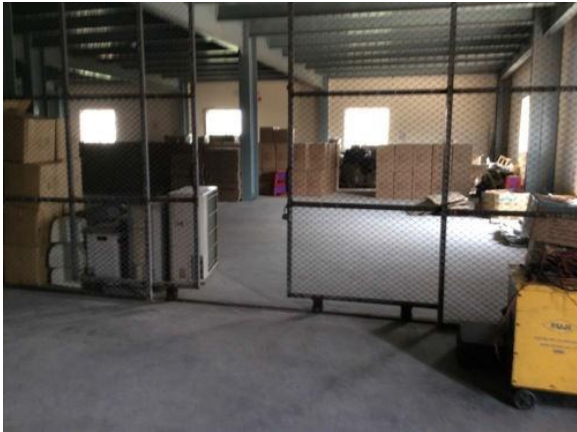
| F-2 | Fire Rated Construction | Areas used for combustible storage are not separated by fire-rated construction on ground and first floors. | Provide dedicated storage rooms separated by minimum 1-hr fire-rated construction. | Within 3 months |

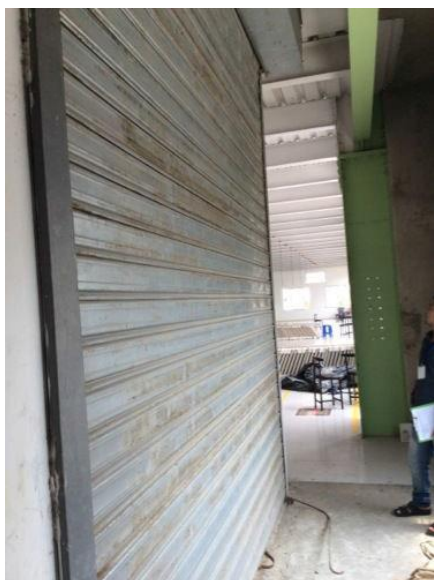
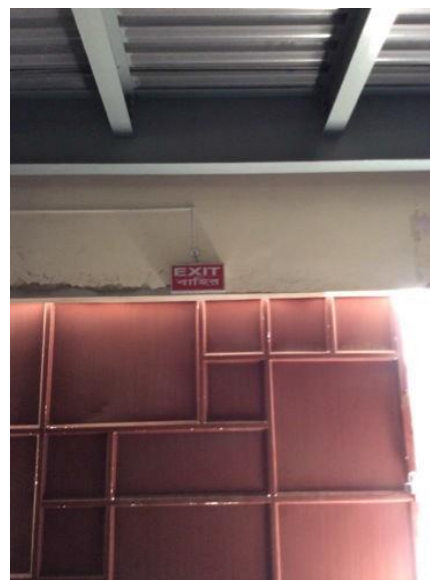
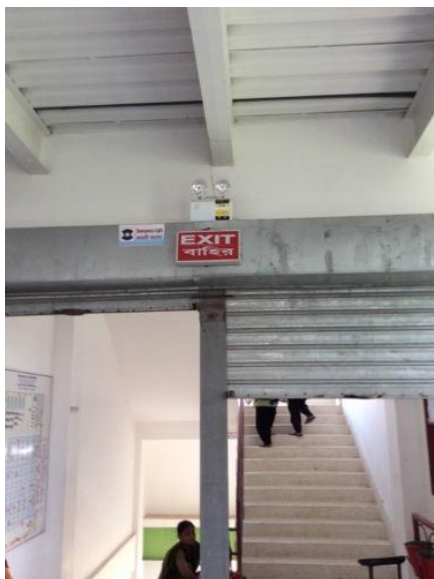
| F-3 | Fire Rated Construction | The exit stairs are not separated from work areas and other spaces on each floor by fire-rated construction. | <p>Provide minimum 1.5-hr fire rated doors and seal all unprotected openings to separate the exit stairs from work areas and other building spaces on all floor levels. Ensure that the fire doors are self-closing and positive latching and that they are provided with fire exit (panic) hardware where serving production floors.</p> <p>If fire doors are required to be held open for functional reasons, provide automatic-closing devices tied to the fire alarm system.</p> | Within 3 months |

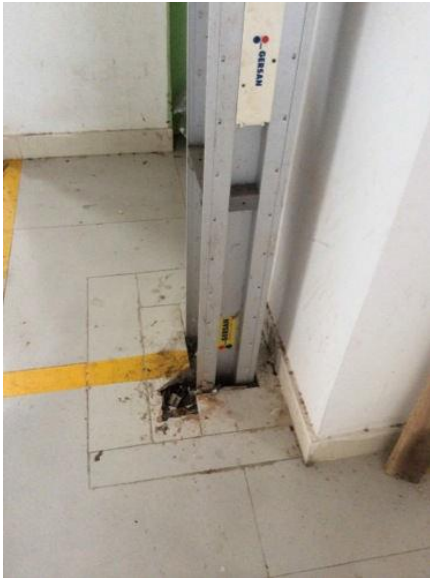
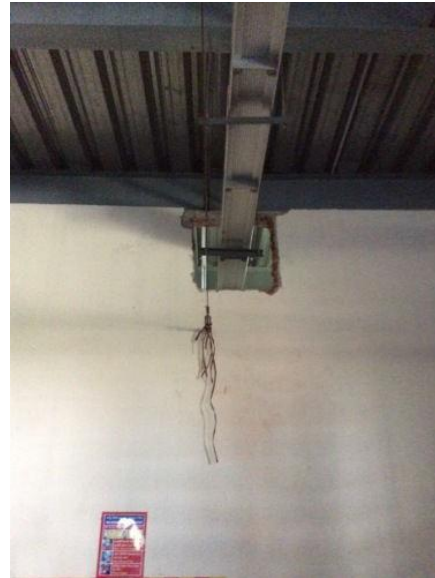
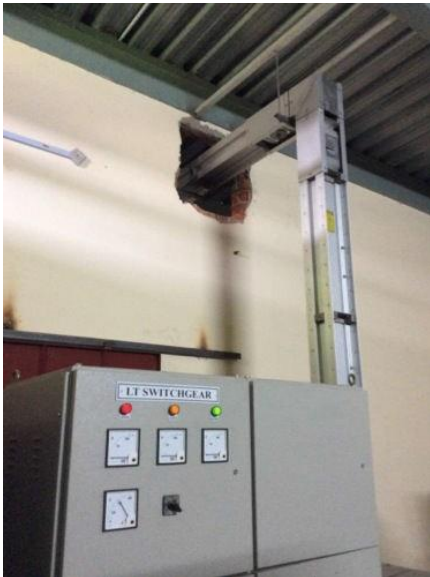
| F-4 | Fire Rated Construction | Unsealed penetrations and openings are located in the fire-rated floor/ceiling assemblies. | <p>Provide a minimum 2-hr fire-rated shaft to separate the utility risers from each floor level.</p> <p>Seal all penetrations and openings in floor/ceiling assemblies to maintain the fire separation.</p> | Within 3 months |

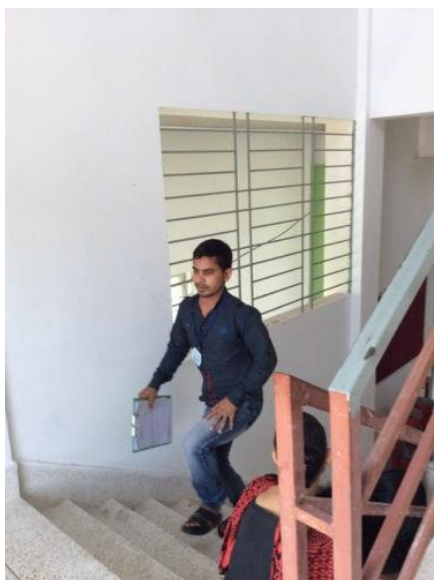
| F-5 | Fire Rated Construction | Unsealed penetrations and openings are located in exit stair enclosures. | Seal all penetrations and openings in exit stair enclosure walls to maintain the fire separation. | Within 3 months |

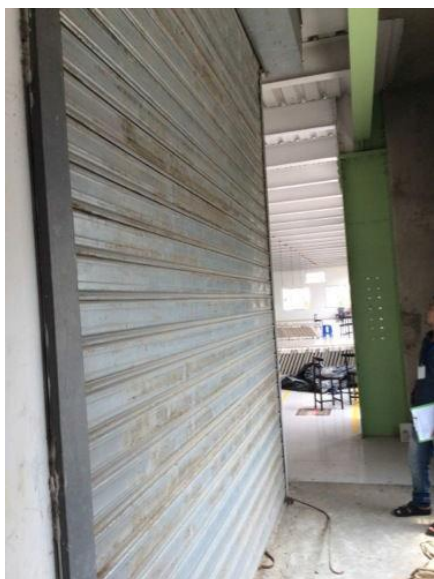
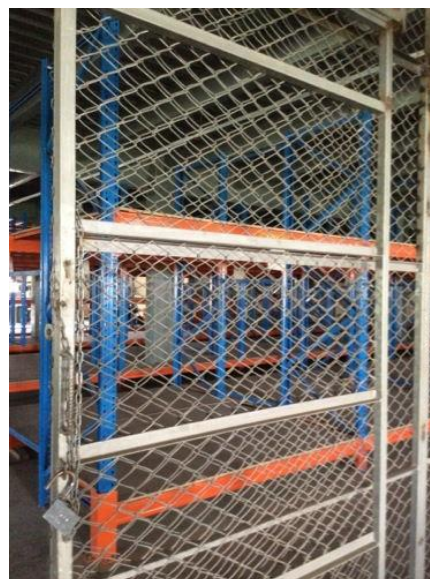
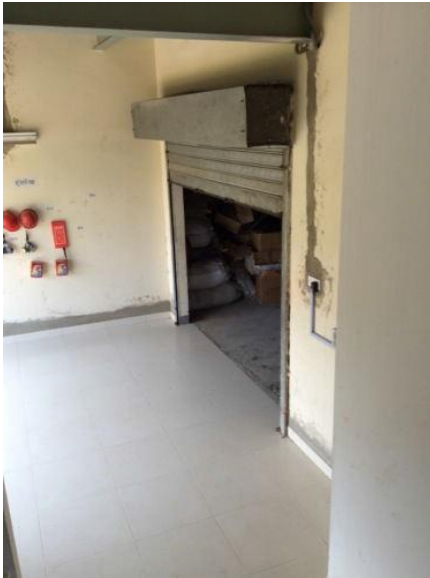
| F-6 | Egress | Egress doors / gates with locking features are provided at building exits, exit stairs, along egress routes and exit discharge on all floors. Except for first floor east exit stairs, gates/doors were open and unlocked during inspection. | Remove locking features from all egress doors / gates.<br><br>If locks are required for security reasons, utilize special door locking features complying with NFPA 101. | Immediate |

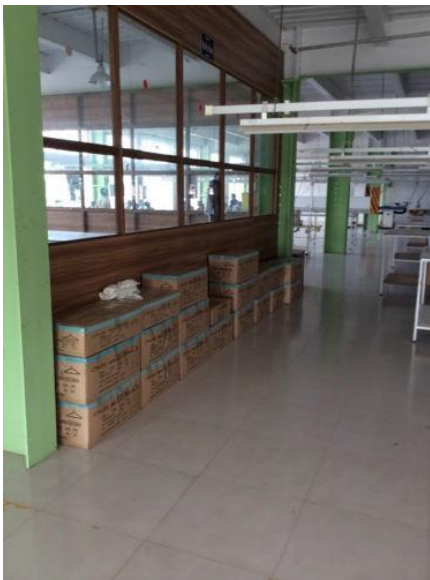
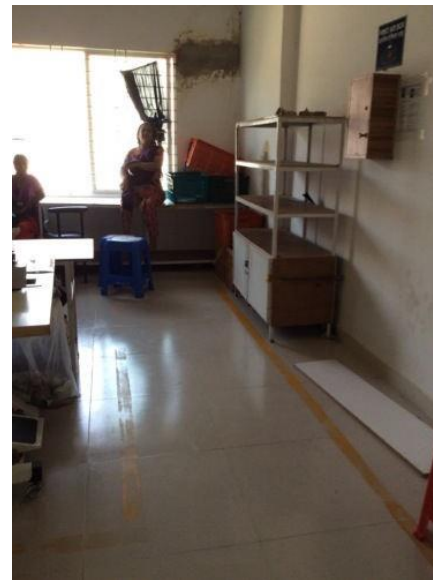
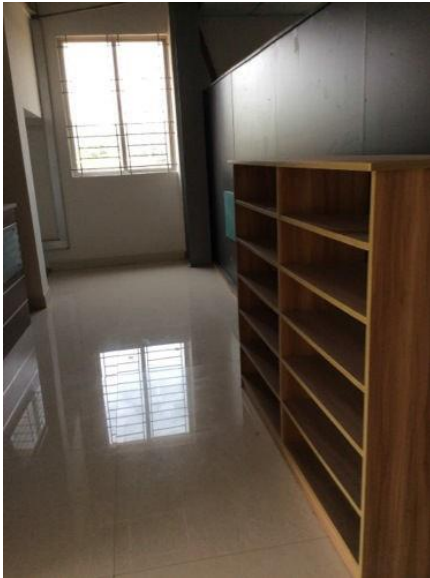
| F-7 | Egress | Storage was located in the egress path on first and ground floors. | Keep egress paths and stairs clear of storage. | Immediate |

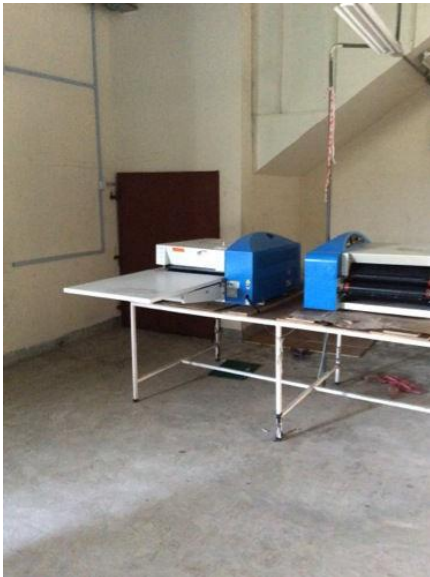
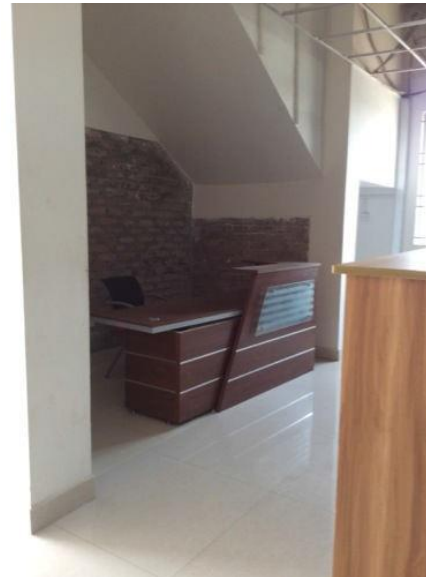
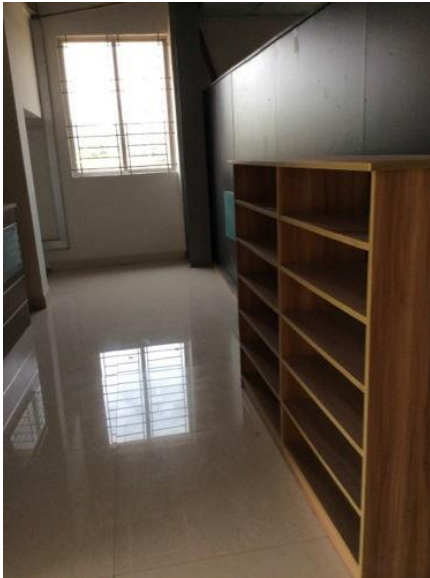
| F-8 | Egress | Storage was located in the exit stair. On north and south stairs | Remove all storage from exit stairs and egress paths. | Immediate |

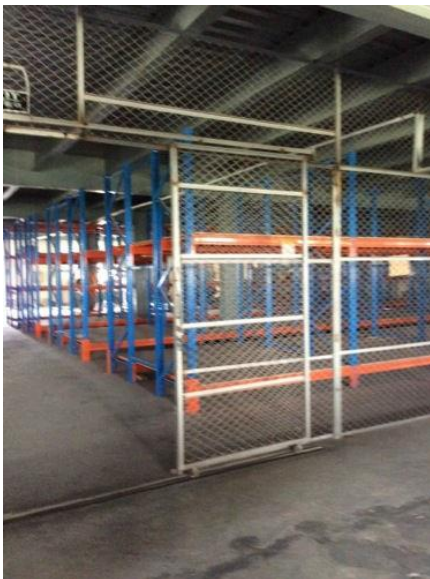
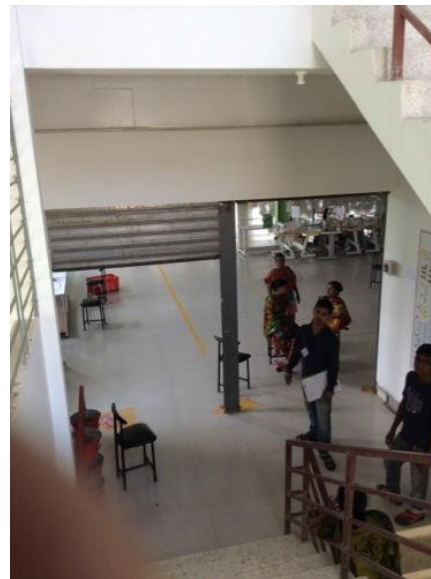
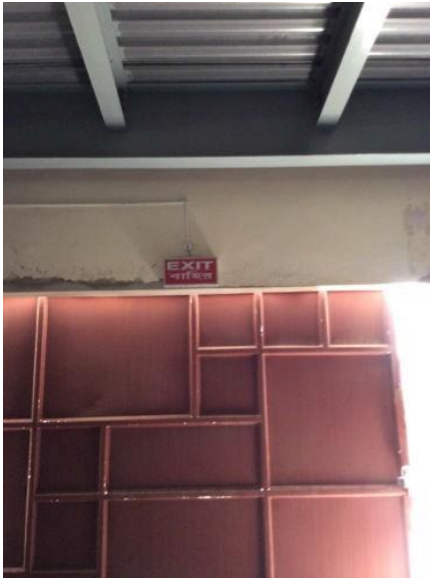
| F-9 | Egress | Collapsible gates / sliding doors and roll down doors are provided at building exits, exit stairs, along egress route and exit discharge on all floors. | <p>Replace all gates / sliding doors along the means of egress with side-hinged, swinging egress doors.</p> <p>If locks are required for security reasons, utilize special door locking features complying with NFPA 101.</p> | Within 1 month |

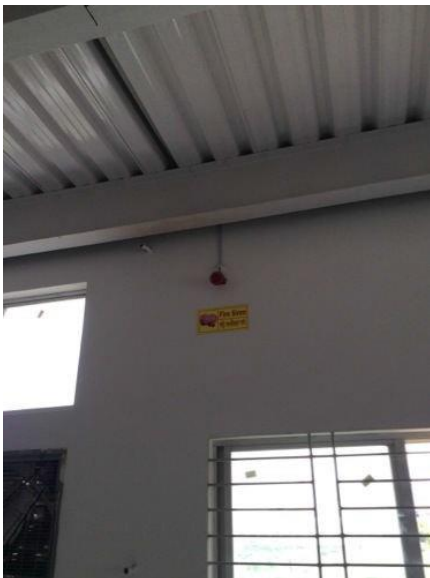
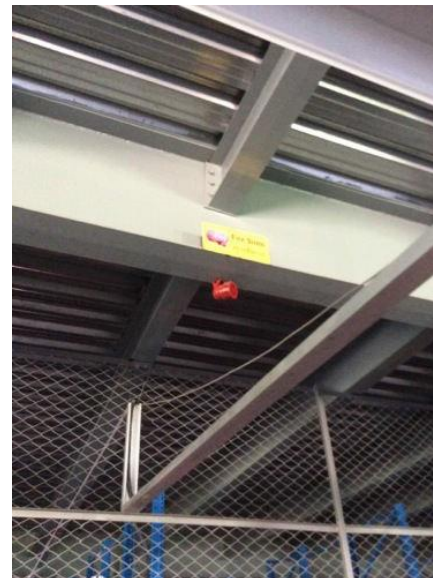
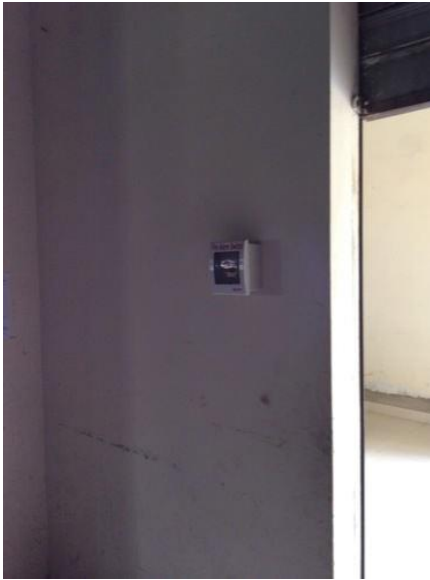
| F-10 | Fire Protection | The fire alarm system is antiquated, not a listed system, and does not provide alarm and notification features consistent with acceptable standards. | Replace the fire alarm system with a new, listed addressable fire alarm system in accordance with NFPA 72. | Design within 4 months, install within 9 months |
