# Best Wool Sweaters Ltd

Jarun, Konabari, Gazipur, Dhaka, Bangladesh  
(+24.000421N, 90.323217E)

15<sup>th</sup> June 2014

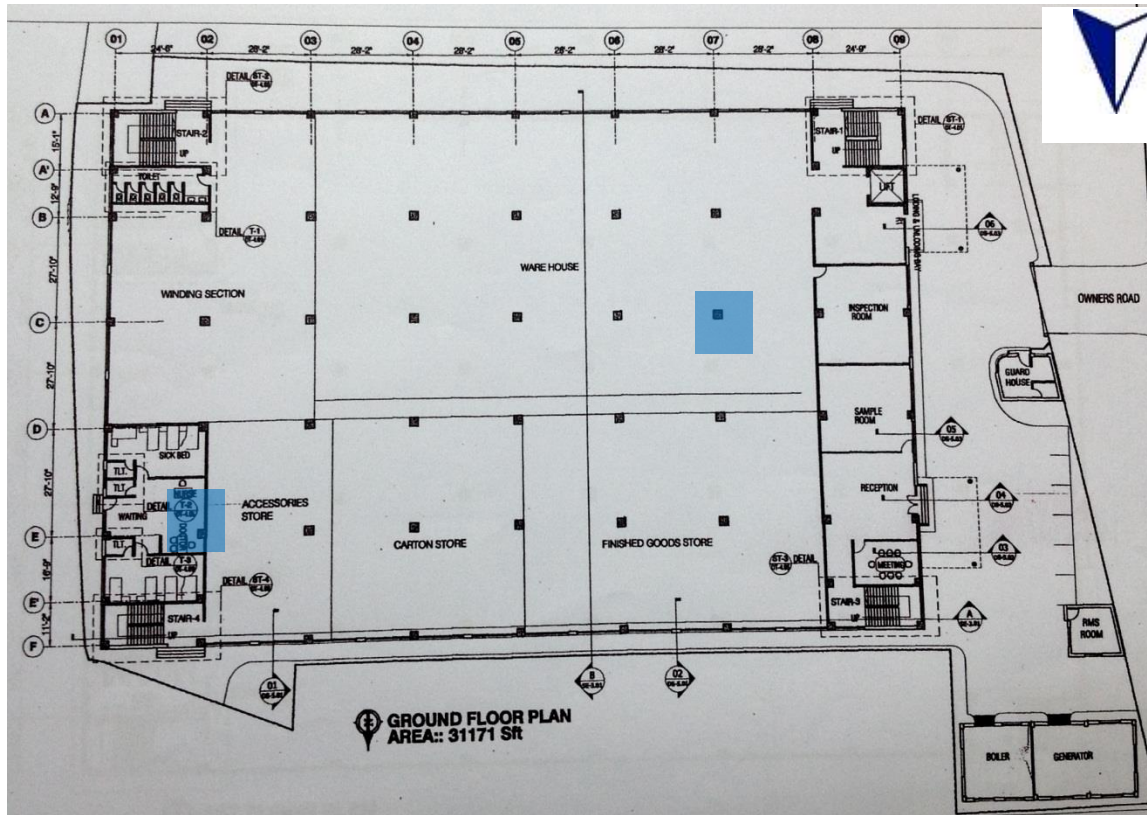
Ground Floor Plan

**Column stresses in the North-East corner of the main building appear to be in excess of normal design limits**

Cursory calculations indicate that column stresses in the N-E corner at Ground Floor level are in excess of normal design limits, due to significant water tank and toilet floor build-up loads.

Tested Columns

| Item No. | Observation | Recommended Action Plan | Recommended Timeline |
|---|---|---|---|
| 1 | Column stresses in the North-East corner of the main building appear to be in excess of normal design limits - due to loading from the elevated Water Tank and significant Toilet floor build-up | Factory Engineer to review design, loads and column stresses in area of the building highlighted above. | 6-weeks |
| 2 | Column stresses in the North-East corner of the main building appear to be in excess of normal design limits - due to loading from the elevated Water Tank and significant Toilet floor build-up | Verify insitu concrete stresses either by 100mm diameter cores or existing cylinder strength data for cores from 4 columns. | 6-weeks |
| 3 | Column stresses in the North-East corner of the main building appear to be in excess of normal design limits - due to loading from the elevated Water Tank and significant Toilet floor build-up | Produce and actively manage a loading plan for all floor plates within the factory giving consideration to floor capacity and column capacity. | 6-months |

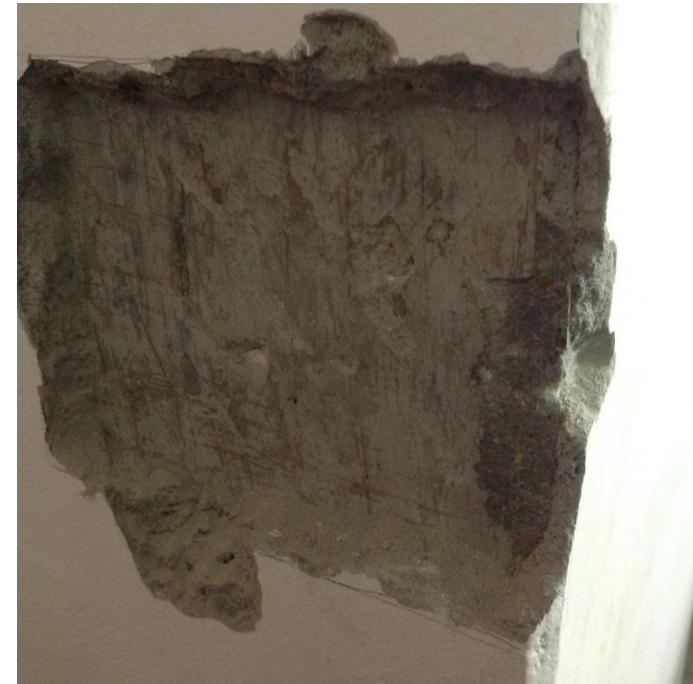
Tested Column

Stone aggregate was observed in the Ground Floor columns. High yield steel reinforcement is called up on the drawings and was observed in the columns at Roof level. Reinforcement quantities observed at Roof level and determined at Ground Floor level appear to be consistent with the drawings.

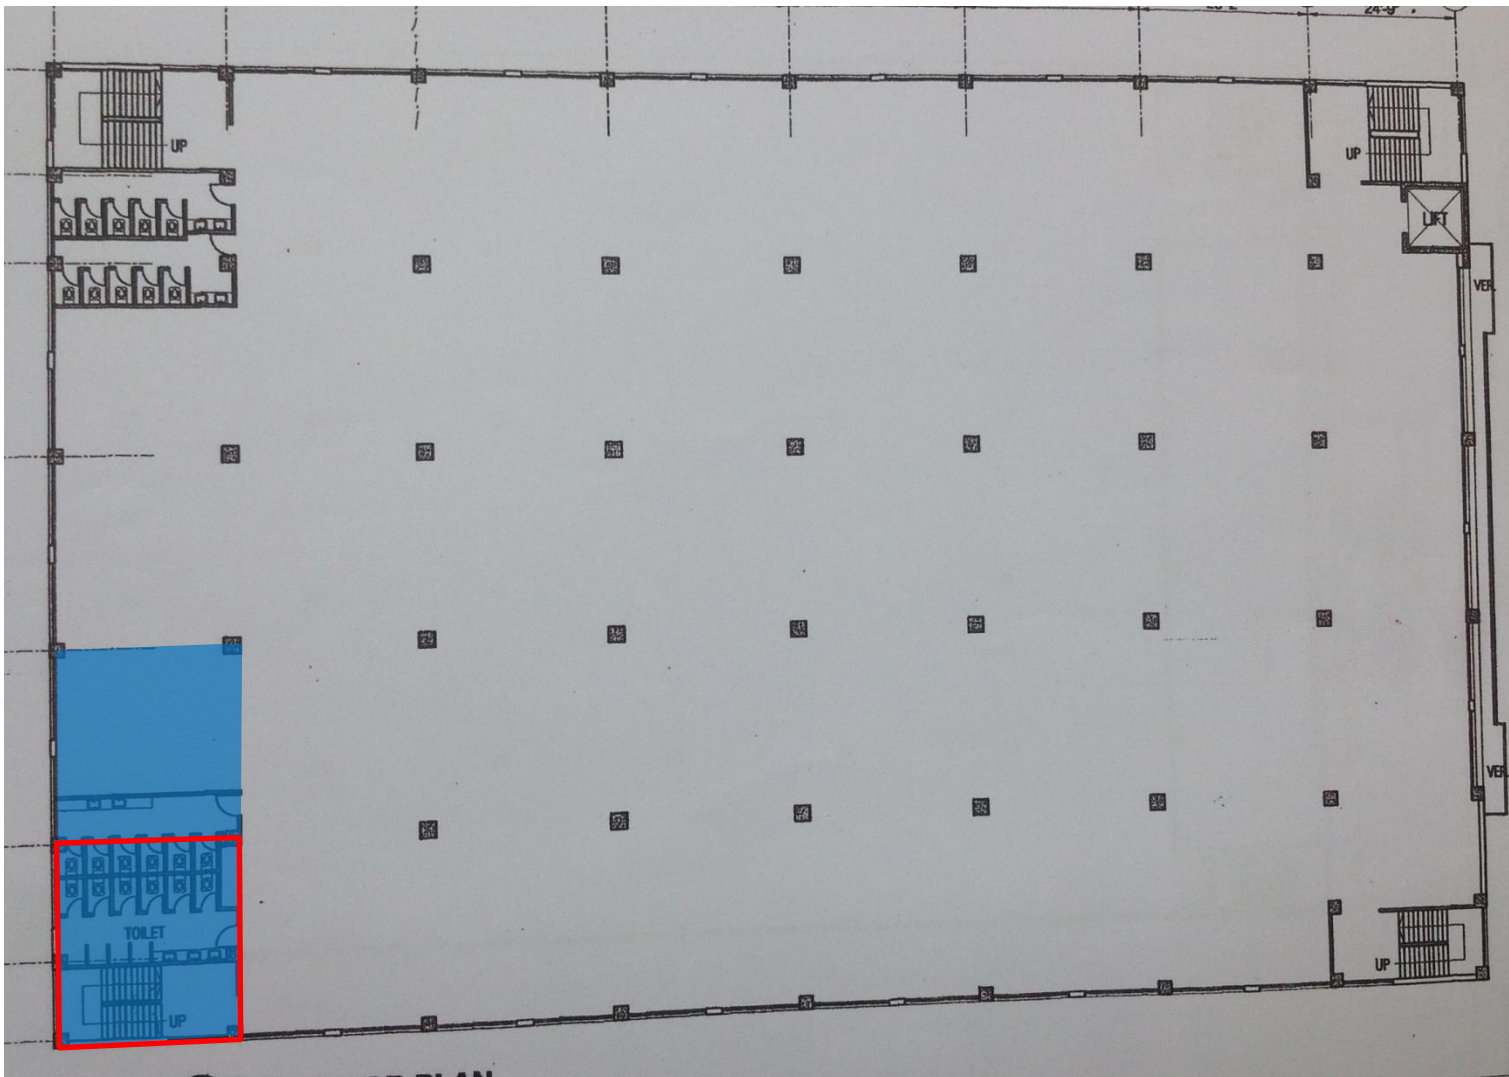
Typical Floor Plan

Extent of Toilets at all floor levels

Extent of Water Tank at Roof level

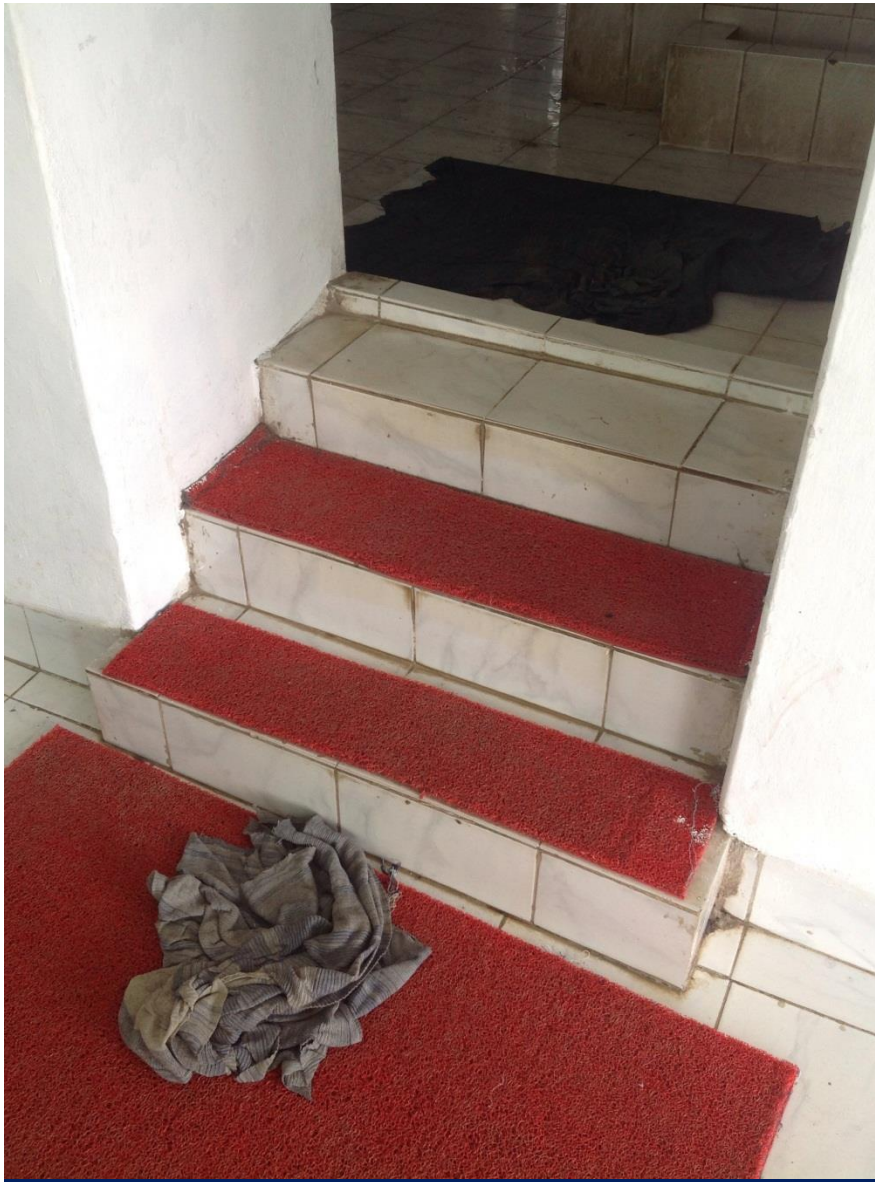
430mm average toilet floor build-up at all floor levels

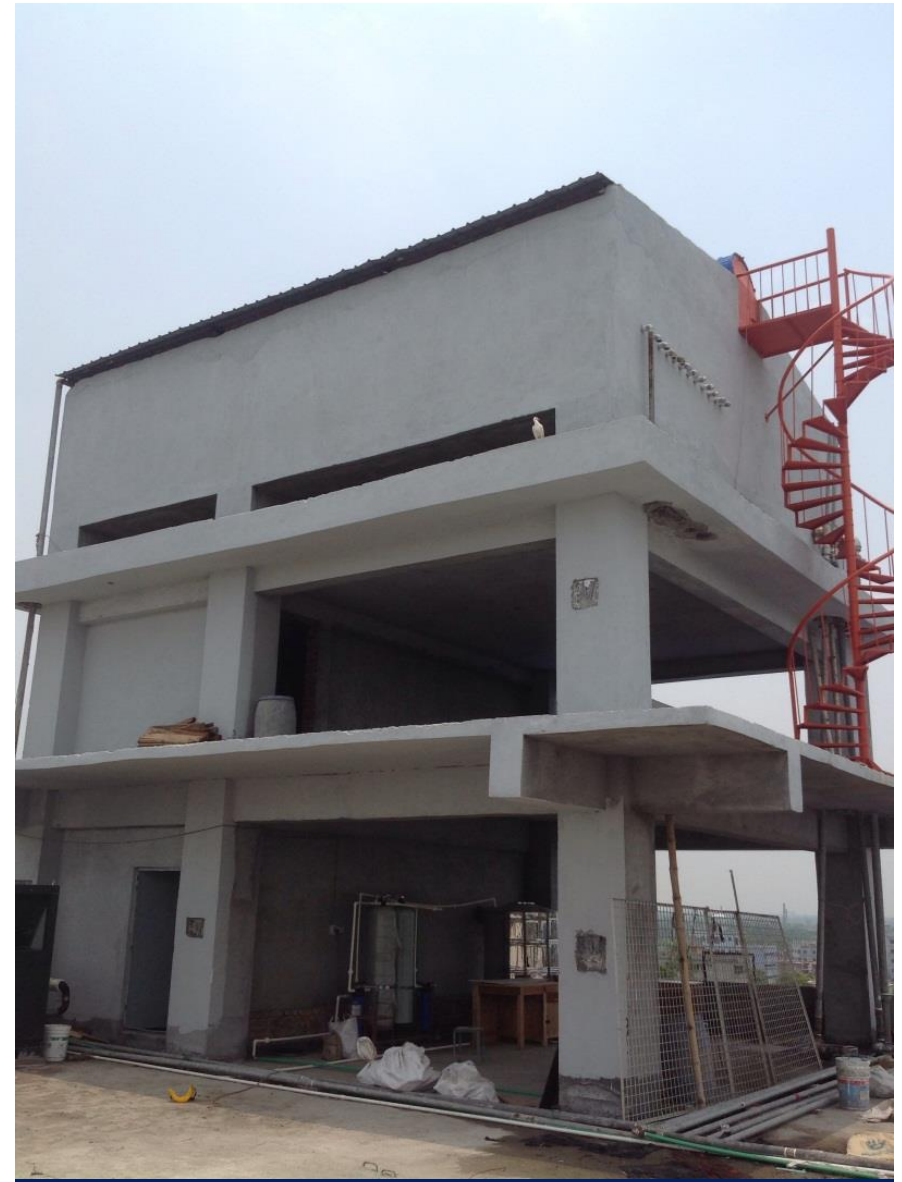
Water Tank at Roof level

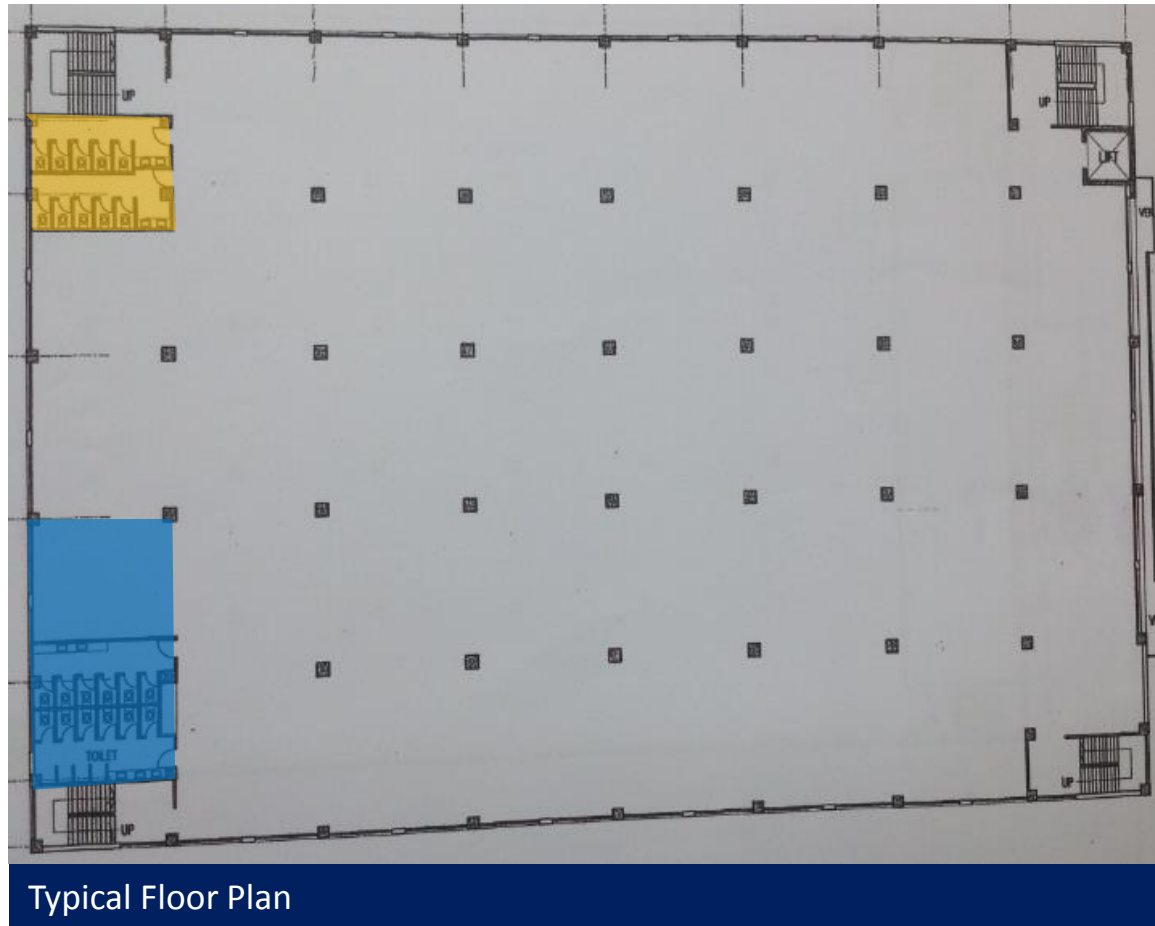
The Toilet block to the South-East corner, adjacent to Stair 3, is not in the location shown on the drawings other than at 1<sup>st</sup> Floor level. At all other floors, the majority of the Toilets are located to the North-East corner, adjacent to Stair 4, and, while these vary in size, occupy a larger area than is shown on the drawings.

Toilets typically not located in this area, other than at 1<sup>st</sup> Floor level

Toilet block in this area is typically larger than shown

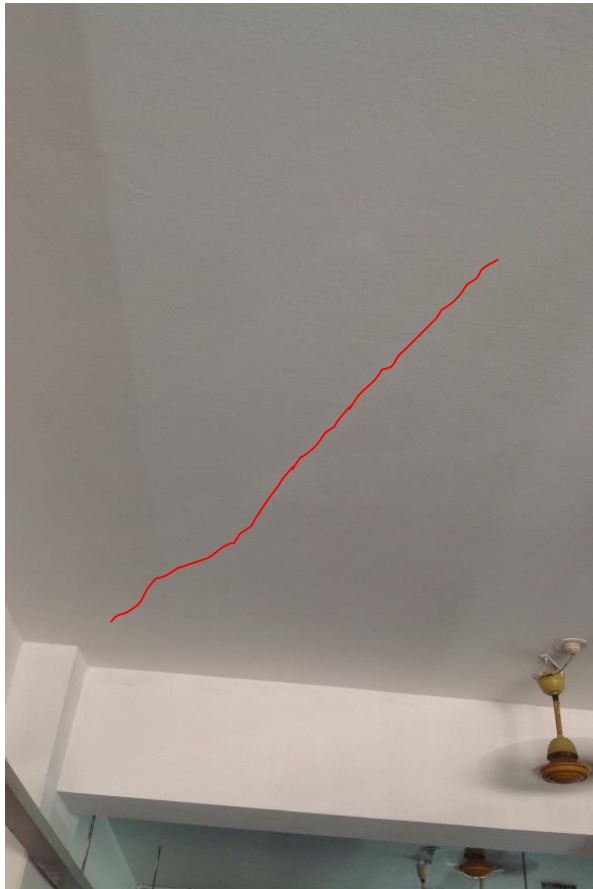
Hairline cracking was observed in the render to a number of beam and slab soffits at most floor levels. Cracking was also observed to the top of the slab. Note that a large number of cracks appear to have been filled and / or painted over. It is not clear whether the cracking extends into the concrete.

Cracking to slab soffit

| Item No. | Observation | Recommended Action Plan | Recommended Timeline |
|---|---|---|---|
| 4 | Hairline cracking to soffit of beams and slabs in main building | Monitor cracks to beams and slab soffit. Engage an engineer to investigate if cracks are only in the plastering. | 6-months |
| 5 | Hairline cracking to soffit of beams and slabs in main building | Engage a Building Engineer to advise on load reduction and repair and strengthening of the slab if required. | 6-months |

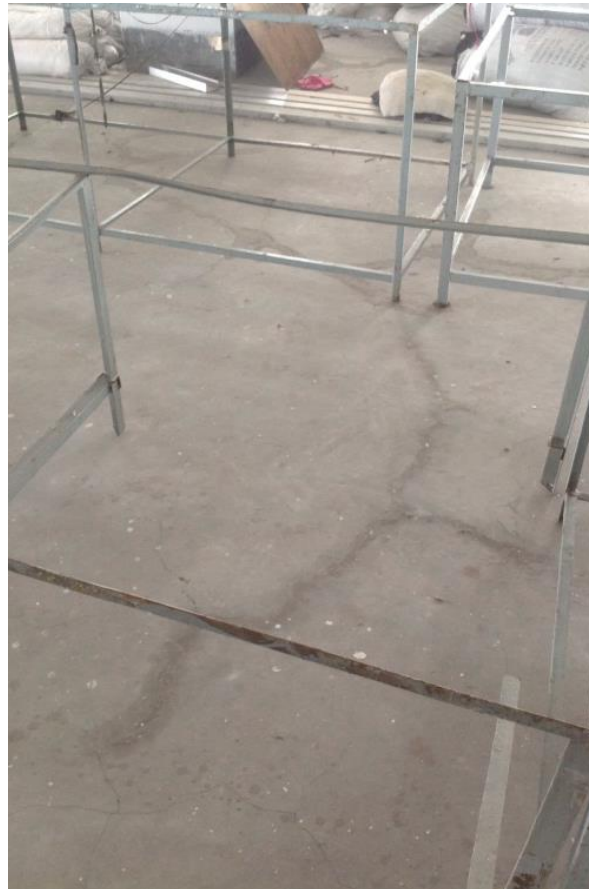
Cracking to top of slab

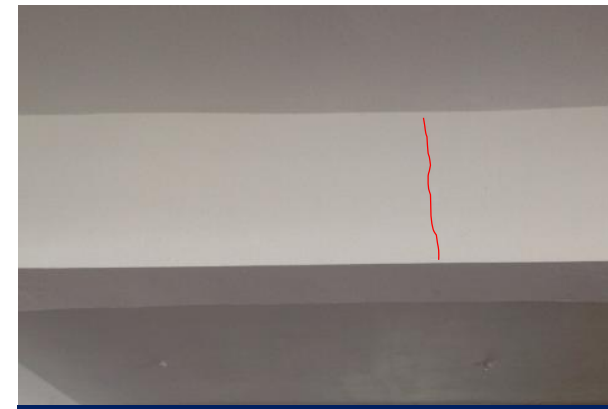
Cracking to Beam Soffit

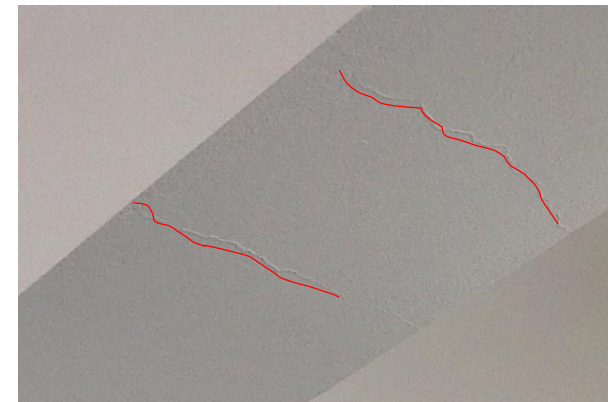
Filled Cracks to Beam Soffit

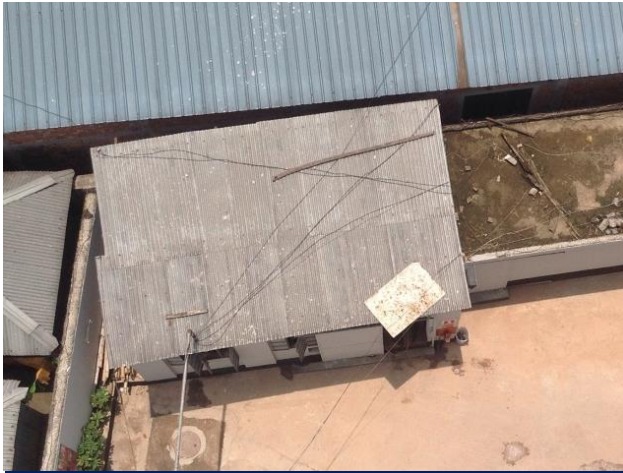
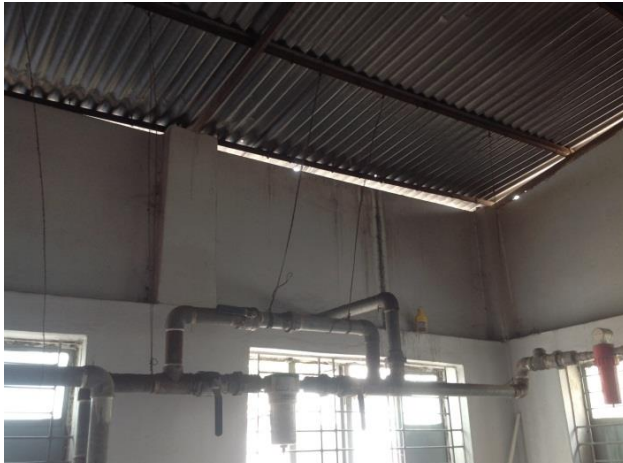
A number of utility buildings and the elevated water tank have lightweight roof structures that appear to be non-engineered and may be unsuitable to resist uplift forces and lateral loads.

Lightweight roof to Compressor Room

| Item No. | Observation | Recommended Action Plan | Recommended Timeline |
|---|---|---|---|
| 6 | Lightweight, apparently non-engineered roof structures to utility buildings | Engage a Building Engineer to review the design of all lightweight roof structures within the compound, and confirm their ability to withstand wind loading pressure, suctions and uplift forces, with special emphasis on connections and bracing. | 6-months |
| 7 | Lightweight, apparently non-engineered roof structures to utility buildings | Building Engineer to implement any actions / supervise any remedial works as identified following the review. | 6-months |

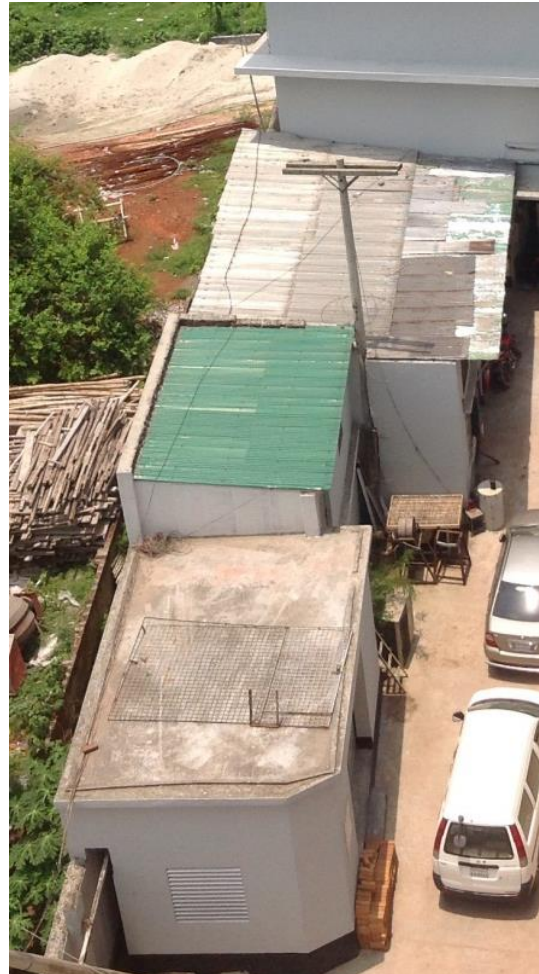
Roofs to Substation and Diesel Generator Room

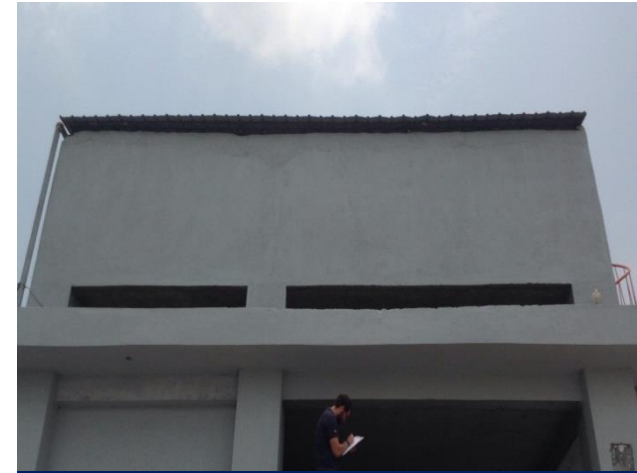
Non-engineered roof to water tank

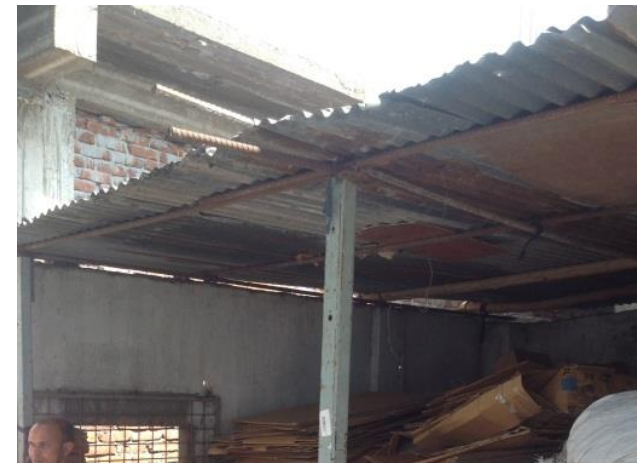
Lightweight roof to Wastage Shed
