# New Era Fashions Mfrs (BD) Ltd

Plot 10,11 & 12  
Sector 8, Road 3, CEPZ, Chittagong  
(22.279298N, 91.776438E)

21<sup>st</sup> June 2014

# Observations

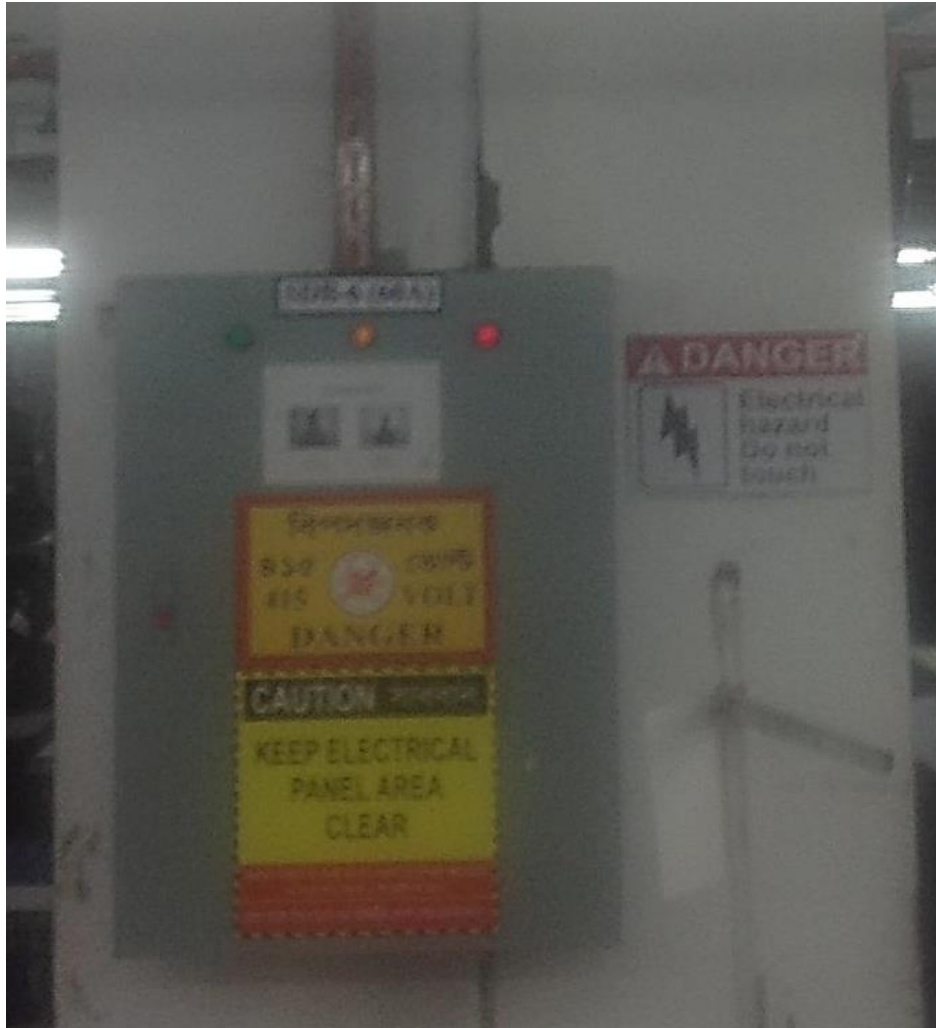
# **Safety Hazard – Water ingress through unsealed expansion joint adjacent to electrical panels**

Expansion joint has not been waterproofed resulting in water ingress at 1<sup>st</sup> Floor level. There are serious concerns over the proximity of electrical panels adjacent to the joint.

Water ingress penetrating construction joints where electrical panels are connected

| Item No. | Observation | Recommended Action Plan | Recommended Timeline |
|---|---|---|---|
| 1 | Safety hazard – Water ingress through unsealed expansion joint adjacent to electrical panels | Building Engineer to advise on adequate waterproofing of expansion joint and to supervise works with immediate effect. | <b>Immediate - Now</b> |

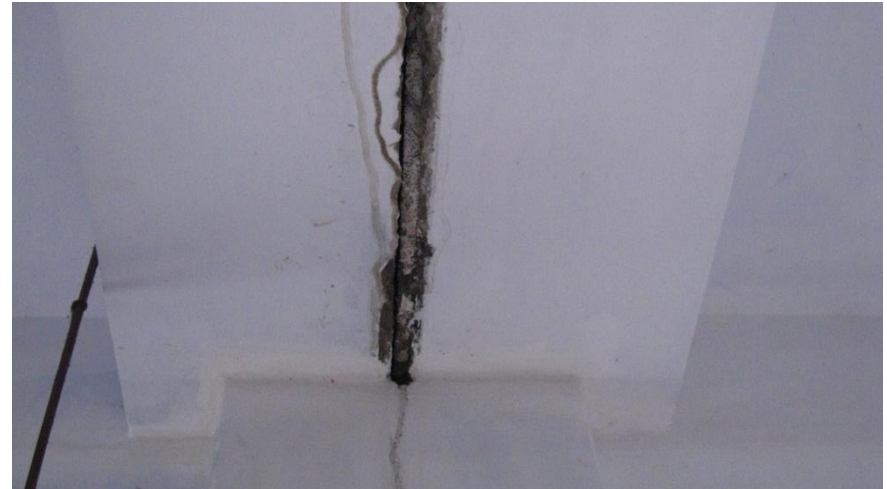
Water ingress at expansion joint

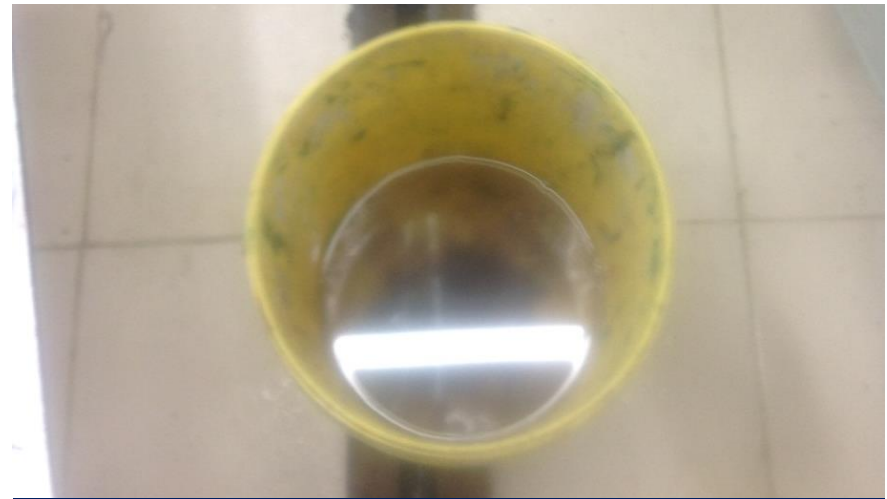
Collected water in a pail during heavy rainfall

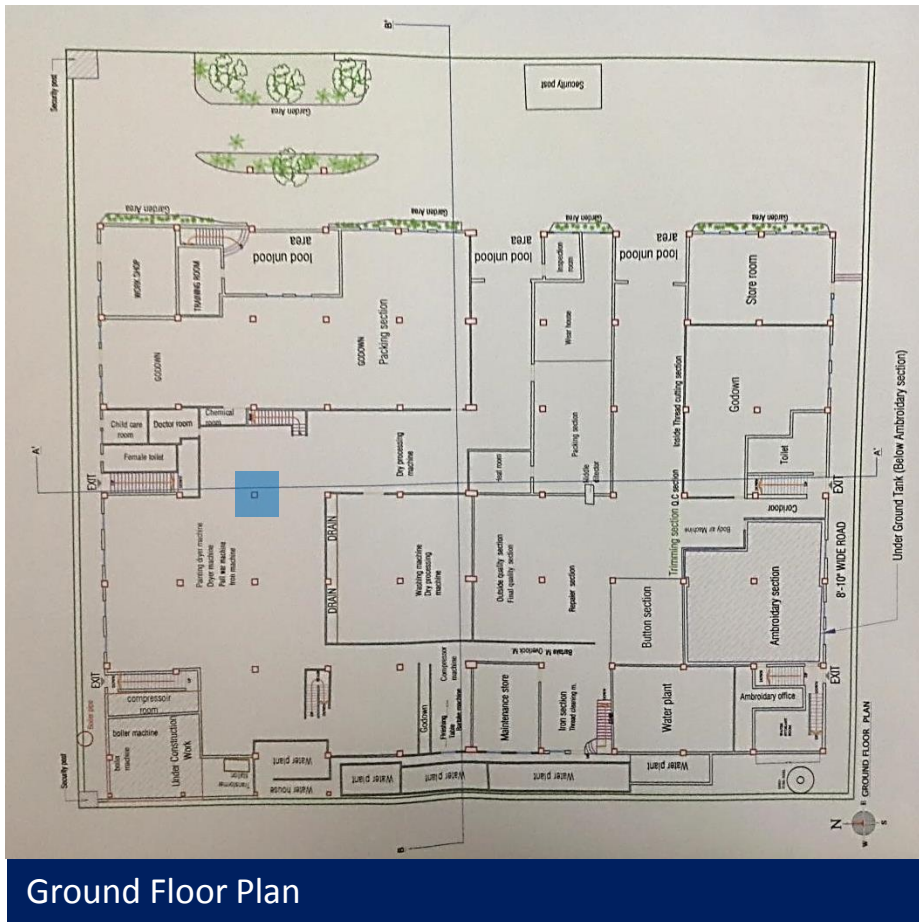
Ground Floor Plan

**Building columns appear to be stressed in  
excess of normal design limits**

Cursory calculations indicate that the working stresses of the columns at Ground Floor level are above normal design limits.

Tested Column

| Item No. | Observation | Recommended Action Plan | Recommended Timeline |
|---|---|---|---|
| 2 | Building columns appear to be stressed in excess of normal design limits | Building Engineer to review design, loads and column stresses in building. | <b>6-weeks</b> |
| 3 | Building columns appear to be stressed in excess of normal design limits | Verify insitu concrete stresses either by 100mm diameter cores or existing cylinder strength data for cores from min. 4 columns. | <b>6-weeks</b> |
| 4 | Building columns appear to be stressed in excess of normal design limits | Verify existing reinforcement in columns. | <b>6-weeks</b> |

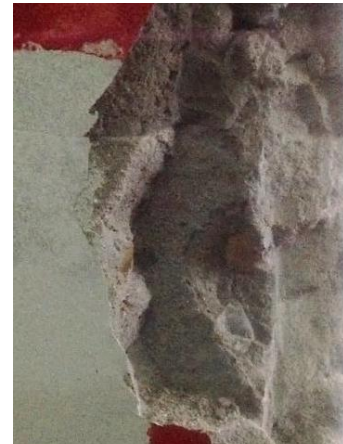
Stone Aggregate

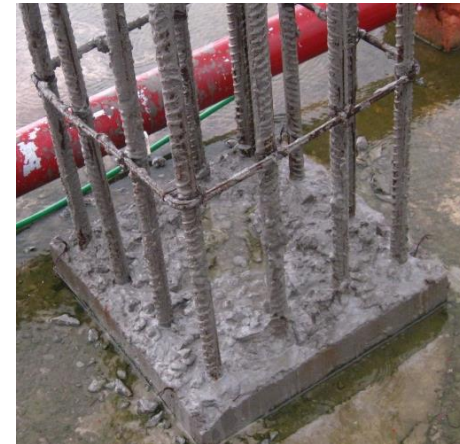
12 no. high yield rebar

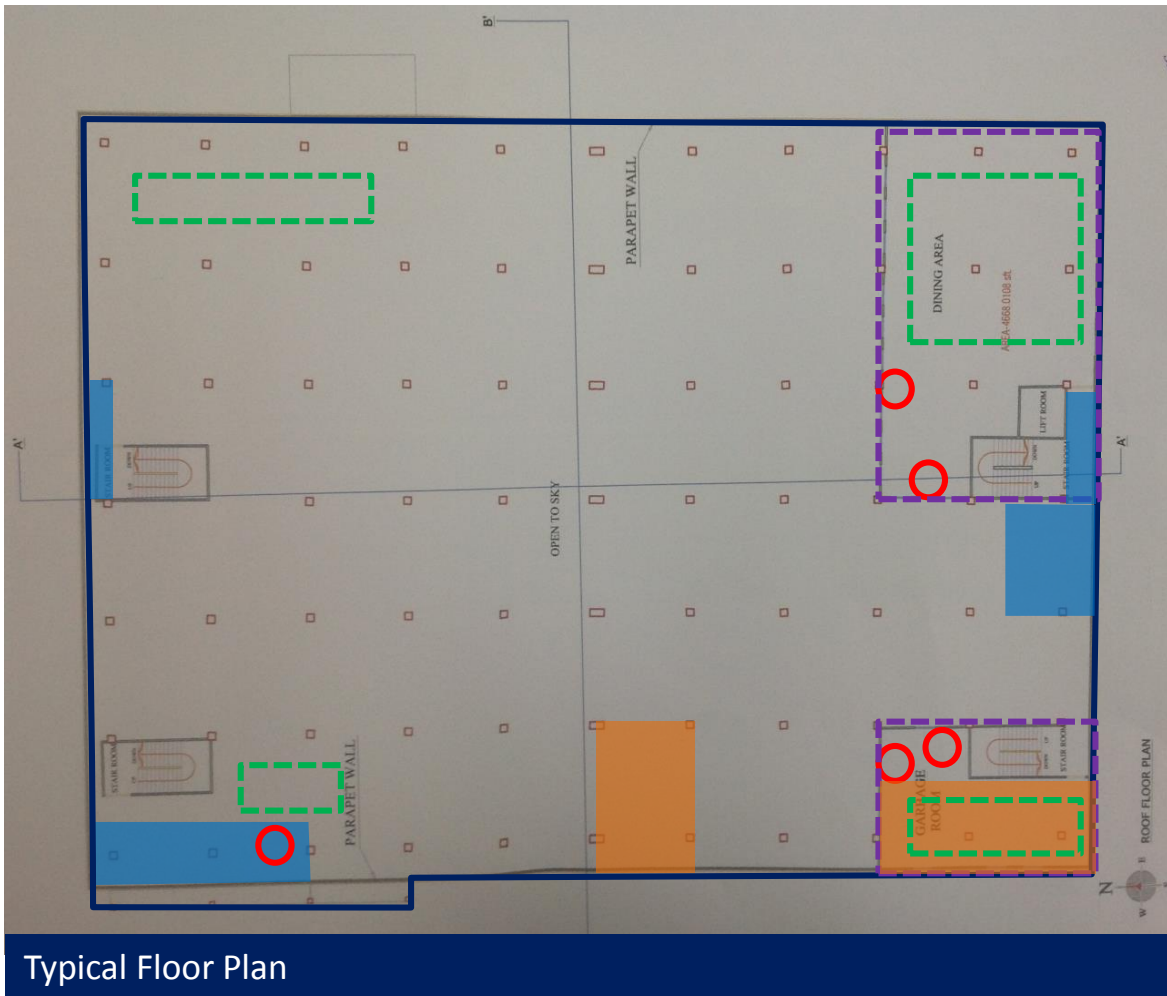
Building footprint

Areas of high loading were observed in the building, including Gazi water tanks and construction material storage at Roof level, fabric and boxed storage at 1<sup>st</sup> and Mezzanine Floor levels, and significant toilet build-up at 1<sup>st</sup> and Mezzanine floor levels. There was no loading plan for the factory building available on the day of the survey.

| Item No. | Observation | Recommended Action Plan | Recommended Timeline |
|---|---|---|---|
| 6 | Heavy floor loading and lack of a Loading Plan | Building Engineer to carry out a design check of floor slabs for loads associated with the water tanks, toilet build-ups and storage areas, and to advise on any necessary alterations taking account of floor capacity. | 6-weeks |
| 7 | Heavy floor loading and lack of a Loading Plan | Factory Management to actively implement and manage Loading Plan. | 6-months |

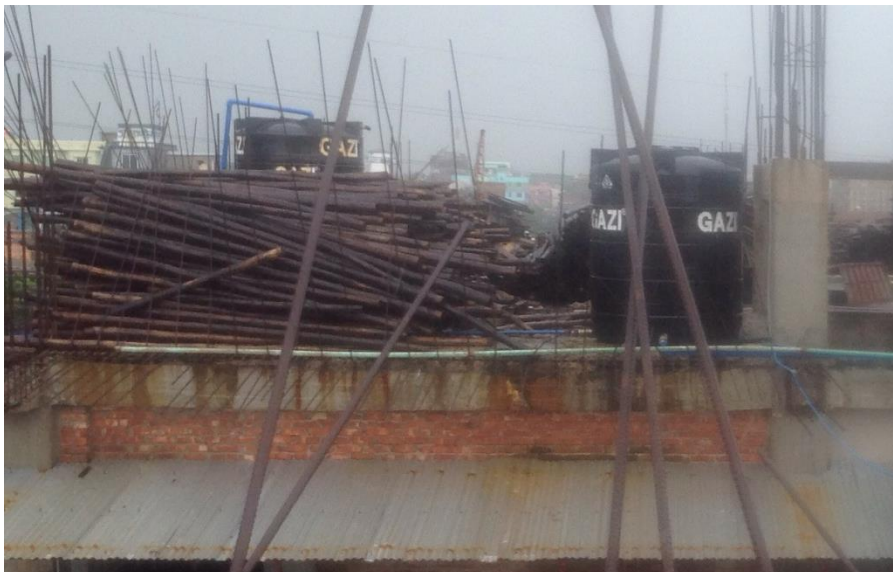
3,000 litre & 5,000 litre water tanks on roof (2<sup>nd</sup> Floor)

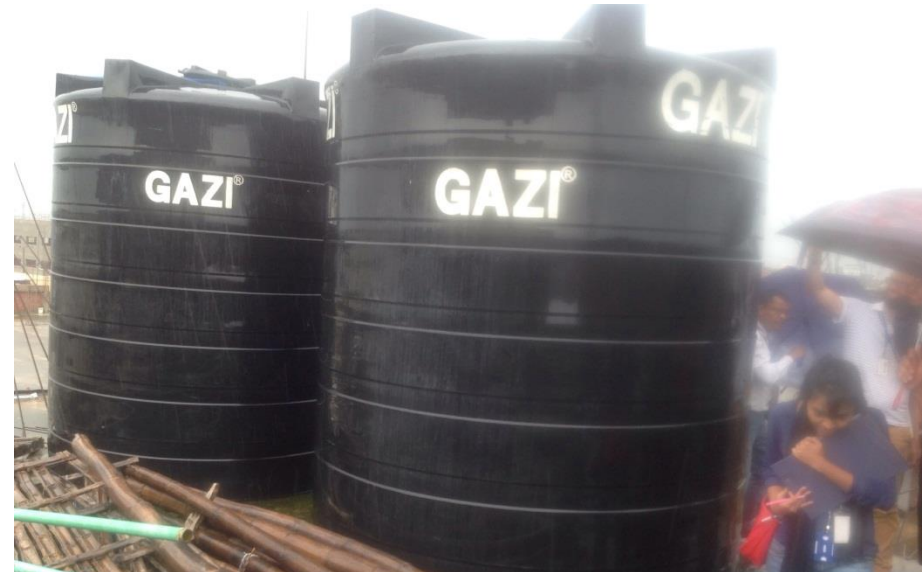
2 No. 10,000 litre water tanks on roof (2<sup>nd</sup> Floor)

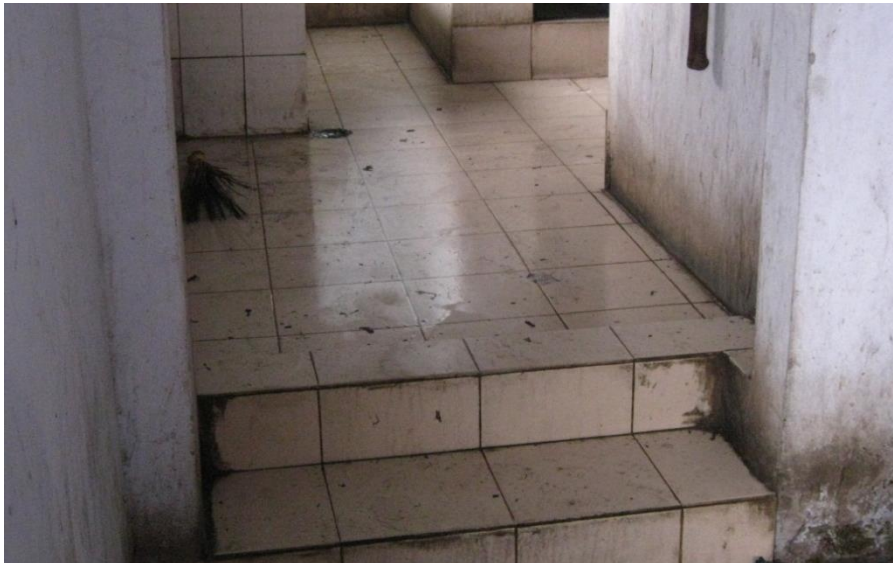
Toilet floor build-up (430mm average)

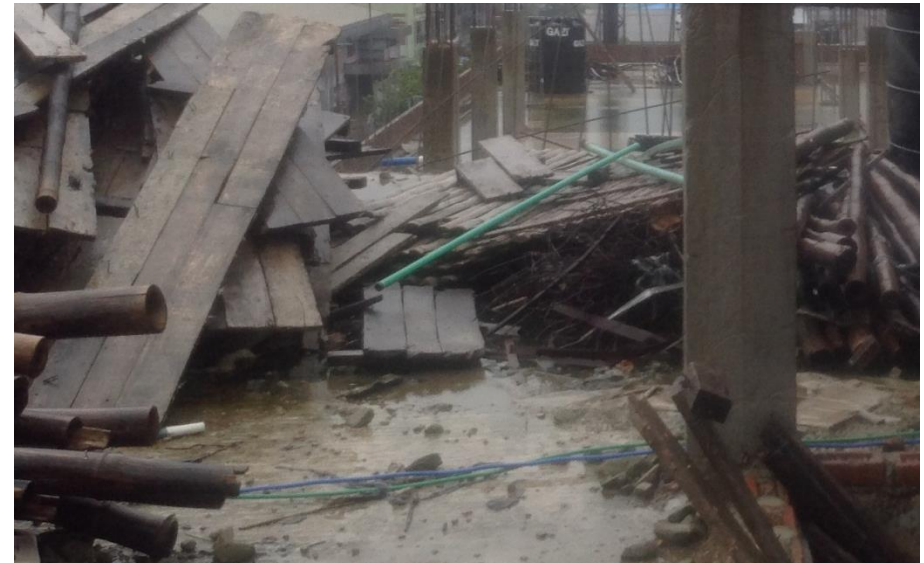
Construction materials on roof (2<sup>nd</sup> Floor)

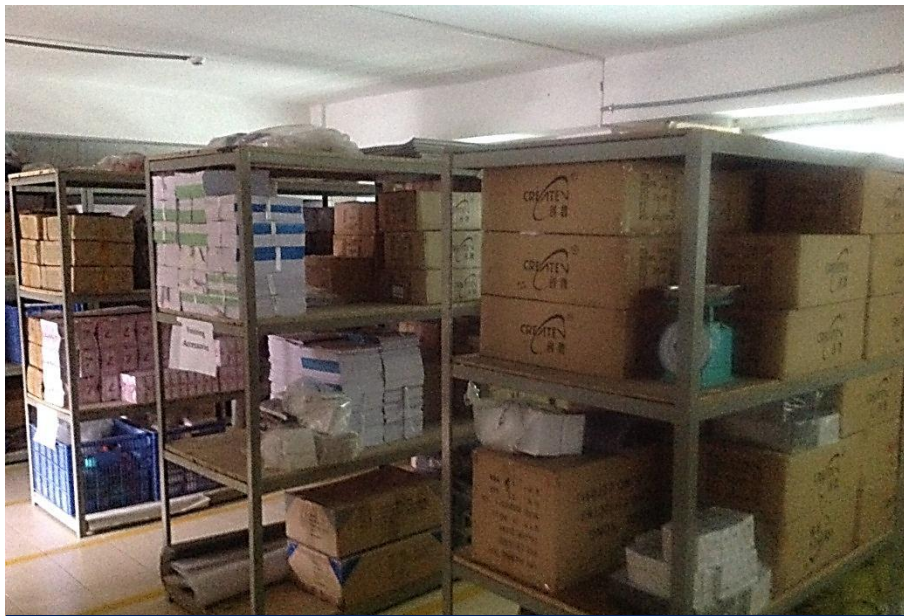
Storage room on Mezzanine floor

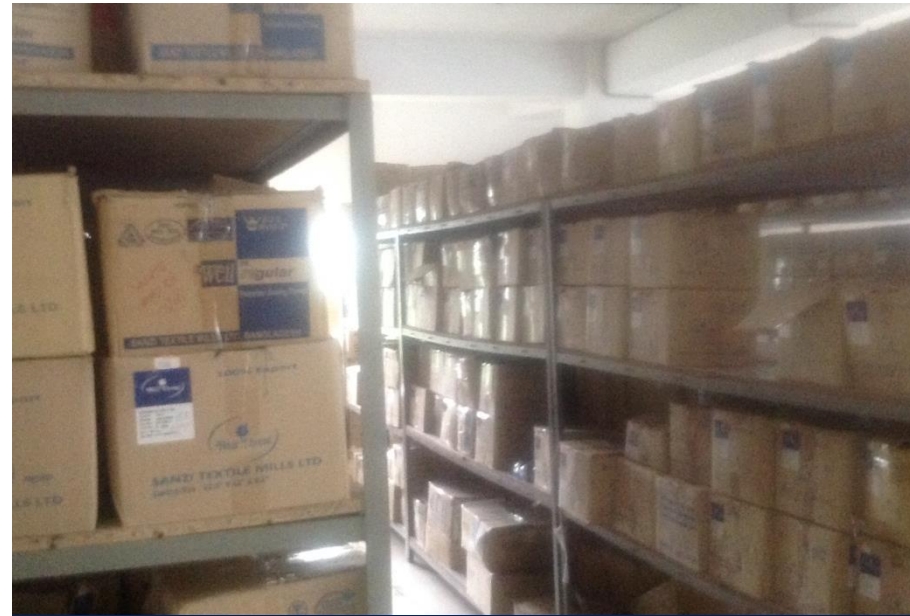
Storage room on 1<sup>st</sup> floor

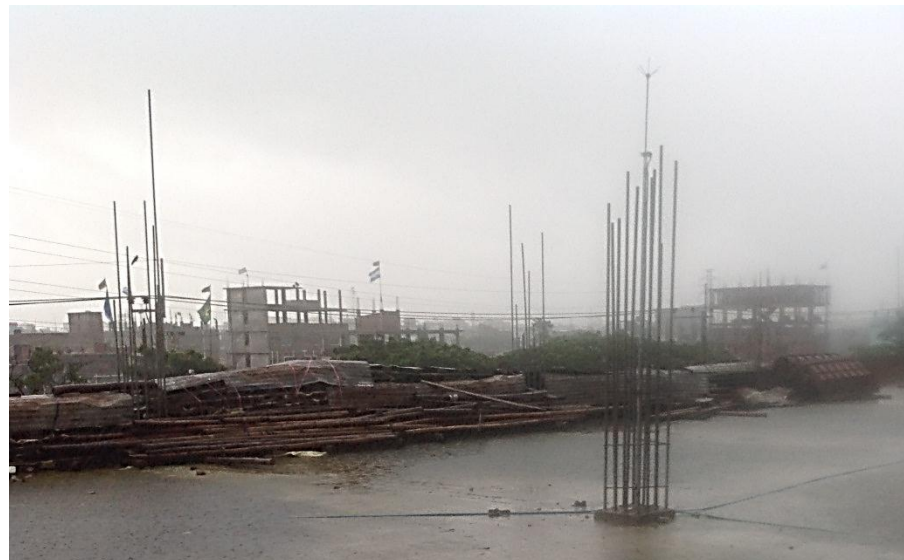
Construction materials on roof (2nd Floor)

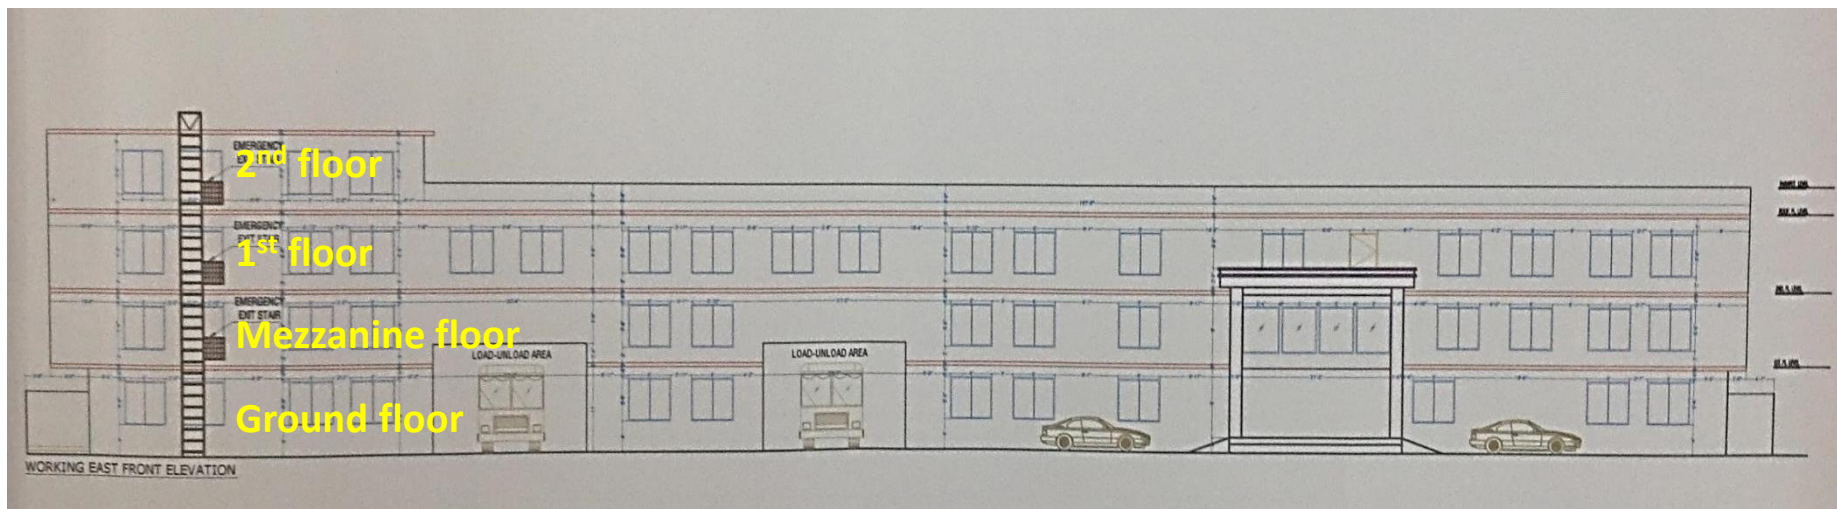
- The soil test report recommended a raft foundation for a structure greater than 3 storeys. The building is 4 storeys inclusive of Mezzanine floor, but the drawings show strip footing foundations. While there are no obvious signs of foundation settlement, cursory calculations indicate that the recommended pressures are being exceeded.
- The structural drawings indicate that all internal columns should have 14 reinforcement bars, whereas only 12 were observed using the Ferro-scanner.
- Flat slab construction was observed over a section of the Mezzanine Floor, while the drawings indicate beam and slab construction throughout.
- Toilet areas with significant floor build-up are larger than indicated on the design drawings.

East elevation showing a 3 storey building plus one Mezzanine Floor level (total of 4 storeys)

| Item No. | Observation | Recommended Action Plan | Recommended Timeline |
|---|---|---|---|
| 9 | Irregularities in documentation requiring clarification | Building Engineer to review foundation design in relation to allowable bearing pressure. | 6-weeks |

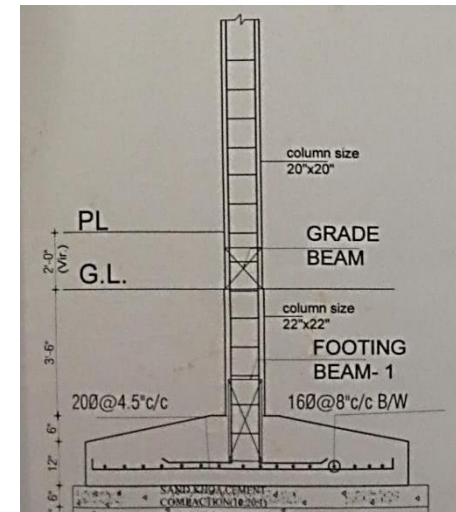
Foundation type recommendations (extract from Soil Test Report):  
For structures greater than 3 storeys a raft foundation is recommended

Strip foundation

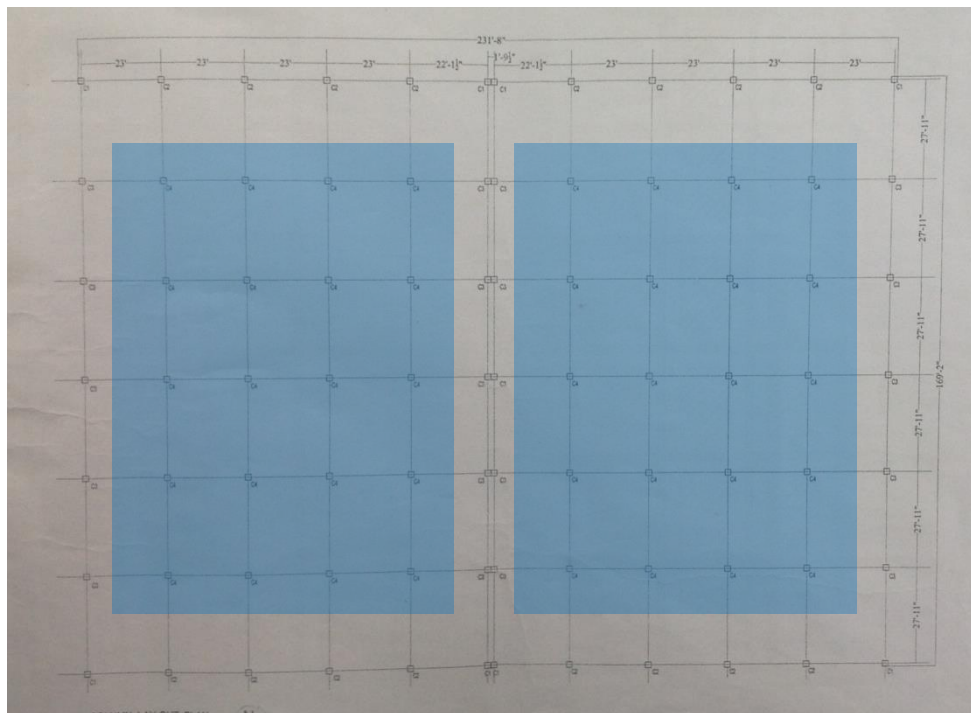
Column layout highlighting extent of internal column C4

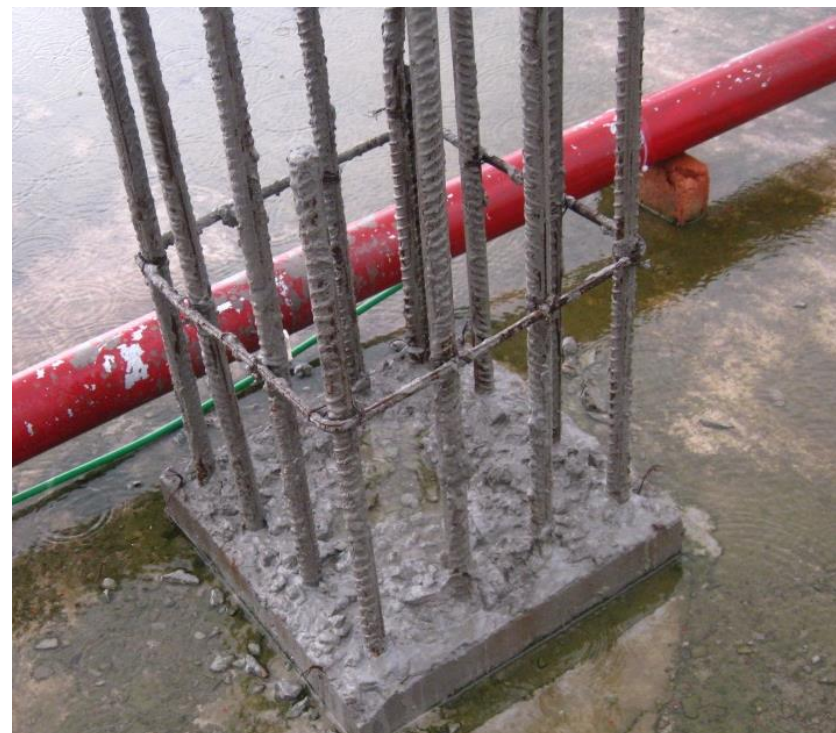
12 no. bars observed in internal column C4 at Roof level and confirmed at Ground Floor level using the Ferro-scanner

14 no. bars shown on drawings for column C4

| Item No. | Observation | Recommended Action Plan | Recommended Timeline |
|---|---|---|---|
| 8 | Irregularities in documentation requiring clarification | Building Engineer to survey all areas of the building, collect information and prepare a full and accurate set of “as-constructed” drawings. | 6-weeks |

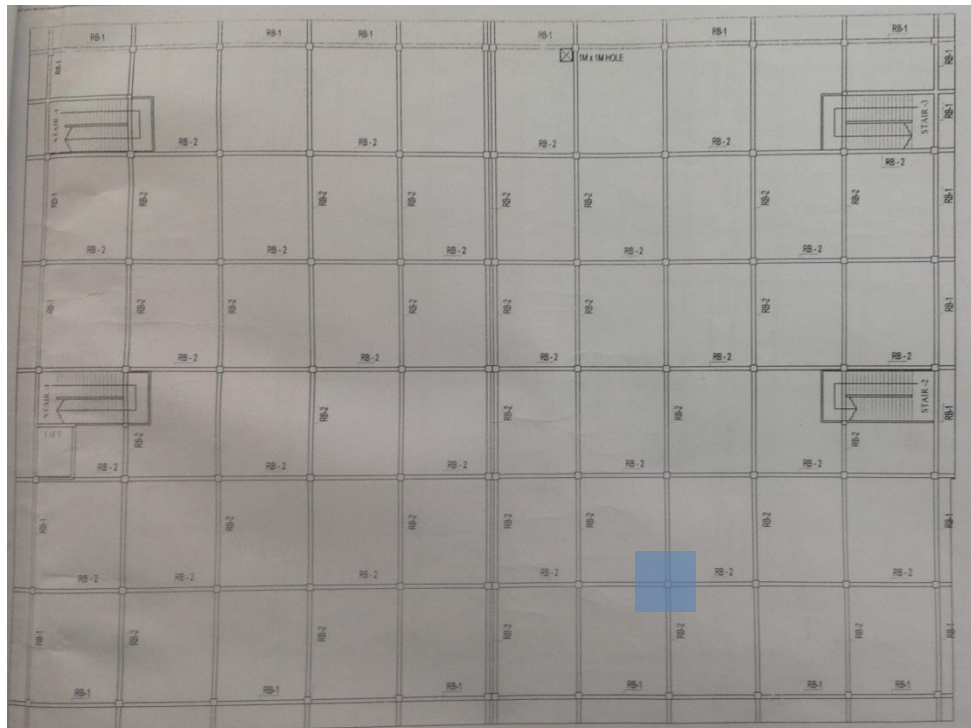
Typical floor beam layout

Mezzanine Floor column observed to be supporting flat slab

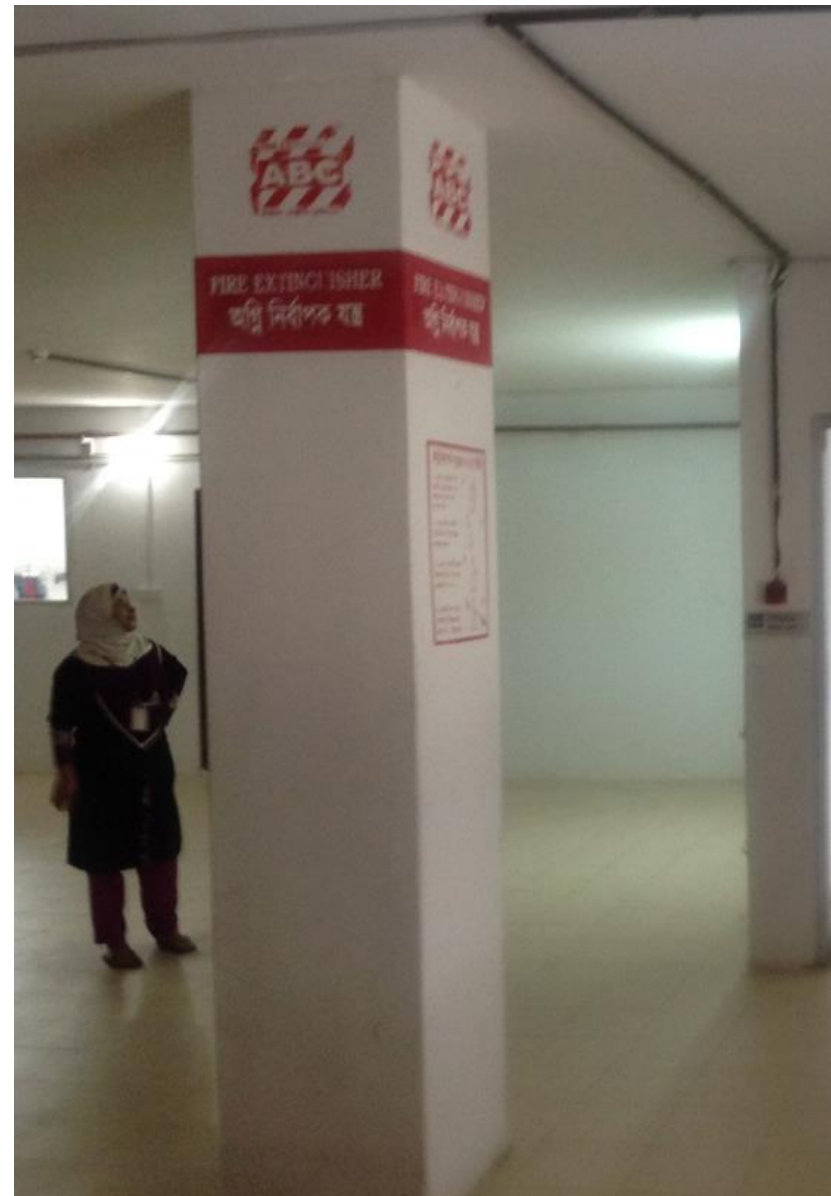
Column supporting flat slab

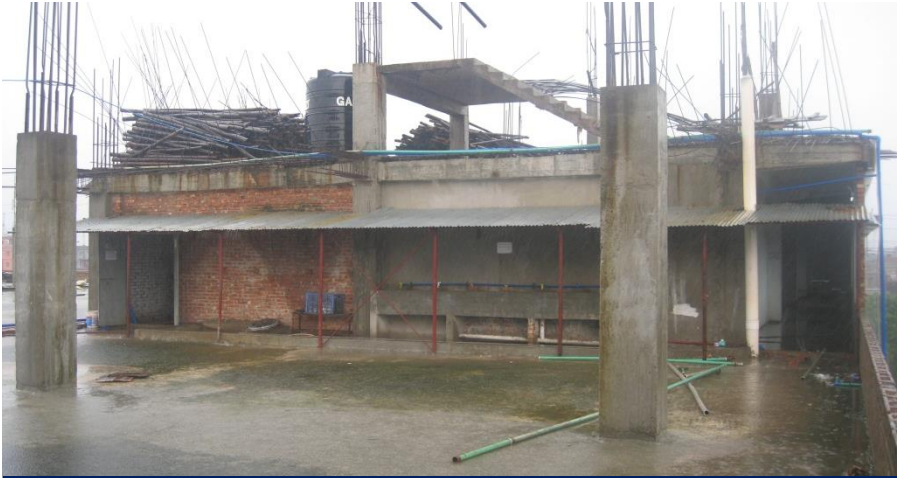
There are a number of lightweight roof structures. These structures appear to be non-engineered and not designed to resist uplift forces and lateral loads.

Canopy outside the dining room at roof level

| Item No. | Observation | Recommended Action Plan | Recommended Timeline |
|---|---|---|---|
| 10 | Lightweight, non-engineered roof structures | Building Engineer to review the design of the lightweight roof structures regarding their ability to withstand wind loading pressure, suction and uplift forces, with special emphasis on connections and bracing. | 6-months |
| 11 | Lightweight, non-engineered roof structures | Building Engineer to implement any actions / supervise any remedial works as identified following the review. | 6-months |

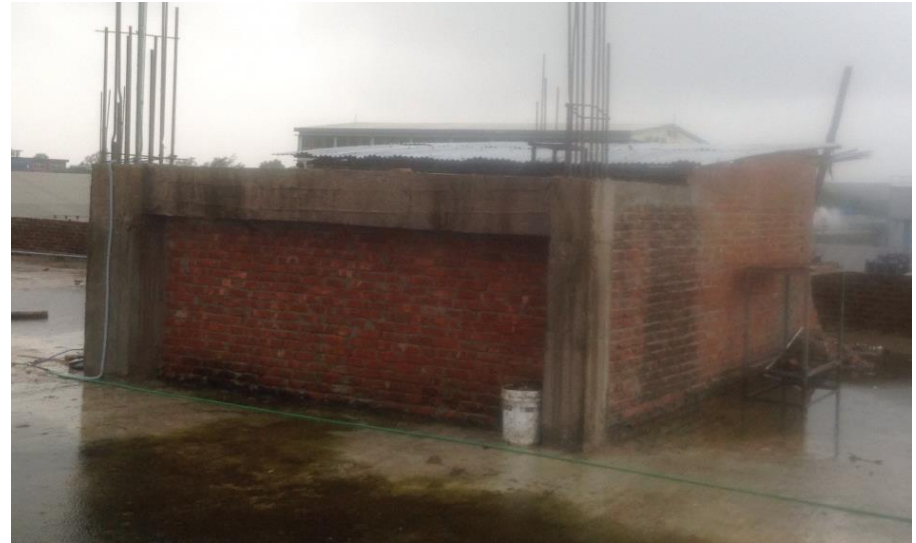
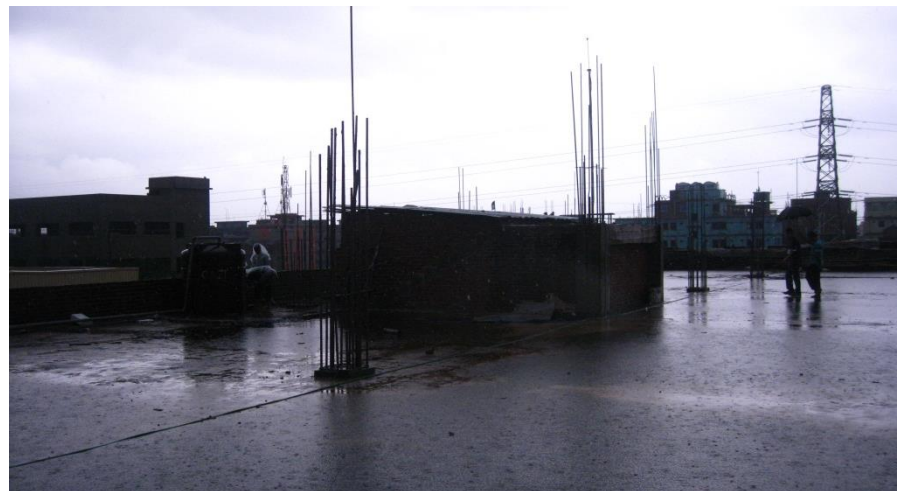
Roof to Northwest stair core

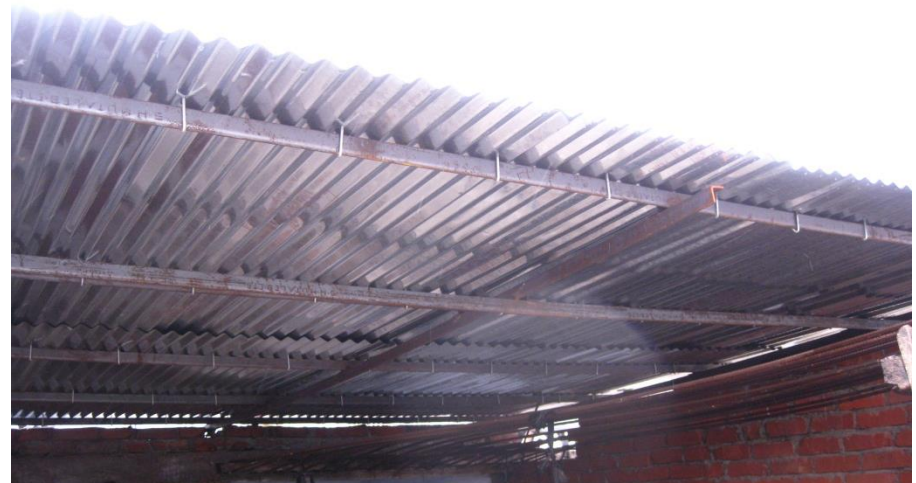
Roof to North stair core
