# Graphic Textiles Ltd.

Sreeampur, Kalampur, Dhamrai, Dhaka  
(23.919114N 90.124967E)

17<sup>th</sup> May 2014

# Observations

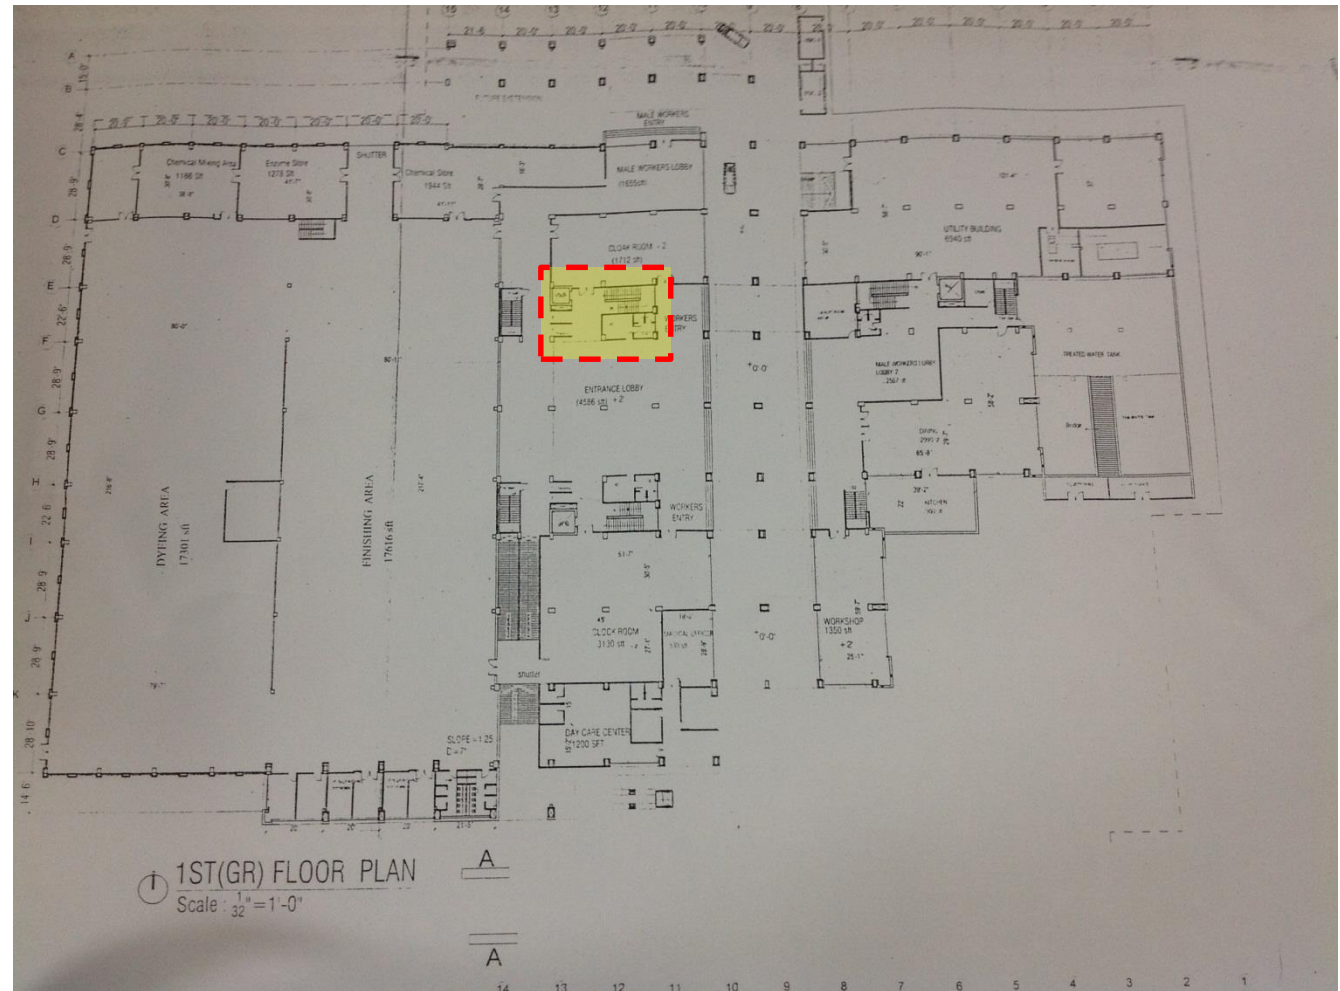
**Column capacity to be reviewed**

Preliminary calculations indicate that columns at Basement and Ground Floor are stressed to levels that require review. A suitably qualified engineer should confirm that all columns have sufficient capacity to support the applied loads. Columns in the area shaded (where the water tanks and toilets are located) are particularly highly stressed.

We understand that ultrasonic pulse velocity testing has been carried out in the past but that this has not been correlated with results from crushing concrete cores. Without correlation this gives an understanding of the degree of compaction but conclusions about the compressive strength of the concrete cannot be accurately drawn. We therefore suggest that cores be taken from a number of columns to determine the in-situ concrete strength as described in the priority actions later in this report

| Item No. | Observation | Recommended Action Plan | Recommended Timeline |
|---|---|---|---|
| 1 | <p>Review capacity of all columns at Basement and Ground Floor Levels.</p> <p>Note – core tests are required. It is understood that existing pulse wave velocity test results have not been correlated against core tests to determine in-situ strength</p> | <p>Verify insitu concrete stresses either by taking 100mm diameter cores from 4 columns (minimum )or using existing cylinder strength data if available. Vertical reinforcement should be exposed prior to coring to ensure it is not damaged by the coring. Suitably qualified structural engineer to confirm suitable positions for cores to be taken.</p> | 6-weeks |
| 2 | <p>Review capacity of all columns at Basement and Ground Floor Levels.</p> <p>Note – core tests are required. It is understood that existing pulse wave velocity test results have not been correlated against core tests to determine in-situ strength</p> | <p>Suitably qualified structural engineer to review design, loads and columns stresses in locations specified.</p> | 6-weeks |
| 3 | <p>Review capacity of all columns at Basement and Ground Floor Levels.</p> <p>Note – core tests are required. It is understood that existing pulse wave velocity test results have not been correlated against core tests to determine in-situ strength</p> | <p>Produce and actively manage a loading plan for all floor plates within the factory giving consideration to floor capacity and column capacity.</p> | 6-months |

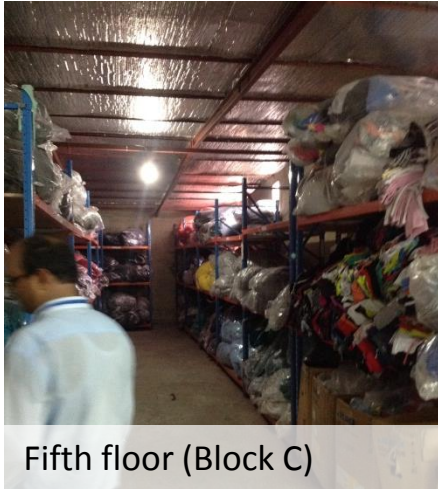
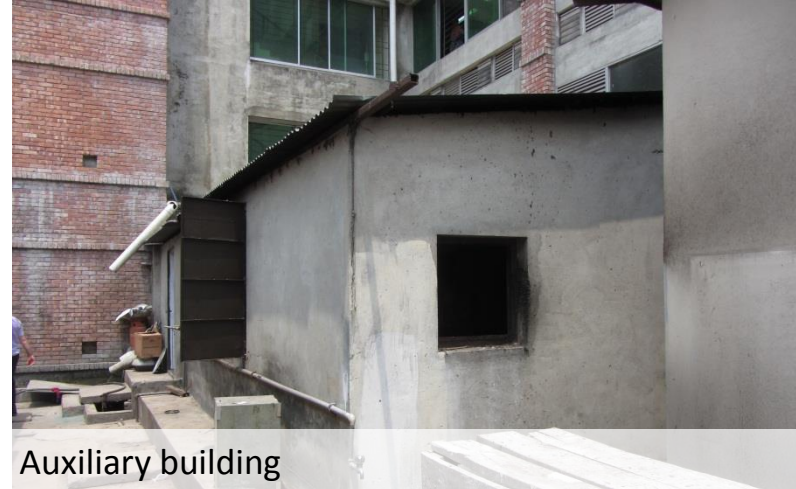
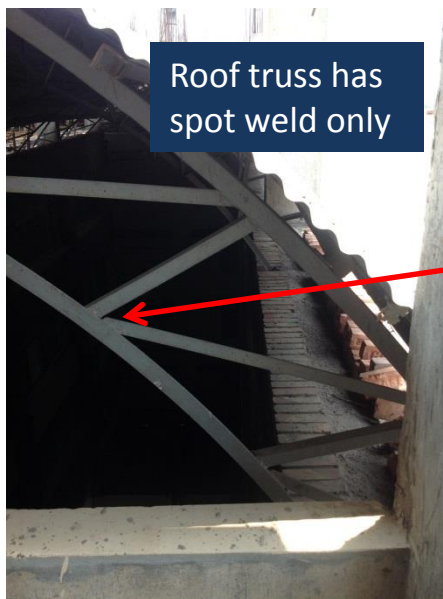
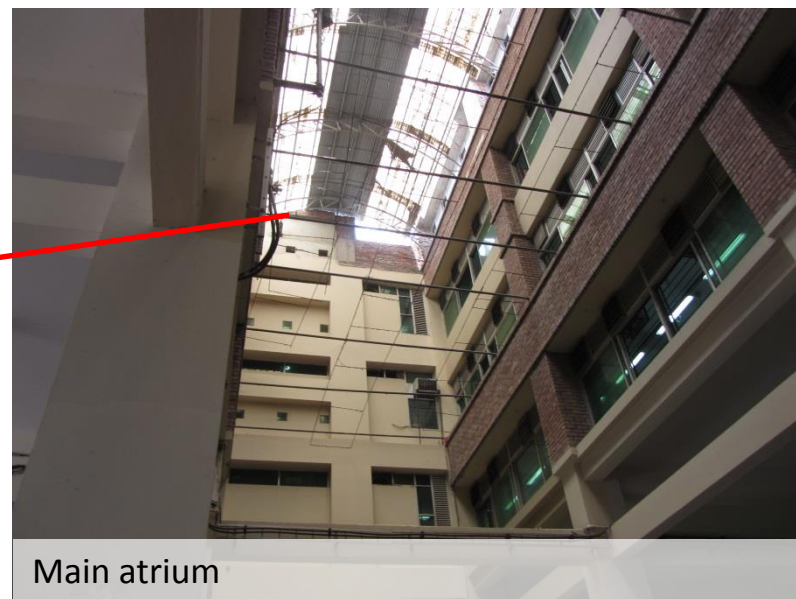
## Non engineered lightweight steel roofs

There are a number of non-engineered lightweight steel roofs namely over the fifth floor of Block C, the main atrium between the blocks and the ancillary buildings at the rear of the building.

| Item No. | Observation | Recommended Action Plan | Recommended Timeline |
|---|---|---|---|
| 4 | Non-engineered lightweight roofs | Qualified structural engineer to check the design of both the elements and the connections in lightweight steel roofs for the design loads stated in BNBC-2006. This applies to the roof over the main atrium spaces, the roof over the over the fifth floor and the auxiliary buildings at the rear of the complex. | 6-weeks |
| 5 | Non-engineered lightweight roofs | Strengthening works to be designed as required. | 6-weeks |

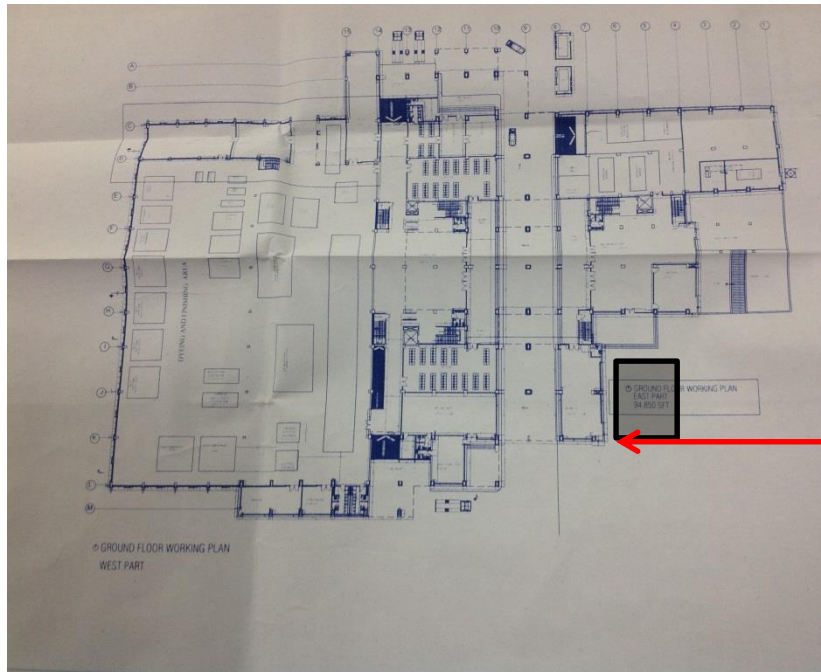
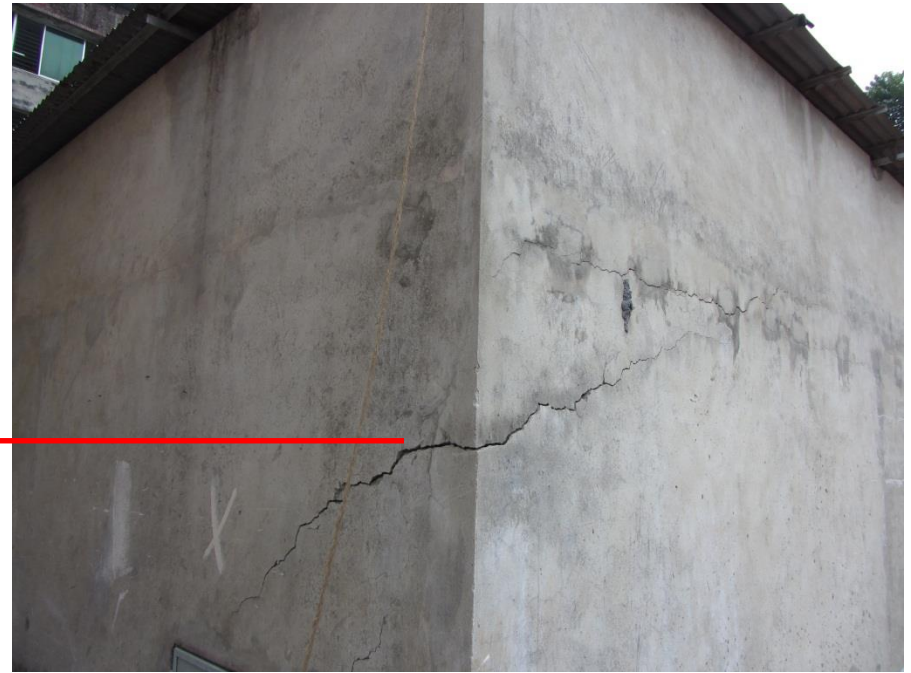
## Crack in load bearing wall

There is a crack in a load bearing wall on one of the auxiliary buildings (not shown on layout drawings). This may be caused by foundation settlement. The crack width should be monitored and, if it increases in size, advice should be sought from a qualified Structural Engineer. No materials should be stored against the wall.

| Item No. | Observation | Recommended Action Plan | Recommended Timeline |
|---|---|---|---|
| 6 | Crack in load bearing masonry wall of ancillary building, possibly due to foundation settlement. | Ensure no materials are being stored against cracked wall. | 6-weeks |
| 7 | Crack in load bearing masonry wall of ancillary building, possibly due to foundation settlement. | Monitor crack to ensure that no further movements take place. | 6-weeks |
| 8 | Crack in load bearing masonry wall of ancillary building, possibly due to foundation settlement. | If crack continues to grow, seek advice from a suitably qualified structural engineer. | 6-months |
| 9 | Crack in load bearing masonry wall of ancillary building, possibly due to foundation settlement. | Continue to monitor crack and repair as necessary to avoid on-going maintenance issues. | 6-months |

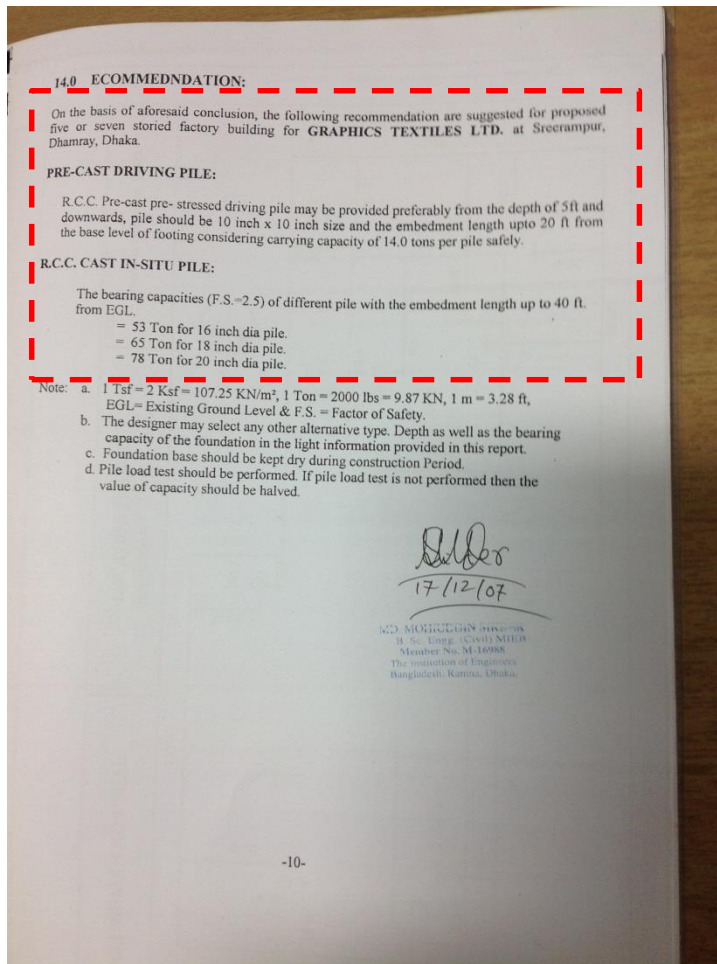
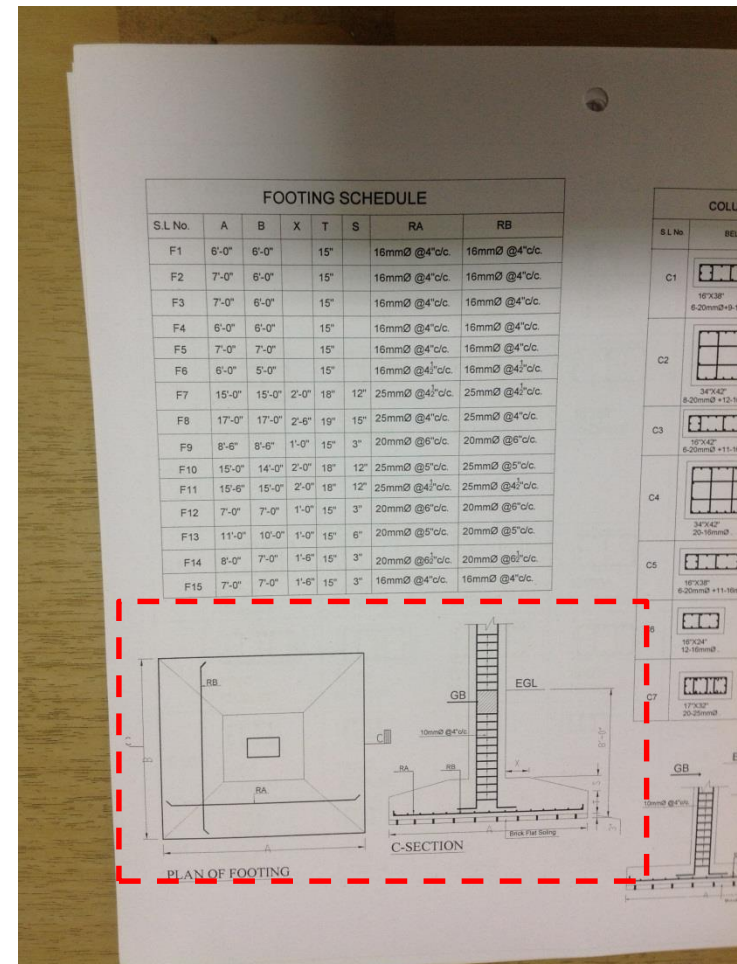
Inconsistencies in record information

The soils report suggests piled foundation while the record drawing show pad foundation. A suitably qualified structural engineer should confirm the foundation type and that the foundations have sufficient capacity for the applied loads.

| Item No. | Observation | Recommended Action Plan | Recommended Timeline |
|---|---|---|---|
| 10 | Inconsistencies in record information/differences between drawings and as-built structure | A suitably qualified Structural Engineer should confirm the foundation type and that the foundations have sufficient capacity for the applied loads | 6-months |

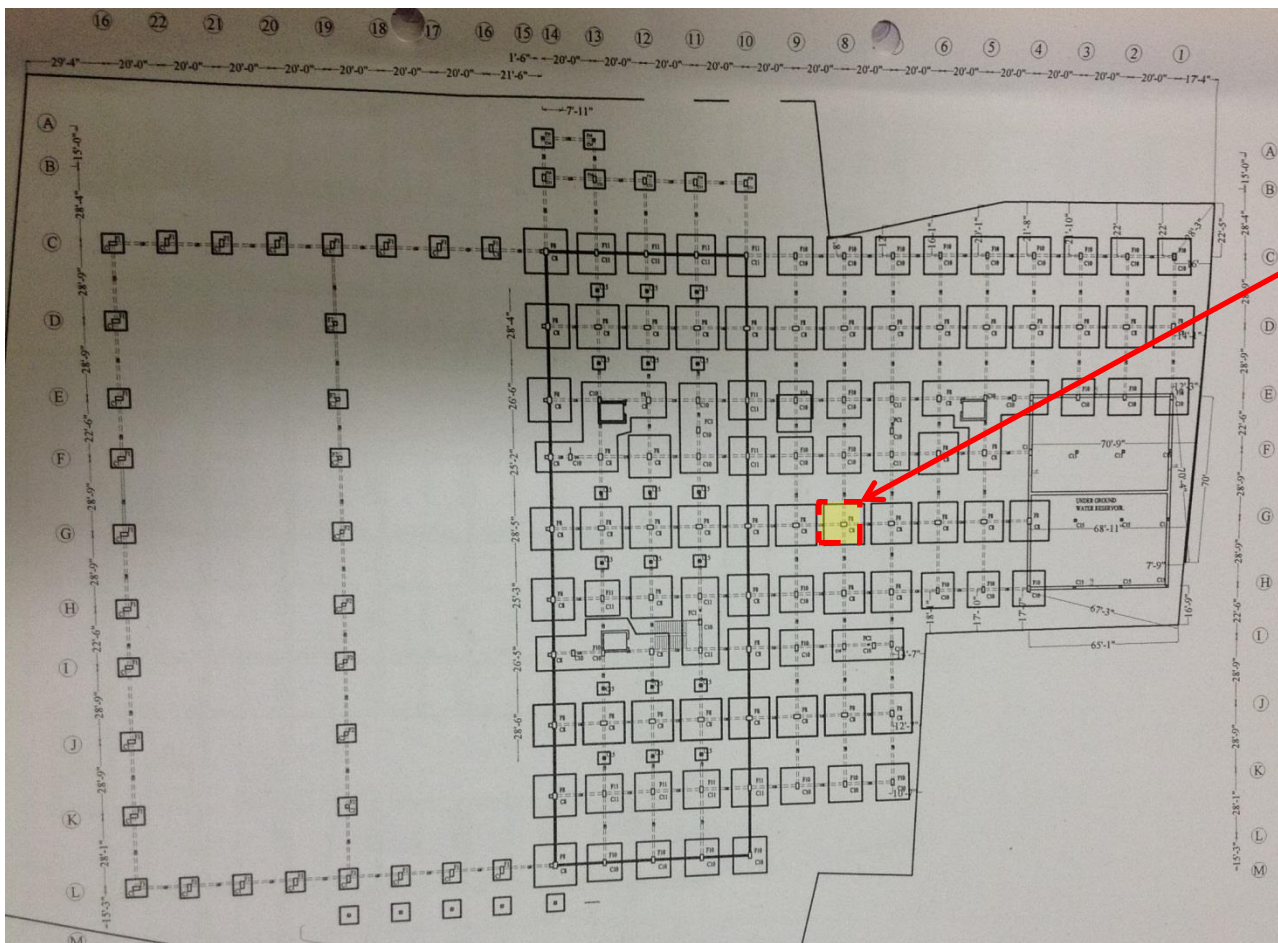
## Differences between drawings and structure

The column shown here is a 'C8' on the column schedule (610mm x 760mm) at ground floor. This was measured as 800mm x 870mm (RC section size) on site.

| Item No. | Observation | Recommended Action Plan | Recommended Timeline |
|---|---|---|---|
| 11 | Inconsistencies in record information/differences between drawings and as-built structure | As built drawings should be updated to reflect exact construction dimensions | 6-months |

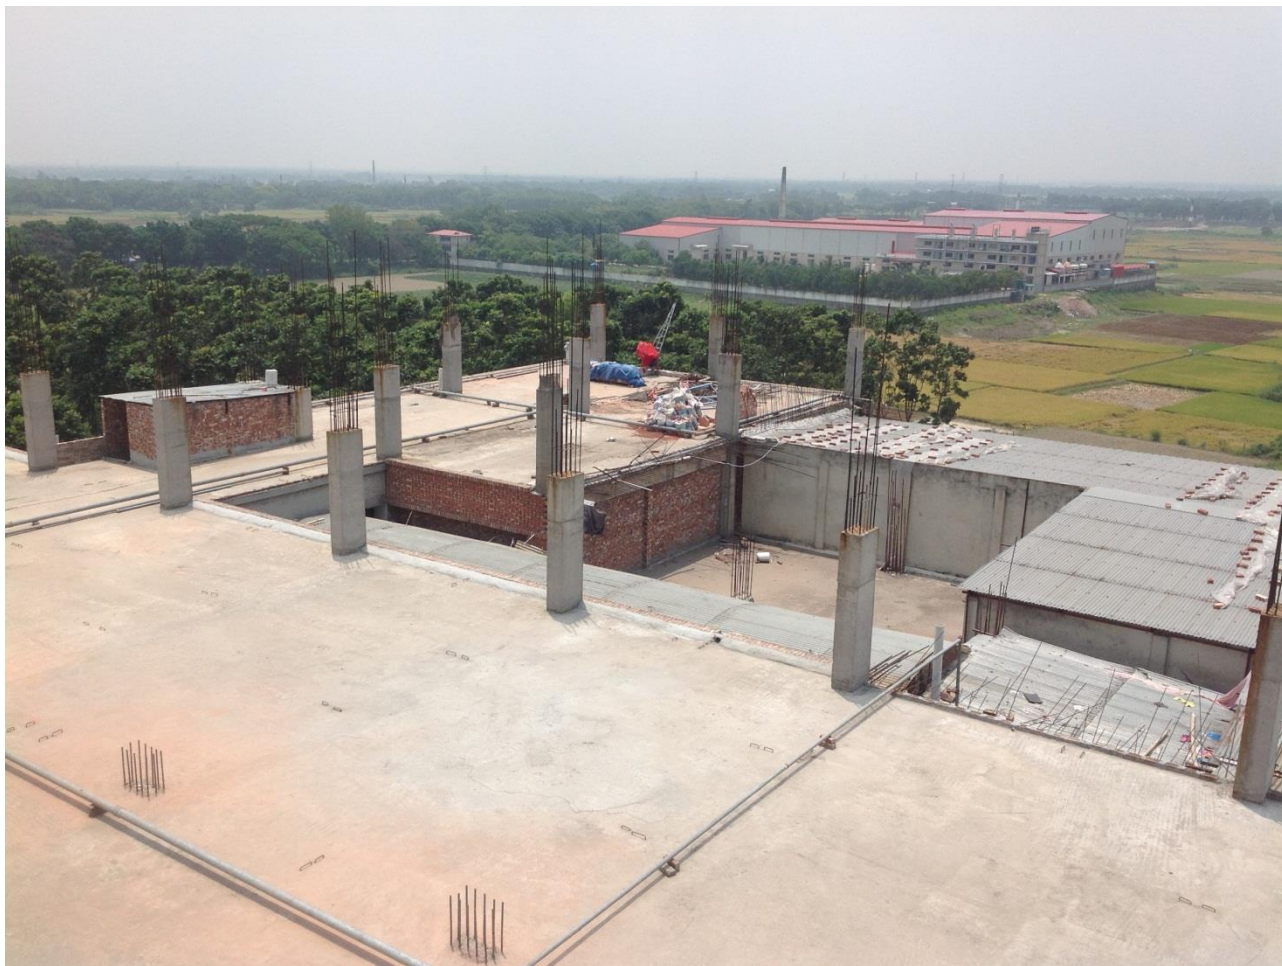
**Columns constructed above sixth floor on Block B.**

Columns have been constructed above the 6<sup>th</sup> floor on Block B slab level. We understand that construction for the 7<sup>th</sup> floor in this area is not planned following the results of ultrasonic pulse velocity testing.

| Item No. | Observation | Recommended Action Plan | Recommended Timeline |
|---|---|---|---|
| 12 | Columns constructed above sixth floor on Block B | Construction above roof on Block B should be removed. | 6-months |
