# RGR Sweater Ltd

VIII Madhakhala, post- Boiragirekala, Shreepur, Gazipur, Dhaka

# Building Observations

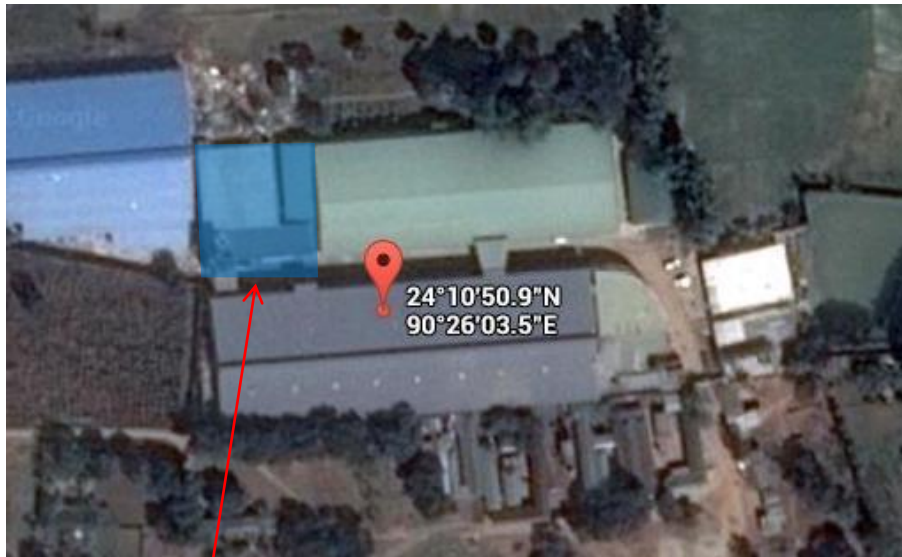
As-built structure

| Item No. | Observation | Recommended Action Plan | Recommended Timeline |
|---|---|---|---|
| 6 | Discrepancies between designed and as-built structures | Building engineer to incorporate all additional structures to the design and to correct the as-built drawings. | 6-months |
| 7 | Discrepancies between designed and as-built structures | Prepare documentation that is missing for existing structures. | 6-months |

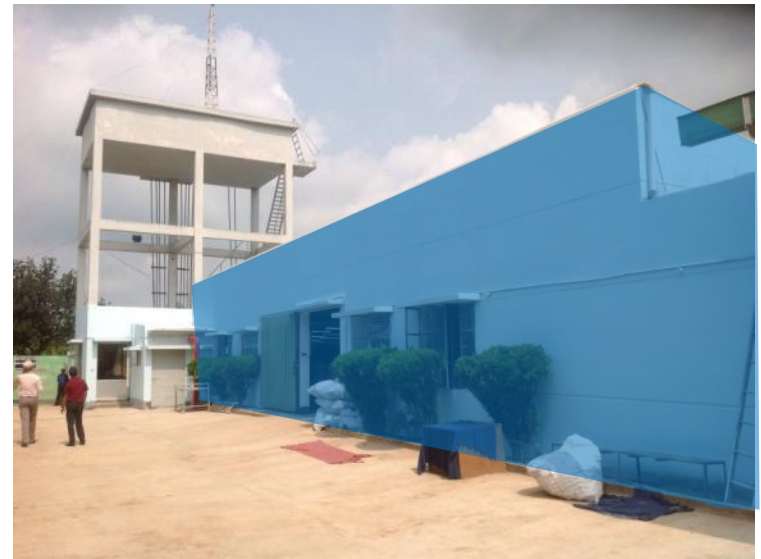
Part of the building not incorporated into the design (winding section)

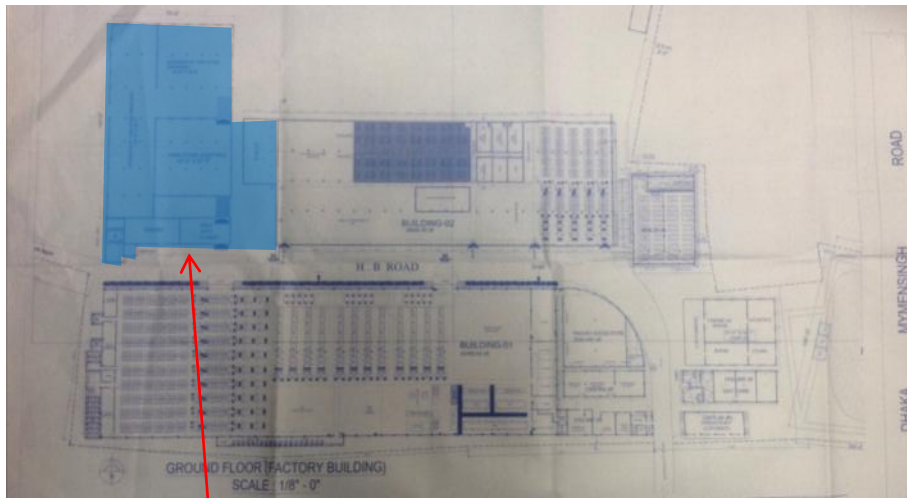
As-designed structure

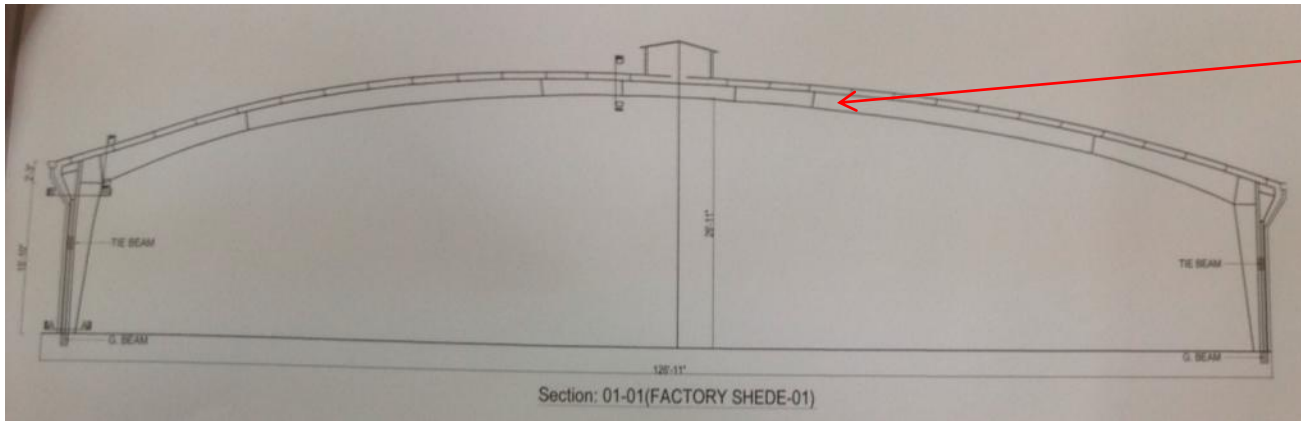
**Structure not in accordance with design**

Curved rafter structure as designed

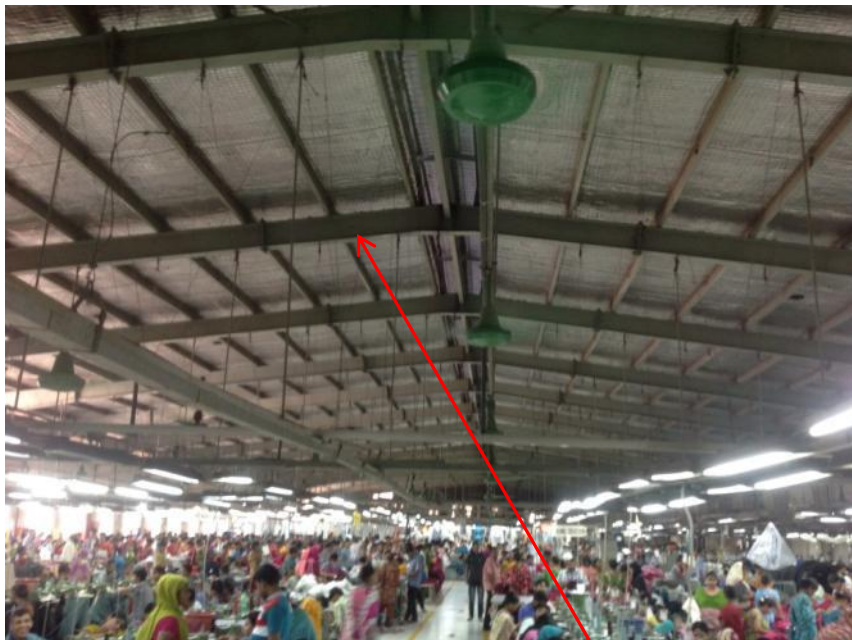
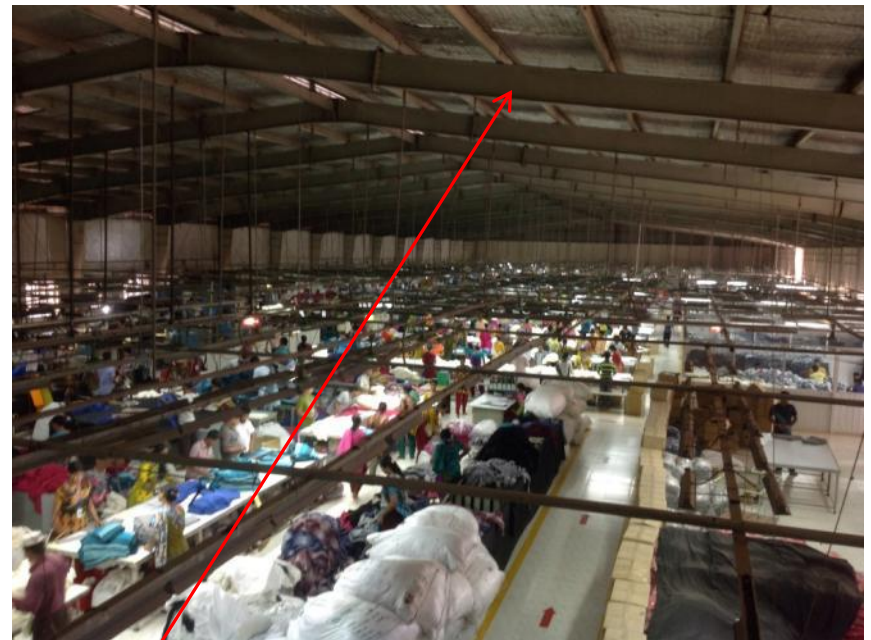
Straight rafter structure as built

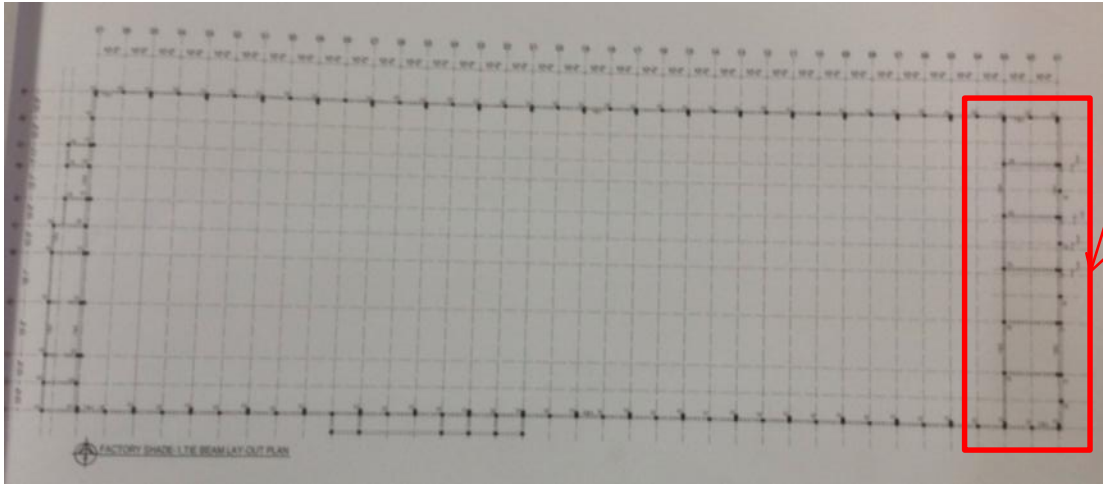
RC Beam/column simple structure as designed

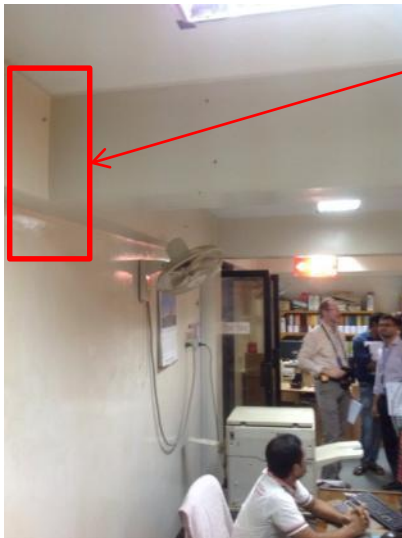
RC Beam supported by steel column

| Item No. | Observation | Recommended Action Plan | Recommended Timeline |
|---|---|---|---|
| 1 | Unconventional support structure for the RC mezzanine beams | Building engineer to check the as-built structure with reference to proper stability and sufficient strength of structural elements. | 6-months |
| 2 | Unconventional support structure for the RC mezzanine beams | Incorporate as-built structure into documentation and drawings. | 6-months |

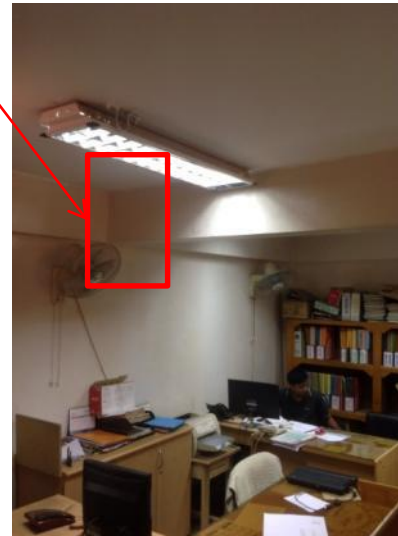
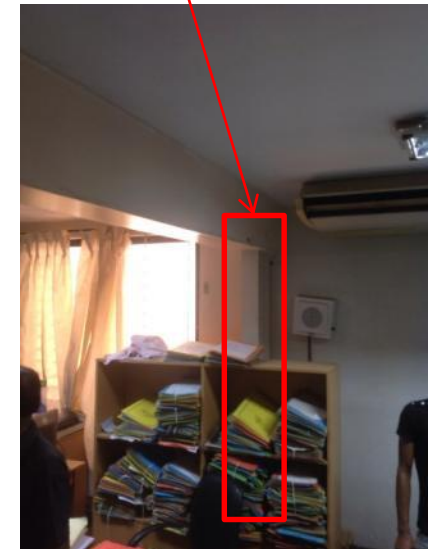
Secondary Beam supported by primary beam

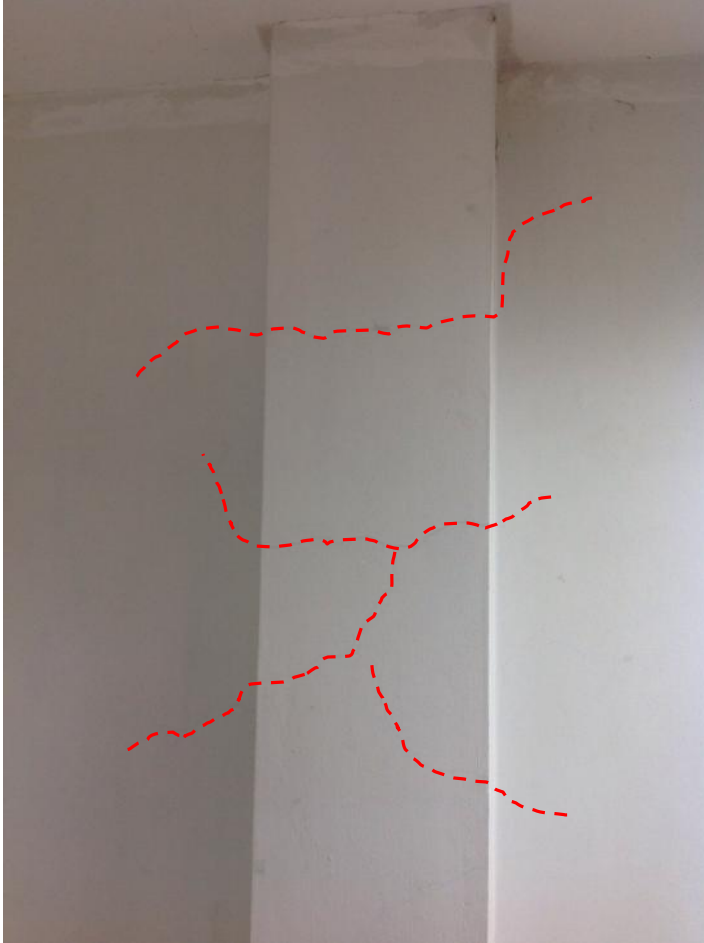
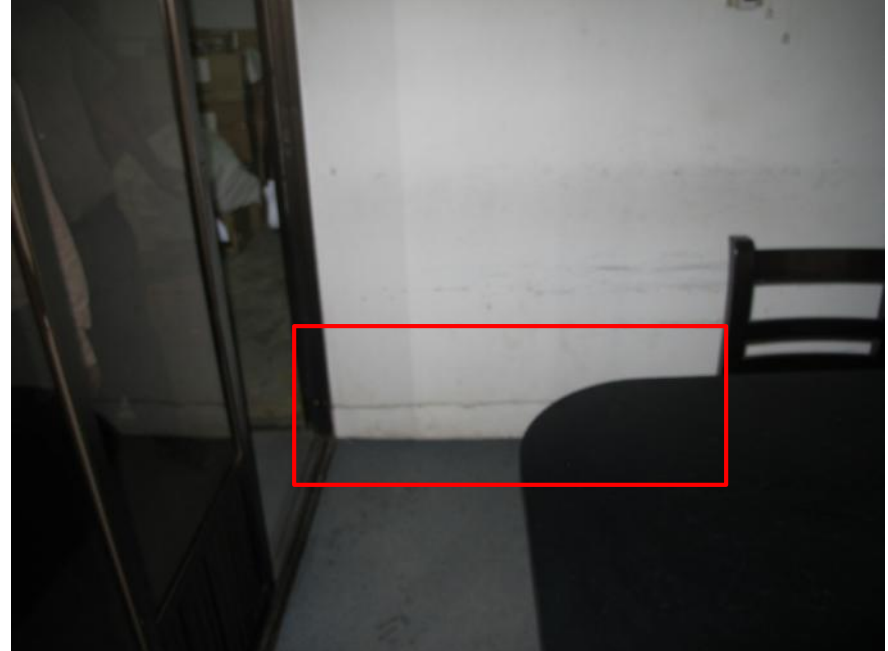
# Cracks in internal brick walls

| Item No. | Observation | Recommended Action Plan | Recommended Timeline |
|---|---|---|---|
| 10 | Cracks in internal brick walls | Fill in brickwork cracks and monitor for further movement | 6-months |

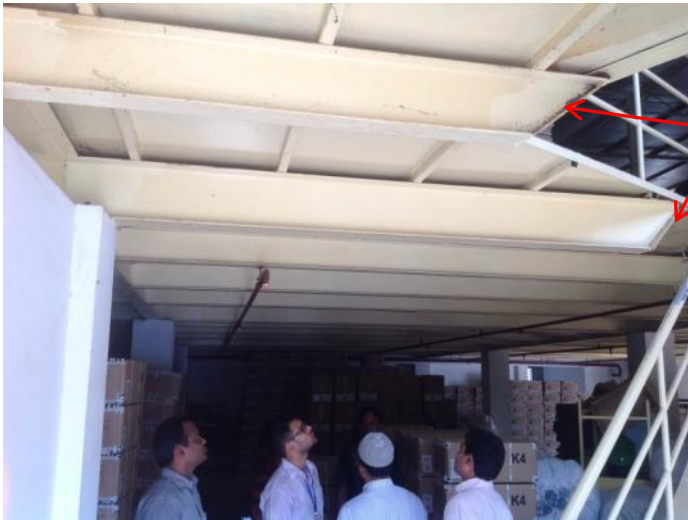
# Untrimmed stair opening

| Item No. | Observation | Recommended Action Plan | Recommended Timeline |
|---|---|---|---|
| 3 | Untrimmed stair opening in Finished Goods store | Building engineer to check if introduced changes to design are affecting existing structure. | 6-months |
| 4 | Untrimmed stair opening in Finished Goods store | Extend terminated beams so that they will be supported from both sides. | 6-months |

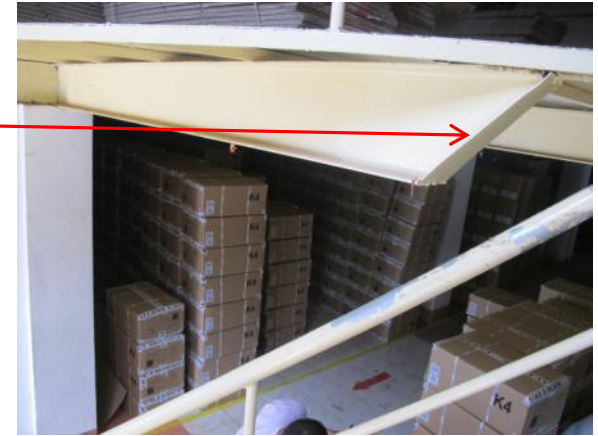
Steel beams terminated at the edge of stair opening floor 1. Works as cantilever

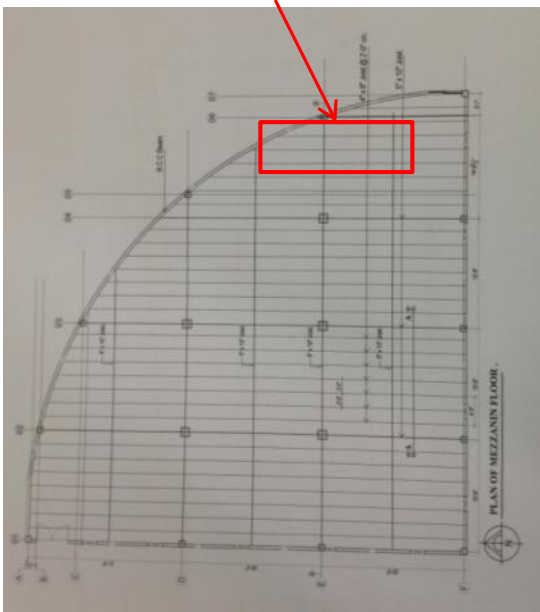
Additional steel stairs, location

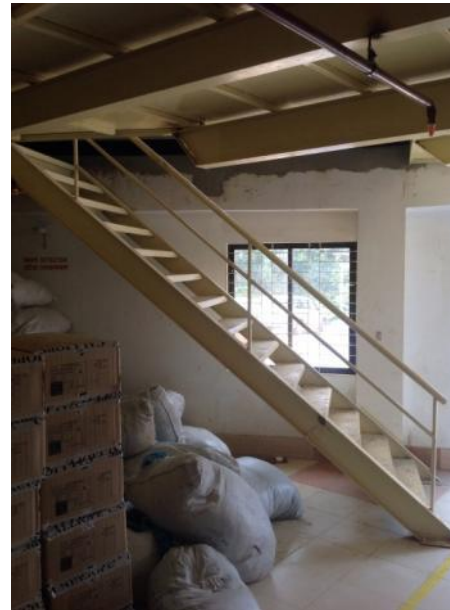
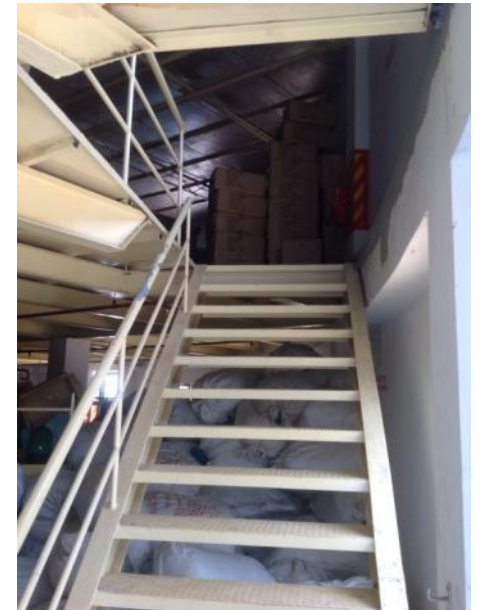
Additional steel stairs

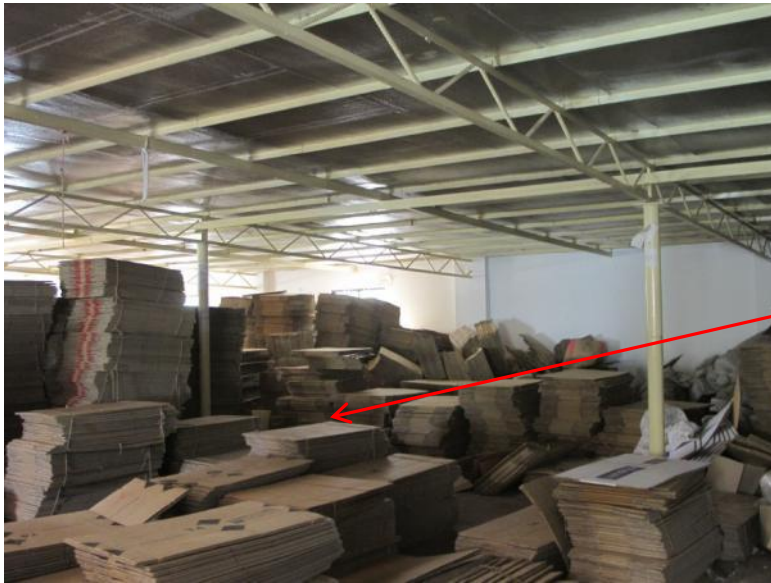
Localised areas of heavily loaded storage over whole floor. Steel sheeting supported by steel beams system structure as a floor.

| Item No. | Observation | Recommended Action Plan | Recommended Timeline |
|---|---|---|---|
| 9 | Localised areas of high loading | Building engineer to ensure the structure is not loaded beyond capacity. Produce and actively manage a loading plan for all floor plates within the factory, giving consideration to floor and column capacity. | 6-months |

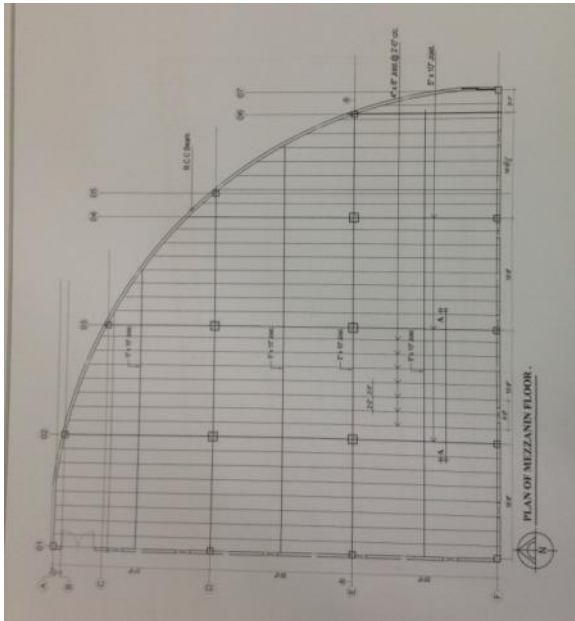
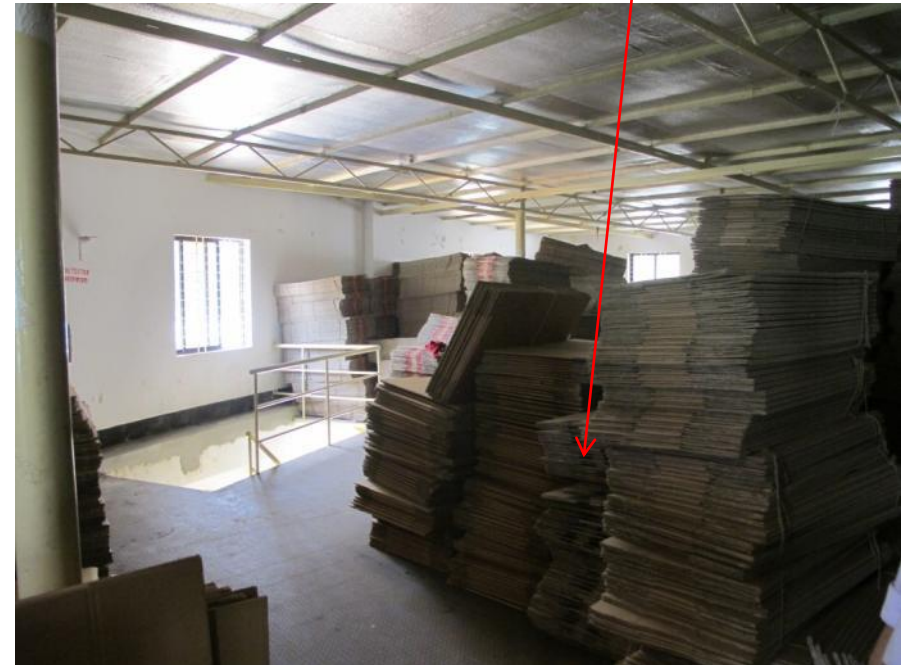
Finished goods store. 1<sup>st</sup> floor

# Localised areas of high loading

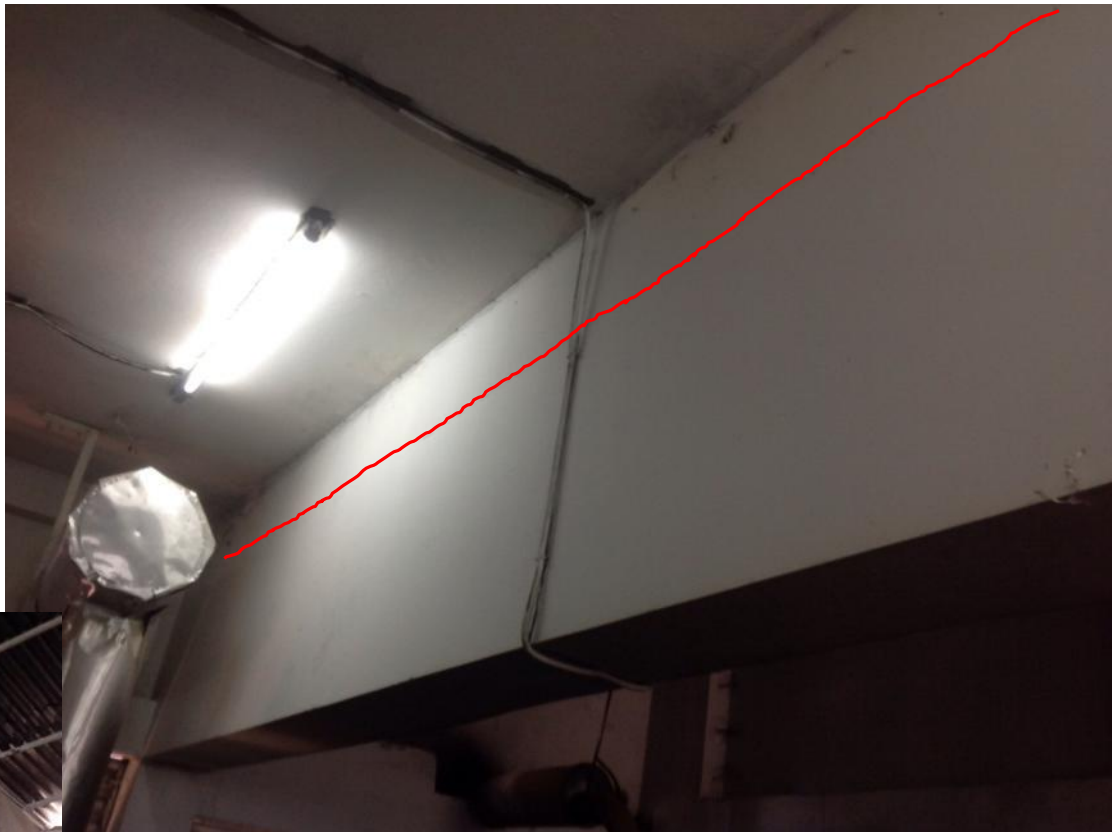
# **Unclear support mechanism to brickwork spanning over large opening**

Boiler room crack along  
lintel

| Item No. | Observation | Recommended Action Plan | Recommended Timeline |
|---|---|---|---|
| 5 | Unclear support to brickwork spanning over large opening | Building engineer to check support details, and prop if there is no adequate support | 6-weeks |

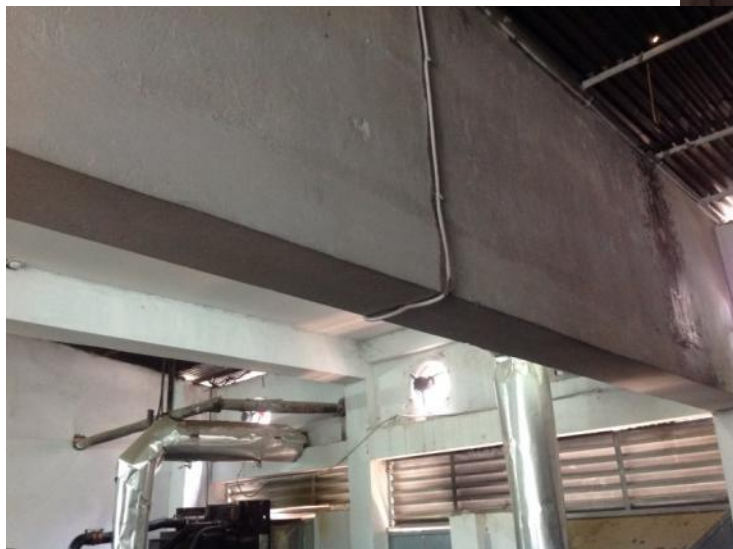
Boiler room  
View from other side

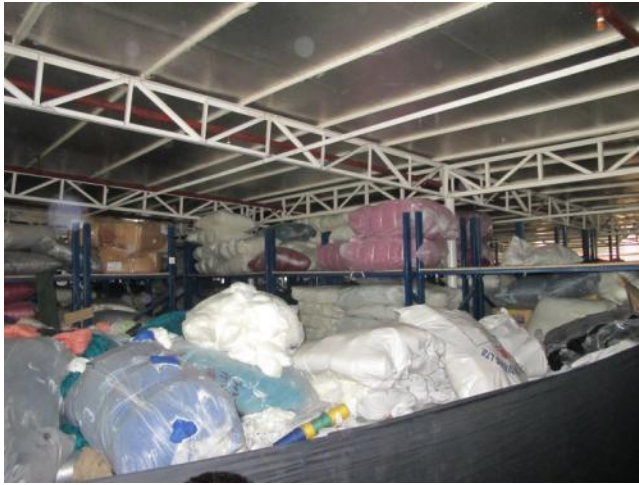
Yarn storage roof structure, some trusses supported off racking system

| Item No. | Observation | Recommended Action Plan | Recommended Timeline |
|---|---|---|---|
| 8 | Non-engineered steel roof structures | Building engineer to check the roof structure and connections, and propose additional reinforcements and stability system to ensure the proper functioning of the structure. | 6-months |

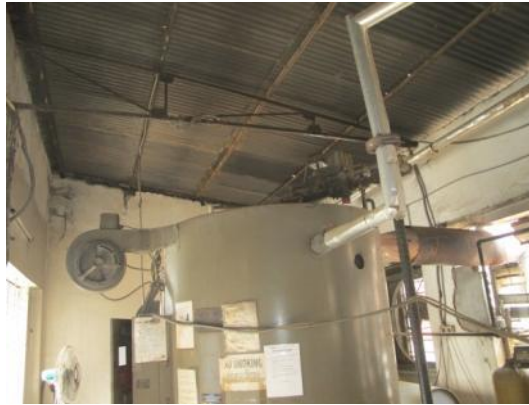
Boiler room roof structure

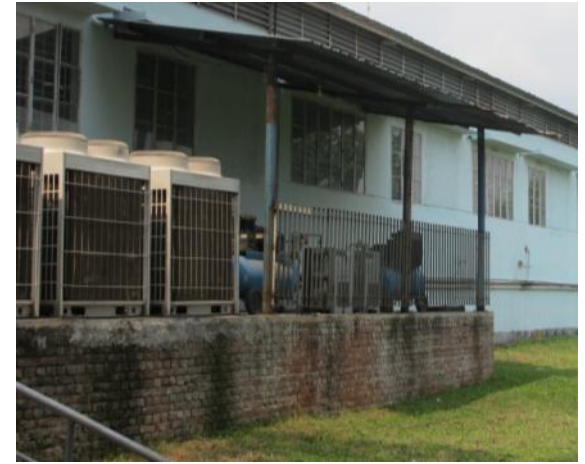
Building 2 - adjacent steel structure

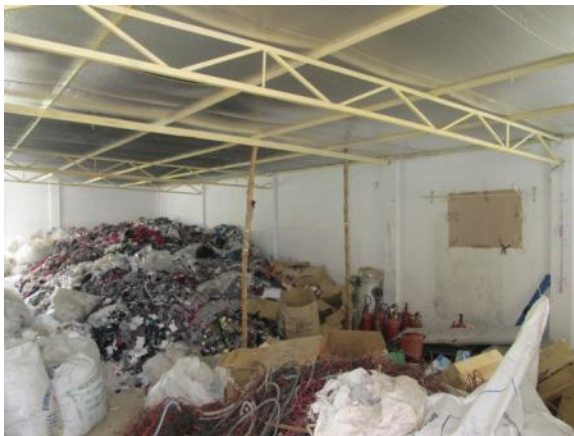
Chemical/waste storage roof structure; bamboo prop where truss missing

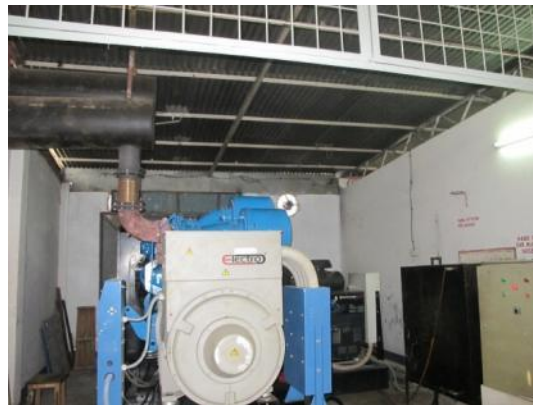
Generator room roof structure

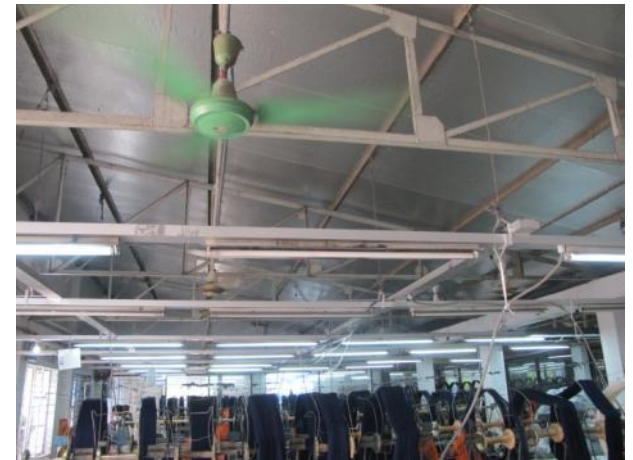
Winding section roof structure
