# Diganta Sweater Ltd. Tricotex Sweaters Ltd. Sweaters Zone Ltd.

Naoujoor, Tangail Road, Chandana,  
Chowrasta, Gazipur - 1702  
(23.988488N,90.365998E)

01 April 2014

# Observations

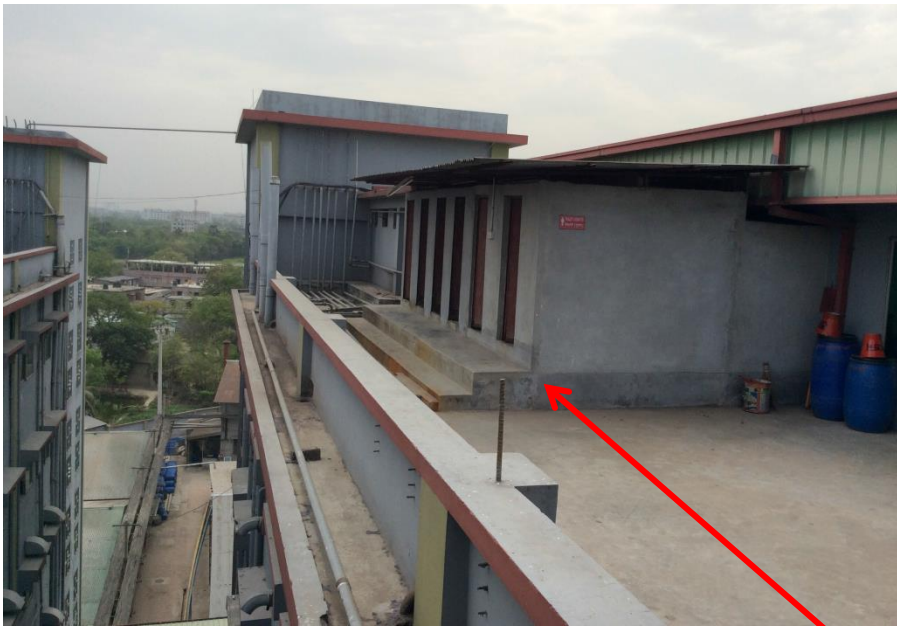
# **Design check required for floor build-ups and toilet areas Buildings 1 and 2**

170mm high floor build-up in toilet area supported by concrete slab and beam arrangement.

| Item No. | Observation | Recommended Action Plan | Recommended Timeline |
|---|---|---|---|
| 4 | Buildings 1 and 2 – Verify slab and beam strengths in toilet areas | Factory Engineer to review design, loads and slab/beam stresses in areas identified above. | 6-weeks |

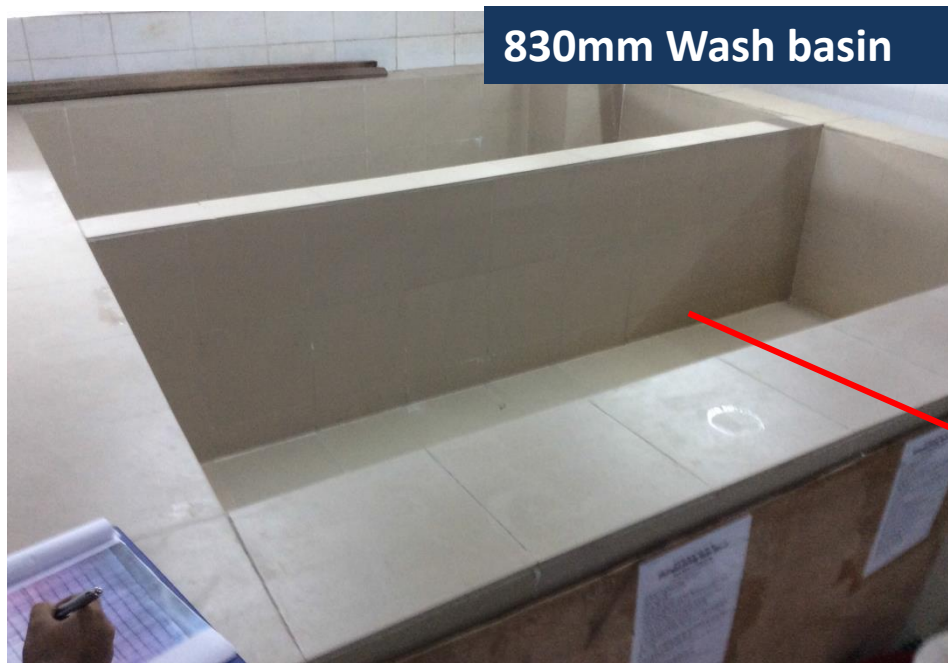
**830mm Wash basin**

**Building Engineer to verify that the columns, slab and beams have been adequately designed to carry floor build-up loads**

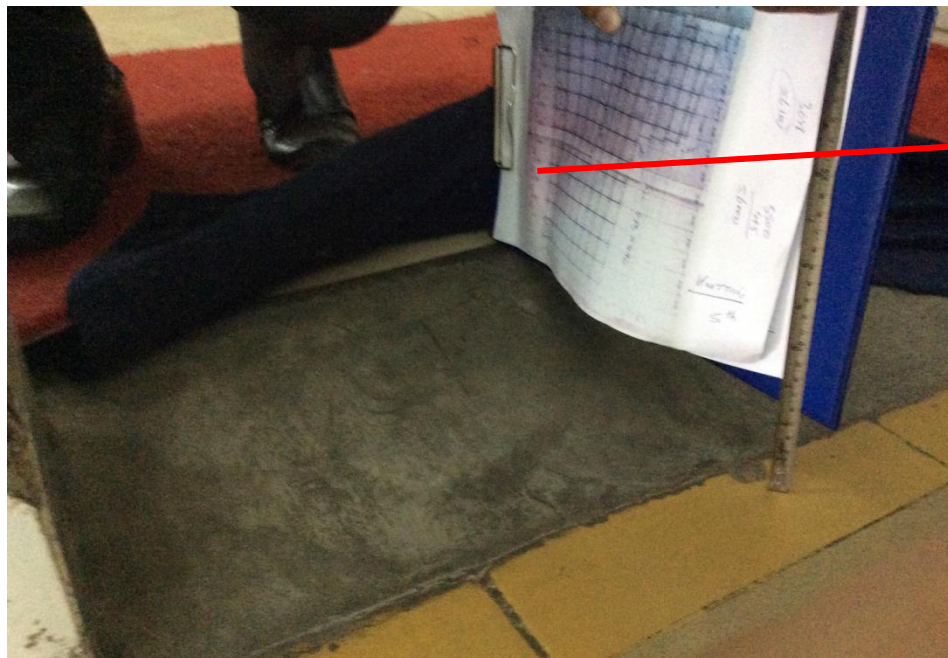
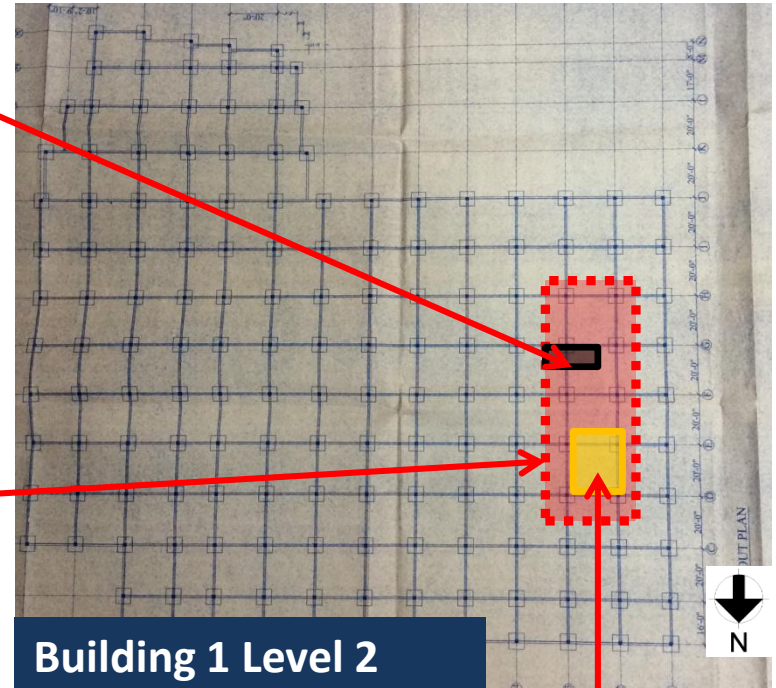
**Building 1 Level 2**

**75mm floor built-up on  
60mm floor built-up**

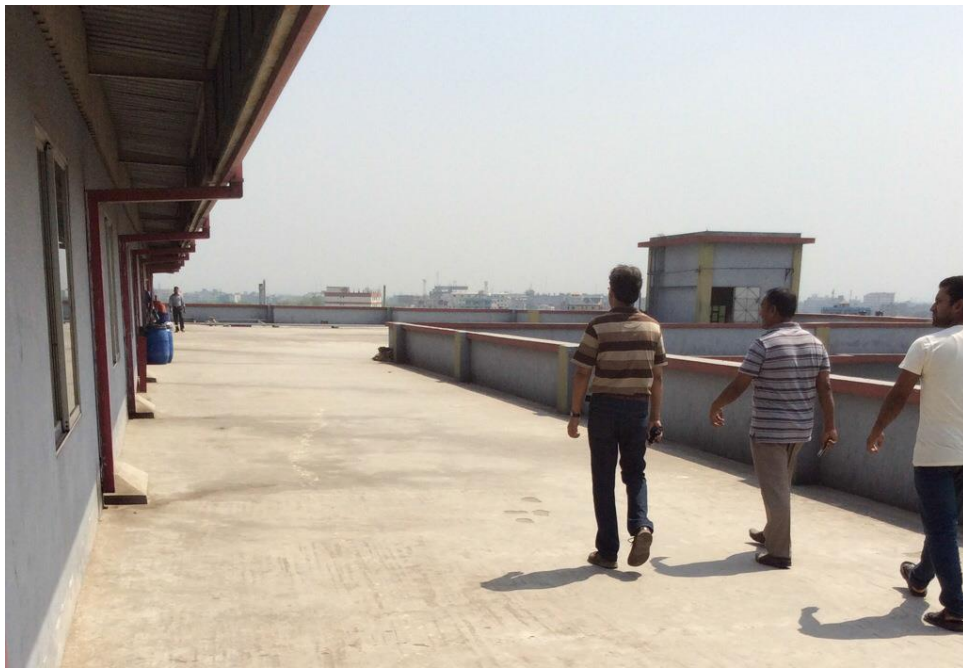
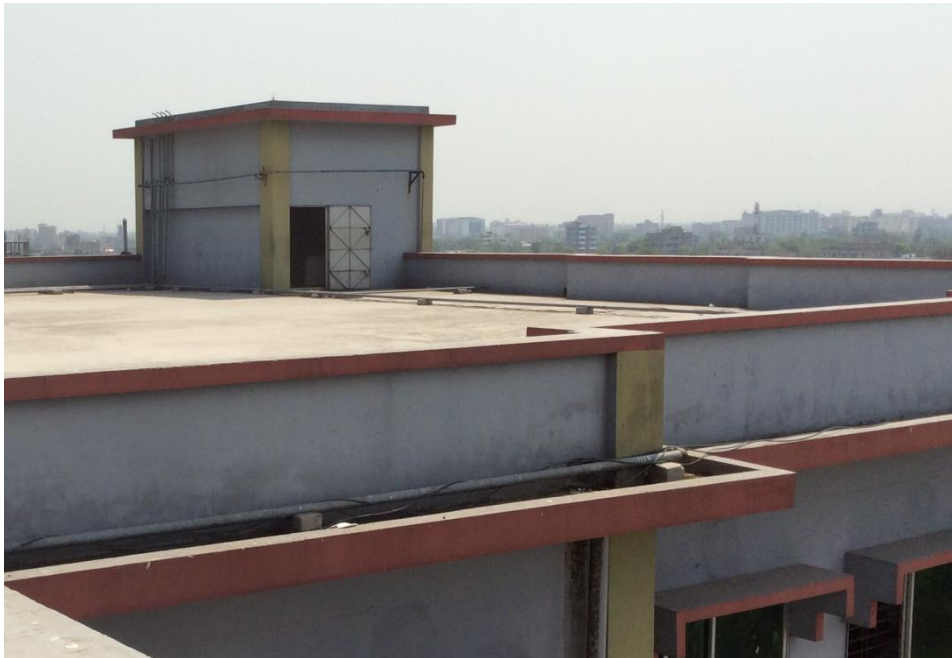
# **Design check required for columns supporting water tanks in Buildings 1 and 2**

**Building 1 water tanks located at corners of the building.**

**Building Engineer to verify that the columns supporting the tanks have adequate carrying capacity**

| Item No. | Observation | Recommended Action Plan | Recommended Timeline |
|---|---|---|---|
| 1 | Buildings 1 and 2 – Verify concrete strengths in ground floor columns below toilet areas and water tanks | Factory Engineer to review design, loads and column stresses in areas identified above. | 6-weeks |
| 2 | Buildings 1 and 2 – Verify concrete strengths in ground floor columns below toilet areas and water tanks | Verify insitu concrete stresses either by cores or existing cylinder strength data , or take 100mm dia. cores from min. 4 no. ground floor columns | 6-weeks |

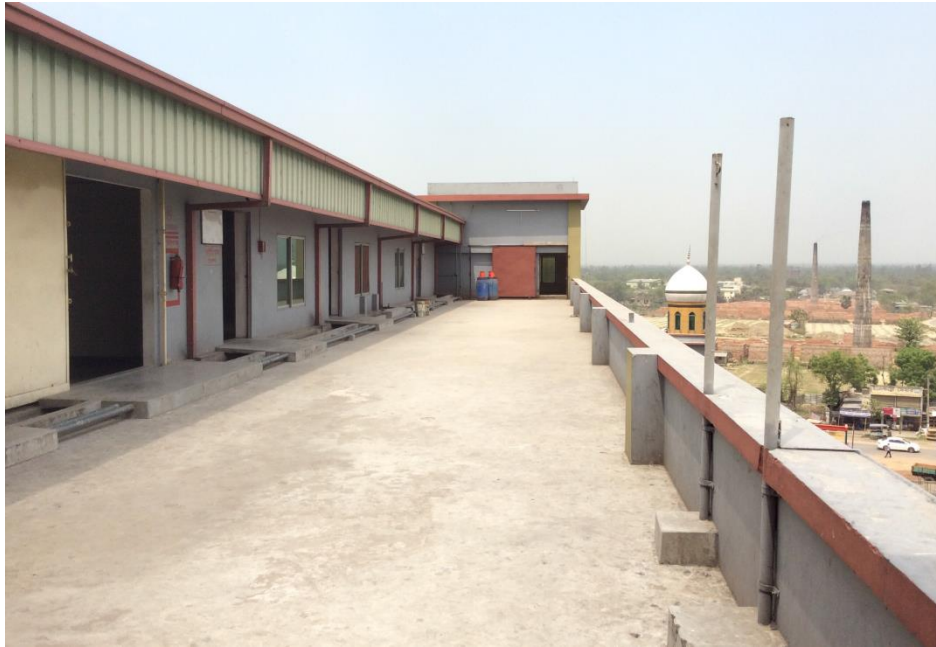
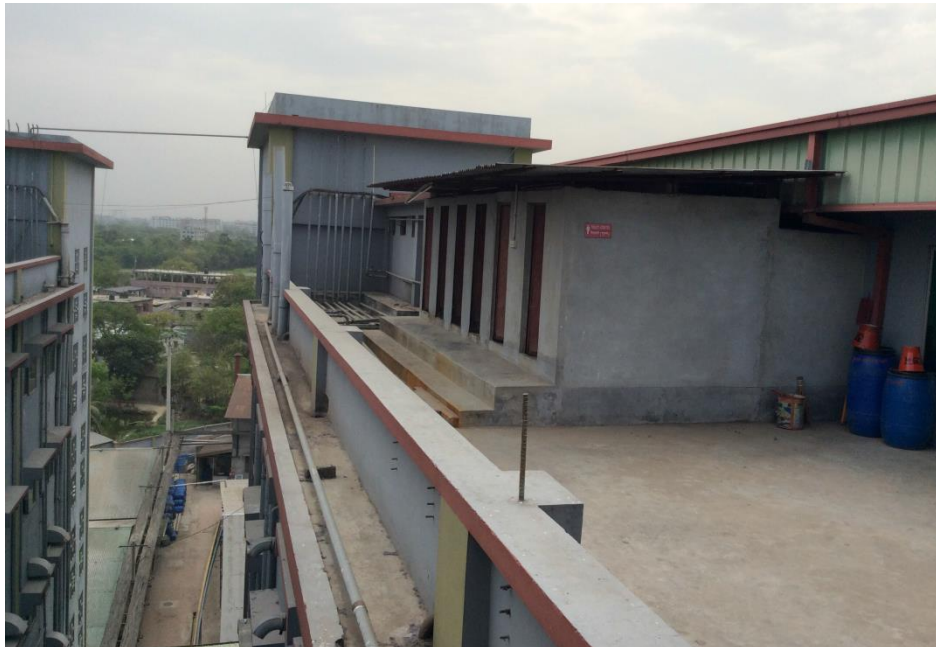
**Building 2 water tanks located at corners of the building.**

**Building Engineer to verify that the columns supporting the tanks have adequate capacity**

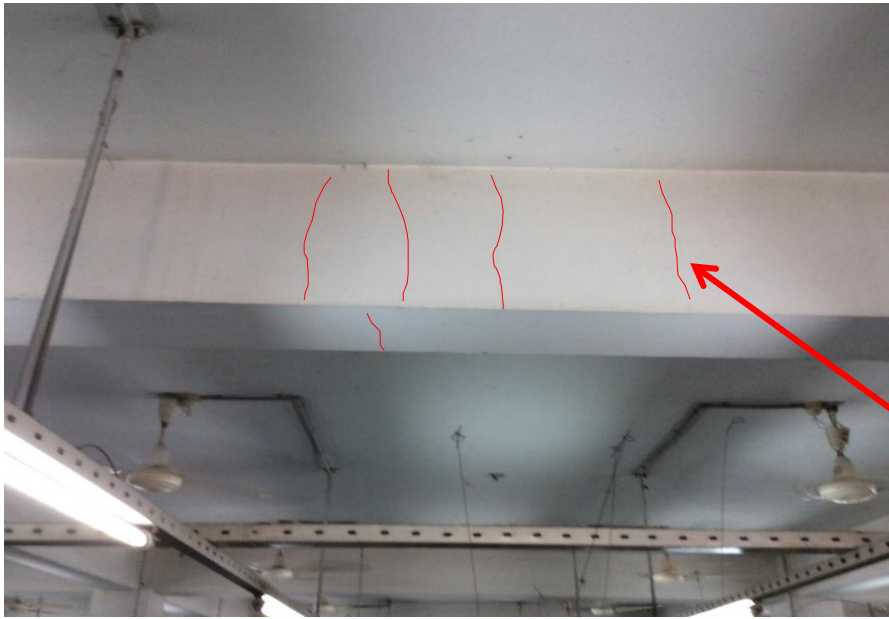
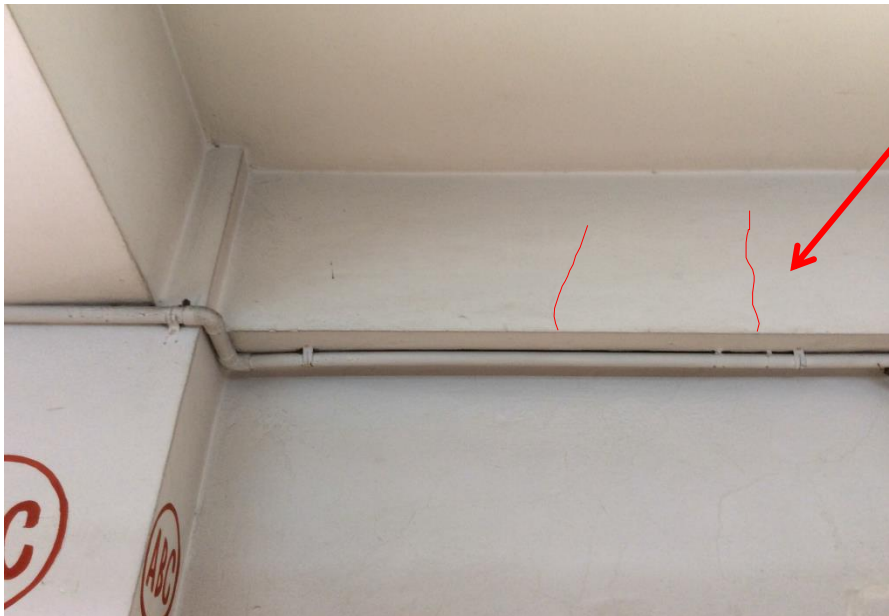
**Hairline cracking observed on soffit  
and sides of beams at all levels of  
Buildings 1 and 2**

**Typical non-structural parallel cracking at mid-span of beam, and random cracks near support. The cracks are more widespread at the underside of the roof.**

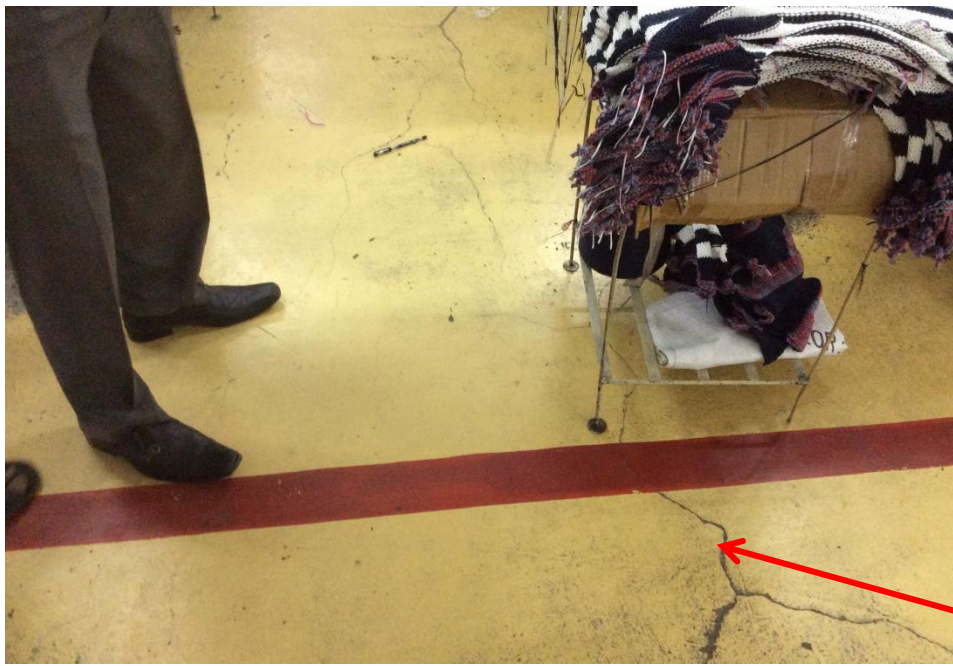
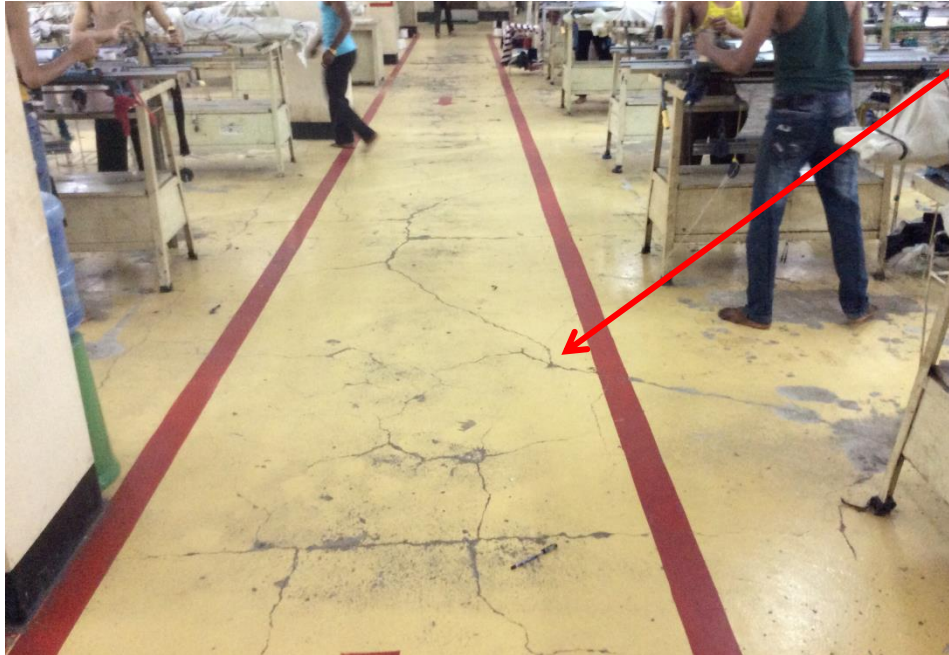
**Cracking observed on the floor  
finishes at all levels where concrete  
screed was used**

Cracking observed on the floor finishes at every level. It appear that these are superficial as there are no evidence that cracking is extending to slab soffit and there is no cracking to tiled areas of the slab.

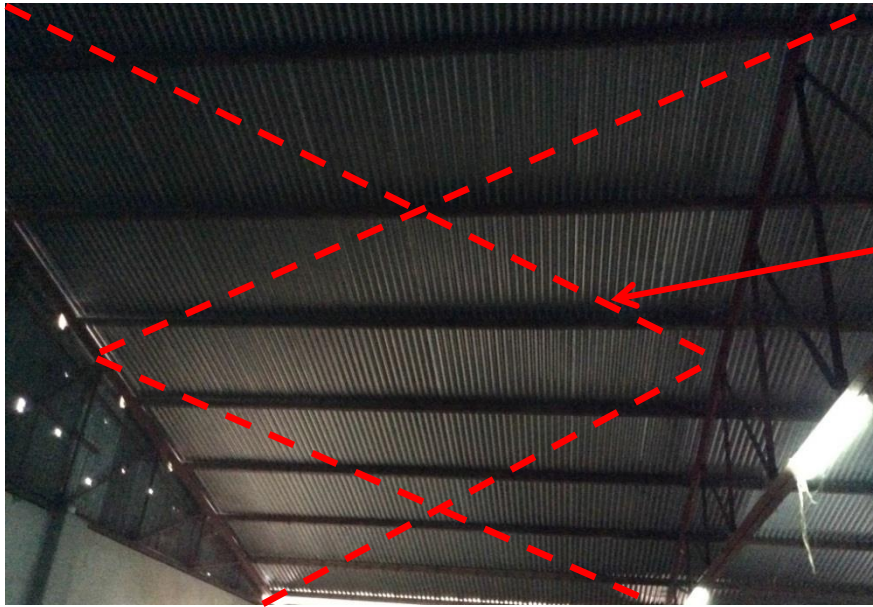
**No roof bracing provided for sheds**

No  
horizontal  
bracing

Design check required for  
lateral stability

| Item No. | Observation | Recommended Action Plan | Recommended Timeline |
|---|---|---|---|
| 6 | Buildings 3 to 7 – Lack of Roof Bracing | Buildings 3 to 7 – Lack of Roof Bracing | 6-weeks |
| 7 | Buildings 3 to 7 – Lack of Roof Bracing | Building Engineer to ensure that any necessary remedial modifications are completed. | 6-months |

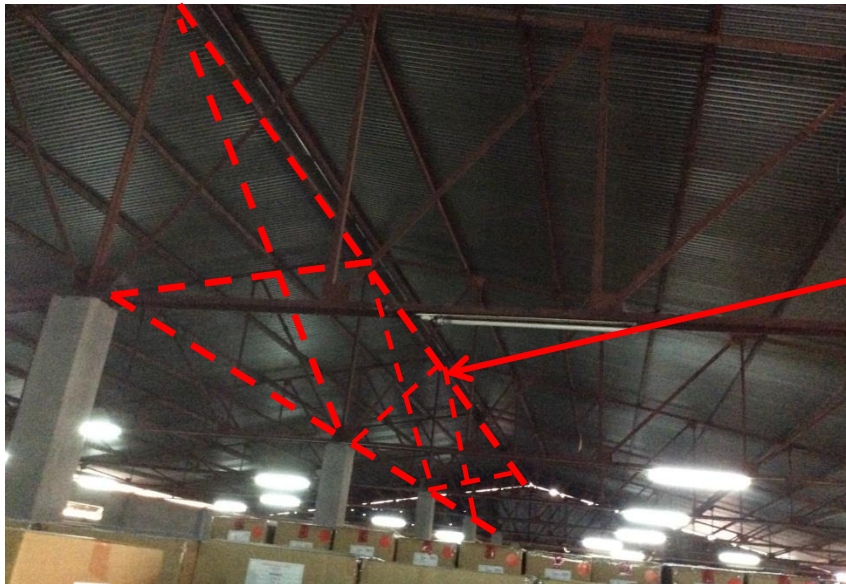
No bracing

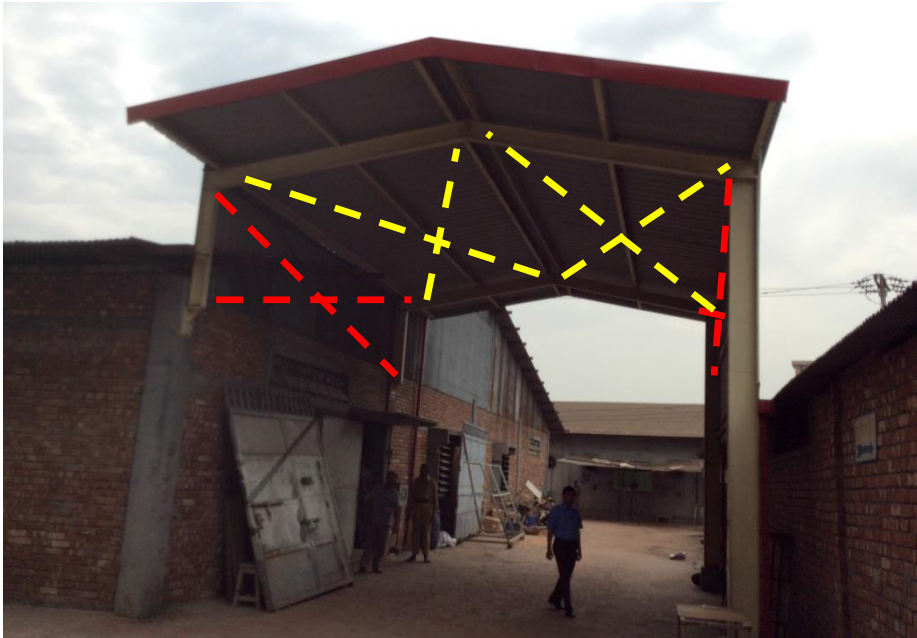
**No bracing provided to the portal frame for stability.**

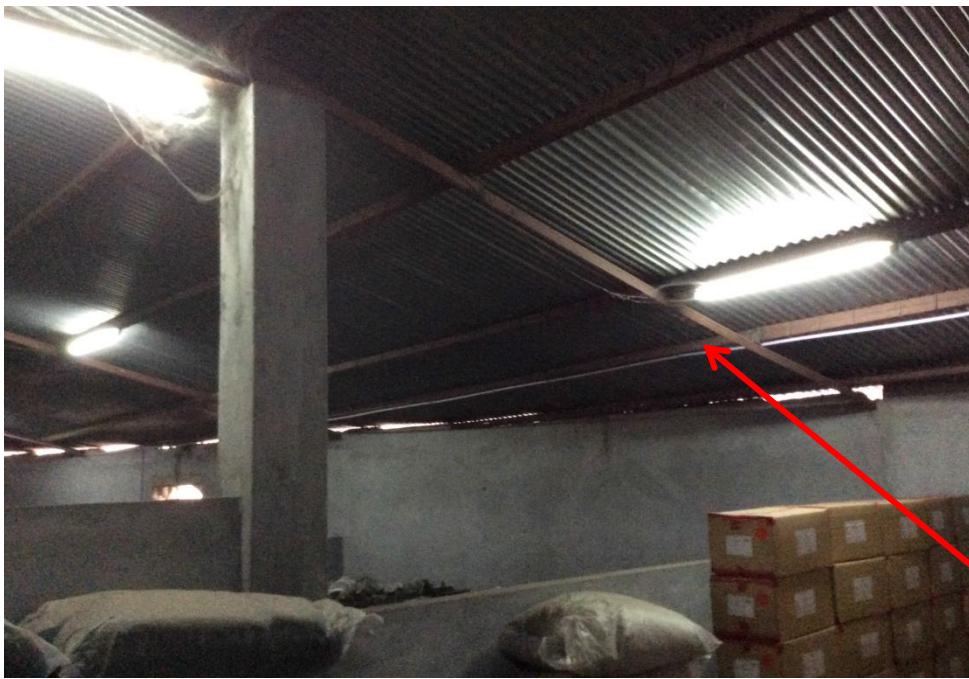
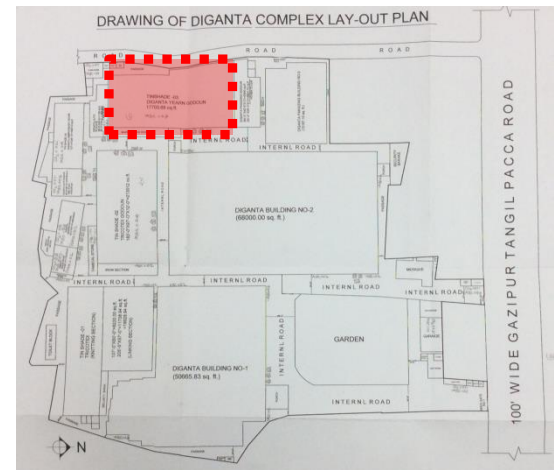
## **Deflections in existing roof structure**

**Rafter deflecting excessively**

**Rafters provided in Building 3 extension appear too small. Review and replace if necessary with suitable steel section.**

| Item No. | Observation | Recommended Action Plan | Recommended Timeline |
|---|---|---|---|
| 8 | Building 7 - Roof Design | Building engineer to review roof design for elements where large deflections are present in Building 7. | 6-weeks |
| 9 | Building 7 - Roof Design | Implement actions arising from review of roof design. | 6-months |

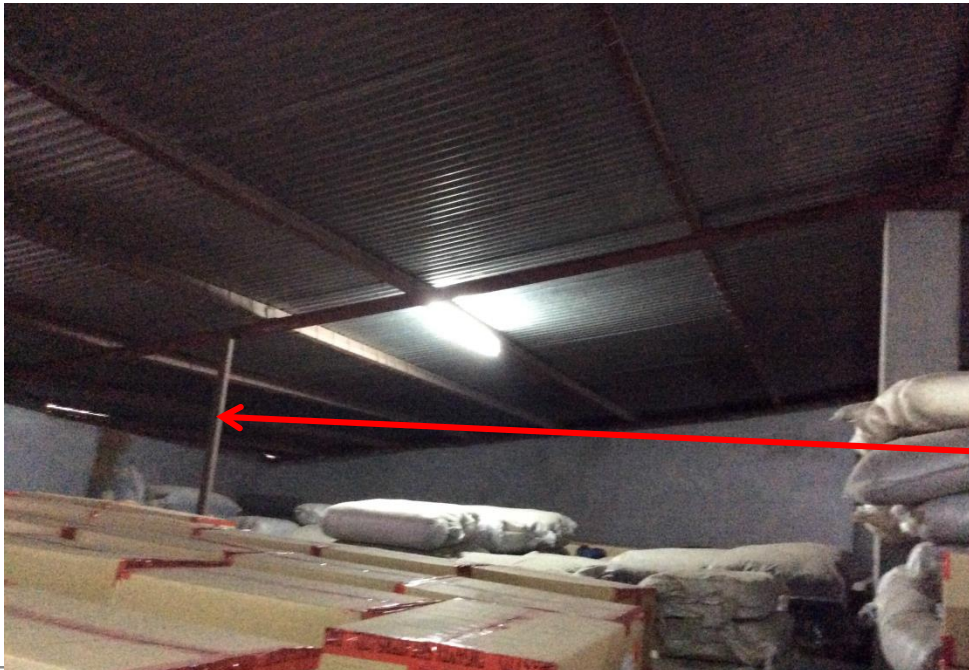
**Existing remedial support.**
