# Fancy Fashion Sweaters Ltd.

1153-54, Shahid Siddique Road, Khailkur, Board Bazar, Gazipur-1704, Bangladesh  
(23.942443N, 90.388539E)

23 March 2014

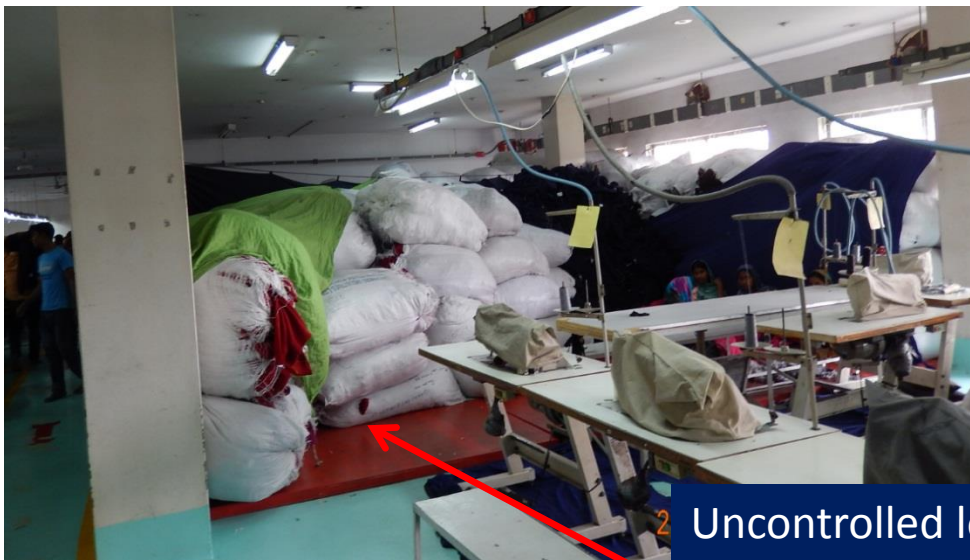
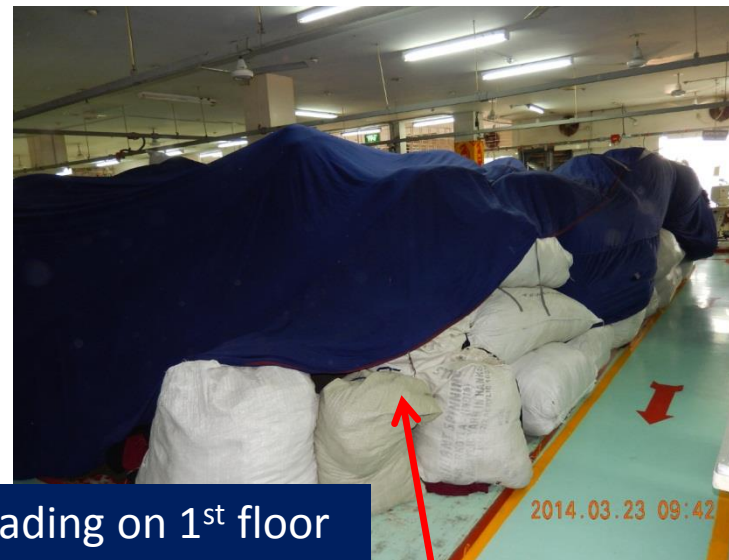
Uncontrolled loading on 1<sup>st</sup> floor

All loading to be managed according to loading plan.

| Item No. | Observation | Recommended Action Plan | Recommended Timeline |
|---|---|---|---|
| 8 | Loading in uncontrolled areas | Reduce loads where noted previously. Loading not to exceed 2kN/m <sup>2</sup> | <b>Immediate - Now</b> |

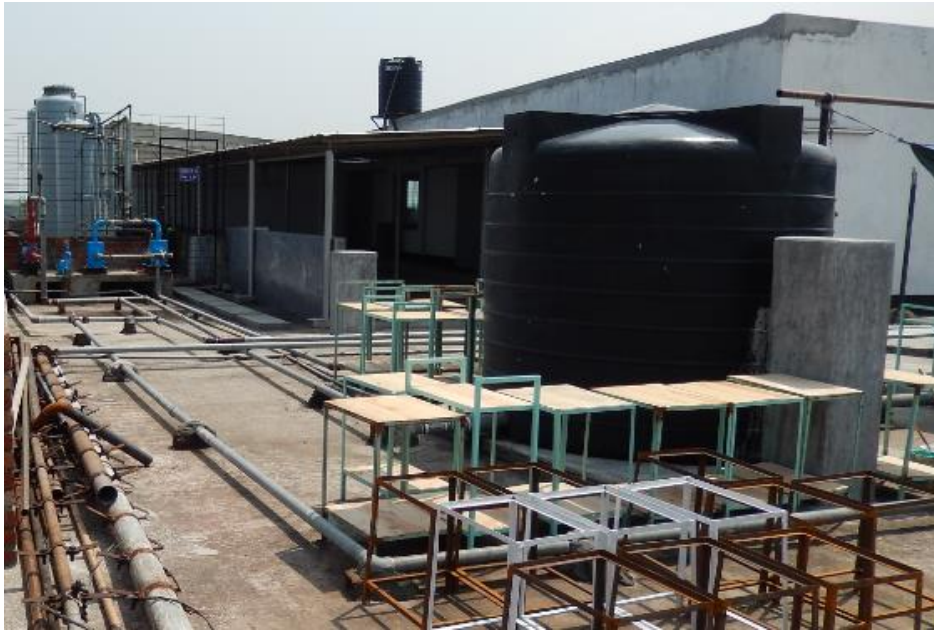
Four 5000 litres water tanks mounted on flat concrete plinth on flat slab close to columns. Tenant confirmed only half full with valve to electrically control.

Building Engineer to check that slab has been designed to accommodate loads in flexure and punching shear.

| Item No. | Observation | Recommended Action Plan | Recommended Timeline |
|---|---|---|---|
| 15 | Concentrated high loading from water tanks on roof slab | Building engineer to check the slab for punching shear and flexural strength. | <b>6-weeks</b> |

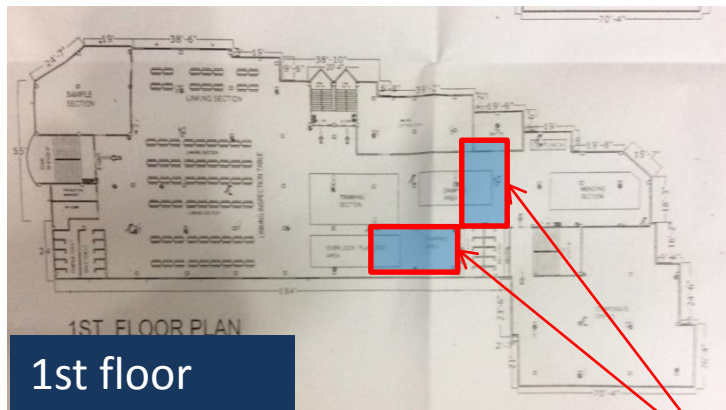
1st floor

Controlled

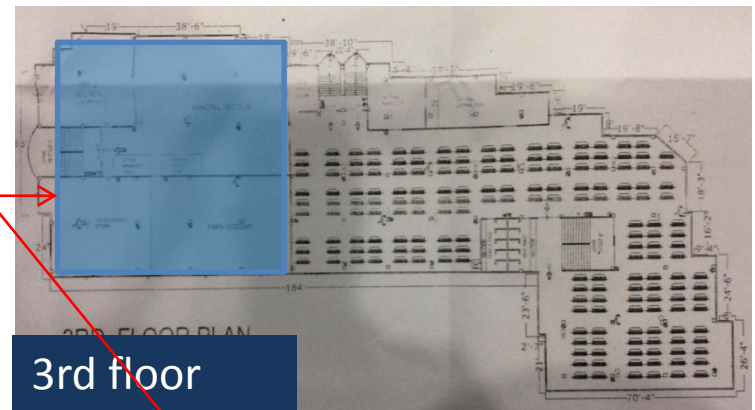
3rd floor

Uncontrolled

Material stacked within storage areas and other areas.

Plan and height restrictions to be introduced to currently uncontrolled areas, to prevent future overloading.

In area labelled uncontrolled loading should be limited in accordance with loading plans until DEA complete and results available.

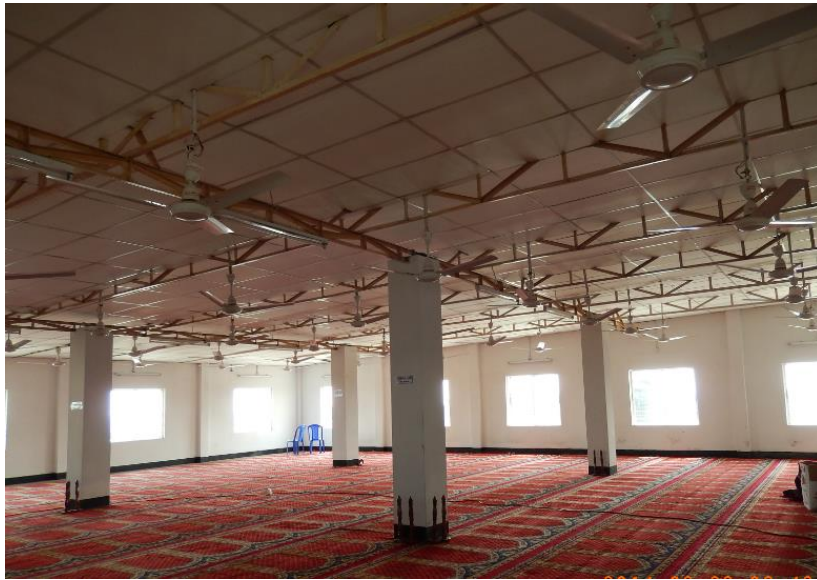
Prayer room primary trusses smaller than secondary trusses. Design to be checked.  
Masonry wall stability to be checked.  
Connections to be designed and checked for uplift

| Item No.23 | Observation | Recommended Action Plan | Recommended Timeline |
|---|---|---|---|
| 17 | Non engineered steel frames at 5th and 6th stories | Detail Engineering Assessment to access and design remedial works if possible. | Immediate - Now |
| 18 | Non engineered steel frames at 5th and 6th stories | Temporary structures to be removed or strengthened to meet current design standards. Work to be carried out within 6 weeks. | 6-weeks |

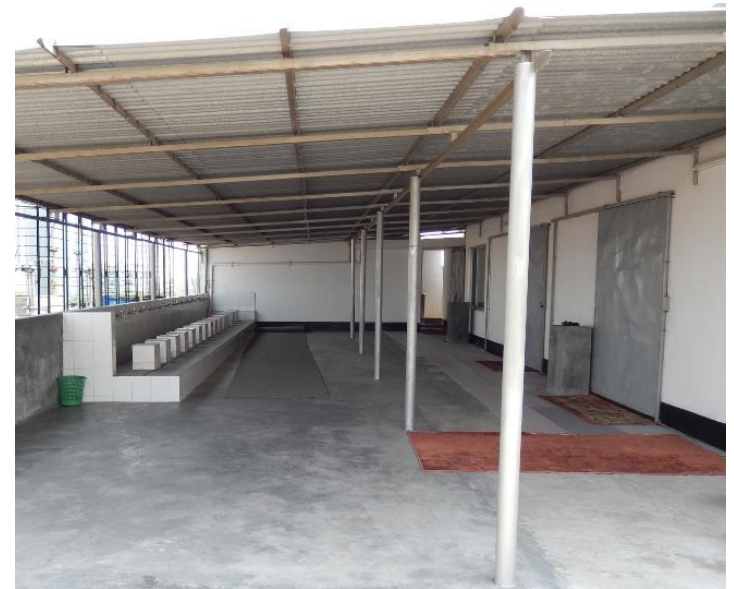
Open sided shelter adjacent to prayer room.  
Detailed design check required for vertical and lateral stability.  
insufficient for loads in severe winds.  
Engineered structure required.  
Current structure to be removed

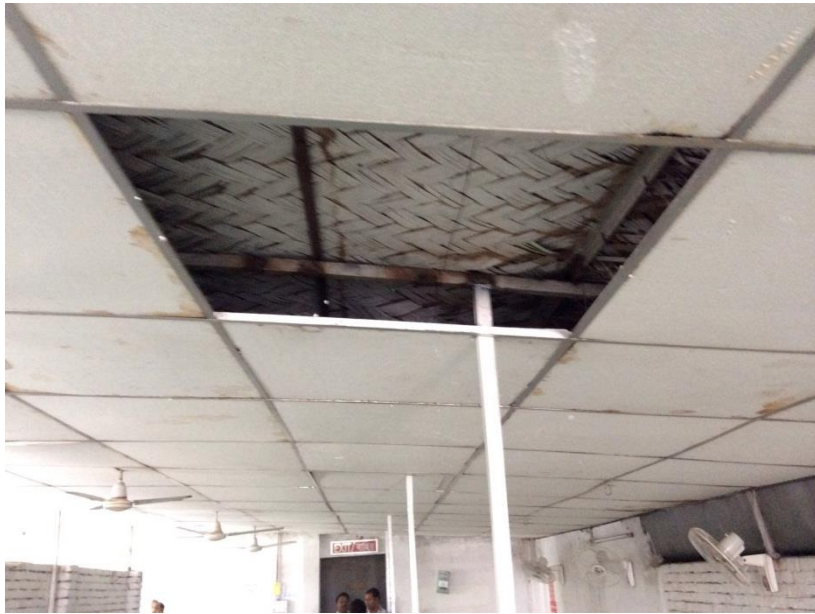
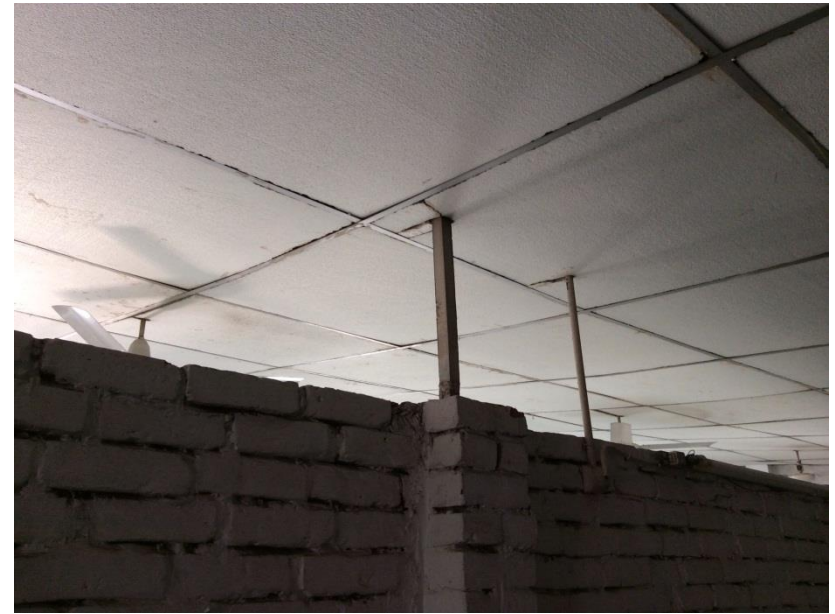
Dining rooms.  
40x40mm RHS posts and beams  
insufficient for loads in severe winds.  
Engineered structure required.  
Current structure to be removed

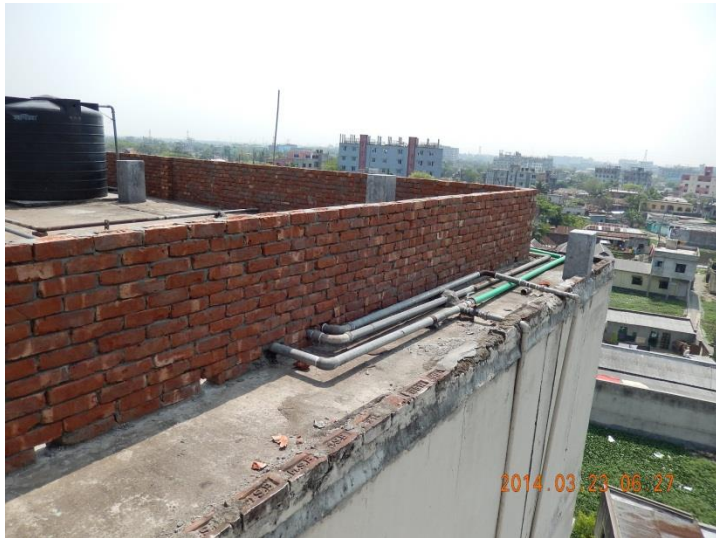
Free standing single leaf parapet walls with intermediate piers at approximately 3 to 6m. Piers insufficient. Parapet wall to be strengthened or to be removed.

| Item No.23 | Observation | Recommended Action Plan | Recommended Timeline |
|---|---|---|---|
| 19 | Lateral Stability of Single Leaf Masonry Walls | Detail Engineering Assessment to access and design remedial works if possible. | Immediate - Now |
| 20 | Lateral Stability of Single Leaf Masonry Walls | Remedial works to be carried out to make wall stable. | 6-weeks |

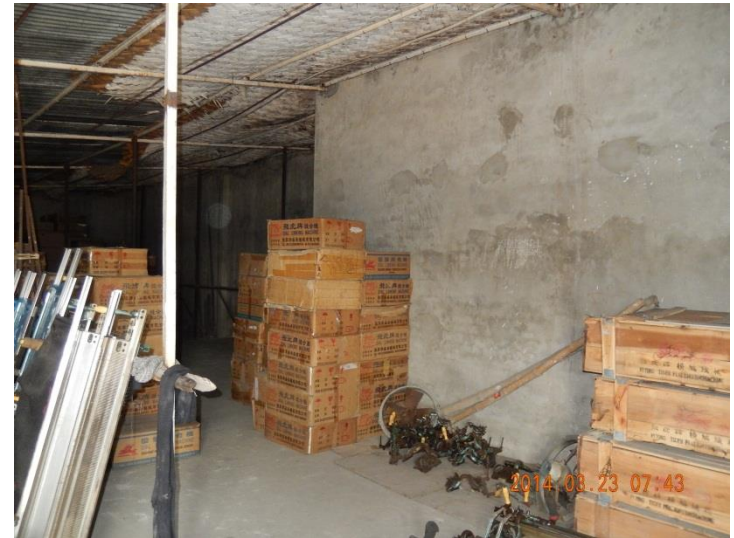
3.5m high free standing masonry walls generally on upper floors have inadequate head restraint and piers. To be strengthened or removed.

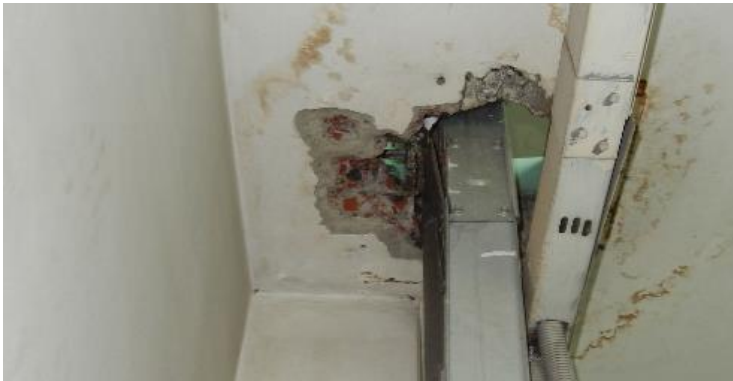
Service void formed in slab very close to column and beam strip. Hole sides irregular and beam strip reinforcement exposed. Punching shear to be verified.

| Item No. | Observation | Recommended Action Plan | Recommended Timeline |
|---|---|---|---|
| 16 | Service hole close to column locations | Building engineer to check the slab for punching shear. Holes sides to be made good. Exposed reinforcement to be cleaned of all rust and holes sides to be formed providing adequate cover to the reinforcement. | <b>6-months</b> |

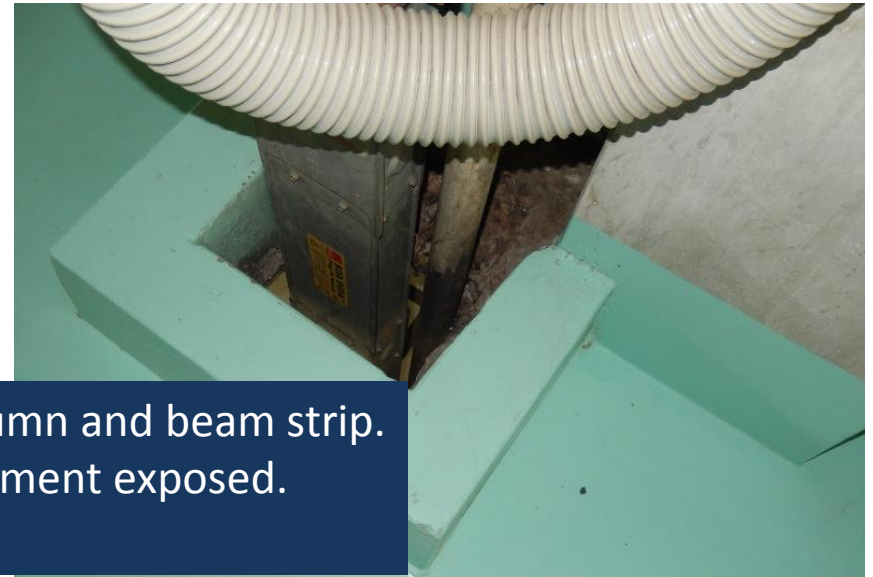
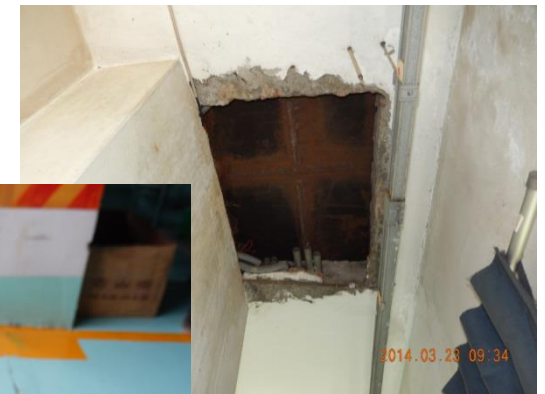
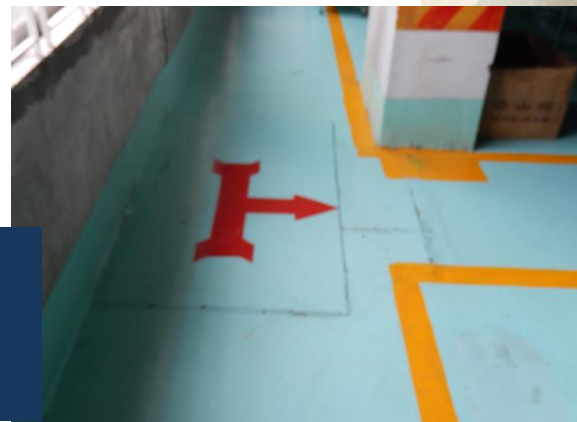
Service void formed in cantilever very close to column. Punching shear to be verified.

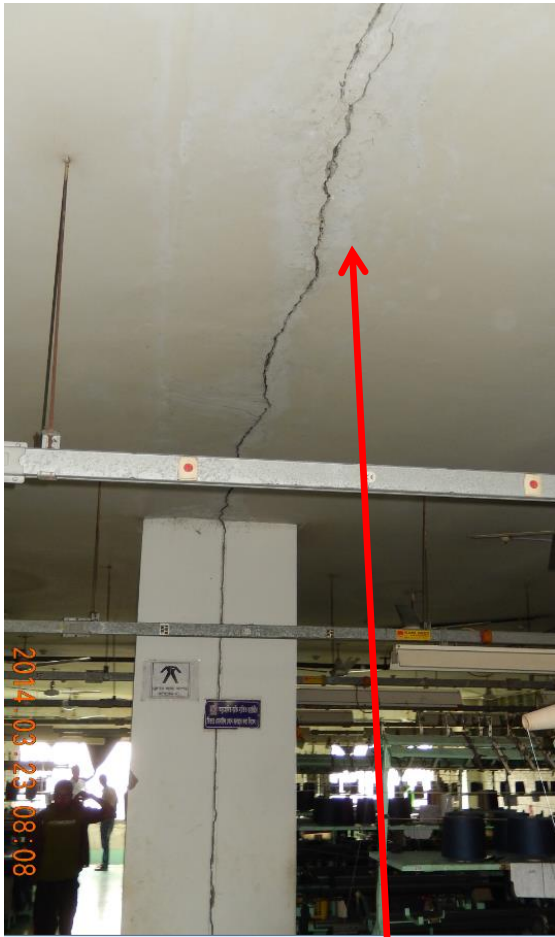
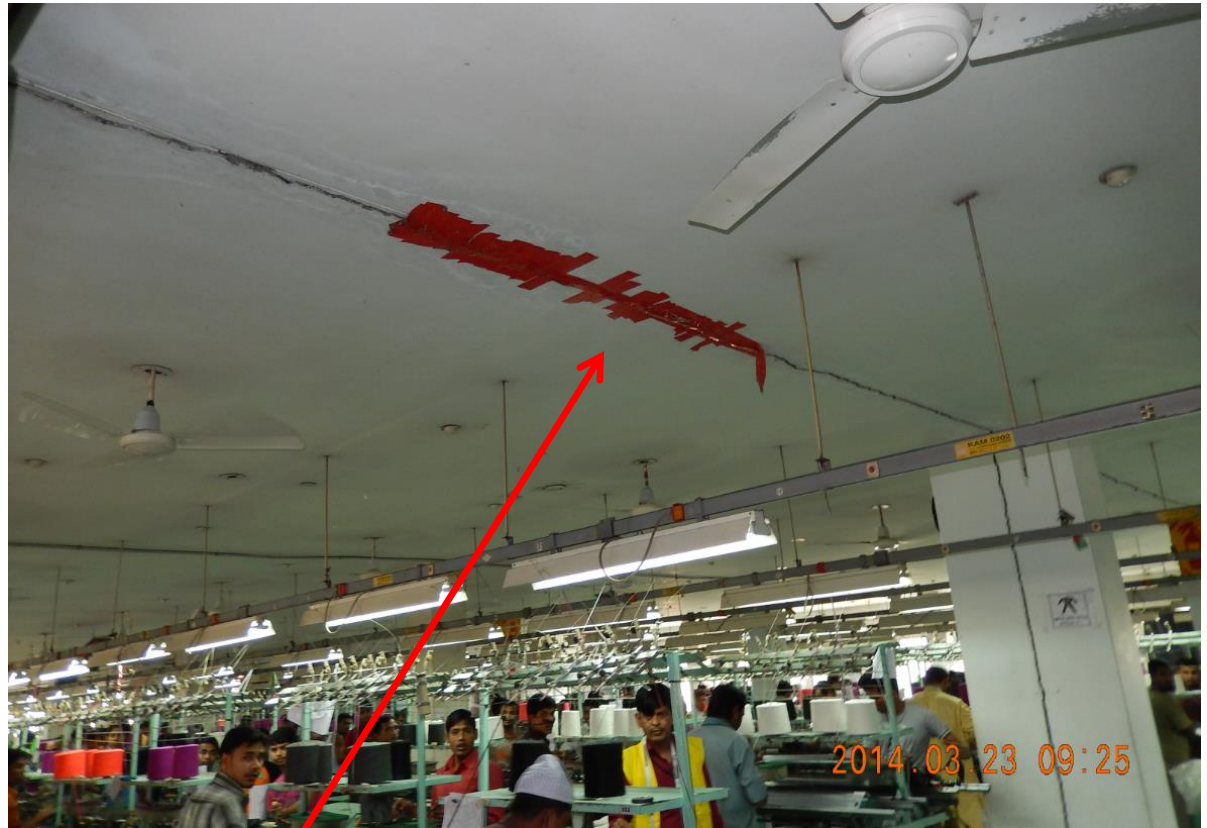
**Movement joint repair required to maintain durability of concrete and prevent plaster falling from height.**

| Item No.23 | Observation | Recommended Action Plan | Recommended Timeline |
|---|---|---|---|
| 22 | Sealing of movement joint | Engineer to propose adequate movement joint repair. | 6-months |
| 23 | Sealing of movement joint | Install maintain proposed repair. | 6-months |

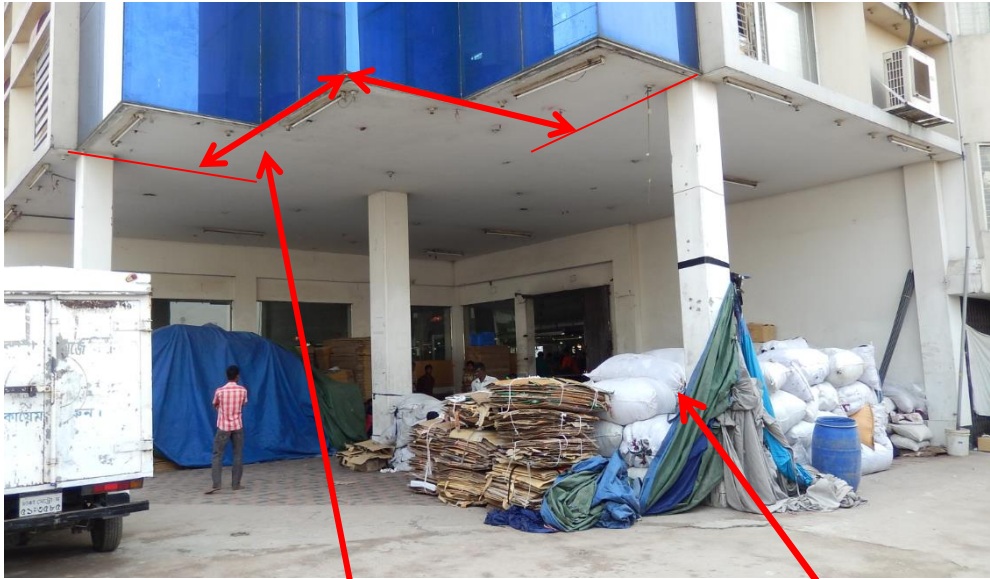
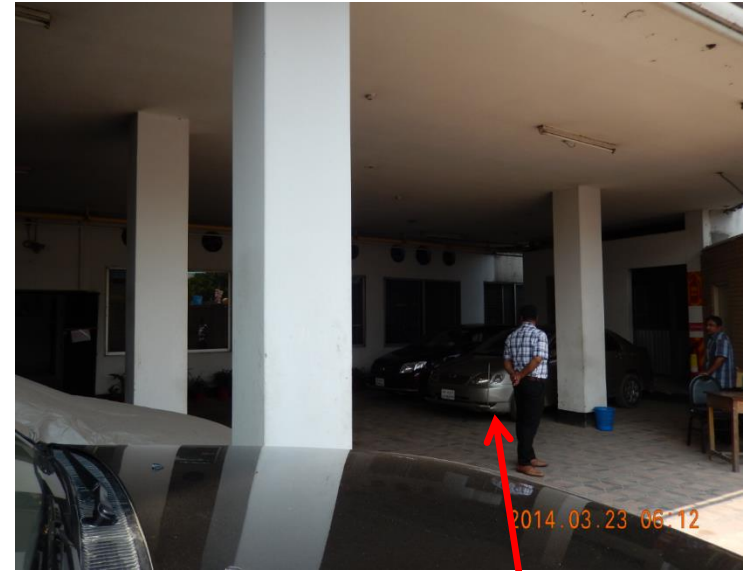
Large cantilever at corner of building. Engineer to justify in the Detailed Engineering Assessment

| Item No.23 | Observation | Recommended Action Plan | Recommended Timeline |
|---|---|---|---|
| 24 | Cantilever Slab | A Detail Engineering Assessment to justify large cantilever corners | Immediate - Now |

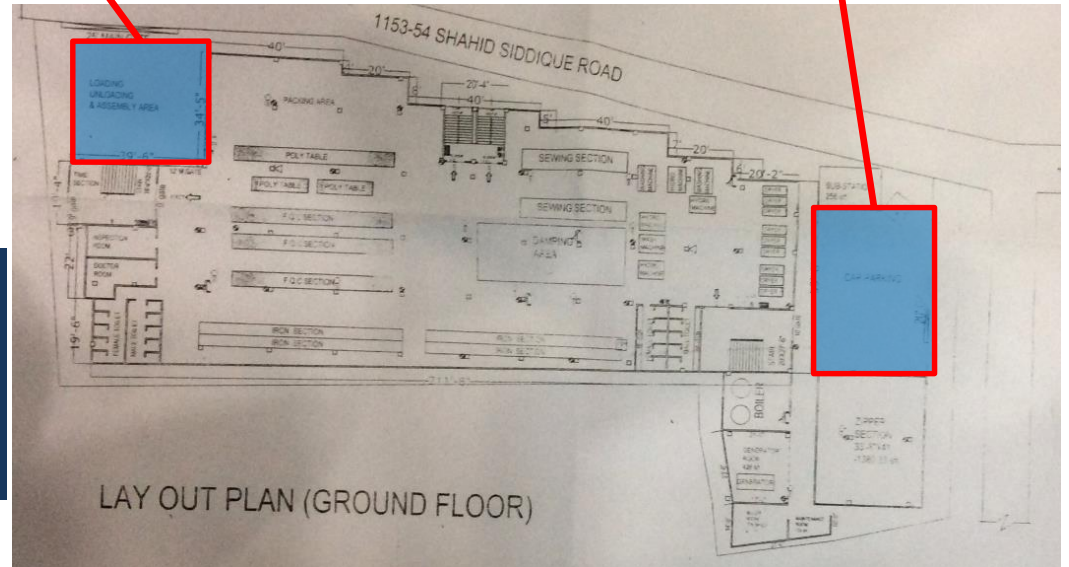
**Column at ground floor should be  
protected from vehicle impact in the  
loading bay**

Loading bay and parking area columns to be protected for vehicle impact or strengthen for vehicle impact load

| Item No.23 | Observation | Recommended Action Plan | Recommended Timeline |
|---|---|---|---|
| 21 | Column at ground floor should be protected from vehicle impact in the loading bay | Provide impact protection at all columns that are in risk of impact from vehicles, either by stopping vehicles approaching the columns, or by strengthening the columns. | 6-weeks |

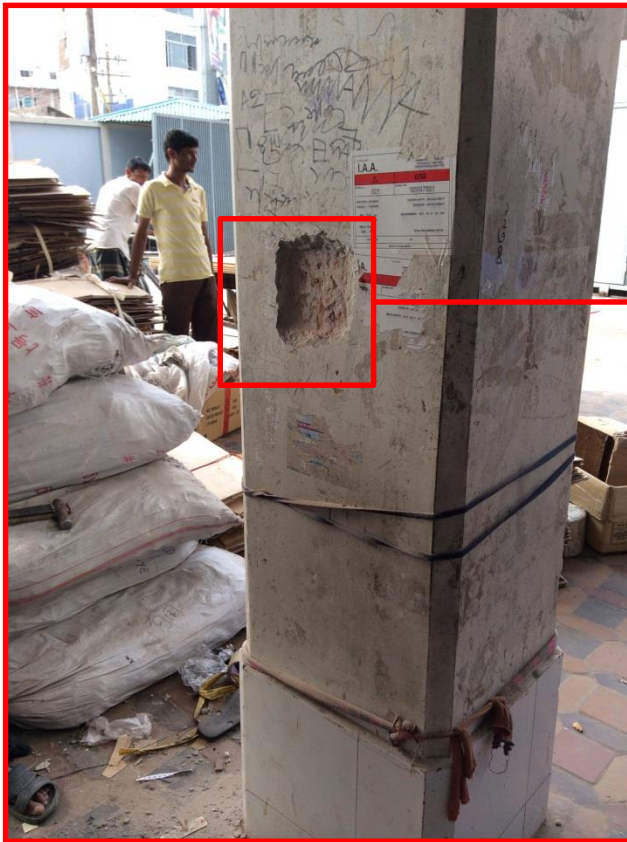
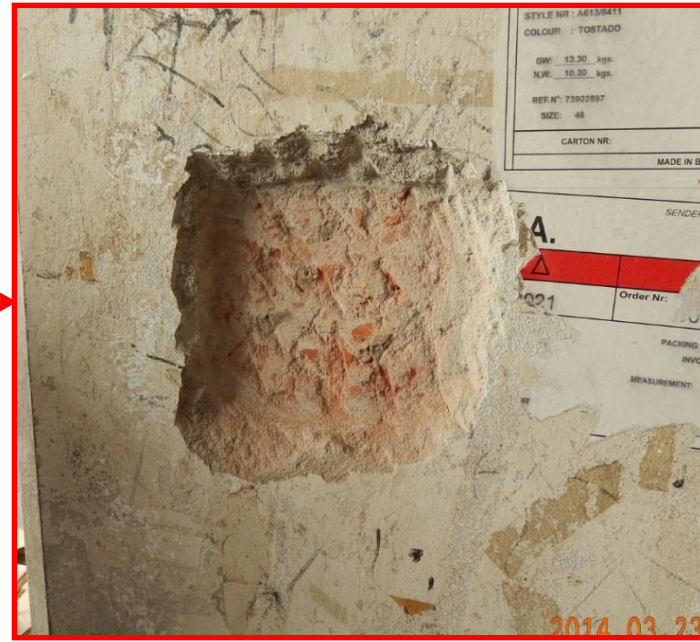
Ferrosan tests carried out on several ground floor columns.
