# **FIRE SAFETY INSPECTION REPORT**

## **HAMS GARMENTS LTD (EXTENSION)**

**ACCORD ID: 12619**

**Inspected By: Shabbir Hossain and Pantha Pallob Das**  
**Date: 11 January, 2017**

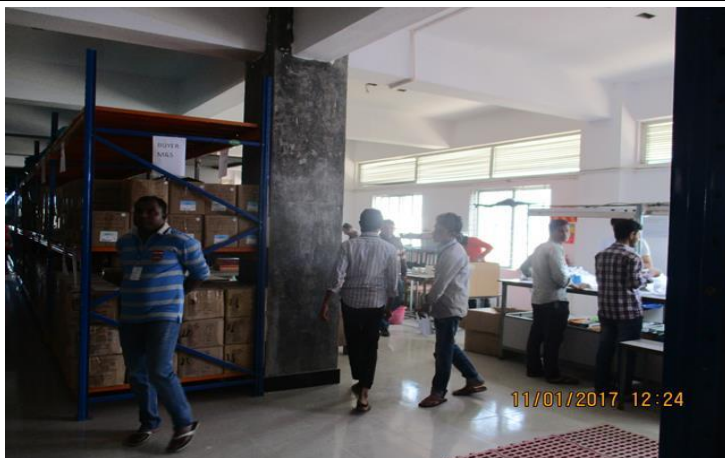
| SI No. | Category | Findings | Required Action | Remediation Time Frame |
|---|---|---|---|---|
| 1 | Fire Rated Construction | The office area on 2nd floor of the building is not fire separated with storage area. | The office area shall be fire separated by 1-hr rated barrier construction with minimum 0.75 hr opening protective assemblies, the discharge for office area never shall be through the storage area. | Within 3 months |

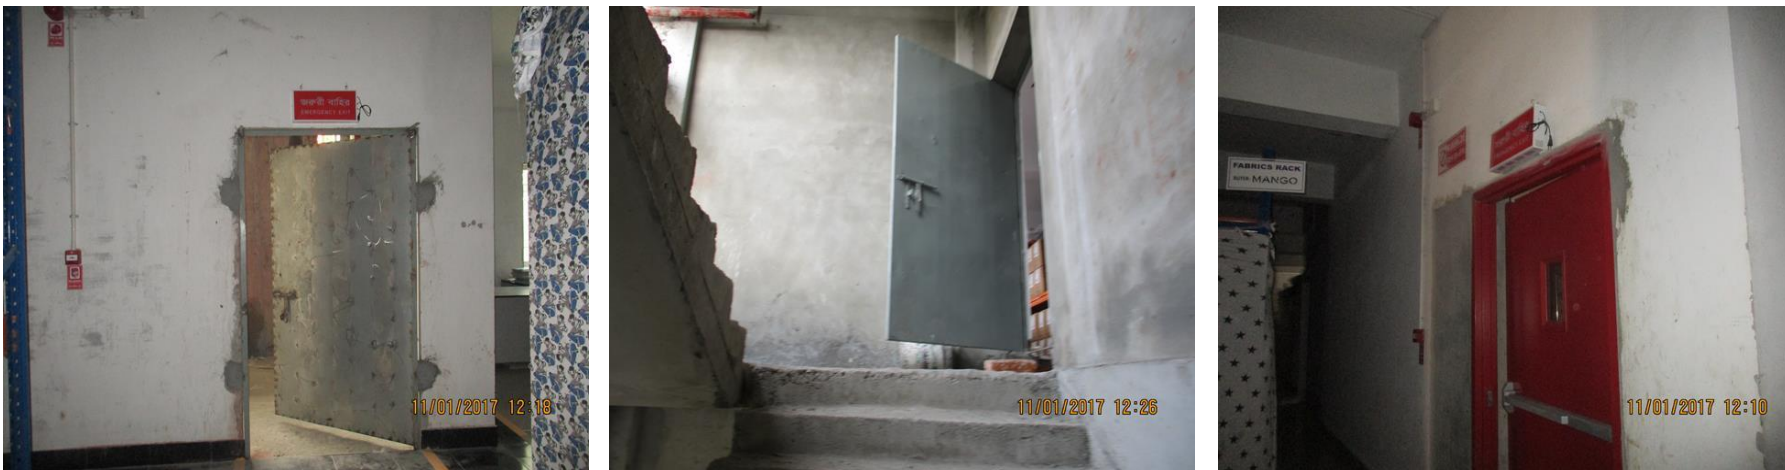
| 2 | Fire Rated Construction | The exit stairs are not separated from work areas and other spaces on each floor by fire rated construction due to unprotected openings and penetrations. | <p>The exit stair enclosure shall be provided with a minimum 1-hr fire resistance rating for buildings with 3 or fewer stories and a minimum of 2- hr. fire resistance rating for buildings 4 or more stories. Provide 0.75 hr. fire rated door and seal all penetrations and openings by 1 hr. fire rated fire rated barrier construction for building with 3 or fewer stories. Provide 1.5 hr. fire rated door and seal all penetrations and openings by 2 hr. fire rated fire rated barrier construction for building with 4 or more stories.</p> <p>Provide a fire-resistive rated assembly between the exterior exit stairs and the building up to 10 ft. beyond the end of the stair to achieve the required separation. The rated assembly shall be approved and/or designed by a qualified fire protection engineer.</p> <p>Ensure that the fire doors are self-closing and positive latching and that they are provided with fire exit (panic) hardware where serving production floors. If fire doors are required to be held open for functional reasons, provide automatic closing devices tied to the fire alarm system.</p> | Within 3 months |

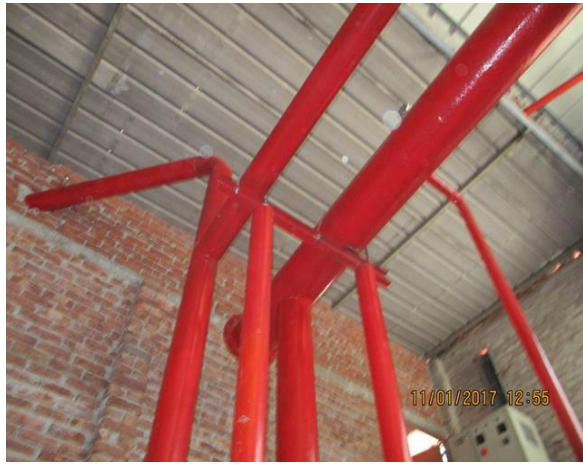
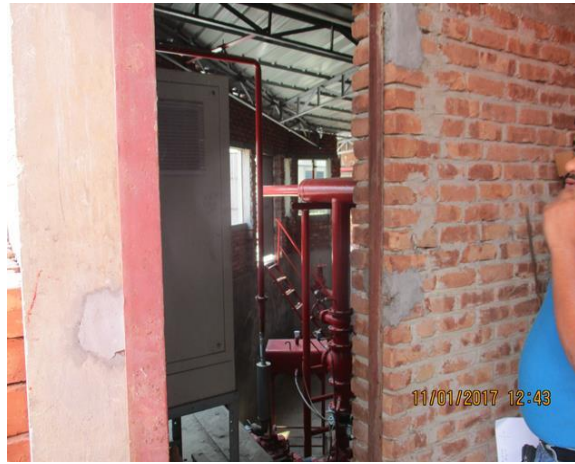
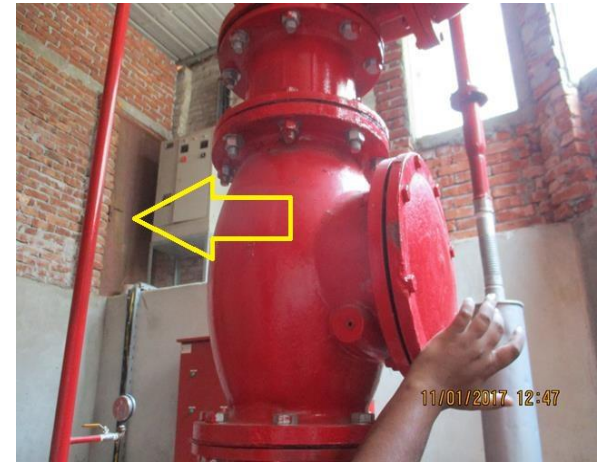
| 3 | Fire Rated Construction | The fire pump room is not fire separated with adjacent occupancies due to common non-rated ceiling, openings and penetrations. | Provide fire pump room with 2 hr rated fire separation when not sprinklered and 1 hr rated fire separation when provided with automatic sprinklers, in accordance with NFPA 20. In the case exterior it shall be 50 ft away from another occupancy. | Within 3 months |

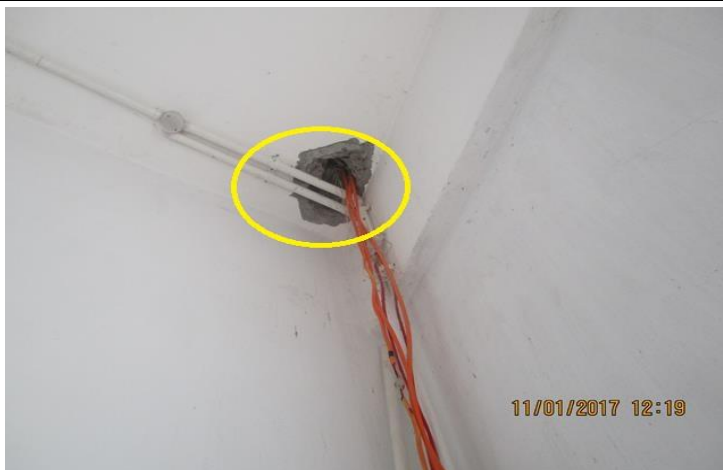
| 4 | Fire Rated Construction | <p>Unsealed penetrations and openings are located in the fire-rated floor/ceiling assemblies.</p> <p><b>Location:</b> On every floor.</p> | Seal all penetrations and openings in floor/ceiling assemblies to maintain the fire separation. | Within 1 month |

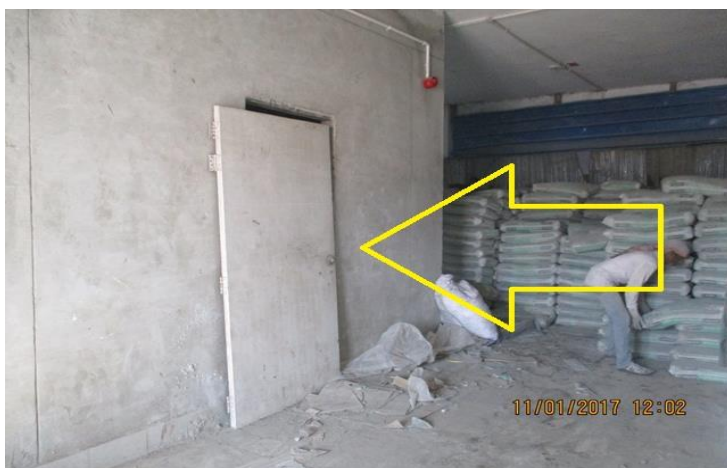
| 5 | Fire Rated Construction | <p>Elevator shaft is directly open into floor without proper fire separation due to unprotected door opening.</p> <p><b>Location:</b> South-East Stair enclosure on ground floor.</p> | <p>Ensure minimum 1.5-hr fire rating for the door of elevator shaft otherwise close the shafts area with 2-hr fire rated construction barrier and 1.5-hr fire rated doors.</p> | <p>Within 3 months</p> |

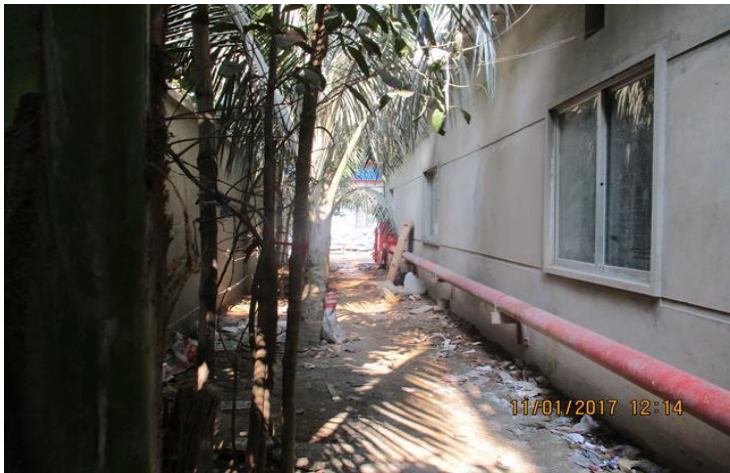
| 6 | Fire Rated Construction | <p>1. The exit discharge path for building serving west exit is less than 10 ft wide and is not separated from the building interior.</p> <p>2. The exit discharge path in-between shed-1&amp;2 is less than 10 wide and not separated properly from buildings interior.</p> | <p>Seal all penetrations and openings to the interior of the building along the discharge path, up to a height of 10 ft. to provide a minimum 2-hr fire separation.</p> <p>Alternatively, provide a second remote discharge path to the public way (only include this if feasible).</p> | Within 3 months |

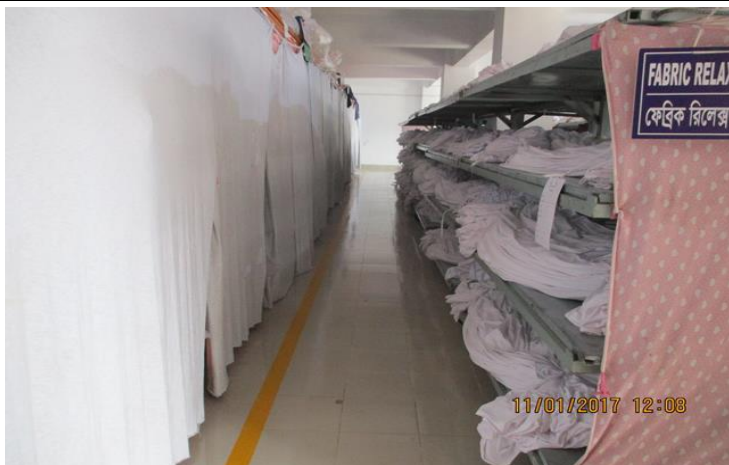
| 7 | Egress | <p>The width of egress aisles is less than 36-in.</p> <p><b>Location:</b> On ground,1st, 2nd floors.</p> | Provide minimum unobstructed aisle width of 36-in. | Within 1 month |

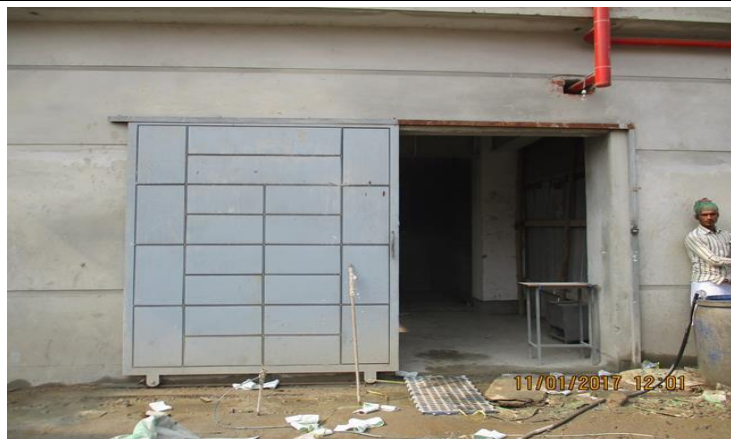
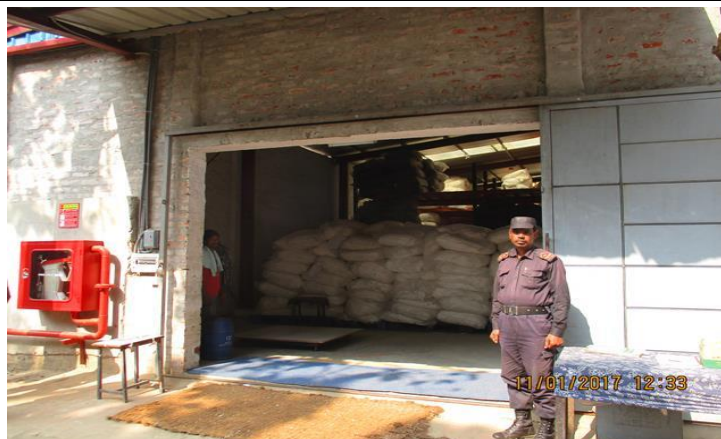
| 8 | Egress | Non-compliant exit doors (sliding type) have provided along means of egress on all the exits of ground floor and shed-1&2. | Replace all collapsible/sliding/shutter type doors & gates by the side-hinged swinging type doors. If locks are required for security reasons, utilize special door locking features complying with NFPA 101. | Within 1 month |

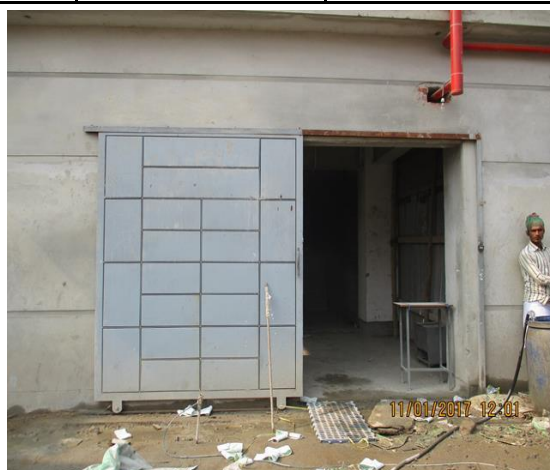
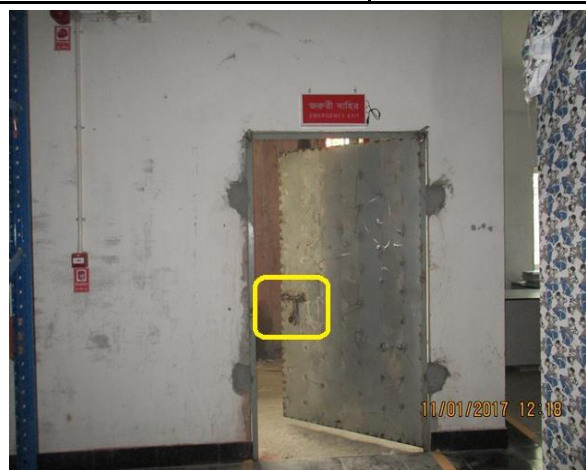
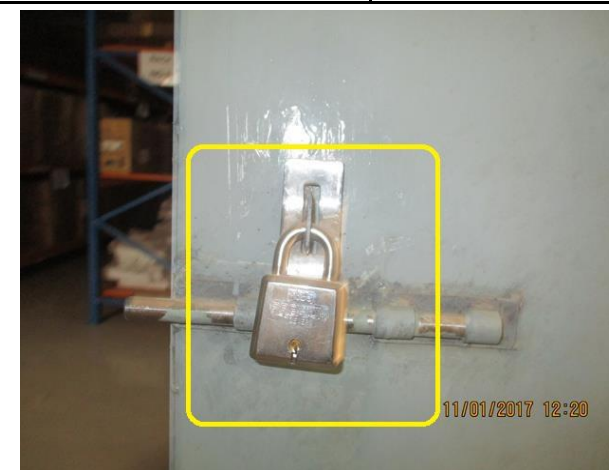
| 9 | Egress | Doors along means of egress are provided with non compliant locking system. (All the exits of building and sheds) | <p>Remove all non compliant locking features from egress doors.</p> <p>If locks are required for security reasons, utilize special door locking features complying with NFPA 101.</p> <p>Doors may be locked where the latch and lock are disengaged with one motion where the occupant load does not exceed 49 persons.</p> <p>Doors may be provided with locking hardware from the ingress side provided that a panic bar is installed on any door with an occupant load exceeding 49 persons.</p> | Immediate |

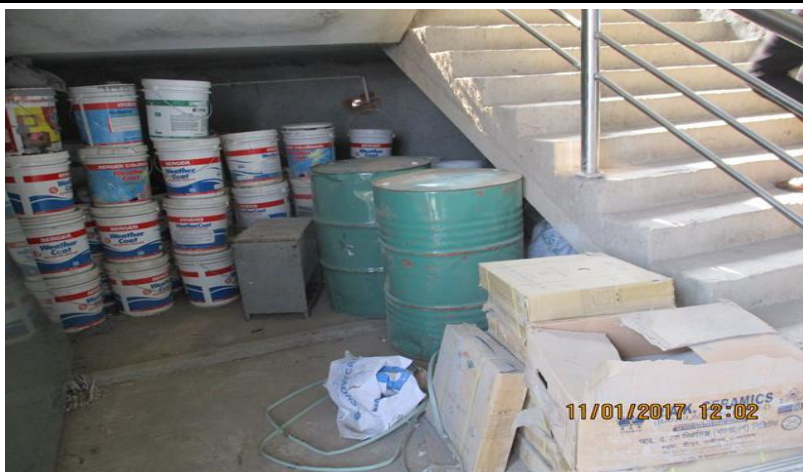
| 10 | Egress | Storage was located in the exit stair on ground floor. | Remove all storage from exit stairs and egress paths. | Immediate |

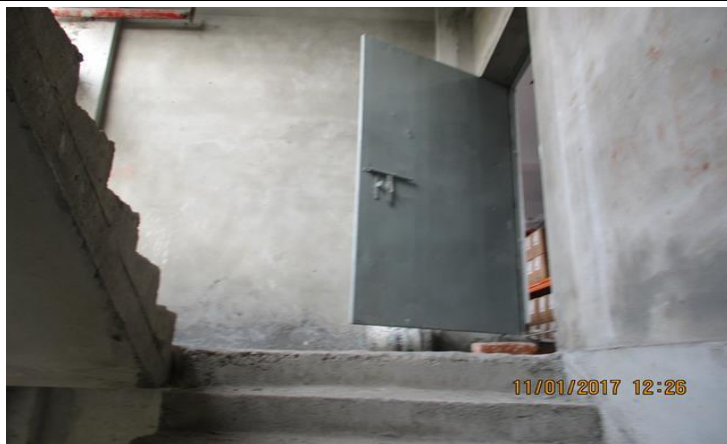
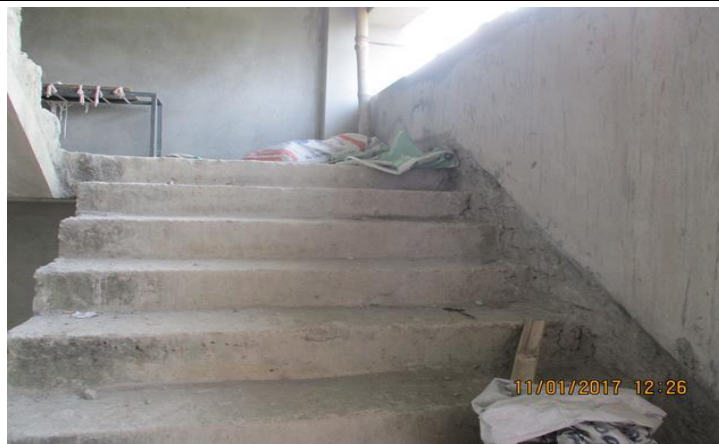
| 11 | Egress | Handrails are not provided on both sides of any of the stairs on all floors. | Provide handrails on both sides of the exit stair. New handrails shall have a minimum height of 865 mm (34 in.) and a maximum height of 965 mm (38 in.) as measured from the leading edge of the tread. Intermediate handrails shall be provided when the stair width exceeds 2.2 m (87 in.) | Within 1 month |

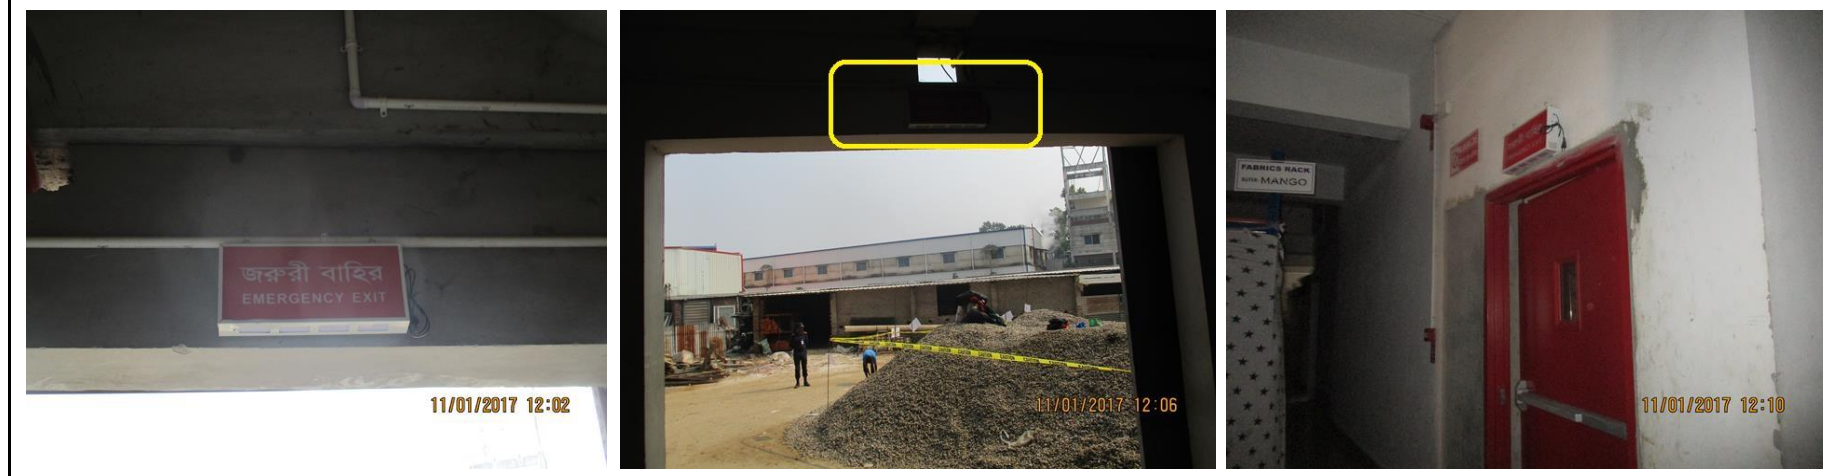
| 14 | Egress Lighting | <p>Exit signage was not provided along a path of egress. (installed exit signage were not functional/illuminated during inspection).</p> <p><b>Location:</b> All floors of the building</p> | <p>Provide exit signs above all building exits to the exterior, all doors to the exit stairs and along all paths of travel where a change of direction is not obvious. Lighted exit signs shall be provided with either battery backup or uninterruptable power supply systems and shall be continuously illuminated.</p> | Within 1 month |

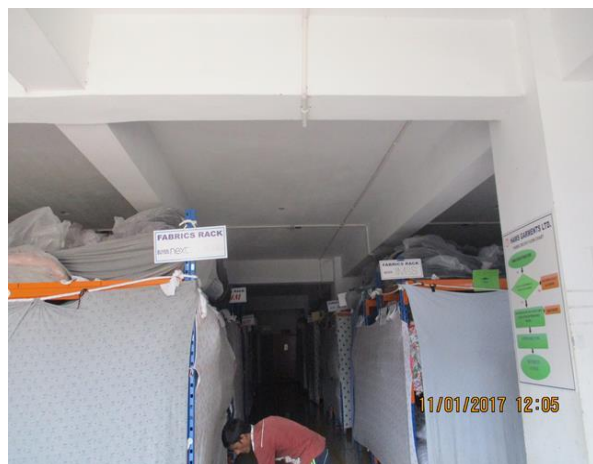
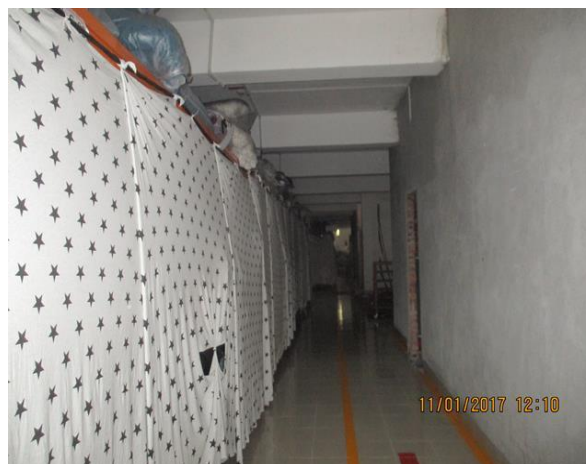
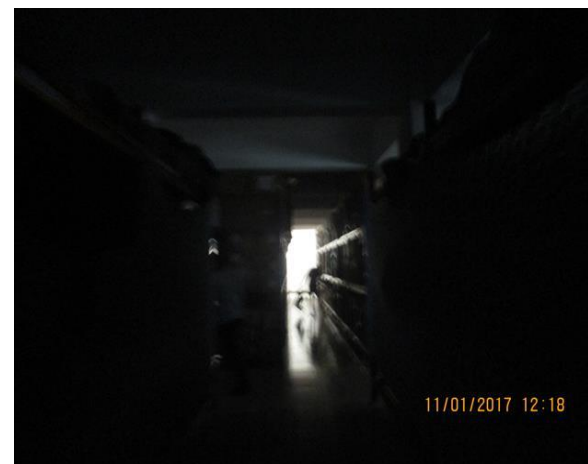
| 15 | Egress Lighting | Based on the number and location of emergency lights observed, adequate illumination levels are not anticipated along egress routes and at exit stairs on all floors of the buildings and shed-1&2. | Test the emergency lighting system on each floor and provide additional emergency fixtures to supply adequate illumination along the means of egress. Provide a minimum illumination of 10 lux at the floor level within exit stairs and along exit discharge paths and a minimum 2.5 lux along exit access aisles. | Within 3 months |

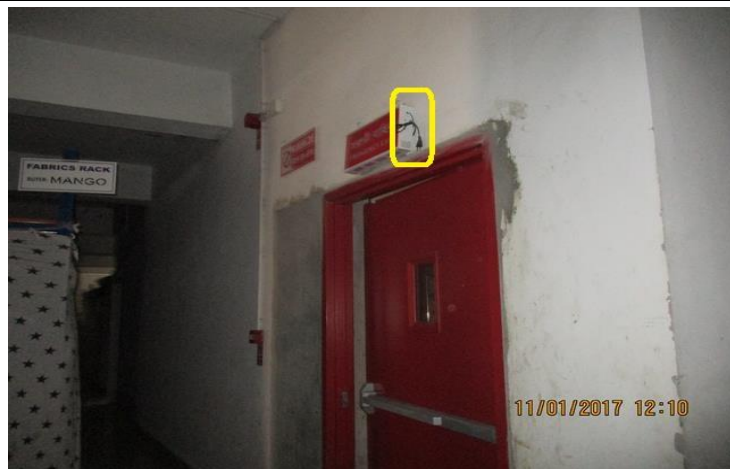
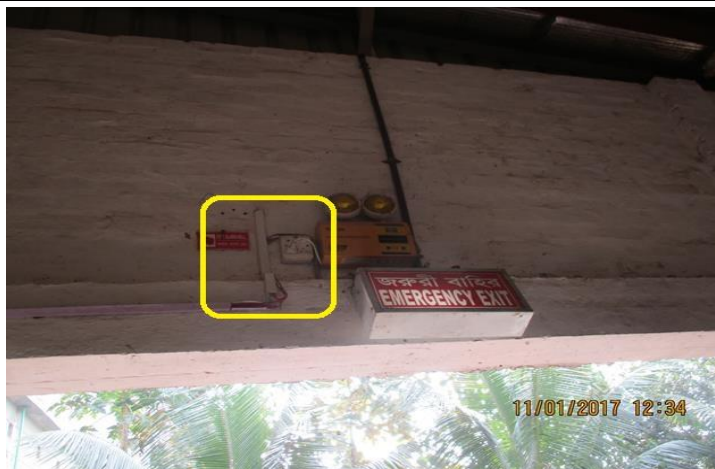
| 16 | Egress Lighting | Manual on-off switch is provided for exit signage units. | Remove manual on/off switches from emergency lighting / exit signage units to prevent them from being switched off. | Within 1 month |

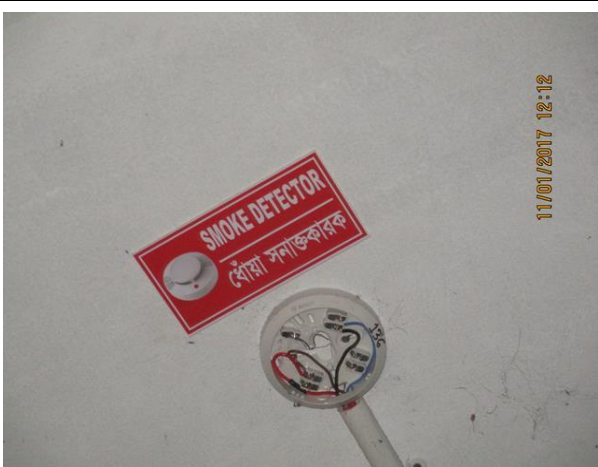
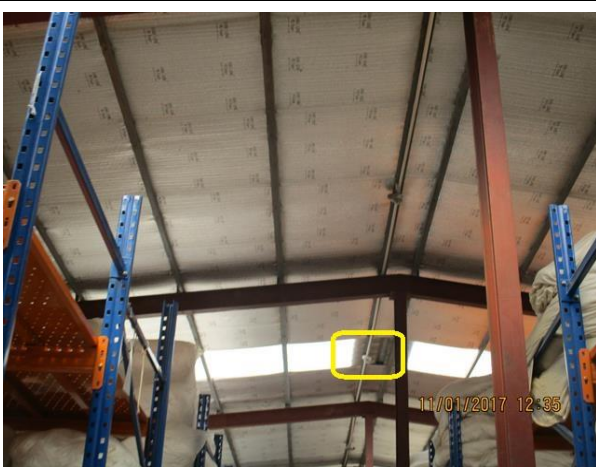
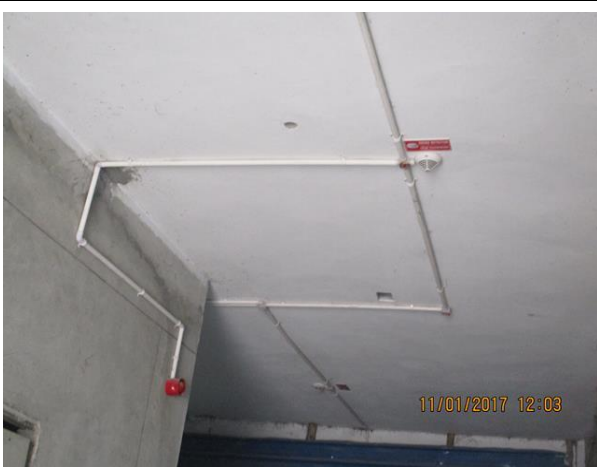
| 18 | Fire Detection and Alarm System | The fire detection and alarm system installation work going on for the buildings, the system installed incorrectly for the sheds. | <p>Install/Modify the fire detection and alarm system with a new, listed addressable fire alarm system in accordance with NFPA 72.</p> <p>Design shall be submitted to ACCORD Chief Safety Inspector for review prior to installation of the system.</p> | Design within 4 months and installation within 9 months. |

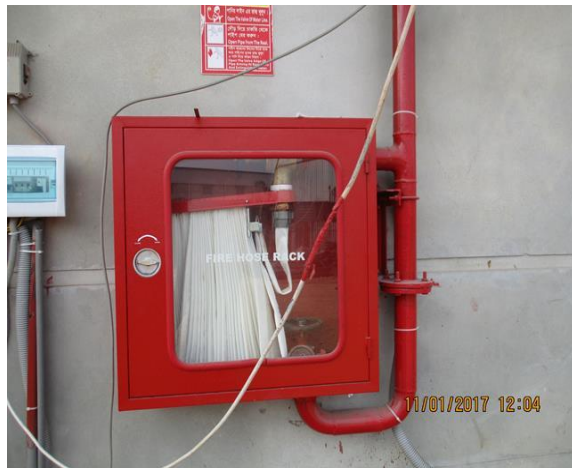
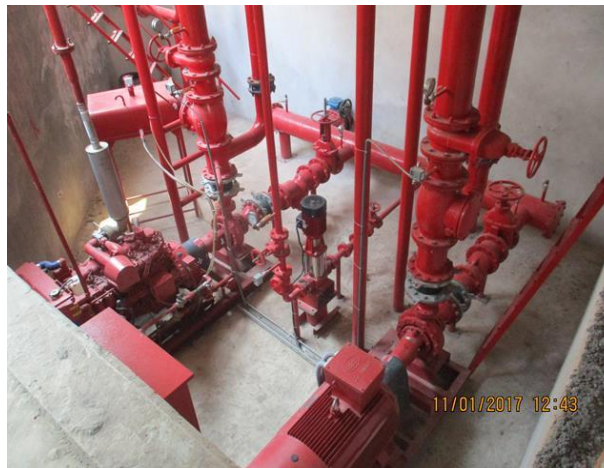
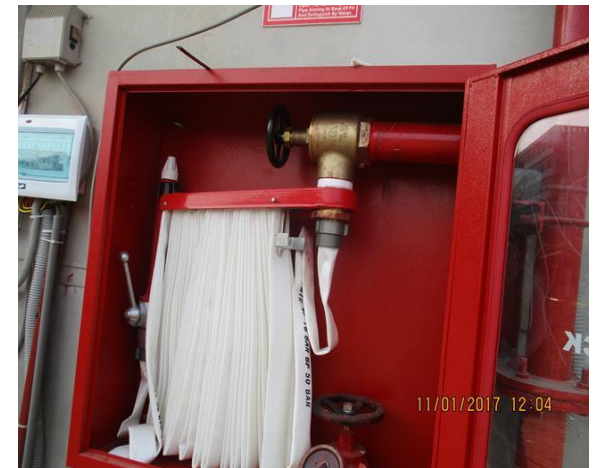
| 20 | Fire Protection System | The highest occupied floor of new store building is more than 10 m (33 ft.) above grade but standpipe system is not installed in the building as per NFPA-14. Fire pump is not listed and not installed properly as per NFPA-20. | <p>Provide class-III standpipe system (both a 40 mm connection with attached hose and a 65 mm connection) throughout the building in accordance with NFPA 14.</p> <p>Design shall be submitted to ACCORD Chief Safety Inspector for review prior to installation of the system.</p> | Design within 4 months and installation within 9 month |
