# Euro Jeans Ltd

Chowdhury Bari, Vogra ,Gazipur  
(23.9789348N,90.3802407E)

14th May 2014

# Observations

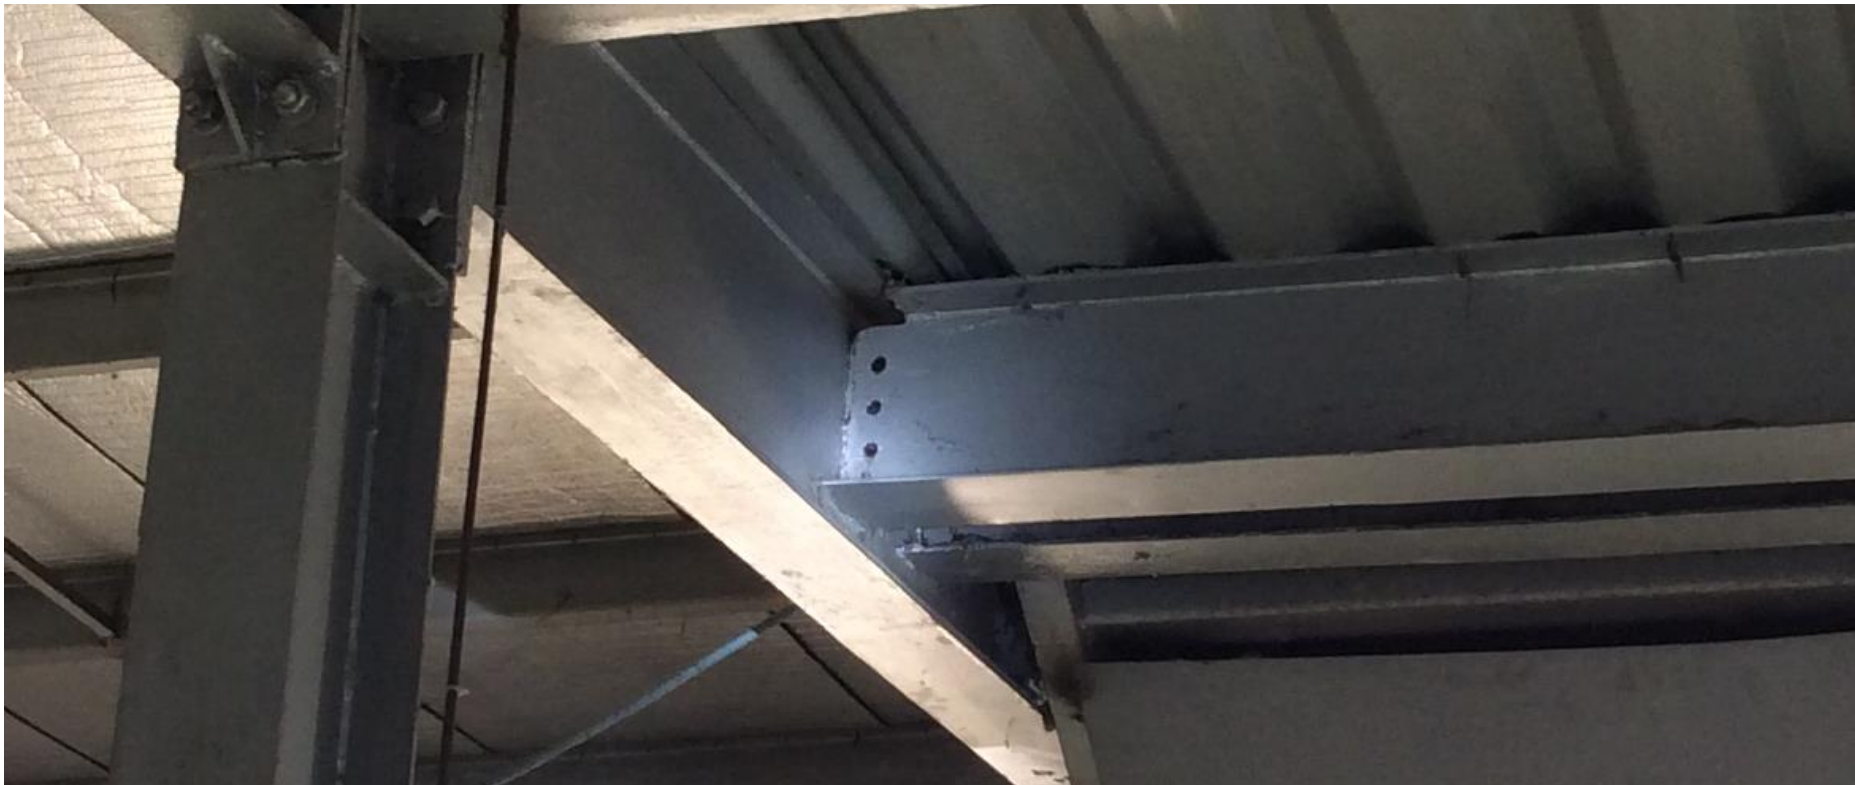
Defects and poor workmanship was observed to a large number of steel connections in Sheds 1 and 2, including distortion and buckling of the connection plates, inadequate bearing / opening up of end plates, inadequate welds, bolt omissions and inadequate replacements, severe rusting and pitting. The issues are likely a cause of overstressing, excessive movement due to instabilities or substandard quality of fabrication / erection. Detailed Engineering Assessment required.

Shed 1 – Welded connection instead of bolted connection

| Item No. | Observation | Recommended Action Plan | Recommended Timeline |
|---|---|---|---|
| 1 | Defects and poor workmanship to the steelwork connections in Sheds 1 and 2 | Building Engineer to review all connection details in Sheds 1 and 2 with immediate effect as part of Detailed Engineering Assessment, refer to attached scope. | Immediate - Now |
| 2 | Defects and poor workmanship to the steelwork connections in Sheds 1 and 2 | Building Engineer to prepare schedule of remedial works, as required. | Immediate - Now |

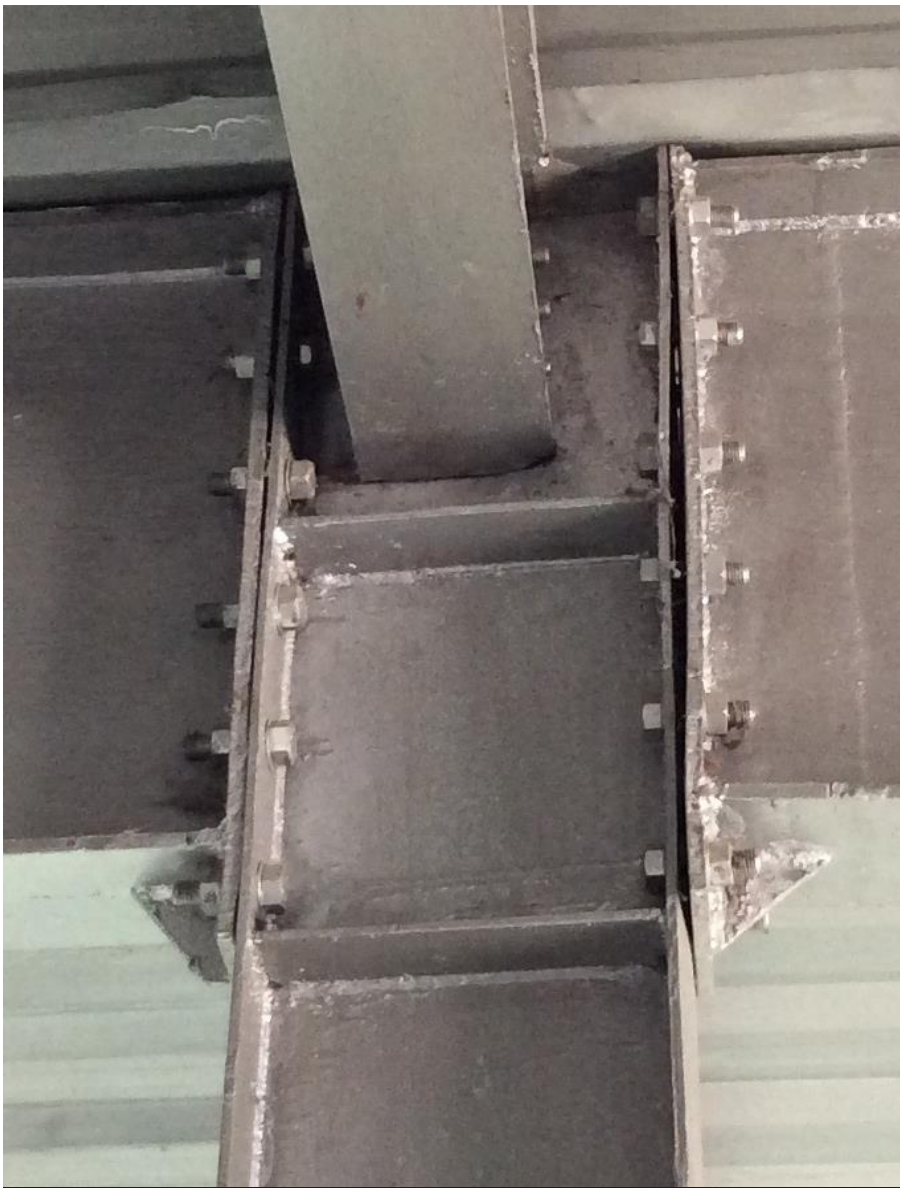
Shed 1 – Distorted end plates / inadequate bearing of end plates

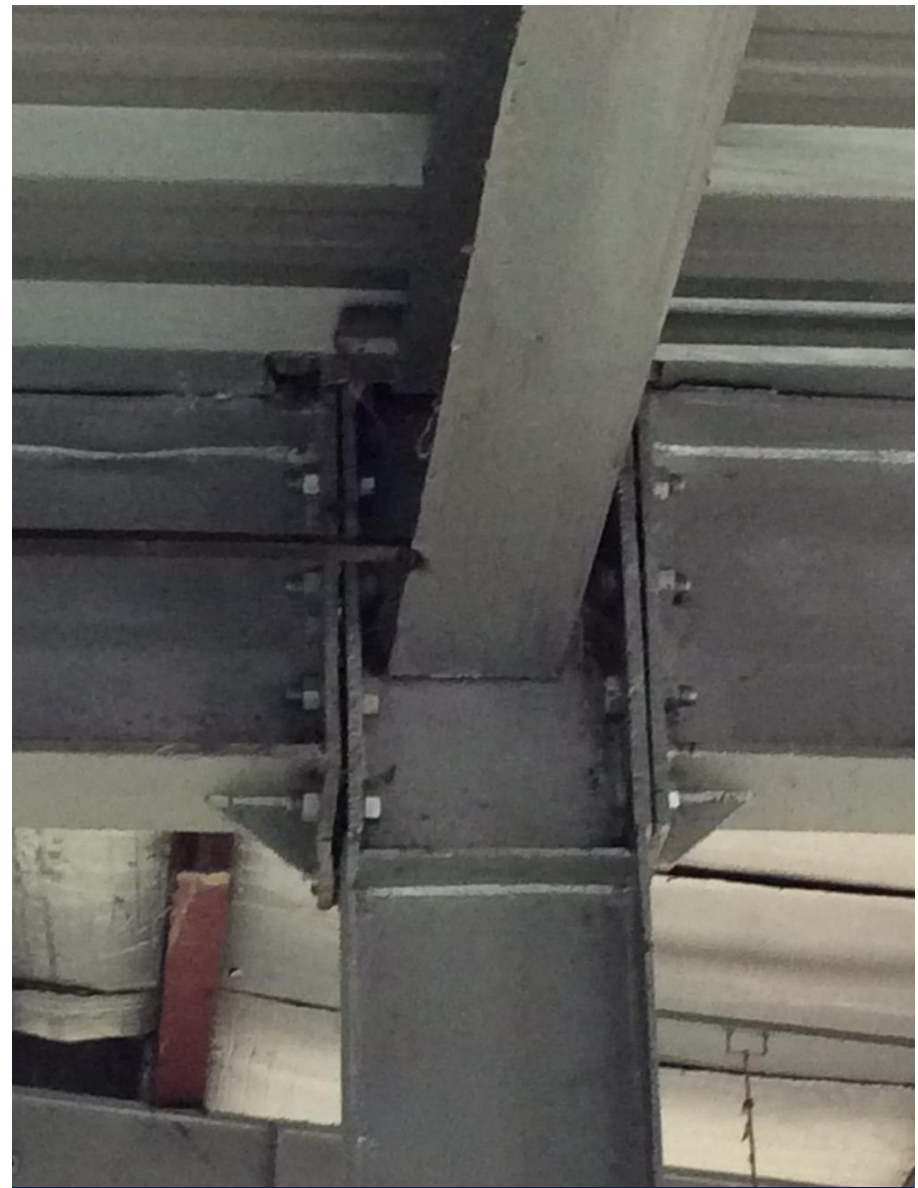
Shed 1 – Distorted end plates / inadequate bearing of end plates

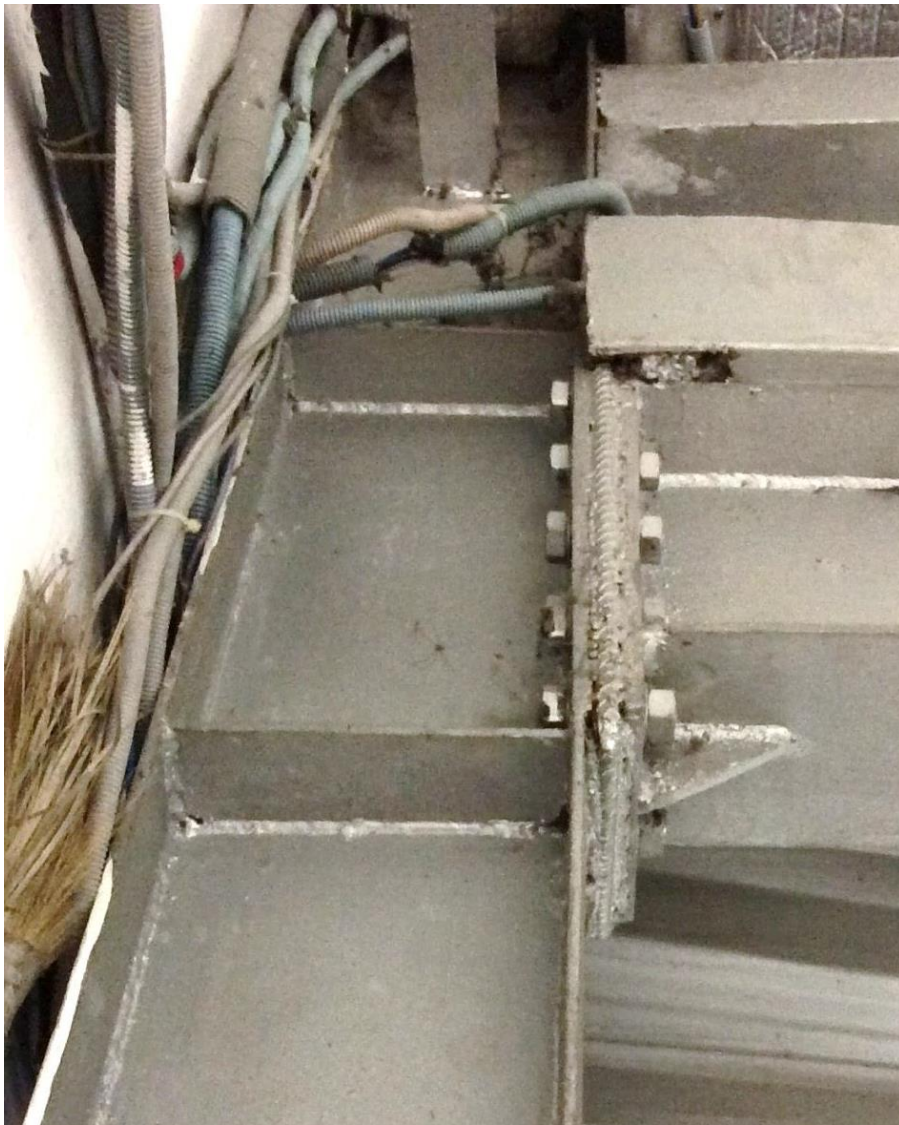
Shed 1 – A large number of connections were observed to have been altered – Rebar appears to have been welded to end plates where there is inadequate bearing.

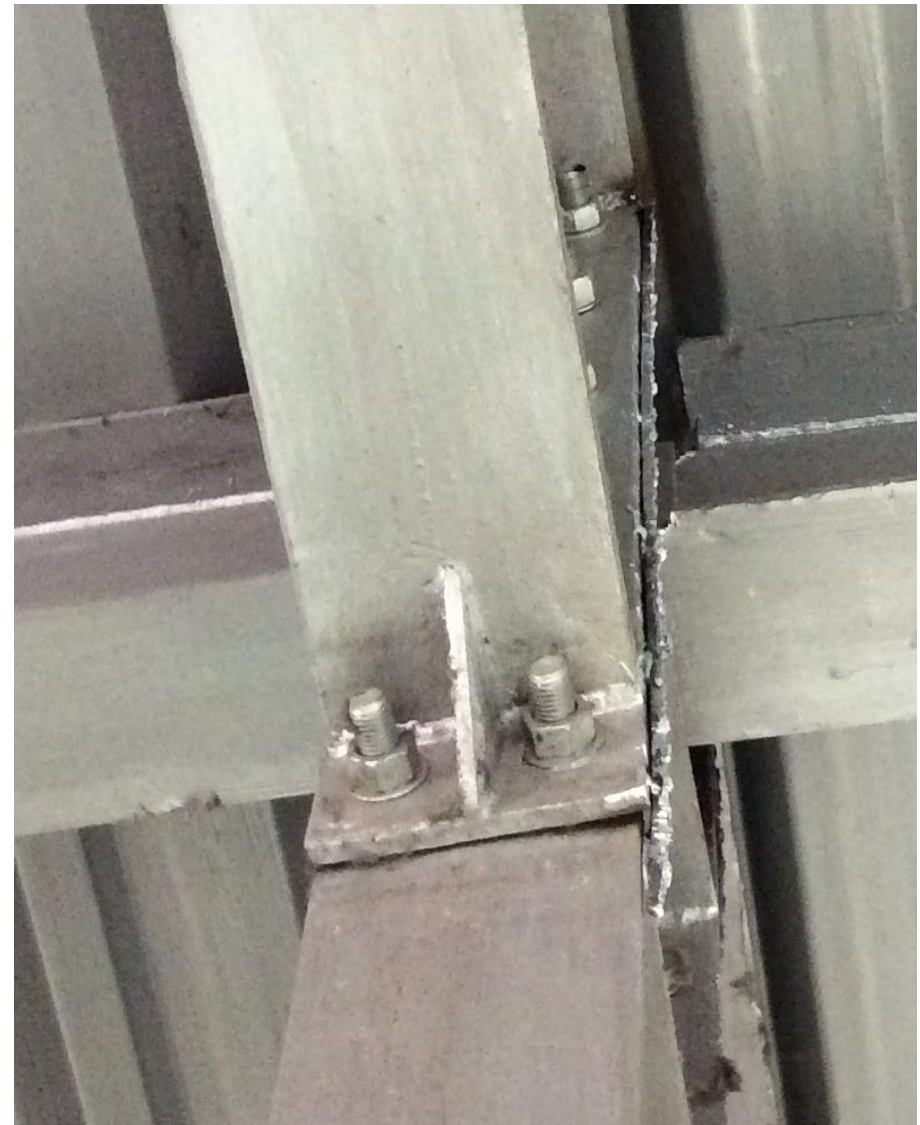
Shed 1 – In many cases where rebar appears to have been welded to end plates as a remedial solution to inadequate bearing, the detail is poorly executed.

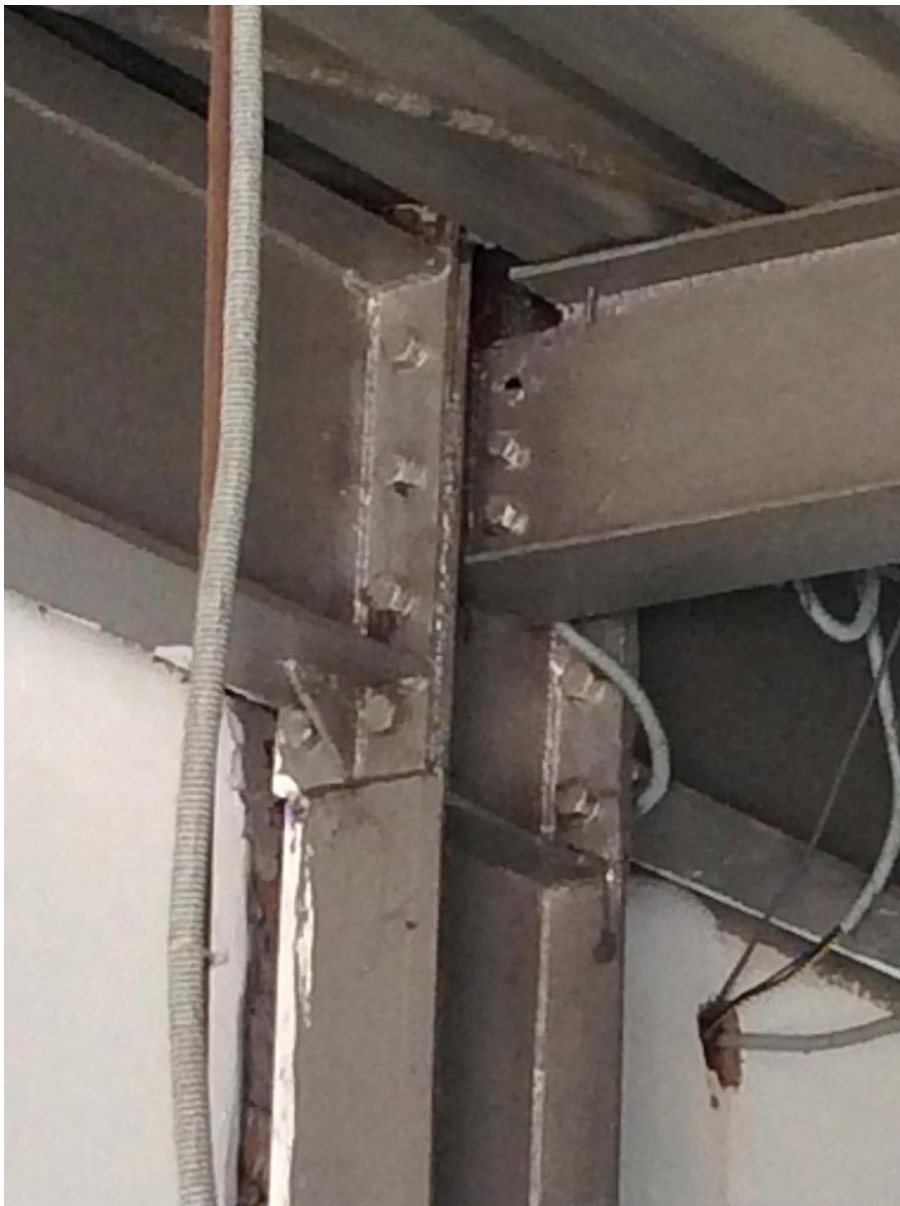
Shed 1 – Missing bolts

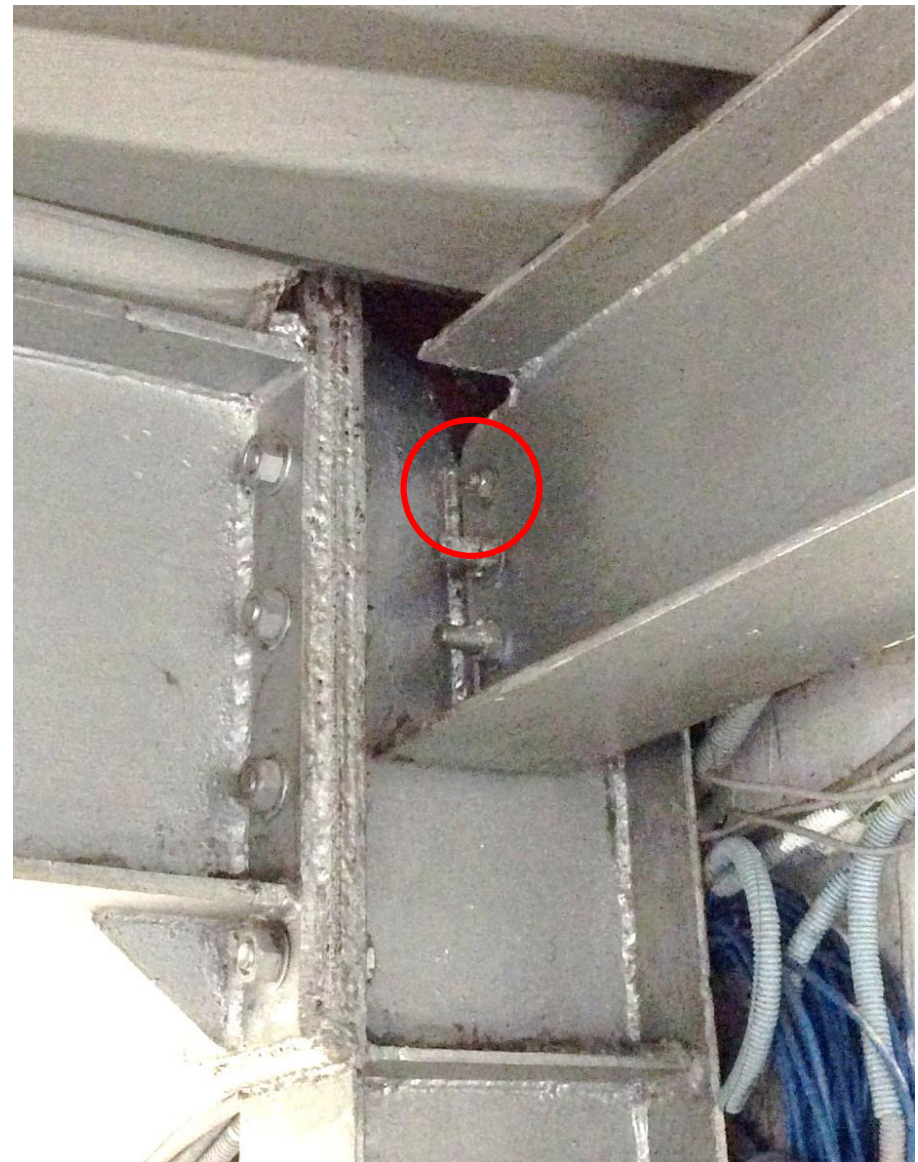
Shed 1 – Inadequate bolt replacements – it appears as though a smaller diameter bolt has been used

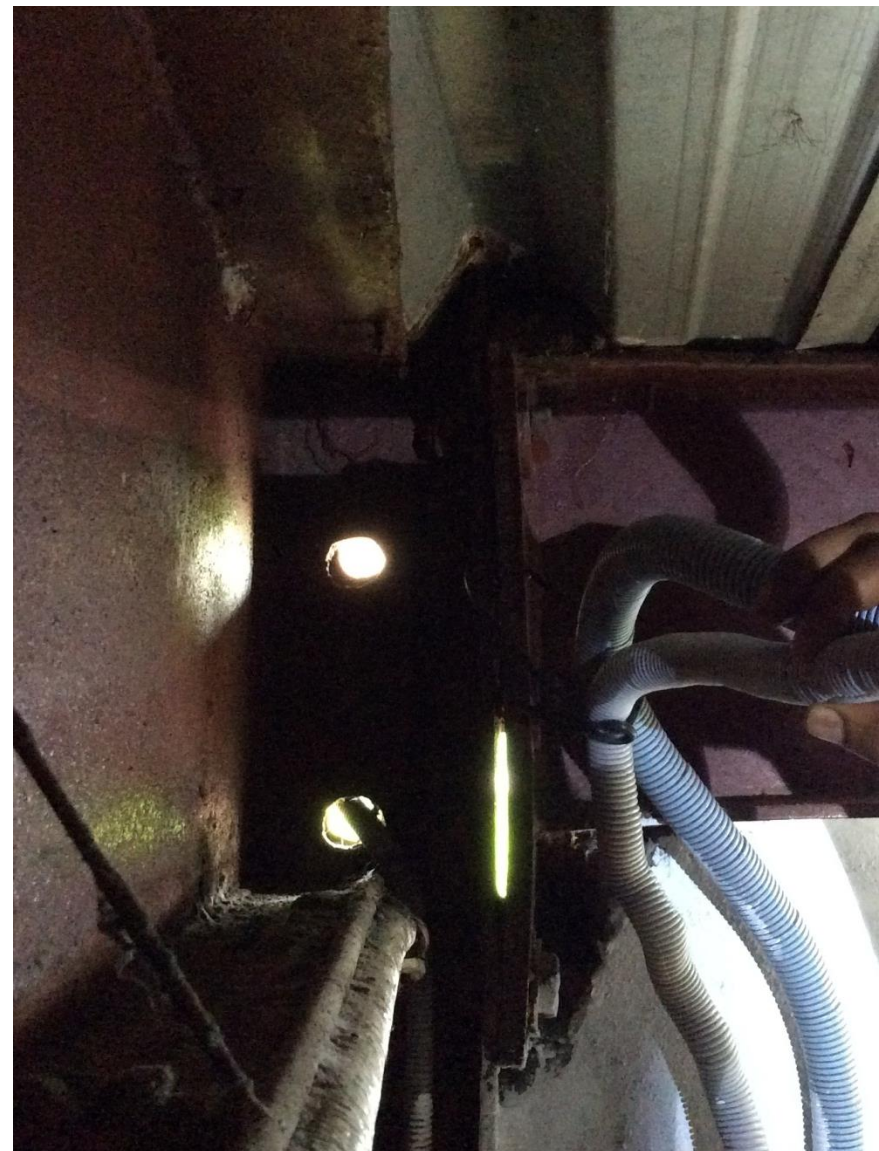
Shed 2 – Buckled end-plate to First Floor edge beam. The plate appears to have buckled either from overstressing and / or inadequate connection

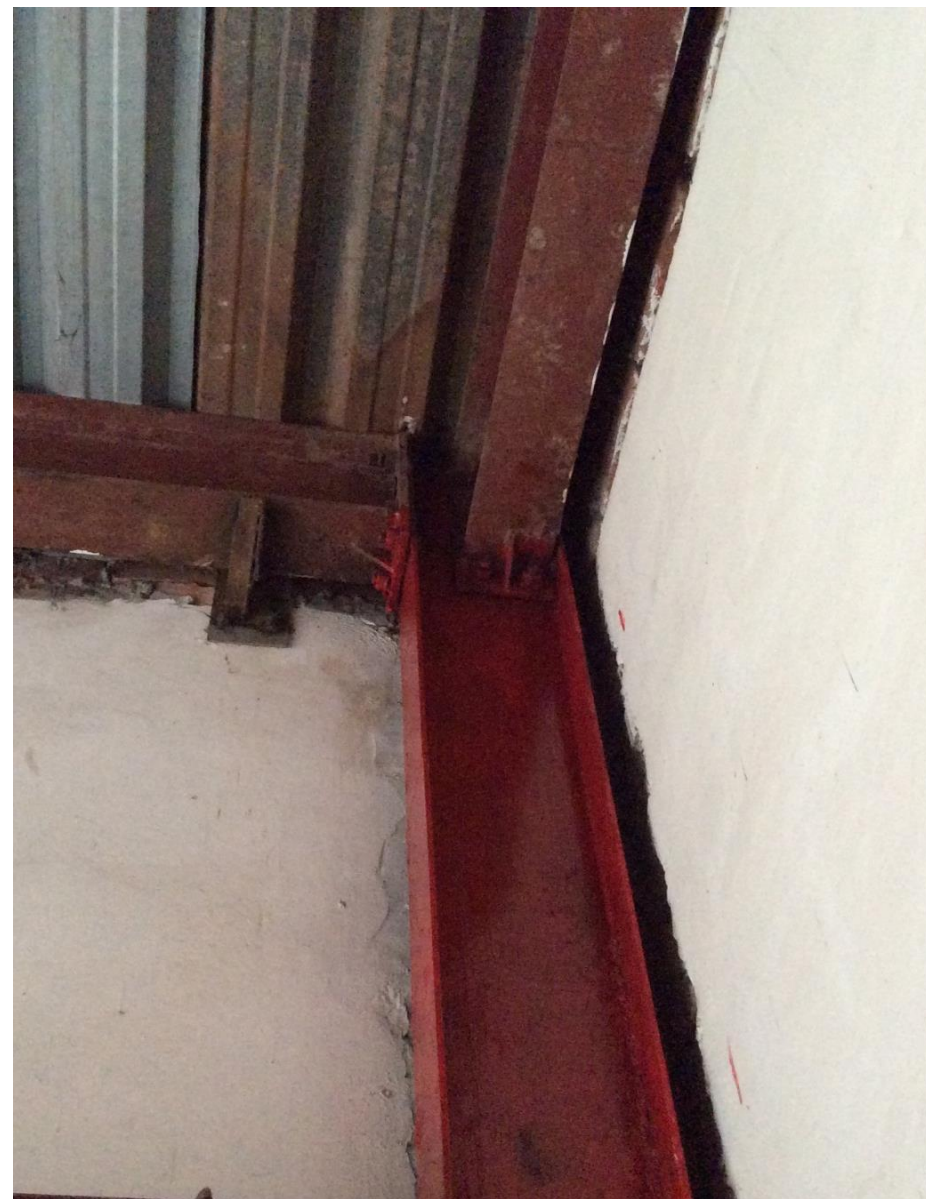
Shed 2 – Column appears to have been painted without adequate remedial work to treat corrosion.

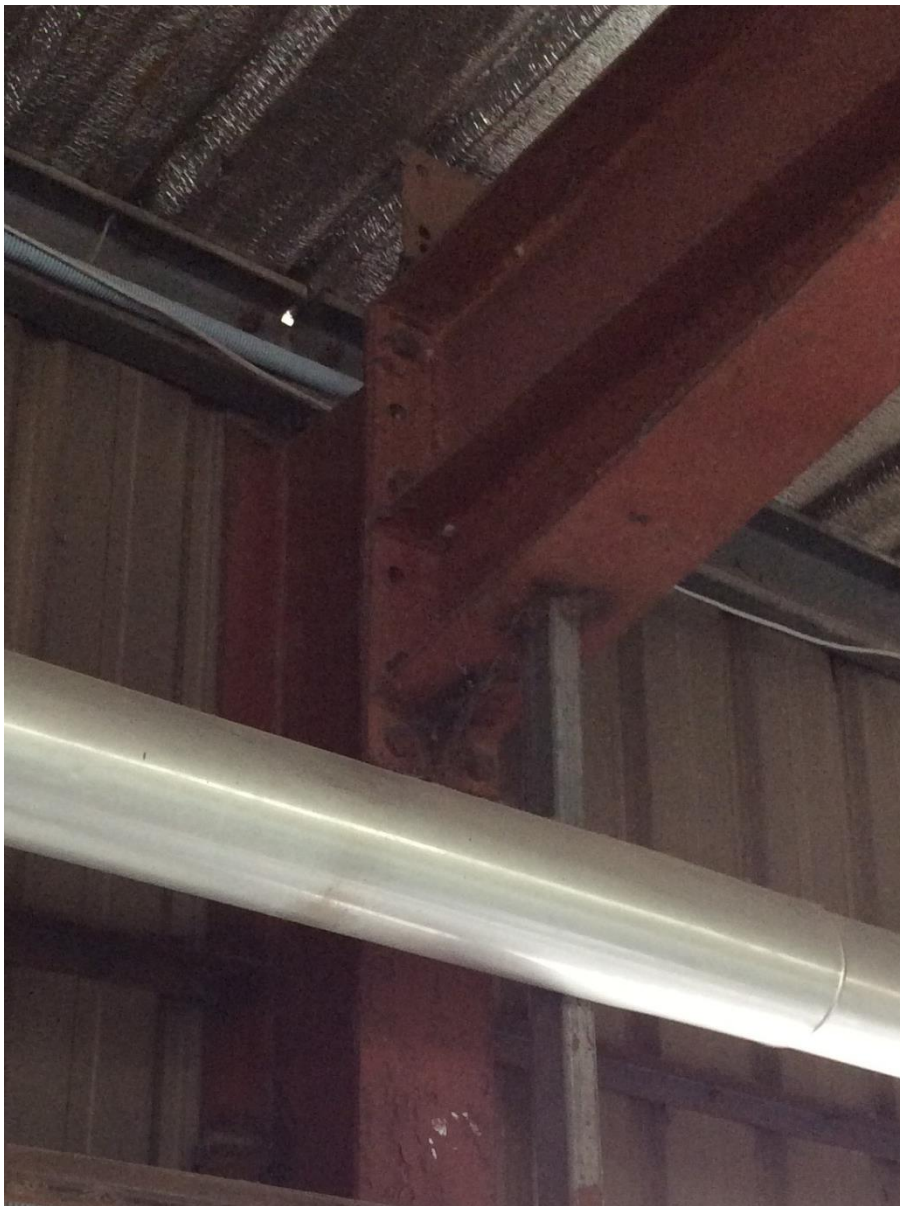
Shed 2 – Missing bolts to portal frame rafter

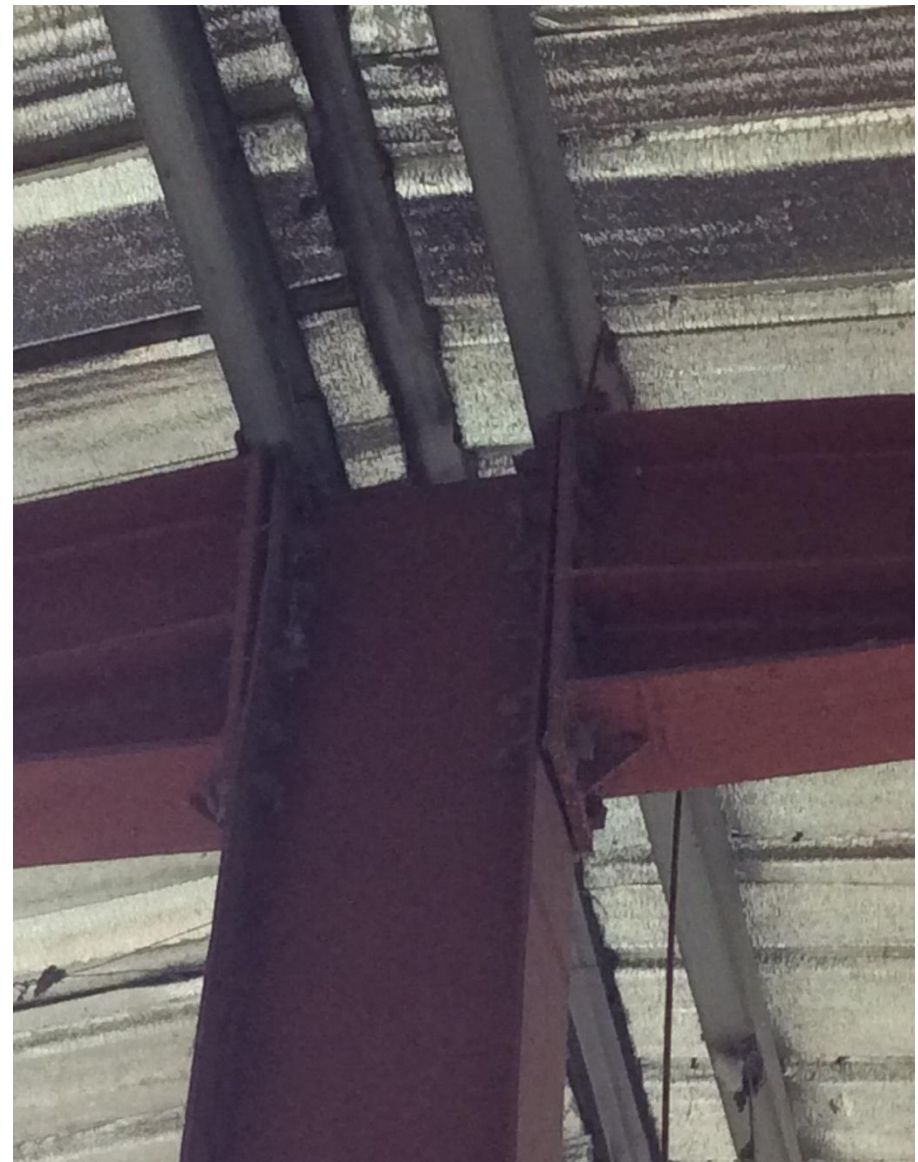
Shed 2 – Distorted end plates / inadequate bearing of end plates to central rafter support

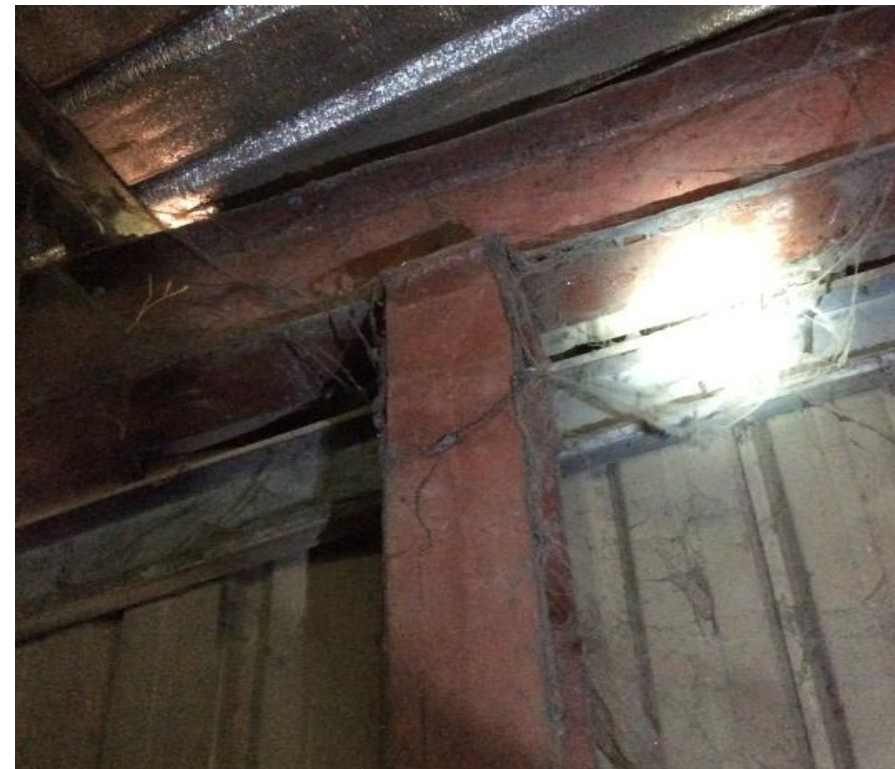
Propping column

There are concerns over the structural adequacy of the rafter to the south gable end of Shed 2. The detail of the portal frame to the South-East corner is atypical: the rafter butts up against the water tank wall instead of a column, and there is no connection to the water tank wall. The rafter is instead propped up by a cantilevering steel column and cantilevers approximately 3m beyond the prop to where it meets the water tank wall. The connection detail between the rafter and the prop is unclear, although the moment capacity of the portal frame appears to have been lost. Detailed Engineering Assessment required.

| Item No. | Observation | Recommended Action Plan | Recommended Timeline |
|---|---|---|---|
| 5 | Concerns over support detail to gable-end rafter at 1st floor level of Shed 2 | Building Engineer to review stability of said rafter, as part of Detailed Engineering Assessment, and to prepare schedule of remedial works as required. | Immediate - Now |

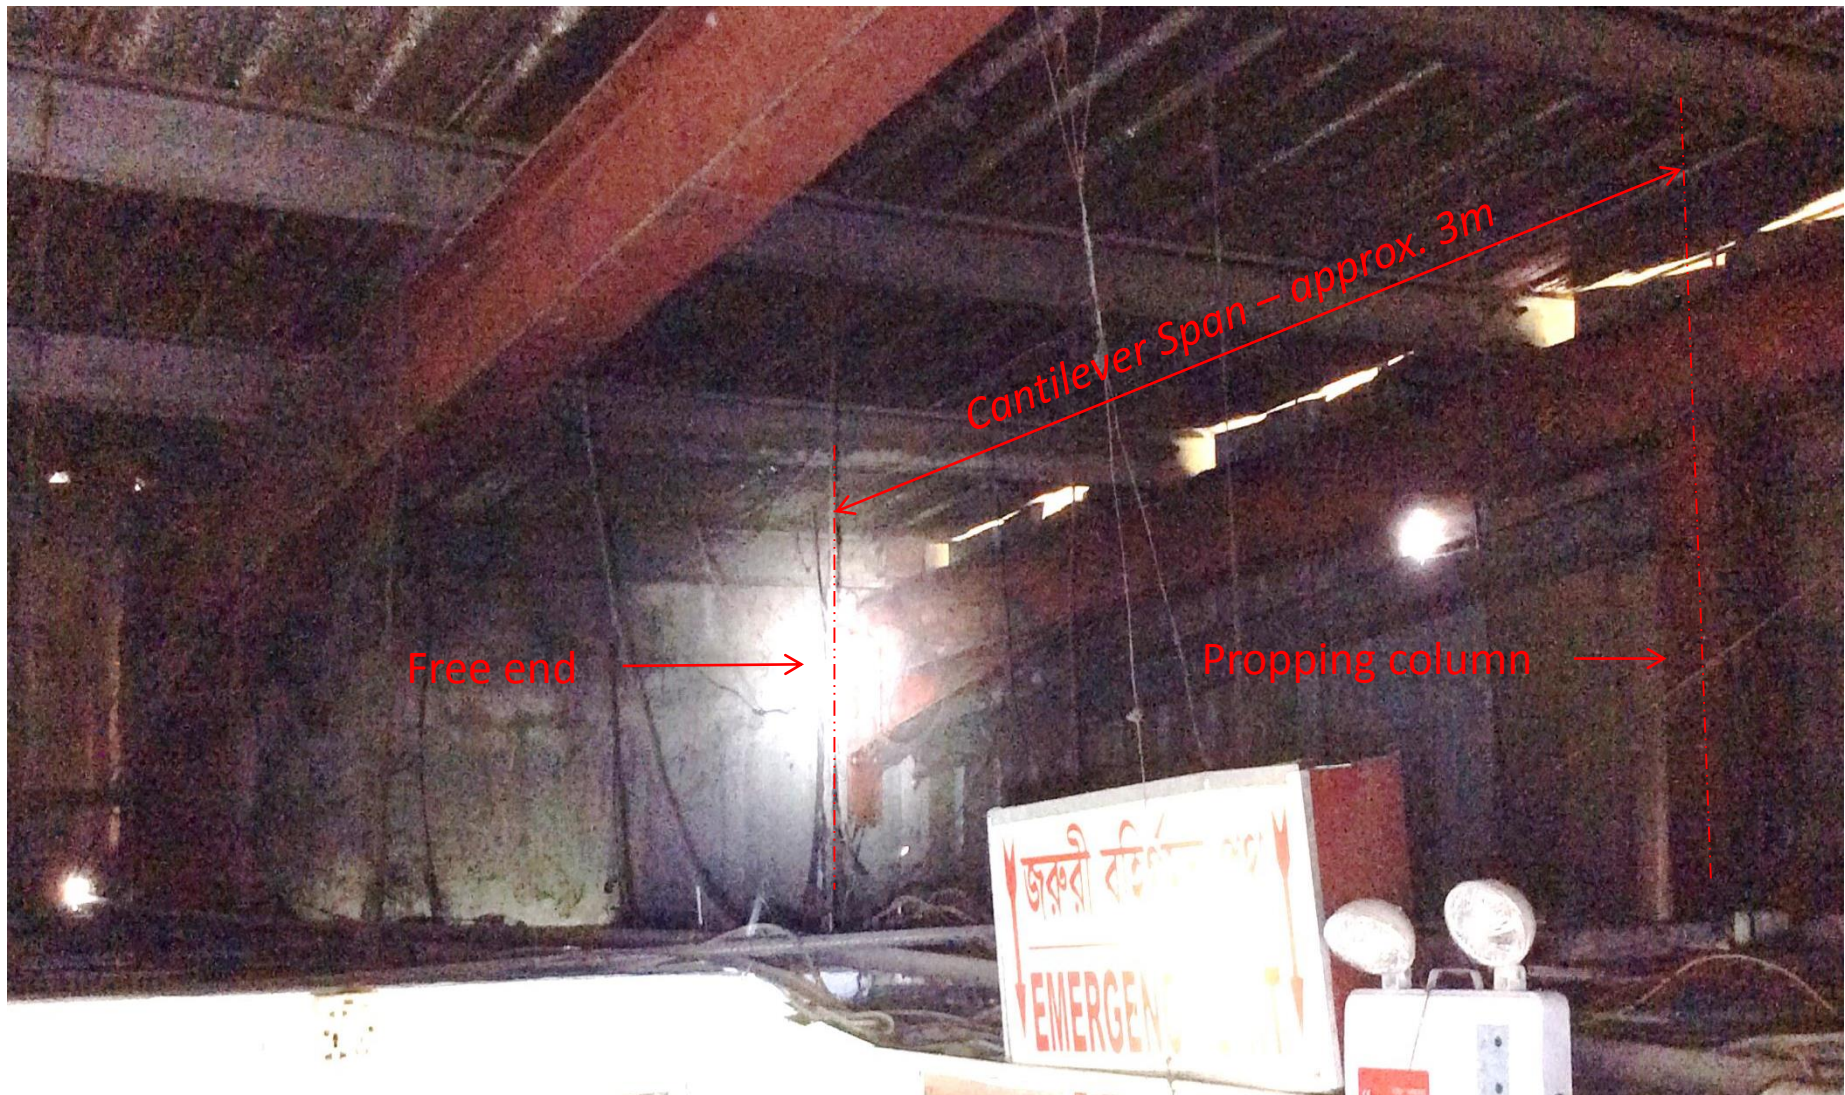
Unconnected end of rafter to South-East corner; rafter propped by a cantilevering steel column

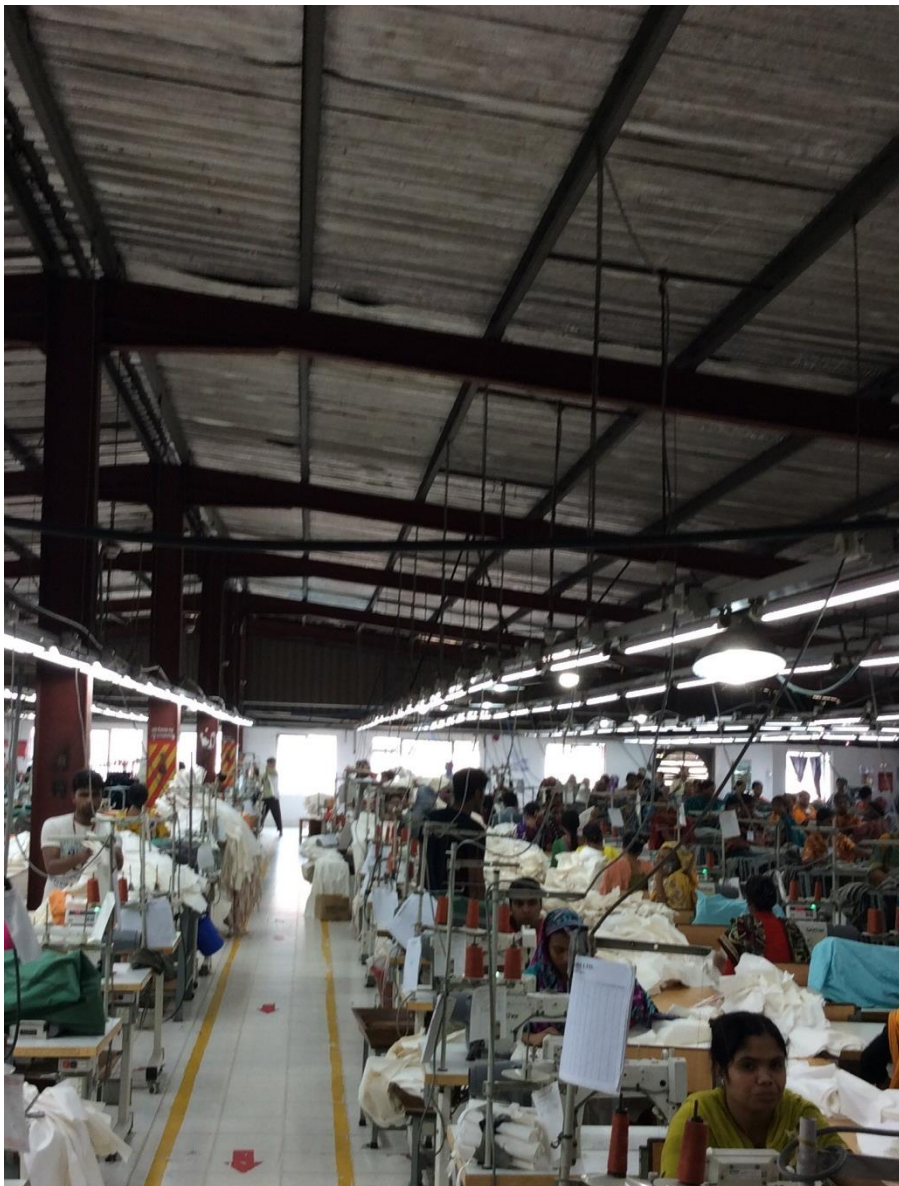
Horizontal and vertical diagonal cable bracing is missing from the two-storey structure of Shed 2, vertical bracing is missing from the single-storey structure of Shed 2, and while bracing is provided to Shed 1, it is loose and therefore ineffective. There appears to be a misunderstanding as to the requirements for bracing in providing support for wind load. Building Engineer to review requirements for bracing to Sheds 1 and 2, and supervise installation and tightening of bracing as necessary.

Shed 2 – Two-storey structure – Horizontal and vertical bracing missing

| Item No. | Observation | Recommended Action Plan | Recommended Timeline |
|---|---|---|---|
| 8 | Lack of / inadequate stability members in Sheds 1 and 2 | Building Engineer to provide necessary vertical and horizontal bracing to Shed 2 and to tighten bracing to Shed 1. | 6-weeks |

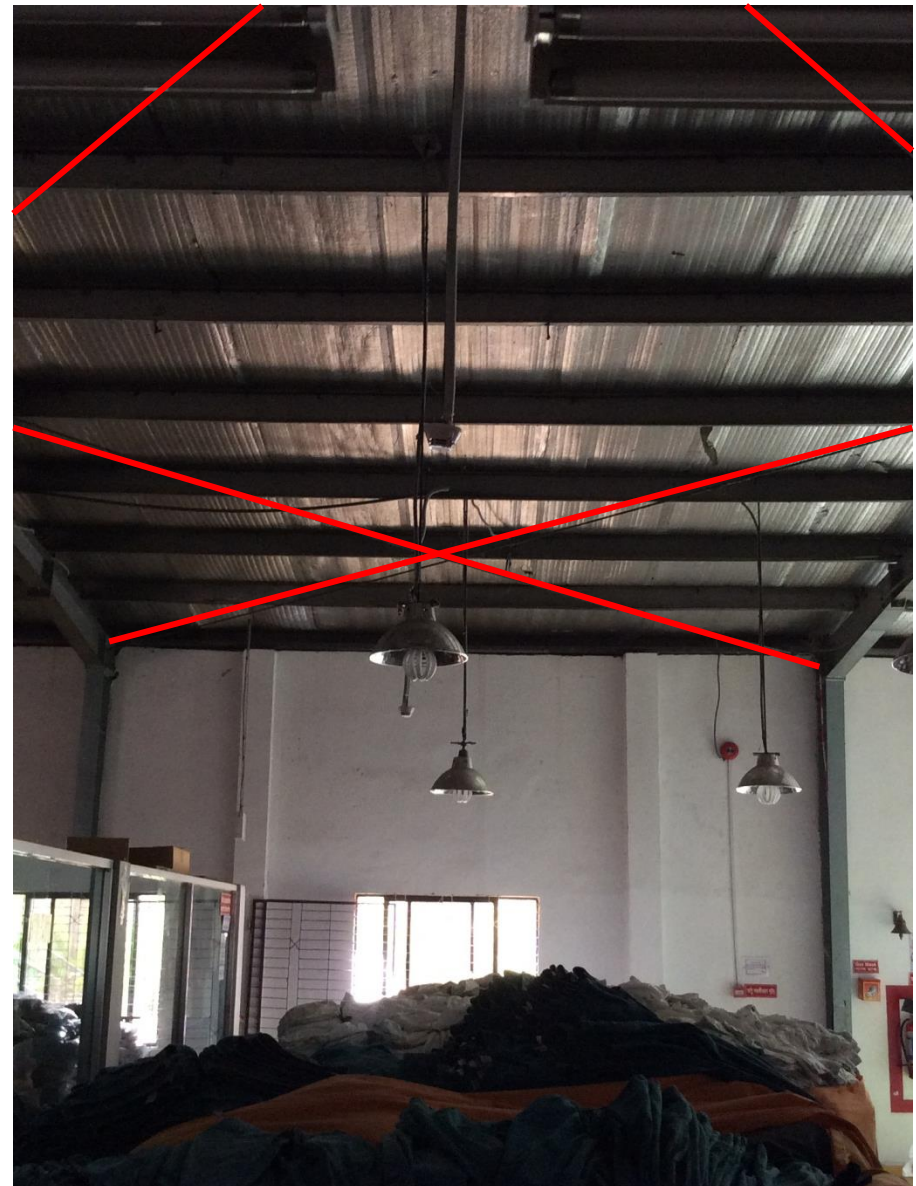
Shed 2 – Single-storey structure – Horizontal bracing missing

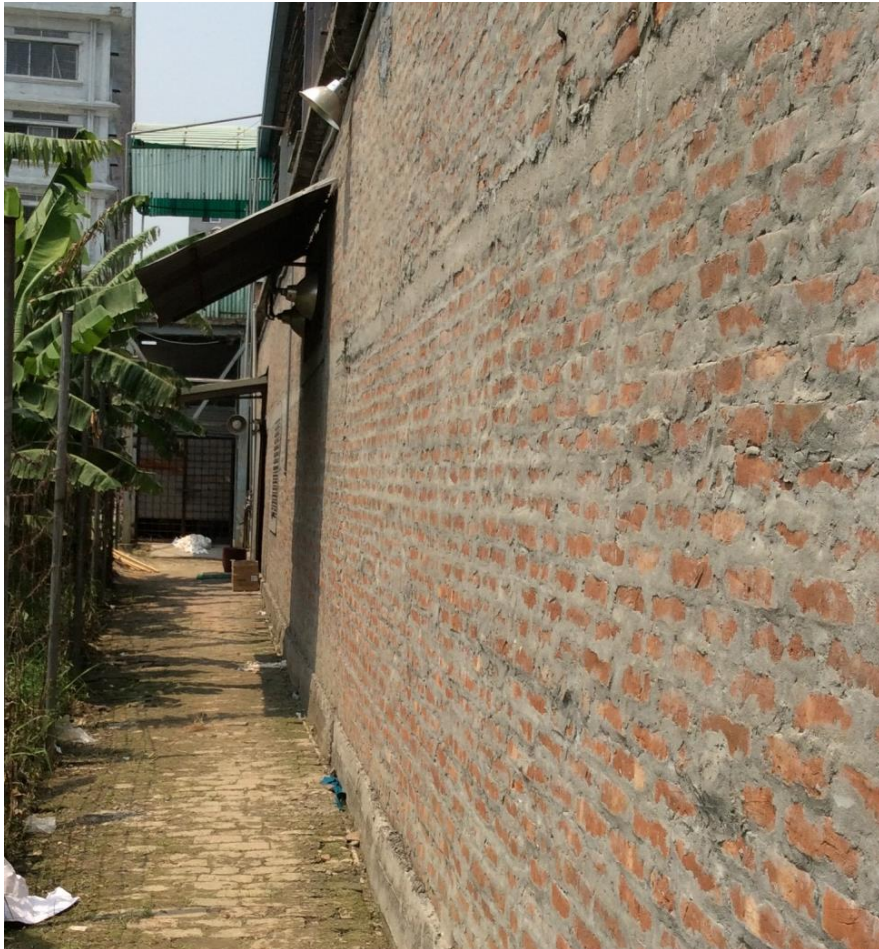
Masonry wall to Shed 2

There are concerns over the lateral stability of the masonry walls to sheds 1 and 2. The walls are approximately 4m high and have brick piers, as opposed to RC columns, which appear to be cantilevering from Ground Floor level. There is no connection between the masonry walls and the portal frame structures.

| Item No. | Observation | Recommended Action Plan | Recommended Timeline |
|---|---|---|---|
| 9 | Unsupported masonry walls to Sheds 1 and 2 | Building Engineer to review lateral stability of masonry walls and to prepare a schedule of remedial / strengthening works, as required. | 6-weeks |

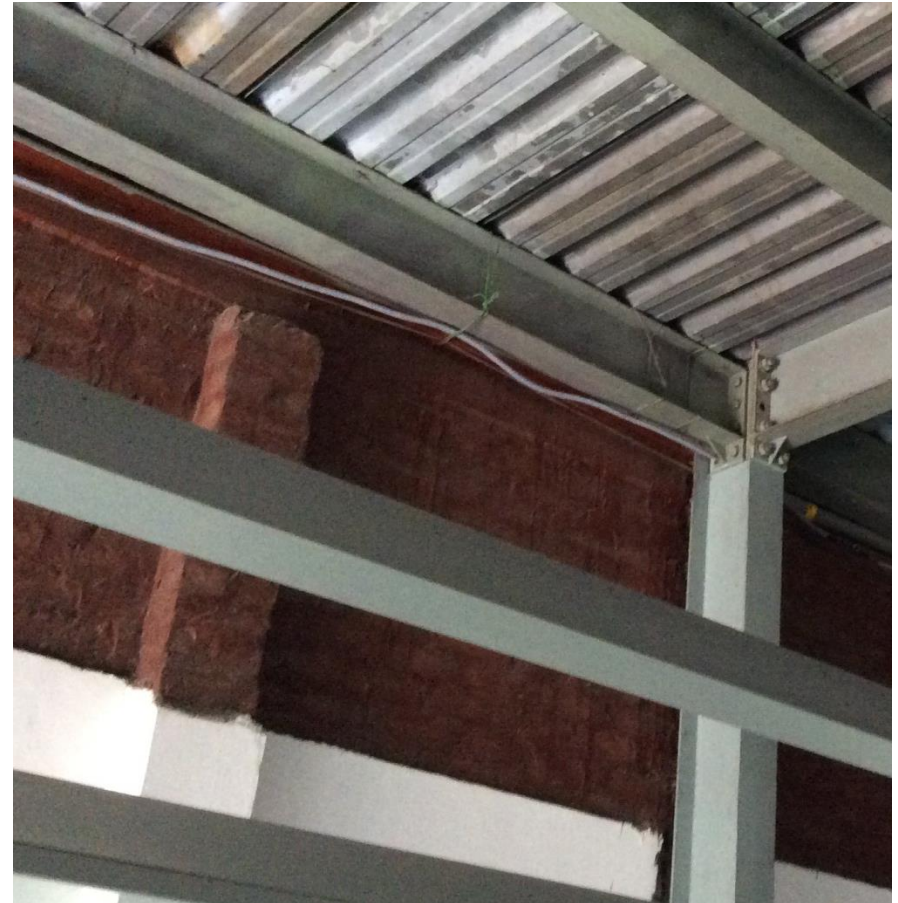
Brick piers and no connection between masonry walls and portal frame columns

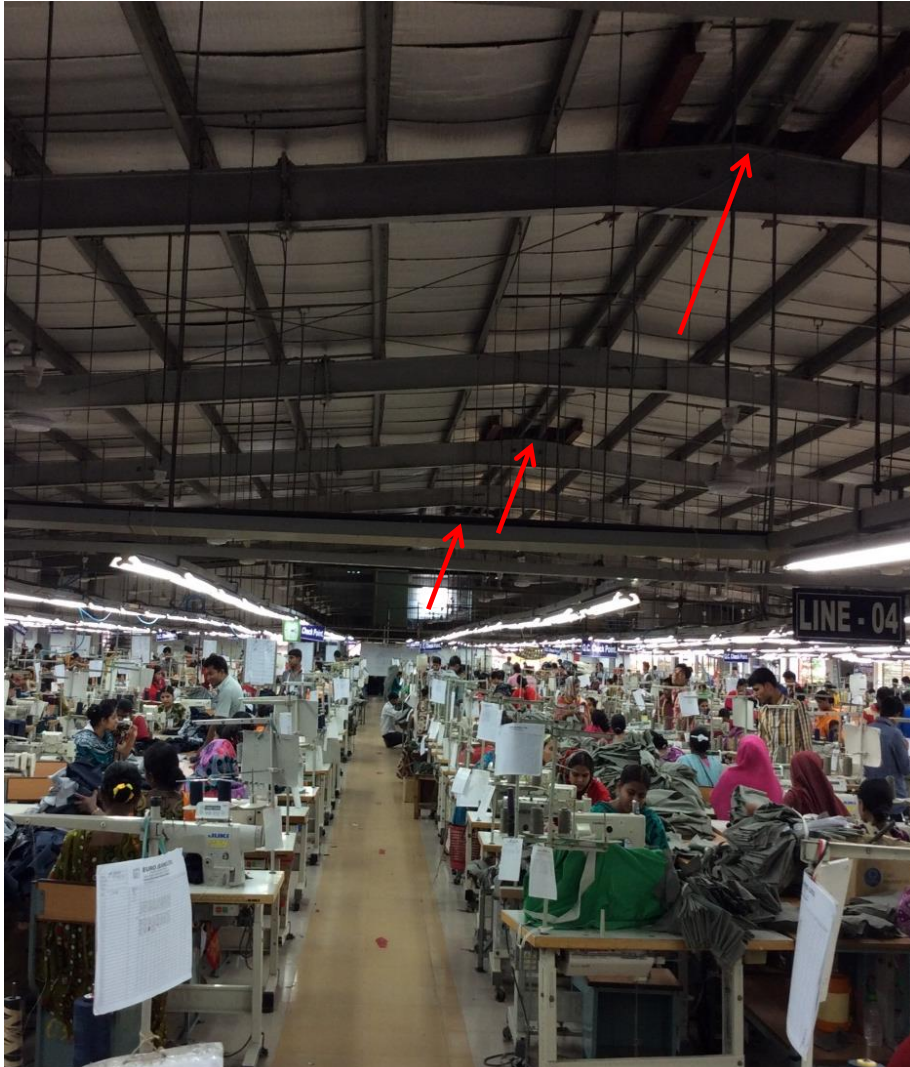
Air vents viewed from Shed 1 floor

There are concerns over the stability of the steel beams erected above the portal frame rafters of Shed 1 to provide support to the air vents. The arrangement appears unstable.

| Item No. | Observation | Recommended Action Plan | Recommended Timeline |
|---|---|---|---|
| 11 | Concerns over stability of air vent support beams to roof of Shed 1 | Building Engineer to carry out review of connection between air vent support beams and the rafters to which they are connected, and to prepare a schedule of remedial / strengthening works, as required. | 6-weeks |

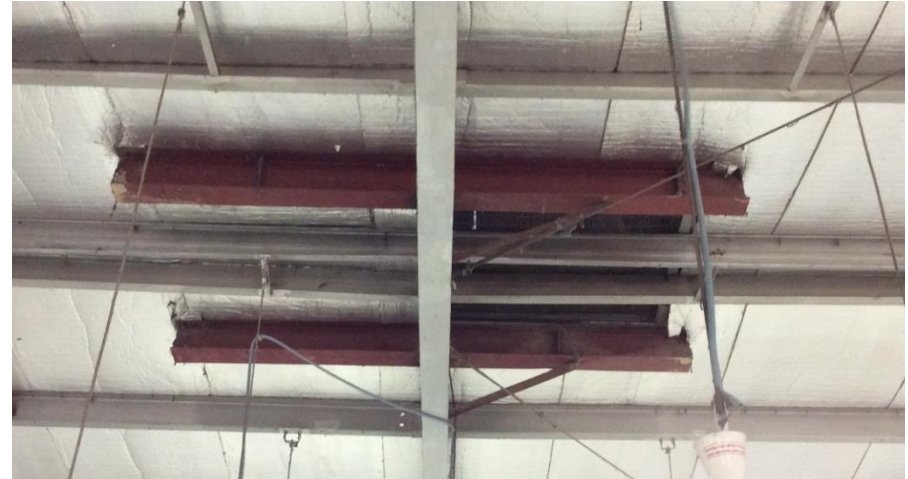
Connection detail unclear – single bracing member only

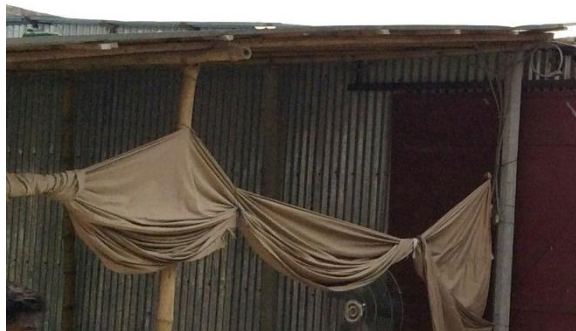
Prayer Room – Corrugated roof on bamboo purlins & posts

| Item No. | Observation | Recommended Action Plan | Recommended Timeline |
|---|---|---|---|
| 13 | Lightweight, non-engineered structures / roof structures to Sheds 3, 4, 5 and 6 | Building Engineer to review the design of all lightweight, non-engineered structures / roof structures within the compound, and confirm their ability to withstand wind loading pressure, suctions and uplift forces, with special emphasis on connections and bracing. | 6-weeks |

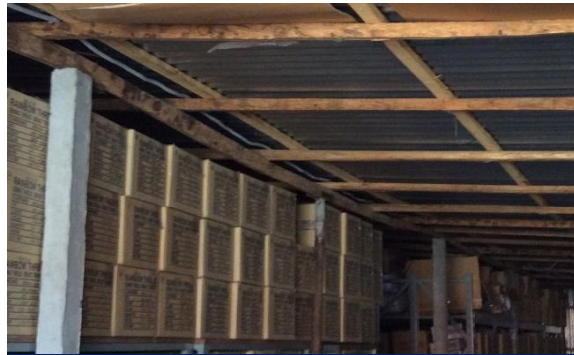
Shed 3 – Corrugated roof on timber purlins on concrete posts

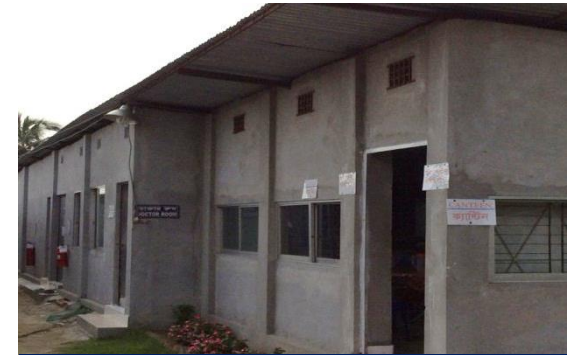
Shed 4 – Corrugated roof on steel angles on Masonry walls

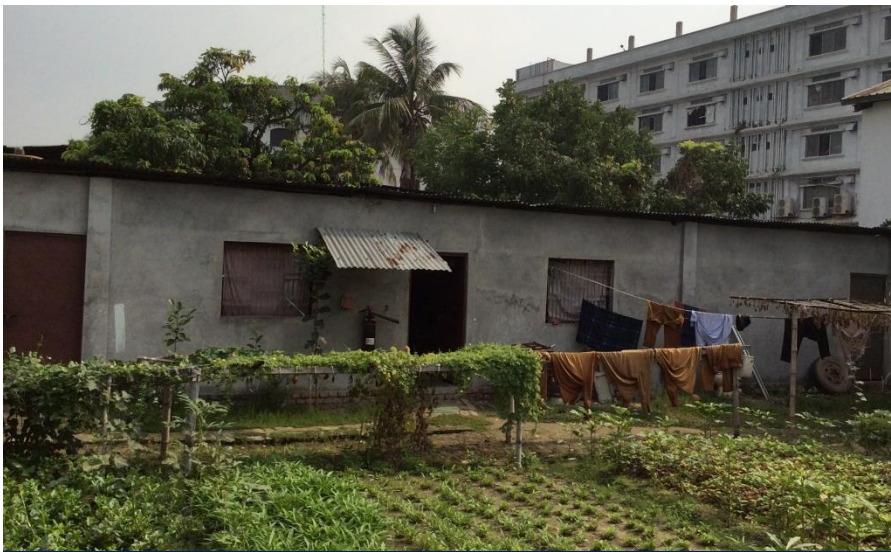
Shed 5 – Corrugated roof on steel angles on masonry walls
