# Euro Jeans Ltd

Chowdhury Bari, Vogra ,Gazipur  
(23.9789348N,90.3802407E)

14th May 2014

# Observations

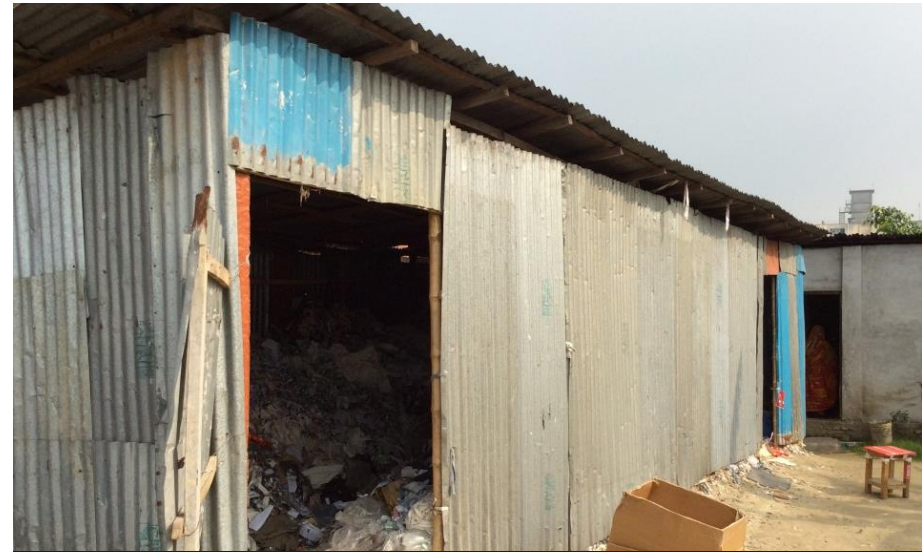
Shed 6 – Corrugated roof on timber purlins on bamboo posts

| Item No. | Observation | Recommended Action Plan | Recommended Timeline |
|---|---|---|---|
| 13 | Lightweight, non-engineered structures / roof structures to Sheds 3, 4, 5 and 6 | Building Engineer to review the design of all lightweight, non-engineered structures / roof structures within the compound, and confirm their ability to withstand wind loading pressure, suctions and uplift forces, with special emphasis on connections and bracing. | 6-weeks |

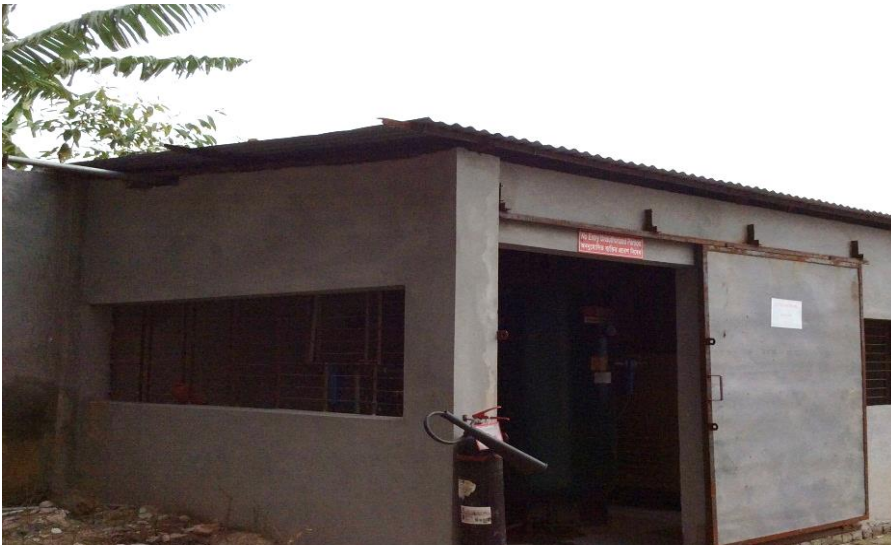
Compressor Room – Corrugated roof on steel angles

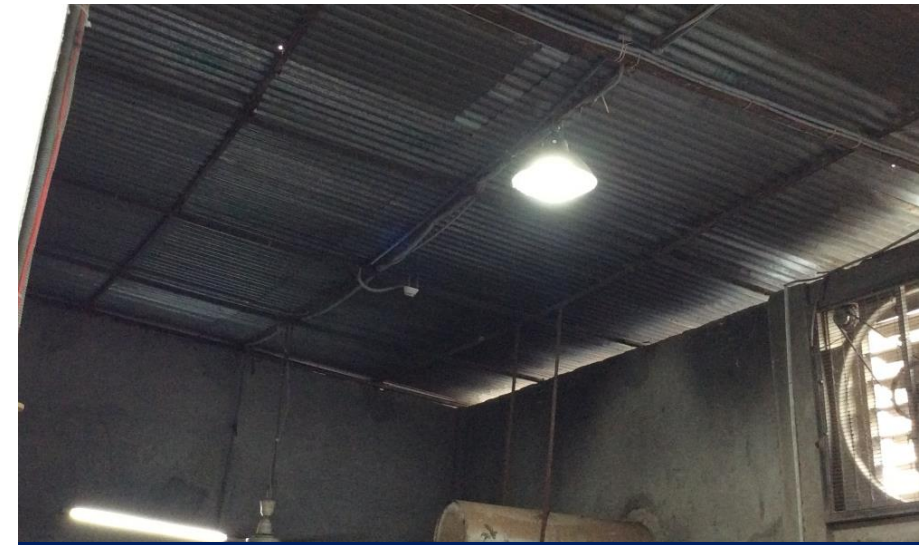
Generator Room – Corrugated roof on steel angles

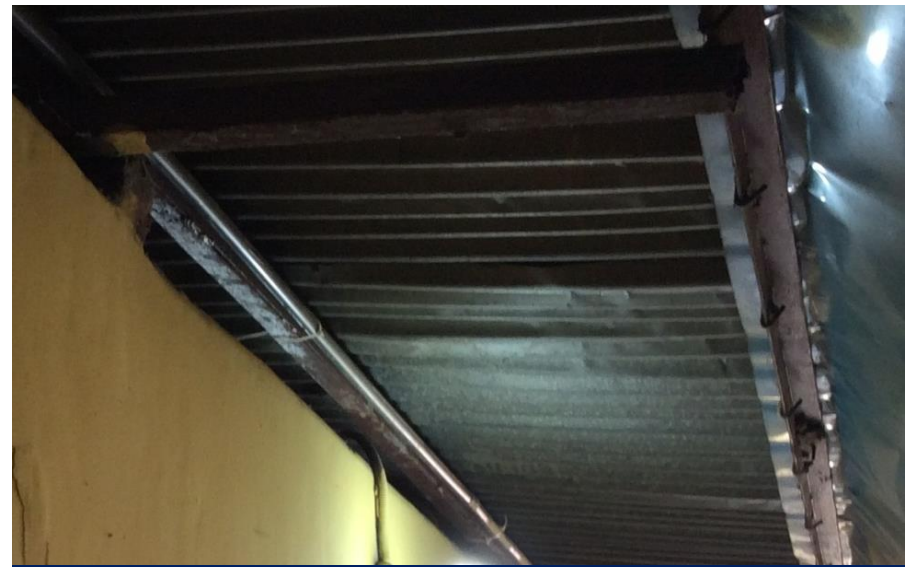
Washrooms - Corrugated roof on steel angles

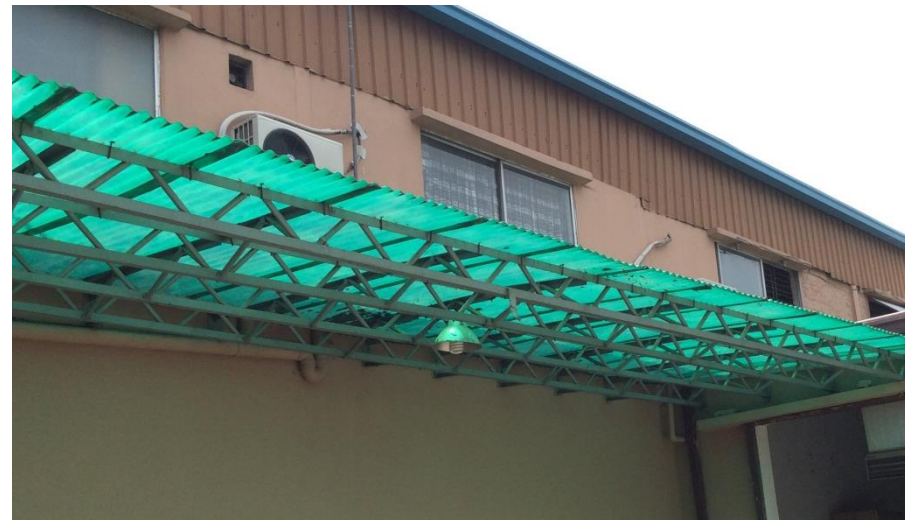
Main Entrance Canopy to Shed 2 – Corrugated plastic roof on steel angle truss

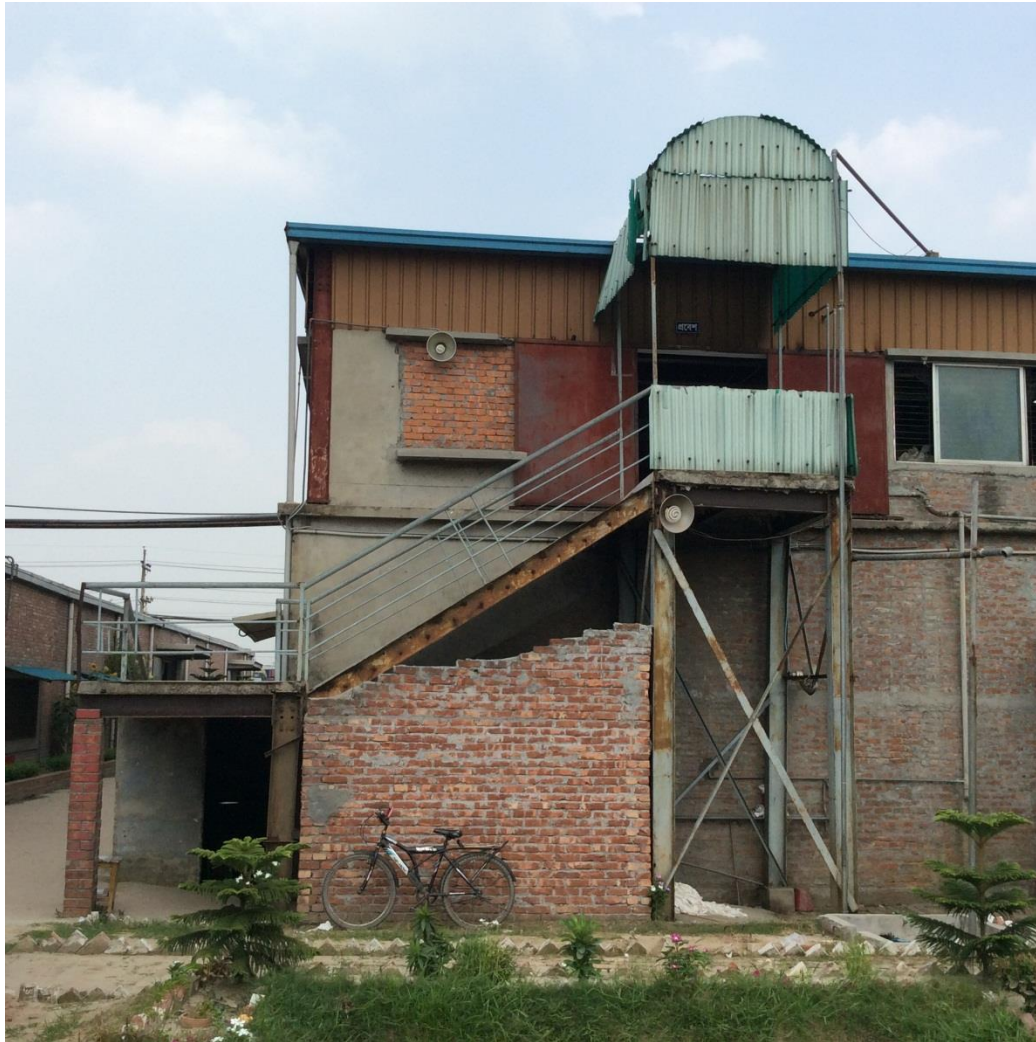
External steel stair to NW corner of Shed 2

There are concerns over the structural adequacy of the external steel stair to the North-West corner of Shed 2, including atypical supports, inadequate bracing, poor connections.

| Item No. | Observation | Recommended Action Plan | Recommended Timeline |
|---|---|---|---|
| 15 | Non-engineered stair to Shed 2 | Building Engineer to review the design of the external steel stair to Shed 2, with special emphasis on connections and bracing, and prepare a schedule of remedial works as required. | 6-weeks |

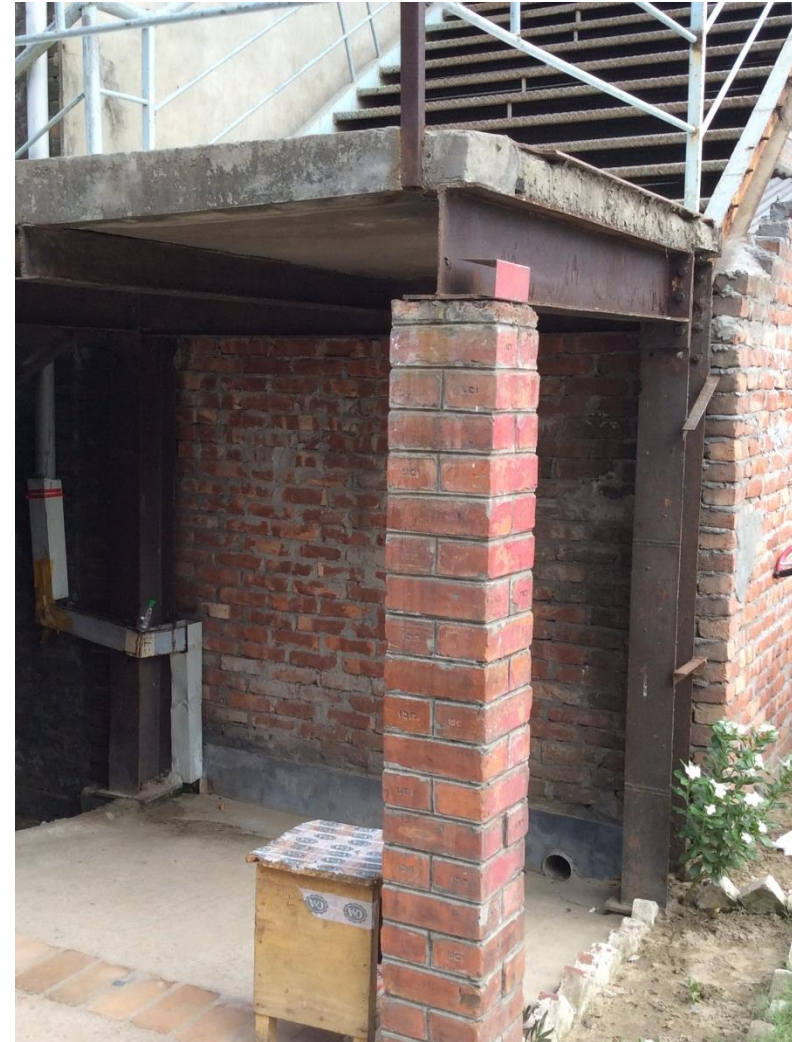
Atypical supports

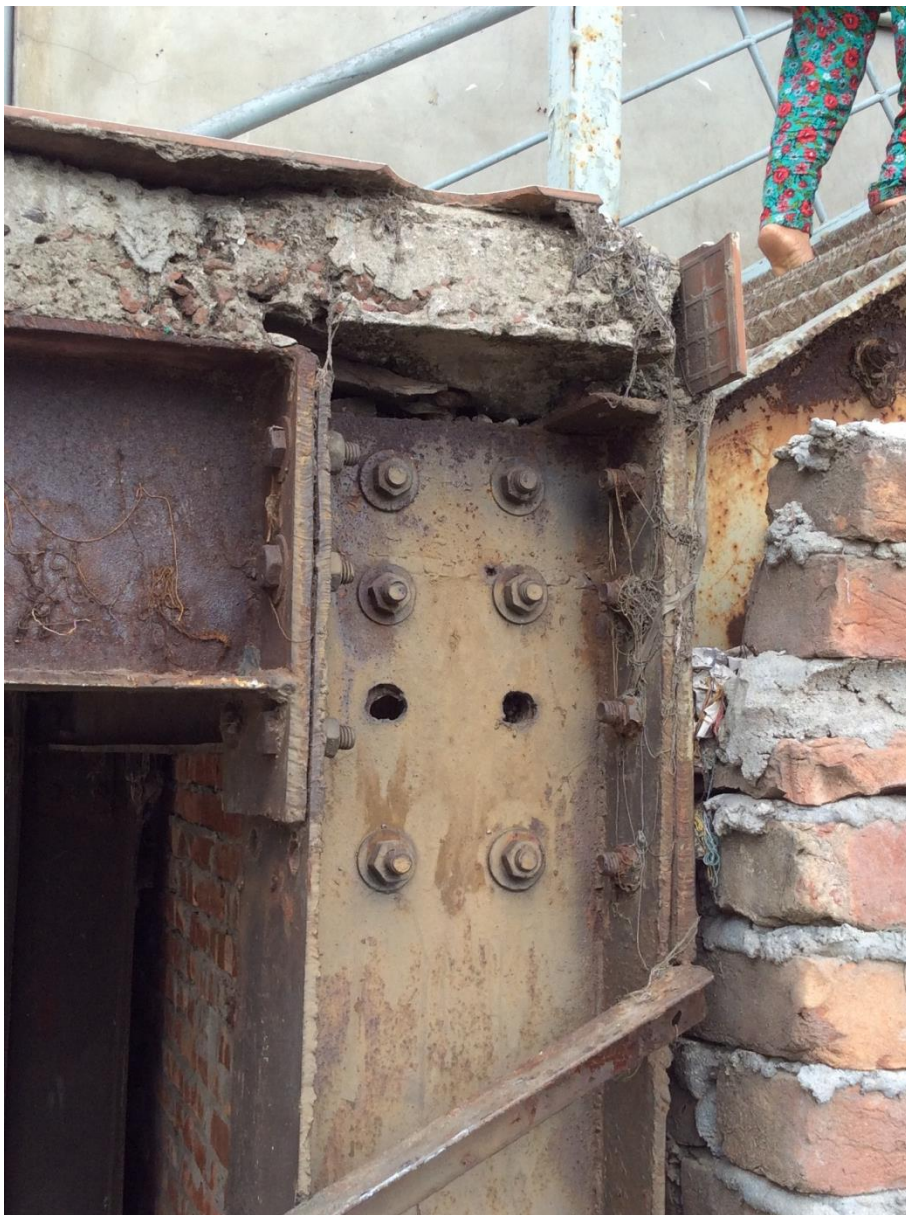
Poor connections

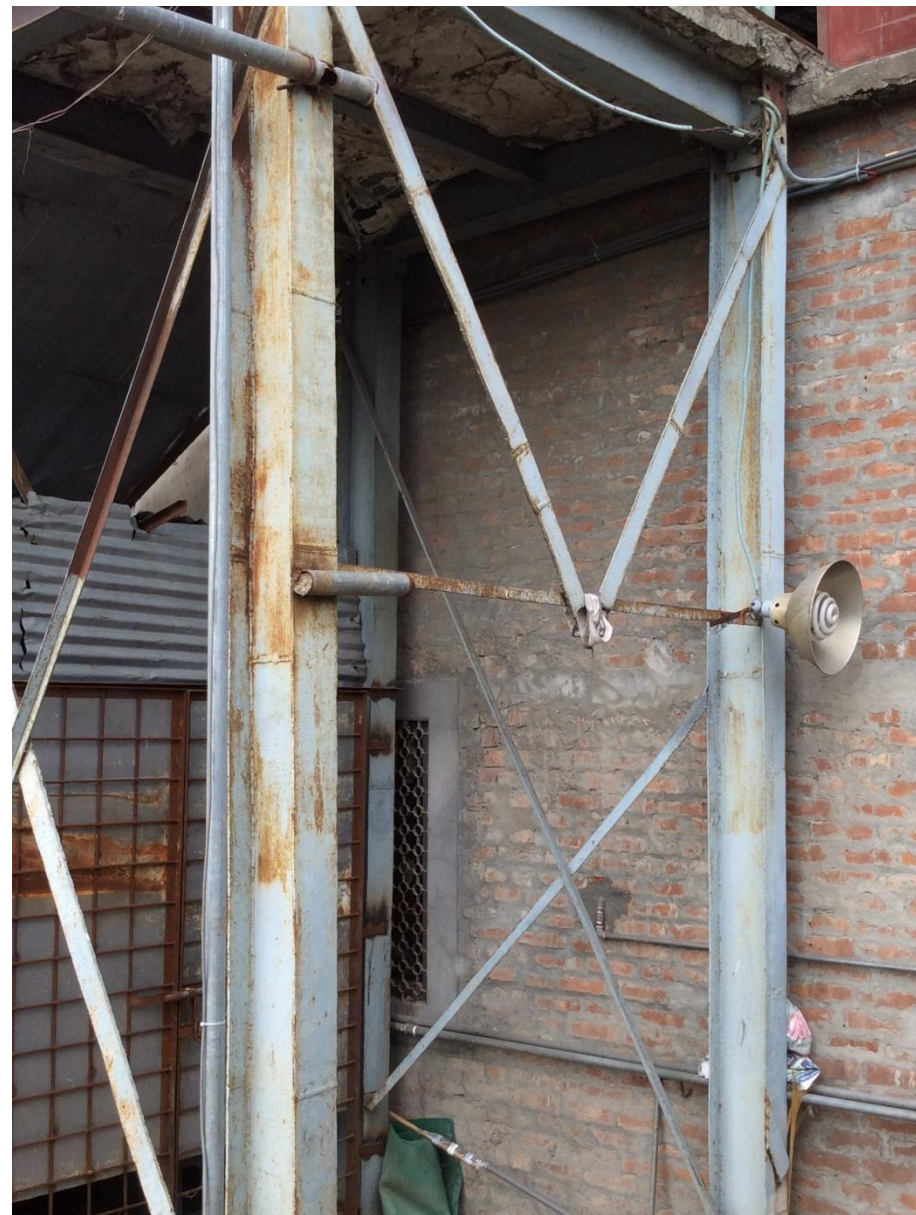
Inadequate bracing

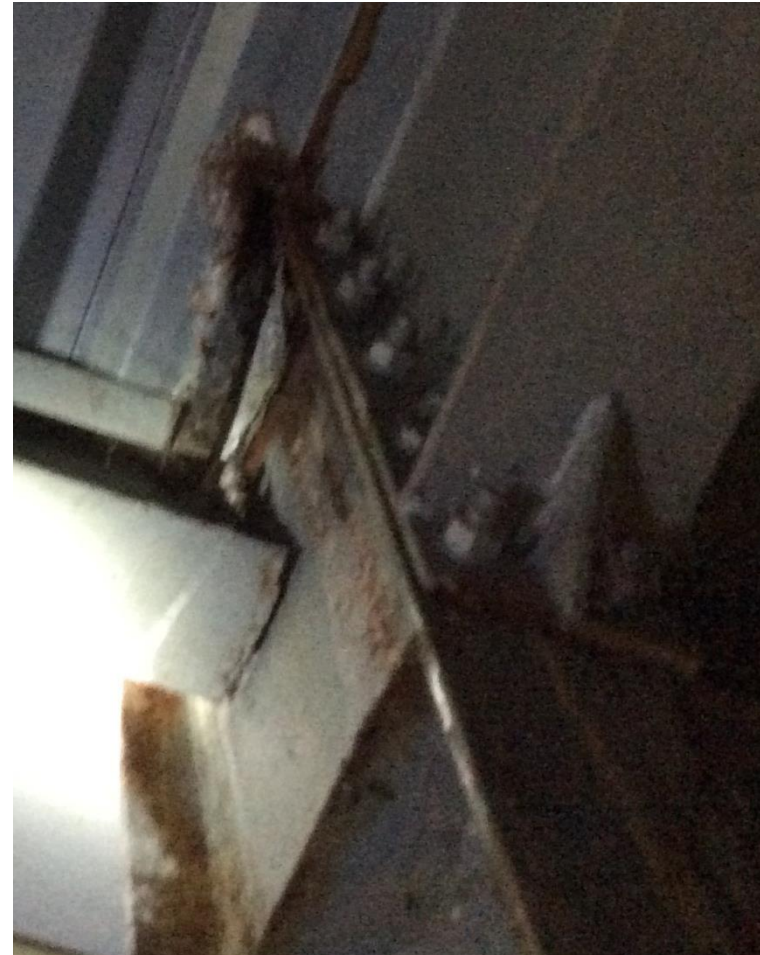
Water ingress, believed to be from leaking services, was observed in the toilet extension to the North-West corner of Shed 1, resulting in corrosion to the portal frame steelwork members and to the reinforcement steel which has become exposed in the RC slab. Remedial works are required.

Corrosion of structural steel members

| Item No. | Observation | Recommended Action Plan | Recommended Timeline |
|---|---|---|---|
| 17 | Water ingress from leaking services into Shed 1 | Building Engineer to identify the cause of leaking and carry out any necessary remedial works. | 6-weeks |
| 18 | Water ingress from leaking services into Shed 1 | Building Engineer to review affected steelwork and prepare a schedule of remedial works as required. | 6-weeks |
