# Aman Knittings Ltd.

Nijim Nagor, Singair Road, Hemeyetpur, Saver, Dhaka  
(23.794351N, 90.269603E)  
30<sup>th</sup> April 2014

# Observations

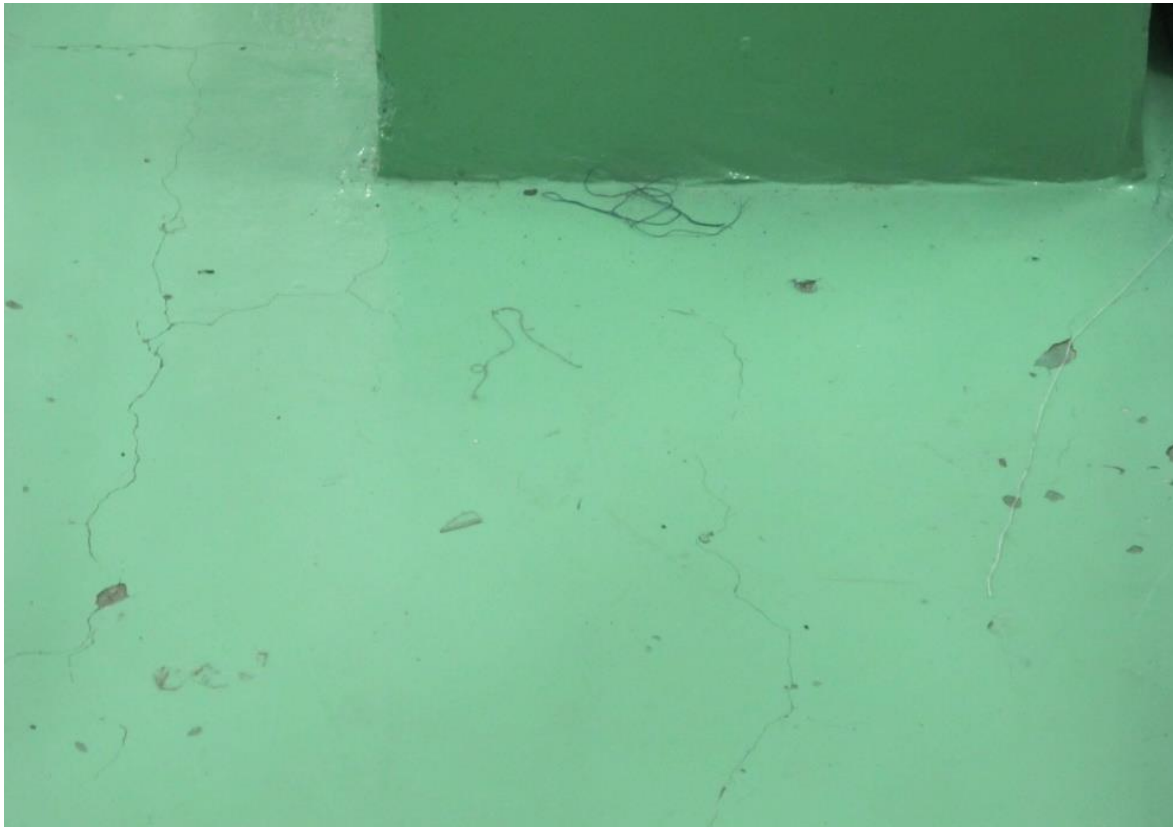
Slab Cracking Around Column Perimeter

We observed cracking on the floor finishes all around the column at 4<sup>th</sup> to a lesser extent on 3<sup>rd</sup> floor, but did not observe any on 2<sup>nd</sup> & 1<sup>st</sup> floors.

Item No.	Observation	Recommended Action Plan	Recommended Timeline
1	Cracking on slab around the perimeter of the columns	Detail Engineering Assessment of as built structure to be commenced as per attached scope. Using verified concrete strength and existing reinforcement of slabs, determine punching shear capacity of slabs at all levels	<b>Immediate - Now</b>
2	Cracking on slab around the perimeter of the columns	Detail Engineering Assessment to be completed	<b>6-weeks</b>
3	Cracking on slab around the perimeter of the columns	If punching shear capacity not justified with present arrangement, define strengthening detail around columns	<b>6-weeks</b>
4	Cracking on slab around the perimeter of the columns	Produce and actively manage a loading plan for all floors within the building giving consideration to floor slab and column capacity.	<b>6-weeks</b>
5	Cracking on slab around the perimeter of the columns	Continue to implement load plan	<b>6-months</b>

6	Cracking on slab around the perimeter of the columns	Implement strengthening measures where required by the DEA	<b>6-months</b>

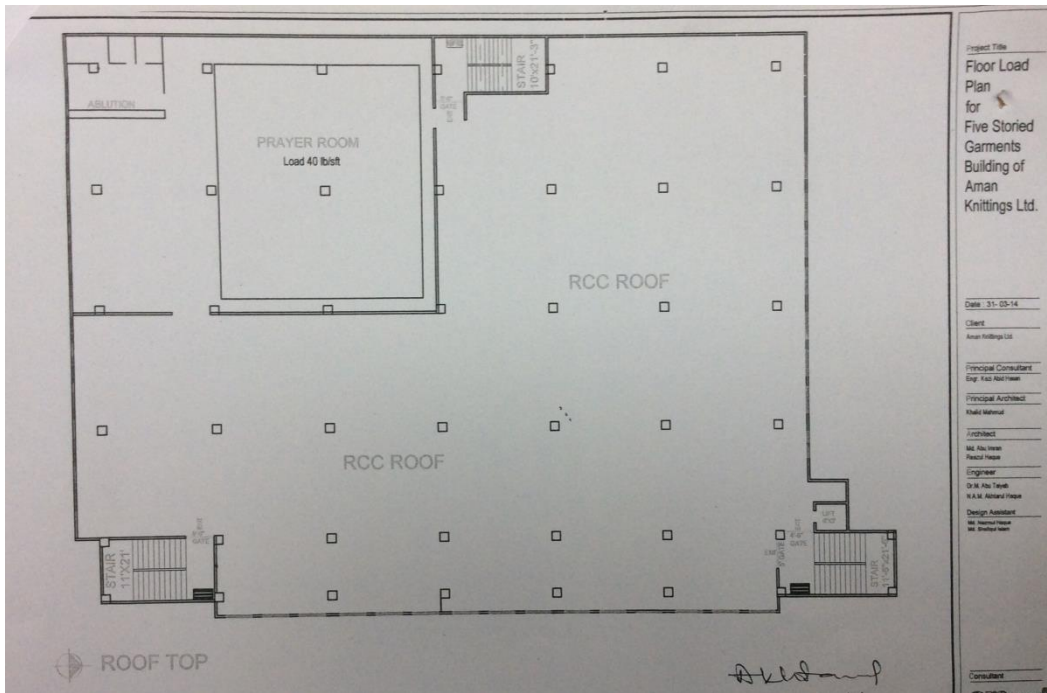
**Typical Column Layout**

**Columns appear to be stressed in excess of normal design limits**

Cursory calculations indicate column working stress is in excess of normal design limits.

Building Engineer is to perform detailed calculations including a Detail Engineering Assessment (See attached scope) and concrete tests to prove column size and (if required):

- Reduce loads by vacating floors
- Reinforce columns

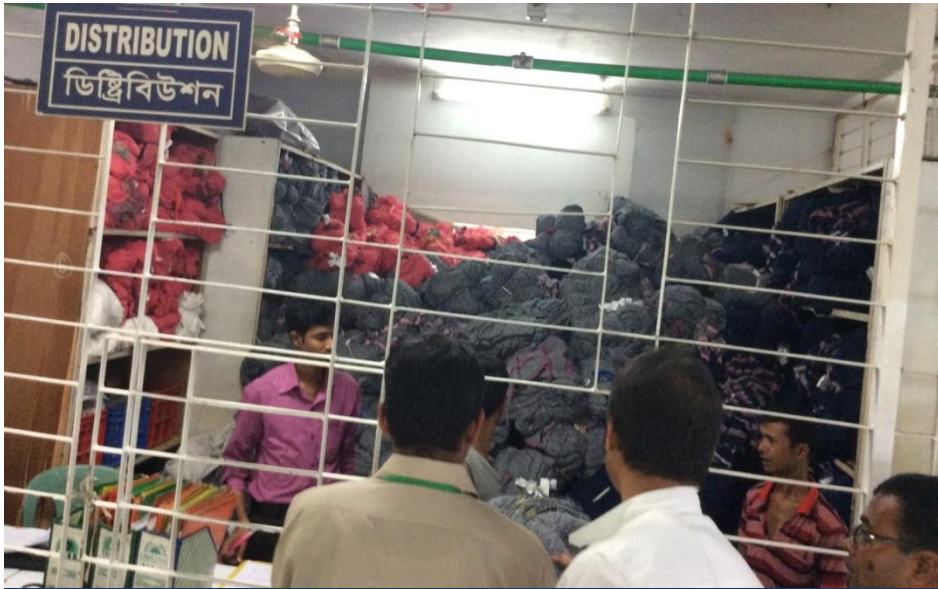
Storage loading at 3<sup>rd</sup> floor

We observed a small area with uncontrolled loading at 3<sup>rd</sup> floor over one cantilever span. Management should maintain the loading limits.

Item No.	Observation	Recommended Action Plan	Recommended Timeline
16	Uncontrolled loads on the Eastern cantilever of the building	Reduce loading on the eastern side of the building where necessary. Produce and actively manage a loading plan for all floors within the building giving consideration to floor capacity and column capacity.	6-weeks
17	Uncontrolled loads on the Eastern cantilever of the building	Continue to implement load plan	6-months
18	Confirm stability of the non-engineered roofs over all sheds	Building Engineer to carry out design check to confirm stability of the steel roofs on all sheds.	6-months
19	Confirm stability of the non-engineered roofs over all sheds	If required, strengthen to support code loading.	6-months
20	Difference between permit drawings and as built construction	As part of the DEA required under Item 1, prepare as-constructed layouts of both buildings and resolve permitting inconsistencies.	6-weeks

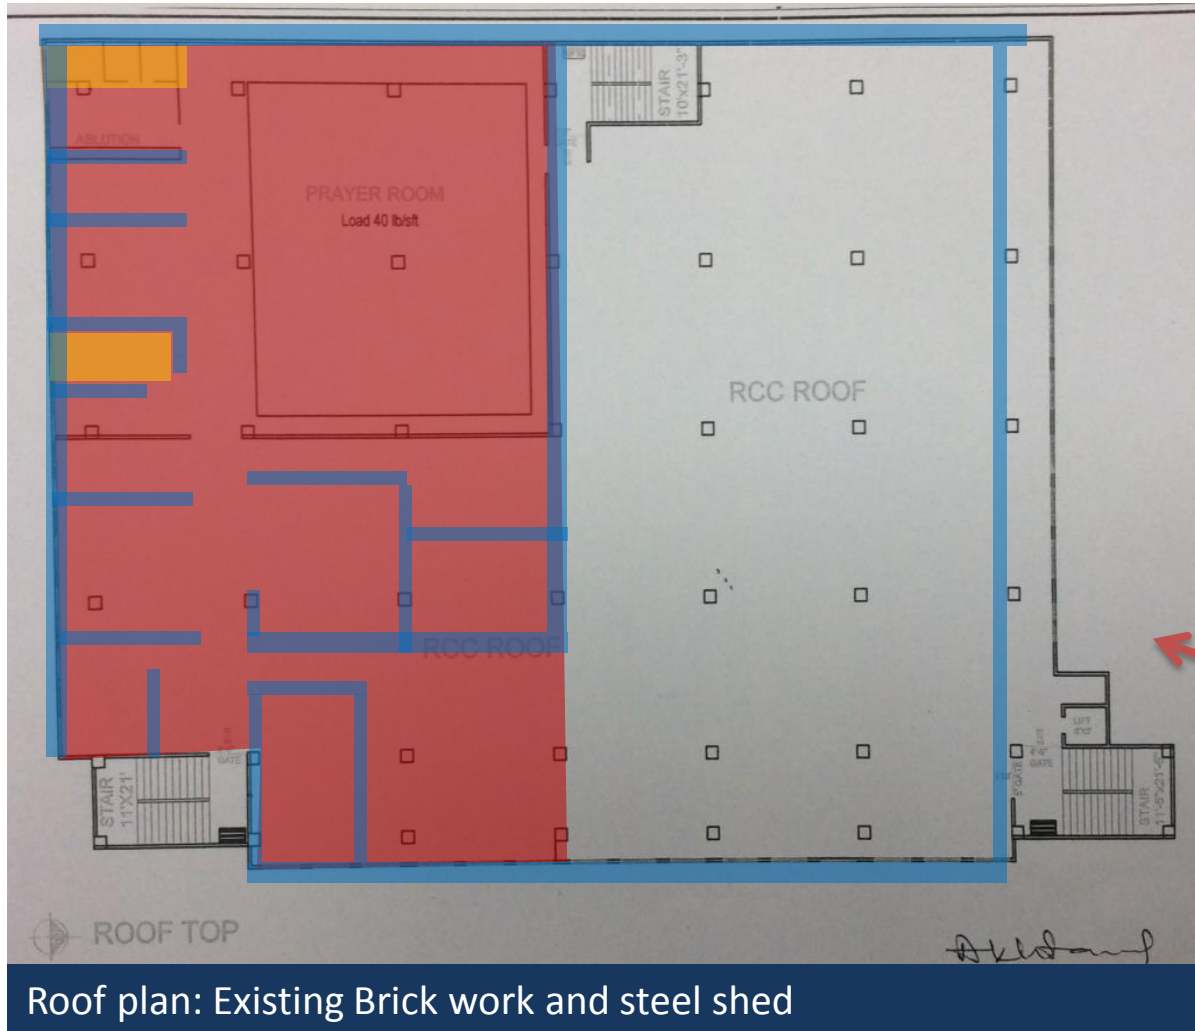
Roof plan: Existing Brick work and steel shed

- Existing Brick Work at roof level
- Build-up inside the toilet
- Steel roof cover

General arrangement drawing. Highlighted areas are as built.

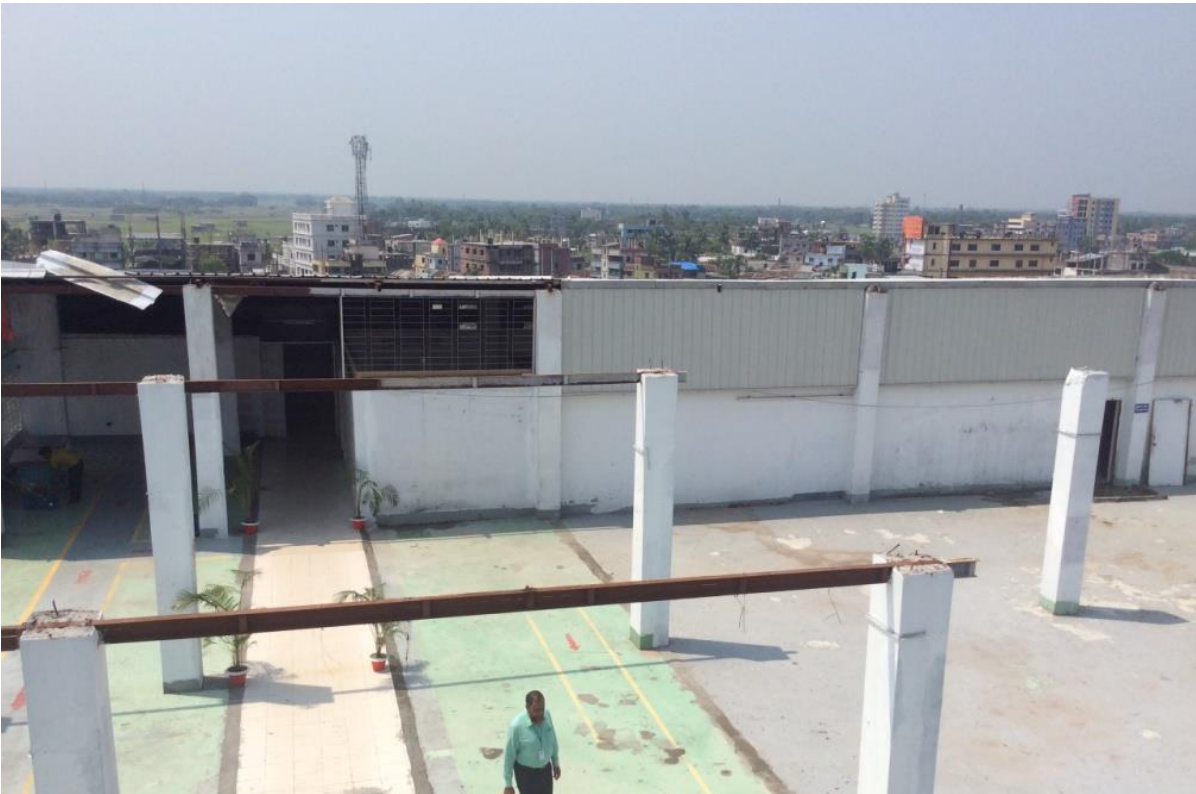
Main Building Roof

Building permit drawing shows a 5 storey building. A 6<sup>th</sup> level was added but has now been partly demolished on instruction of BGMEA, the Fire Brigade and Civil Defence. What remains of the 6<sup>th</sup> storey are rooms enclosed by brick walls with steel roof spanning onto concrete columns, part of which serves as a prayer room. Areas formed by remaining internal brick walls under roof cover, provide other usable areas inside the existing shed.

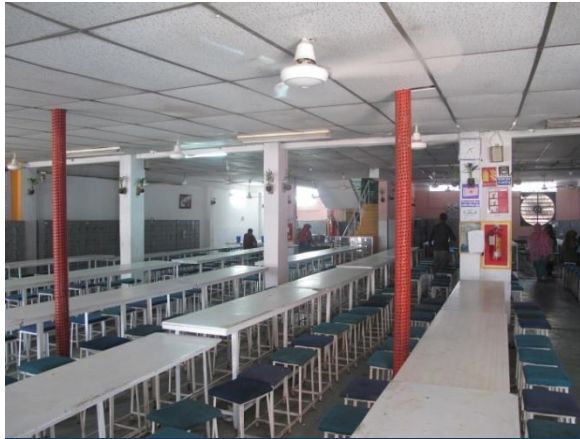
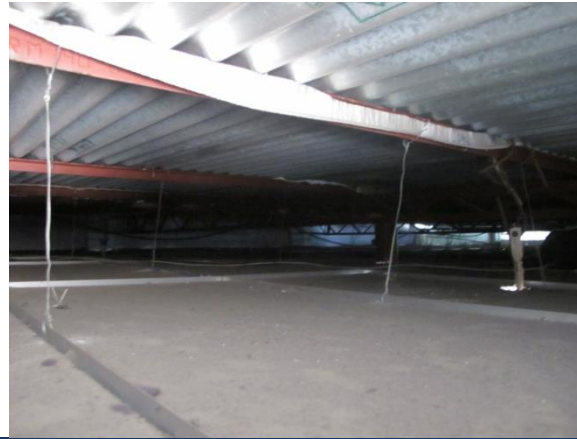
Steelwork over Dining: Shed 1

We observed some non engineered light weight steel structures at roof level of the steel sheds and main building with RC columns. Building Engineer to verify the stability of these steel structures.
