# AJ Fashions Ltd

234/4, Kachukhet, Cantonment, Dhaka-126  
(23.795079N 90.388263E)

7 May 2014

# Observations

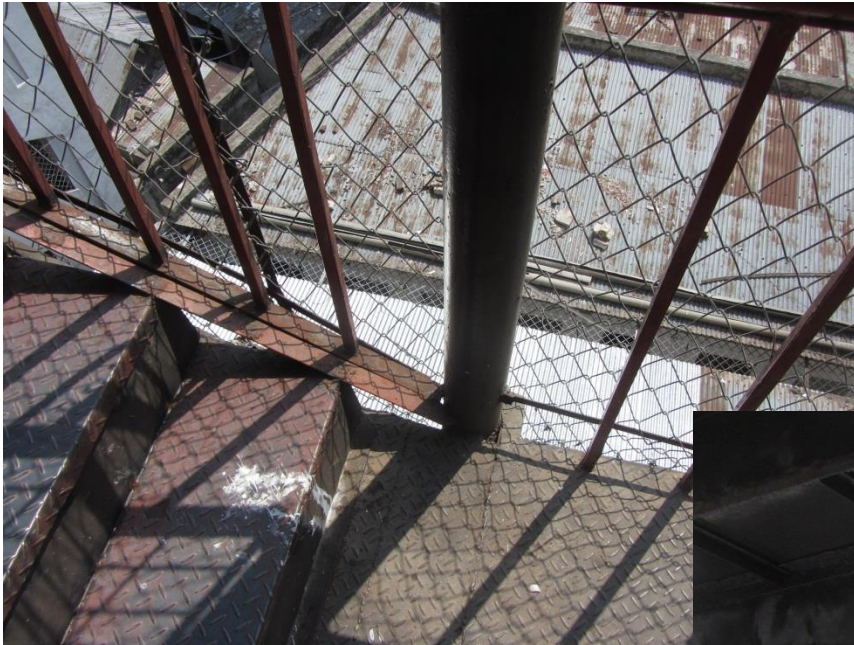
# Non-engineered steel escape stair

Stair tower is non-engineered and has weak stringers and stringer connections and lack of robust tie back to building

| Item No. | Observation | Recommended Action Plan | Recommended Timeline |
|---|---|---|---|
| 1 | Non-engineered steel roof and steel escape stair. | Structural engineer to review design and propose remedial actions where required | 6-weeks |
| 2 | Non-engineered steel roof and steel escape stair. | Carry out remedial actions | 6-months |

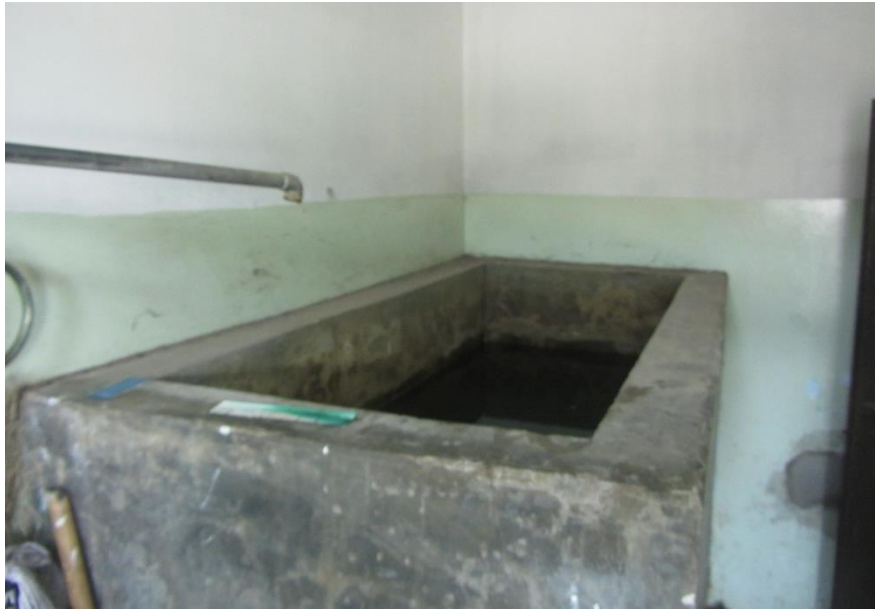
## Stair corner column supports

# High loads on column at corner of staircase

- Water tank on roof & 4<sup>th</sup> floor
- Toilet cubicles
- Facades
- Heavy finishes on stairs

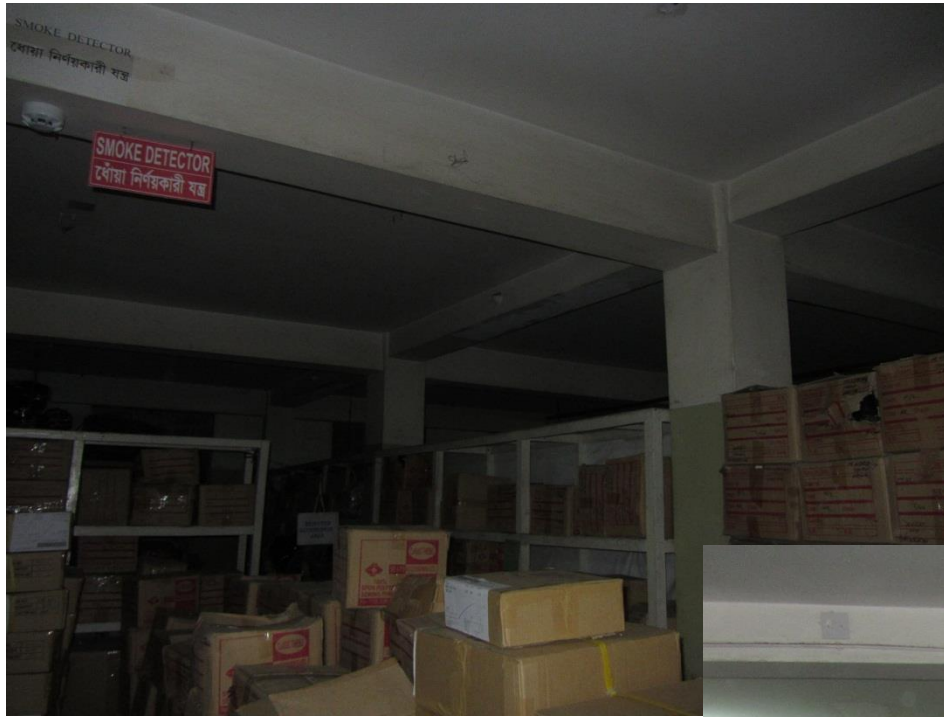
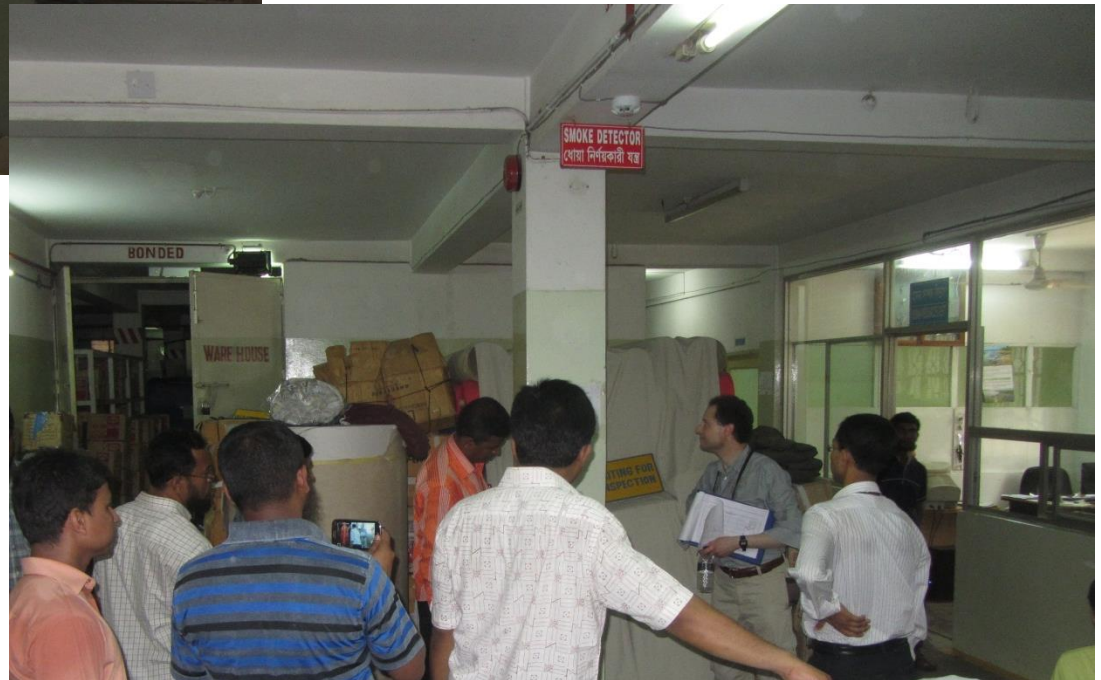
**Downstand beam size varies between levels**

At 1<sup>st</sup> floor (left) soffit beams spanning in shorter direction are shallower. At other levels (below) both beams are the same depth.
