# **FIRE SAFETY INSPECTION REPORT**

## **ESPIRIT APPAREL LTD (PARKZONE)**

**ACCORD ID: 12522**

## Fire Safety Inspection Report

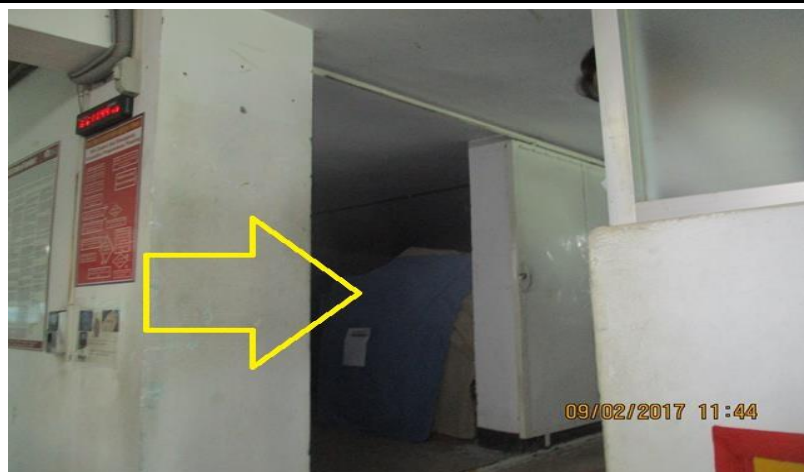
| SI No. | Category | Findings | Required Action | Remediation Time Frame |
|---|---|---|---|---|
| 1 | Fire Rated Construction | Rooms used for combustible storage are not separated by fire rated construction.<br><br><b>Location:</b> 1st floor. | Separate the dedicated storage rooms by minimum 1-hr fire-rated construction. Provide 0.75 hr. fire rated door and seal all penetrations and openings by 1 hr. fire rated fire rated barrier construction. | Within 3 months |

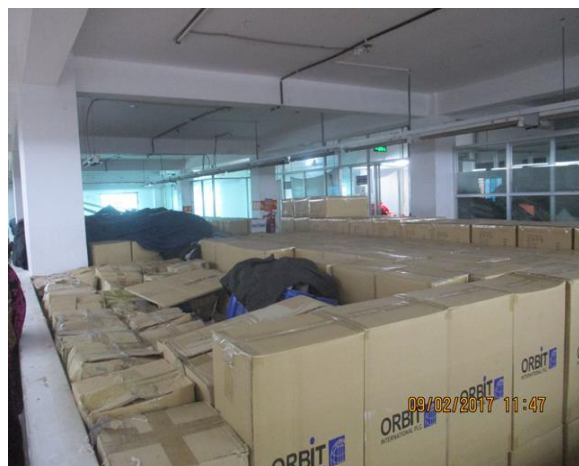
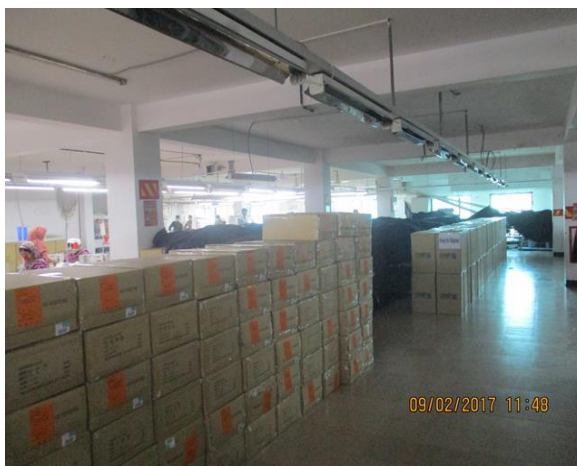
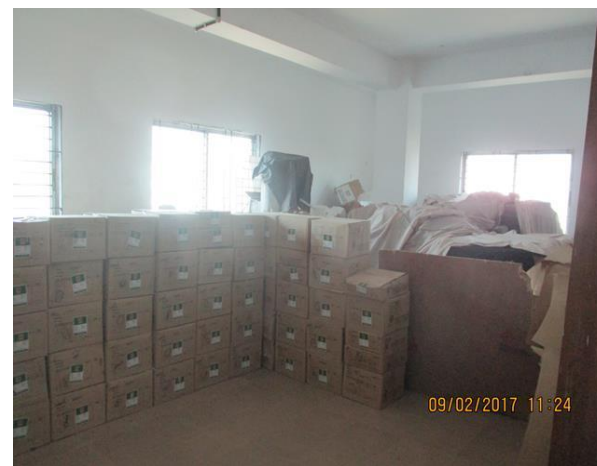
| 2 | Fire Rated Construction | <p>Areas used for combustible storage open to the factory are not separated by fire rated construction.</p> <p><b>Location:</b> 1st floor of the building.</p> | <p>Separate the dedicated storage rooms by minimum 1-hr fire-rated construction. Provide 0.75 hr. fire rated door and seal all penetrations and openings by 1 hr. fire rated fire rated barrier construction.</p> <p>Where separate storage rooms are not feasible, provide defined storage areas and limit the storage arrangement as follows: - Maximum height of 2.45m (8ft.) and maximum area of 23m<sup>2</sup> (250 ft<sup>2</sup>)</p> <p>- If sprinkler protected: maximum height of 3.66m (12ft.) and maximum area of 93m<sup>2</sup> (305ft<sup>2</sup>).</p> <p>Separate areas of unenclosed combustible storage by a minimum clear distance of 3m (10ft.).</p> | Within 3 months |

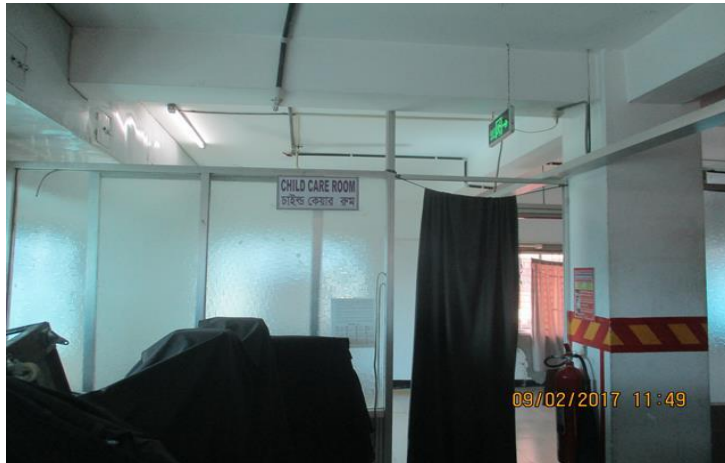
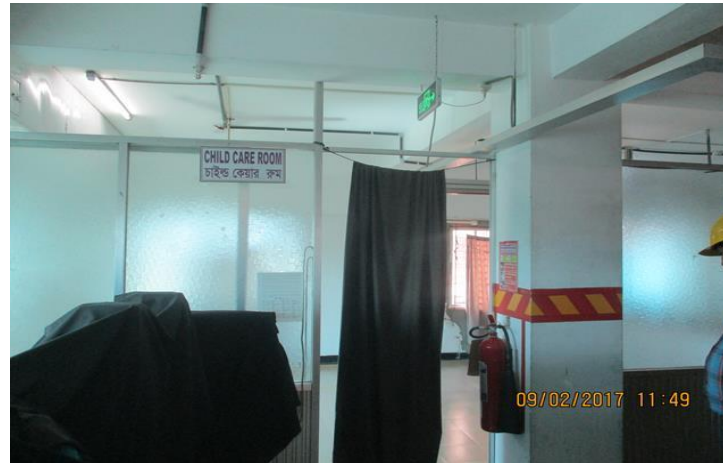
| 3 | Means of Egress | The day-care room located on 1st floor of the building does not meet ACCORD standard 3.4.2.1.1. | Day-care shall be located on the ground floor with a maximum travel distance of 9 m (30 ft) or located one story above level of exit discharge with direct access to an exit enclosure. If the above is not possible provide a minimum 2-hr fire rated exit corridor between the day-care room and exit stair with ACCORD approval. | Within 1 month |

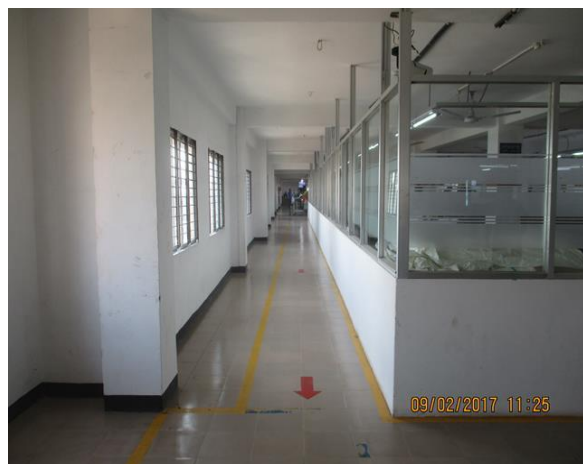
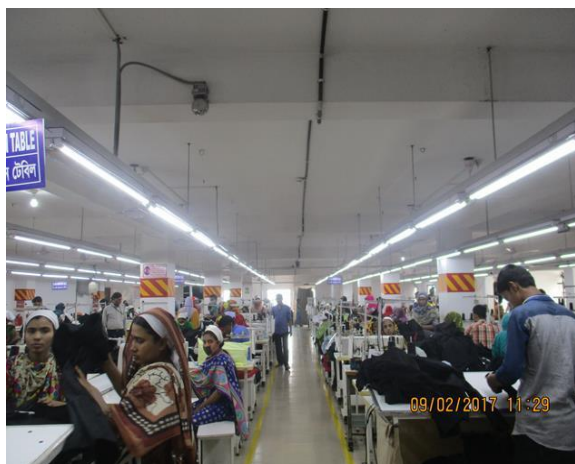
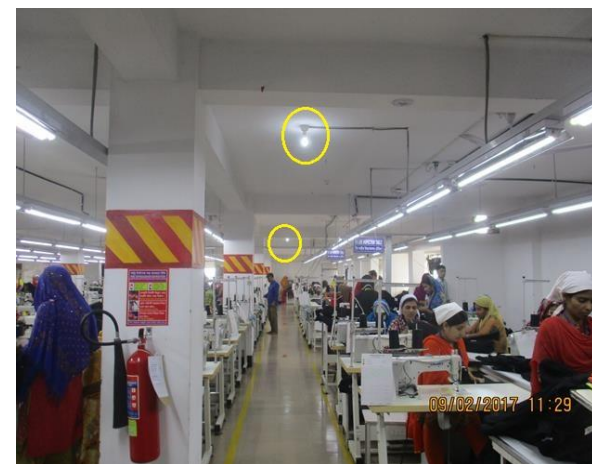
| 4 | Egress Lighting | Based on the number and location of emergency lights observed, adequate illumination levels are not anticipated along egress routes and at exit stairs on all floors. | Test the emergency lighting system on each floor and provide additional emergency fixtures to supply adequate illumination along the means of egress. Provide a minimum illumination of 10 lux at the floor level within exit stairs and along exit discharge paths and a minimum 2.5 lux along exit access aisles. | Within 3 months |

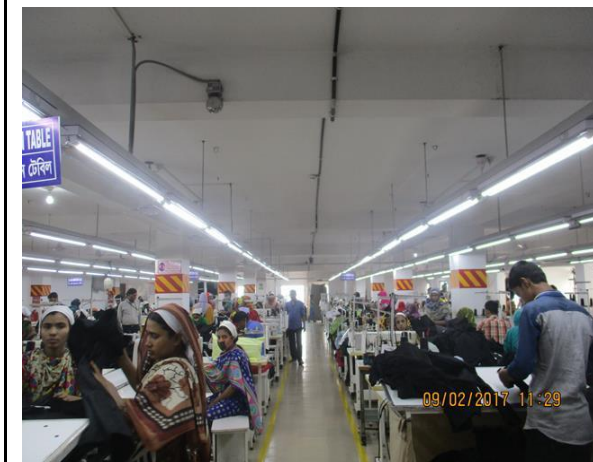
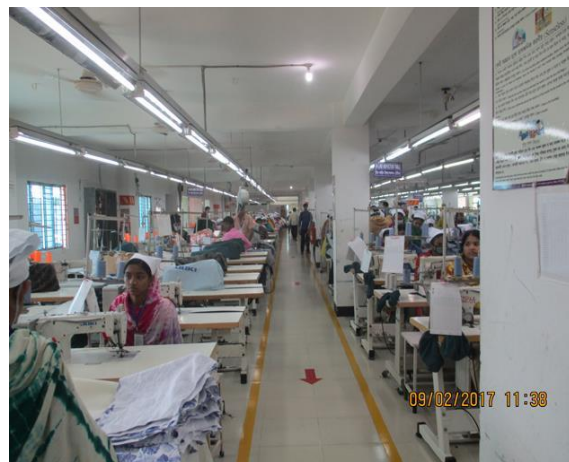
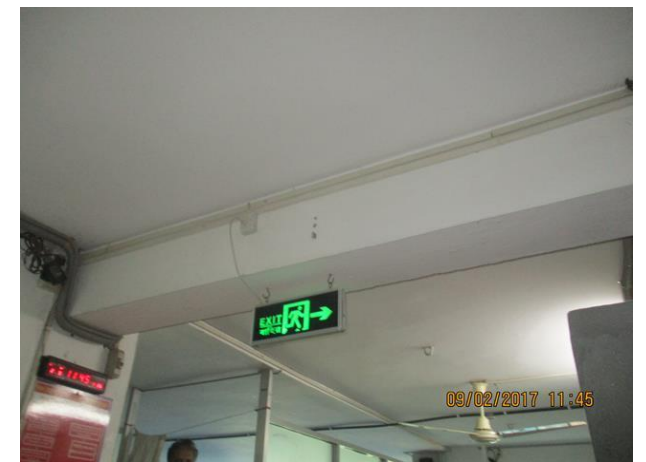
| 5 | Egress Lighting | <p>Directional signs are not provided sufficiently where direction of the path of travel to an exit has changed.</p> <p><b>Location:</b> All floors</p> | <p>Illuminated directional signs shall be provided where there is a change in the direction for the path of travel and the direction to an exit is not obvious.</p> | Within 3 months |
