# **FIRE SAFETY INSPECTION REPORT**

**ORIENT ALLURE LINGERIE**  
**DEWALLIA BARI, KONABARI, GAZIPUR-1346**

**ACCORD**  
on Fire and Building Safety in Bangladesh

March 4, 2014

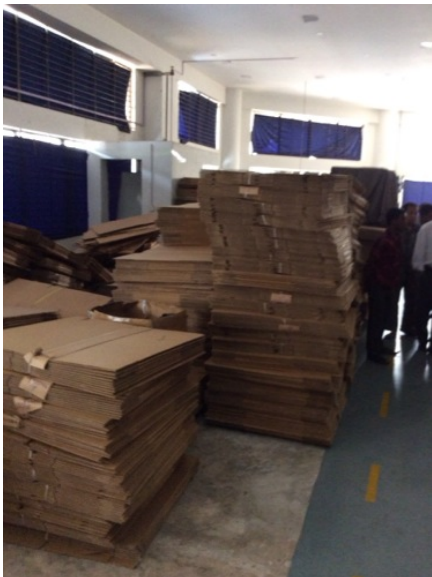
| No. | Category | Finding | Recommendation | Remediation Timeframe |
|---|---|---|---|---|
| F-1 | Fire Rated Construction | Storage rooms and process areas used for combustible storage are not separated by fire-rated construction. | <p>Provide dedicated storage rooms separated by minimum 1-hr fire-rated construction.</p> <p>Where separate storage rooms are not feasible, provide defined storage areas and limit the storage arrangement as follows:</p> <ul style="list-style-type: none"> <li>- Maximum height of 2.4m and maximum area of 23m<sup>2</sup></li> <li>- If sprinkler protected: maximum height of 3.66m and maximum area of 93m<sup>2</sup></li> </ul> <p>Separate areas of unenclosed combustible storage by a minimum clear distance of 3m.</p> | Immediate |

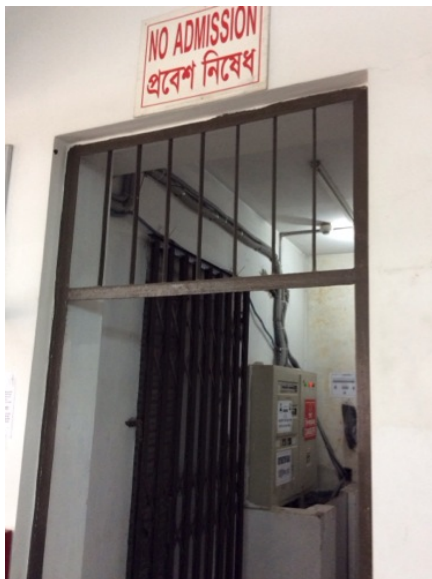
| F-3 | Egress | Collapsible gates and sliding doors are provided throughout the stairwells | Replace all gates and sliding doors along the means of egress with side-hinged, swinging egress doors.<br><br>If locks are required for security reasons, utilize special door locking features complying with NFPA 101. | Within 1 month |

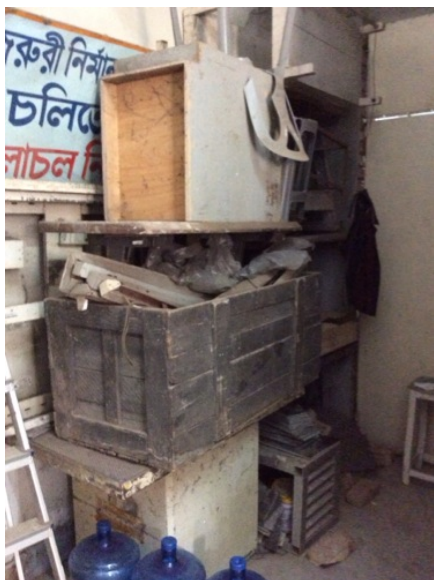
| F-4 | Egress | Storage was located in the SW exit stair on the ground floor. | Remove all storage from exit stairs and egress paths. | Within 3 months |

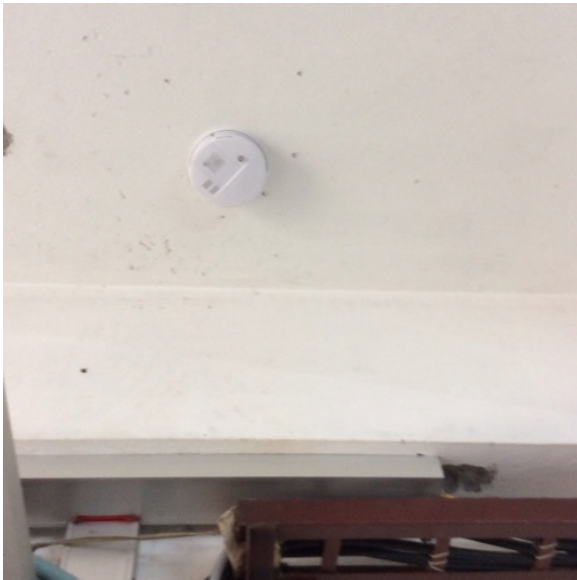
| F-6 | Fire Protection | The building is equipped with single-station smoke alarms. Smoke alarm activation sounds only a local alarm and does not provide automatic fire alarm notification of occupants. | Replace the single-station smoke alarms with automatic smoke detectors tied into the fire alarm system. Configure the fire alarm system to initiate occupant notification upon activation of any two smoke detectors in addition to the manual fire alarm stations. | Within 6 months |

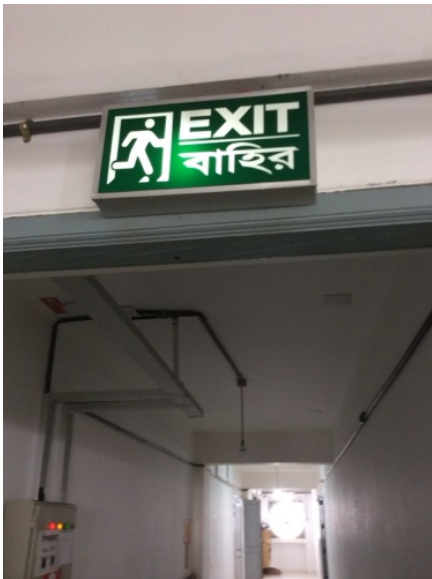
| F-7 | Egress Lighting | Emergency lighting in the NW stair did not function in test mode (burned out, broken, etc.). | Regularly test the emergency lighting system on each floor and replace/repair lights as needed. | Within 3 months |
