# Natural Denim Ltd (new building)

532, Tongabari, Savar, Dhaka

9<sup>th</sup> October, 2016

# Observations

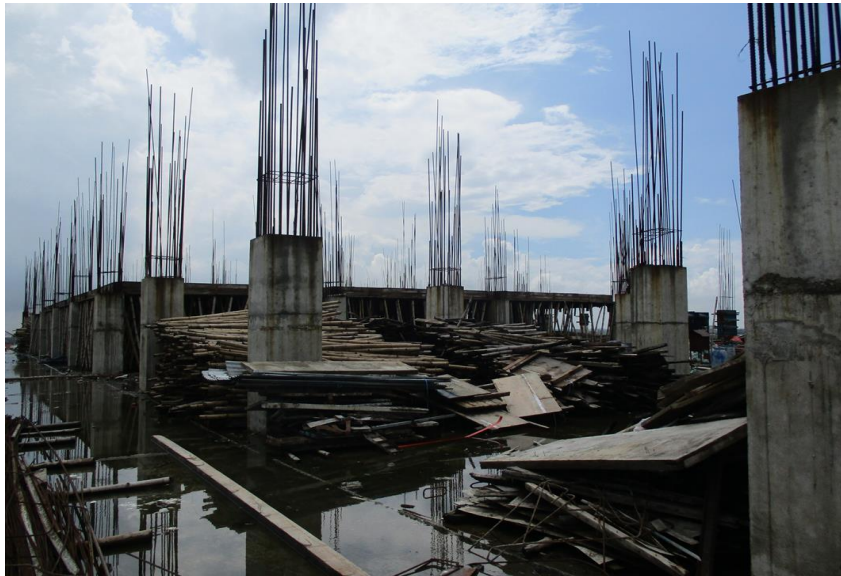
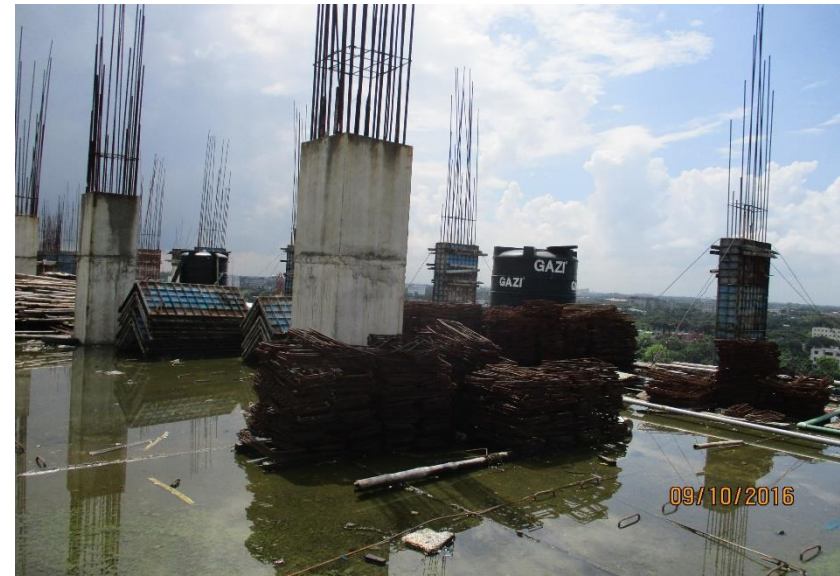
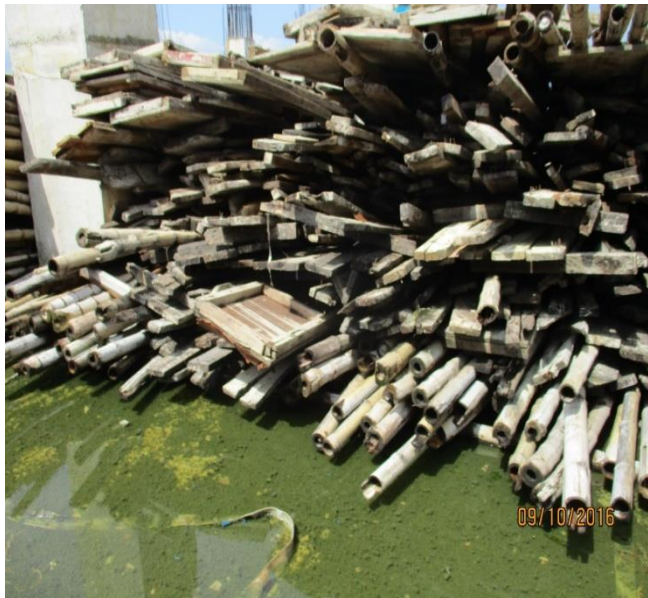
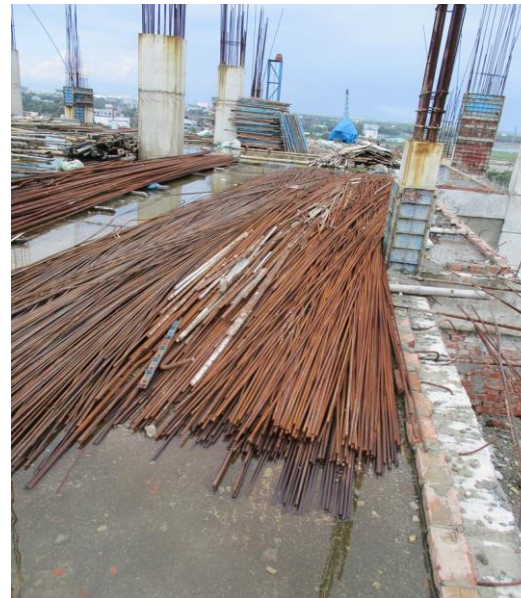
**Construction debris and material was piled up in roof, exceeding design loading for current roof**

Construction debris and material piled up at current roof, which may exceed the design loading of floor capacity. Building engineer requires to actively maintain the construction material that not exceed the floor capacity.

| Item No. | Observation | Recommended Action Plan | Recommended Timeline |
|---|---|---|---|
| 1 | Construction debris and material was piled up in roof, exceeding design loading for current roof floor. | Implement better control to prevent overload of floors by construction materials and derbies. | Immediate - Now |
| 2 | Construction debris and material was piled up in roof, exceeding design loading for current roof floor. | Implement better supervision of floor loadings in storage areas. | 6-weeks |

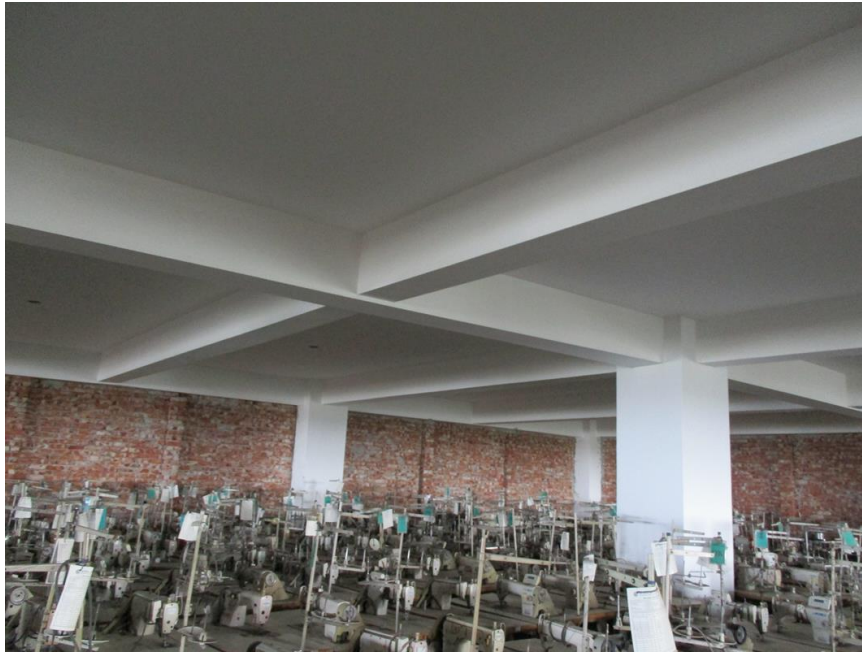
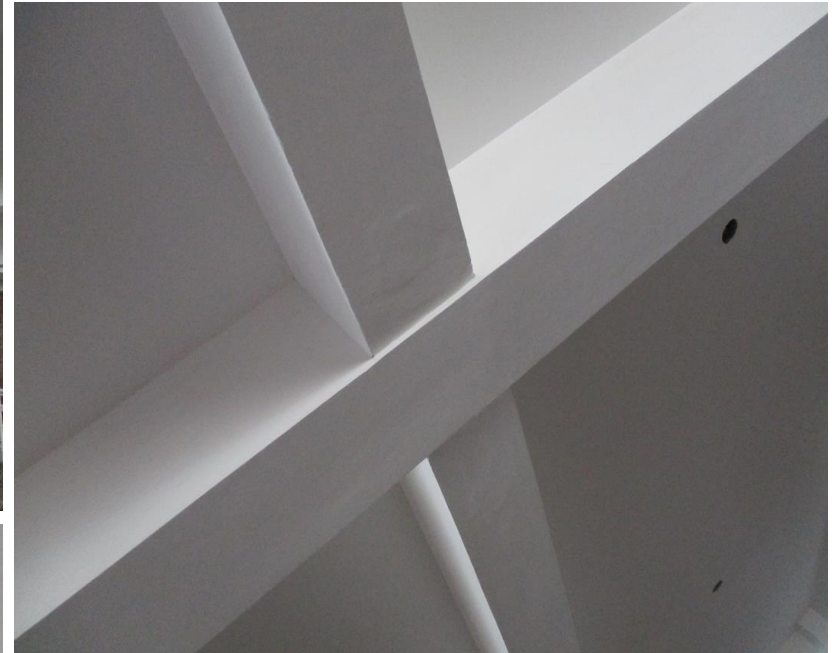
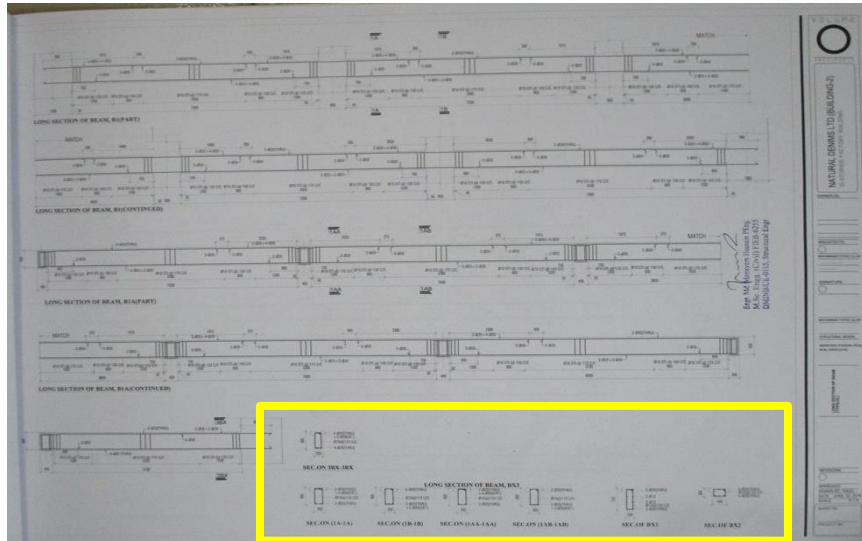
As built structural drawing shows main beam and sub/Secondary beams are same depth. It was observed that sub/secondary beams are minimum of 20 mm shorter than main beam.

| Item No. | Observation | Recommended Action Plan | Recommended Timeline |
|---|---|---|---|
| 3 | Discrepancies between drawings & on-site observations. | Engage a Building Engineer to survey the structure and update a full set of “as-constructed” drawings for Structural and Architectural. | 6-weeks |

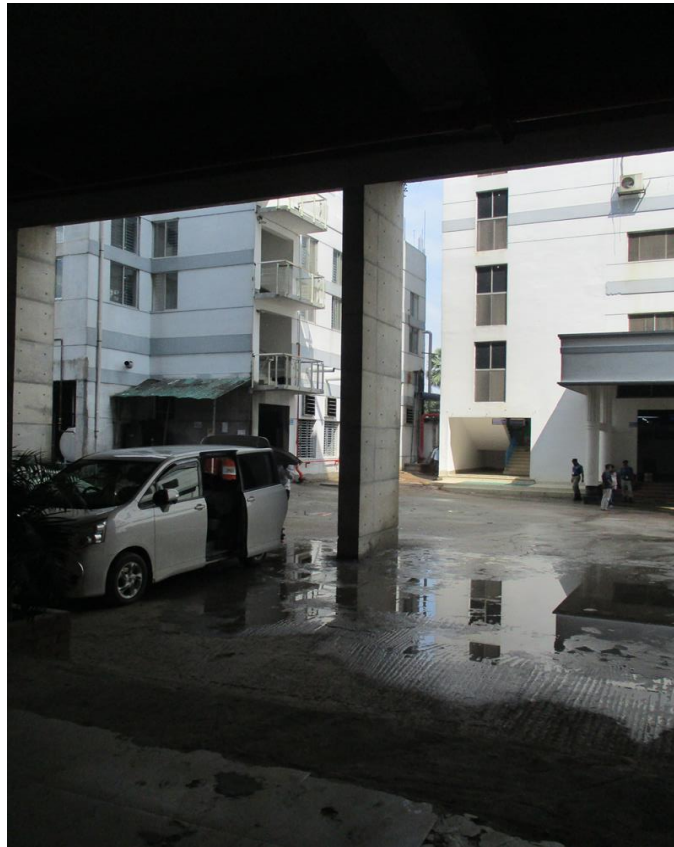
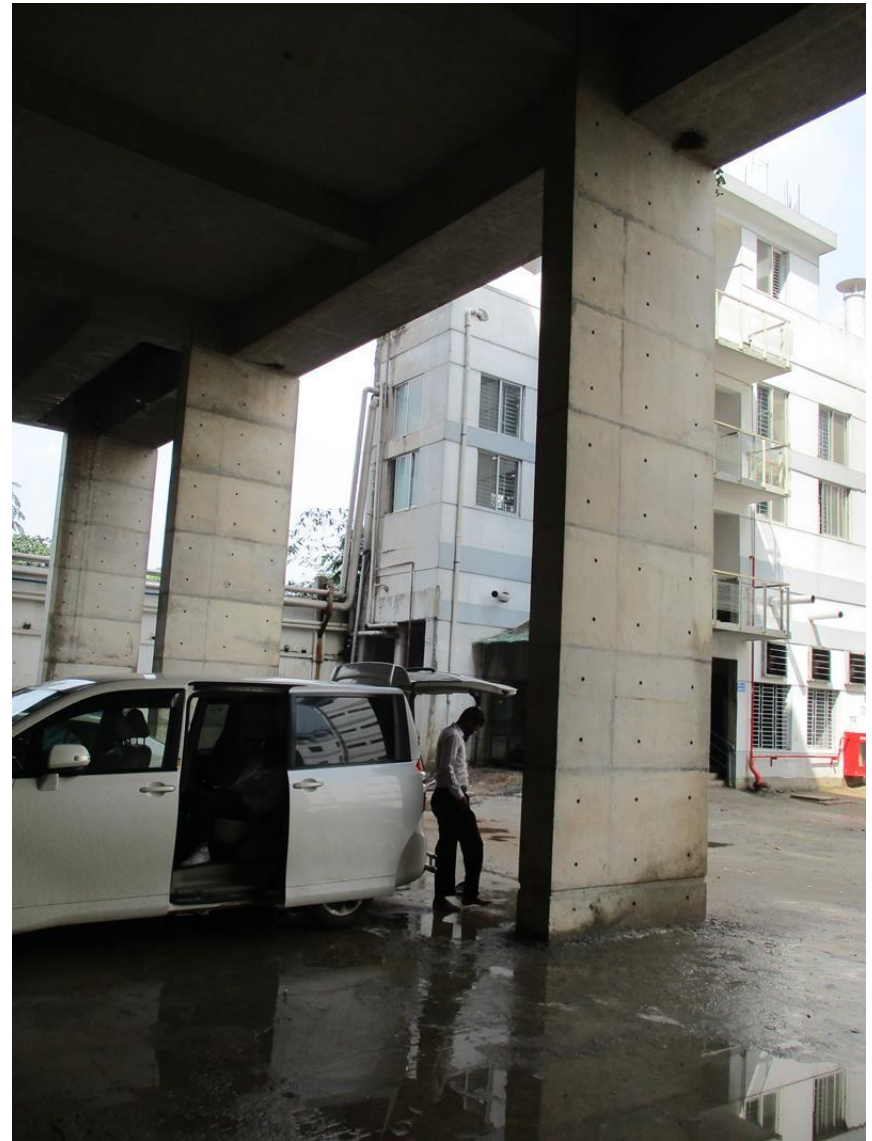
Columns at Loading Bay are susceptible to impact loading from vehicles.

| Item No. | Observation | Recommended Action Plan | Recommended Timeline |
|---|---|---|---|
| 4 | Columns susceptible to impact loading | Building engineer to design appropriate impact protection for critical column within loading dock. | 6-weeks |
| 5 | Columns susceptible to impact loading | Construct and maintain protection to critical column and continue to assess likelihood of vehicle impact to critical elements. | 6-months |

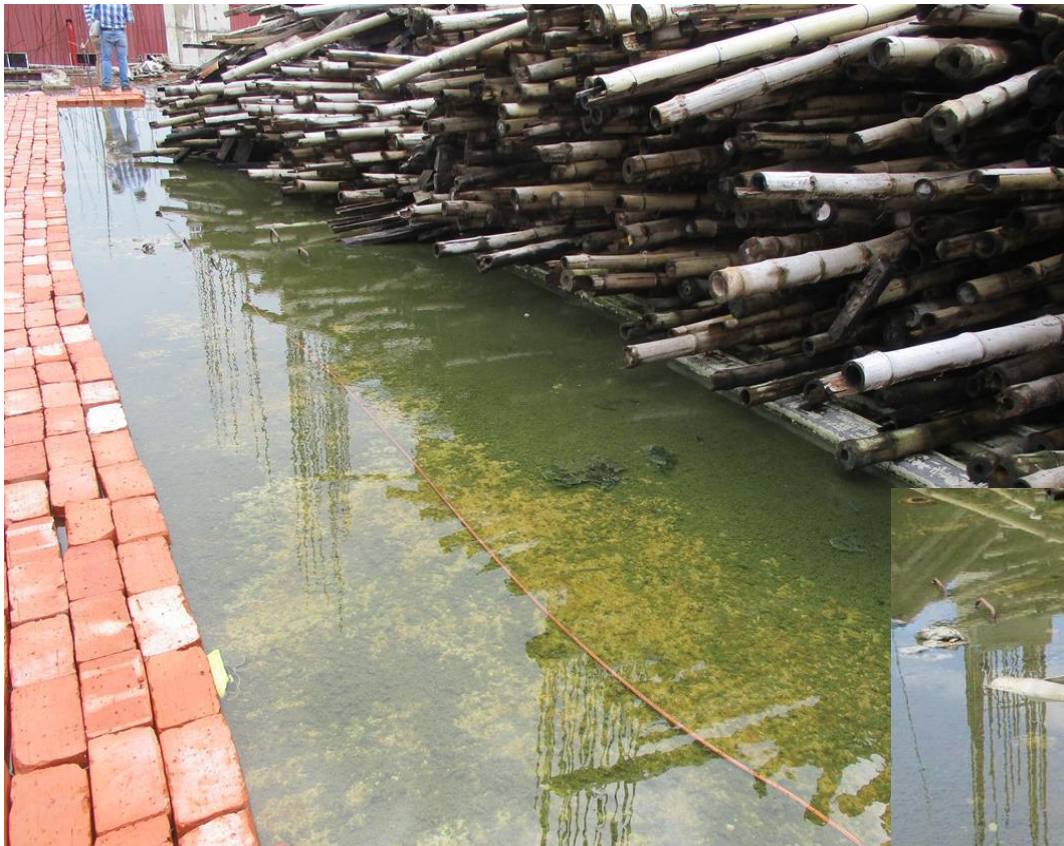
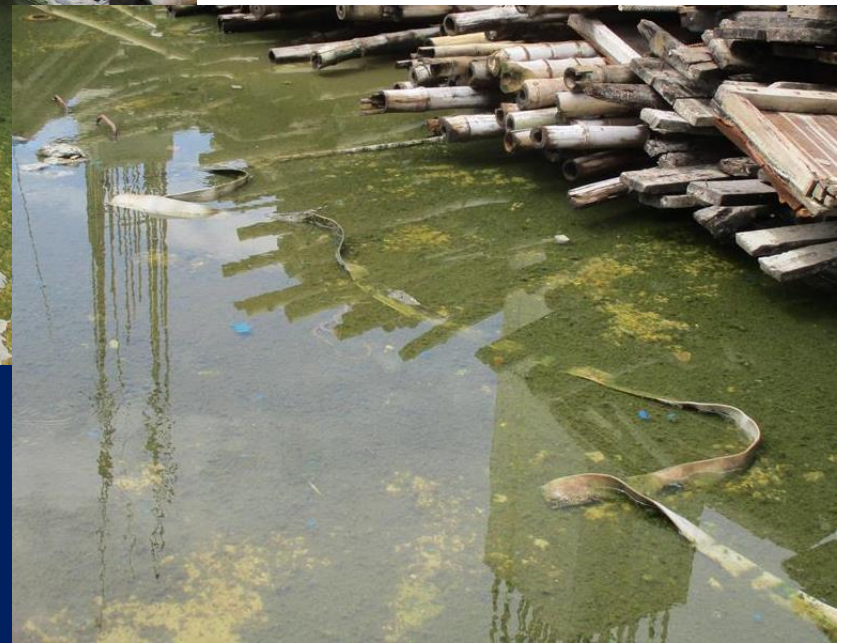
Water ponding at roof was observed and it cause vegetation at roof that also indicates poor drainage system. Building engineer requires to provide water proof coating and improve drainage system.

| Item No. | Observation | Recommended Action Plan | Recommended Timeline |
|---|---|---|---|
| 6 | Water ponding and vegetation at roof | Waterproofing on the roof slab is to be applied. Moreover the roof slab drainage system should be investigated and improved. | 6-months |

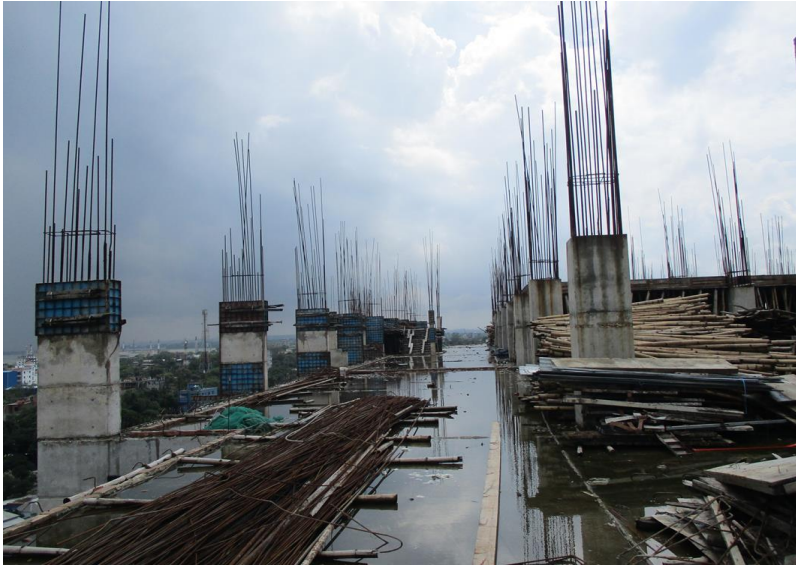
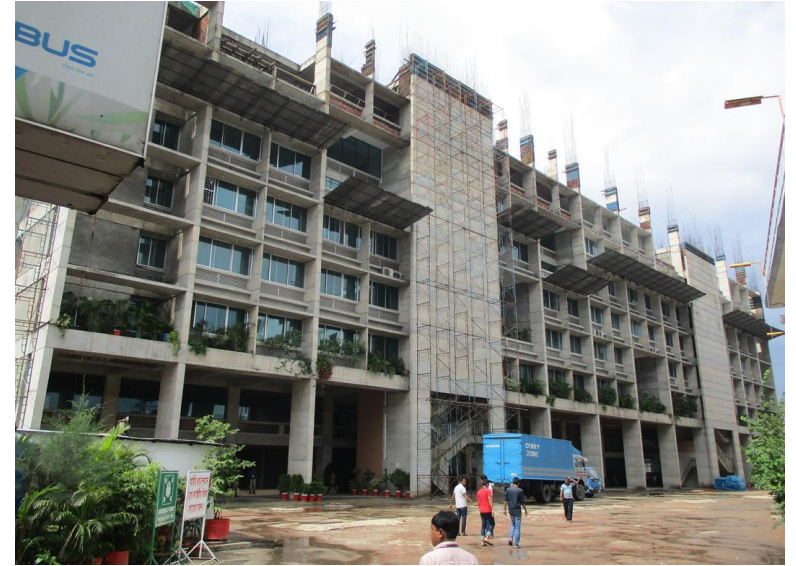
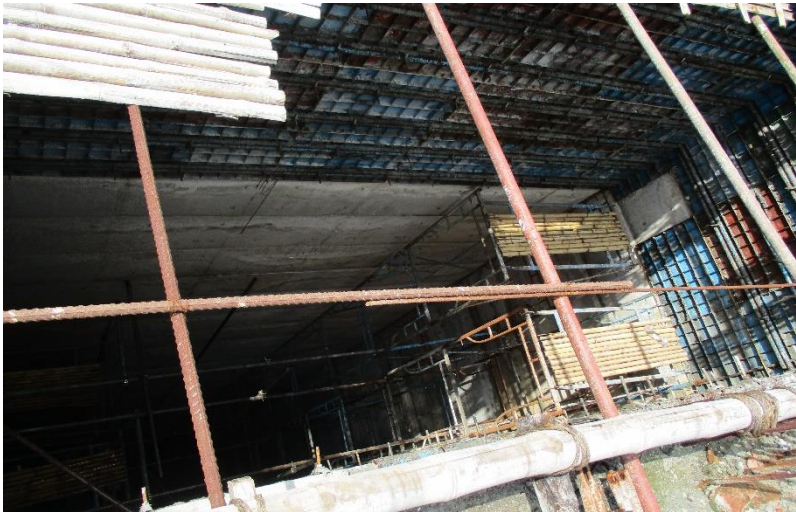
As construction works on going and will carry out, apply safe procedure to ensure worker safety during construction.

| Item No. | Observation | Recommended Action Plan | Recommended Timeline |
|---|---|---|---|
| 7 | Worker Safety during construction | Carryout construction works in safe manner to ensure worker safety. | Immediate - Now |

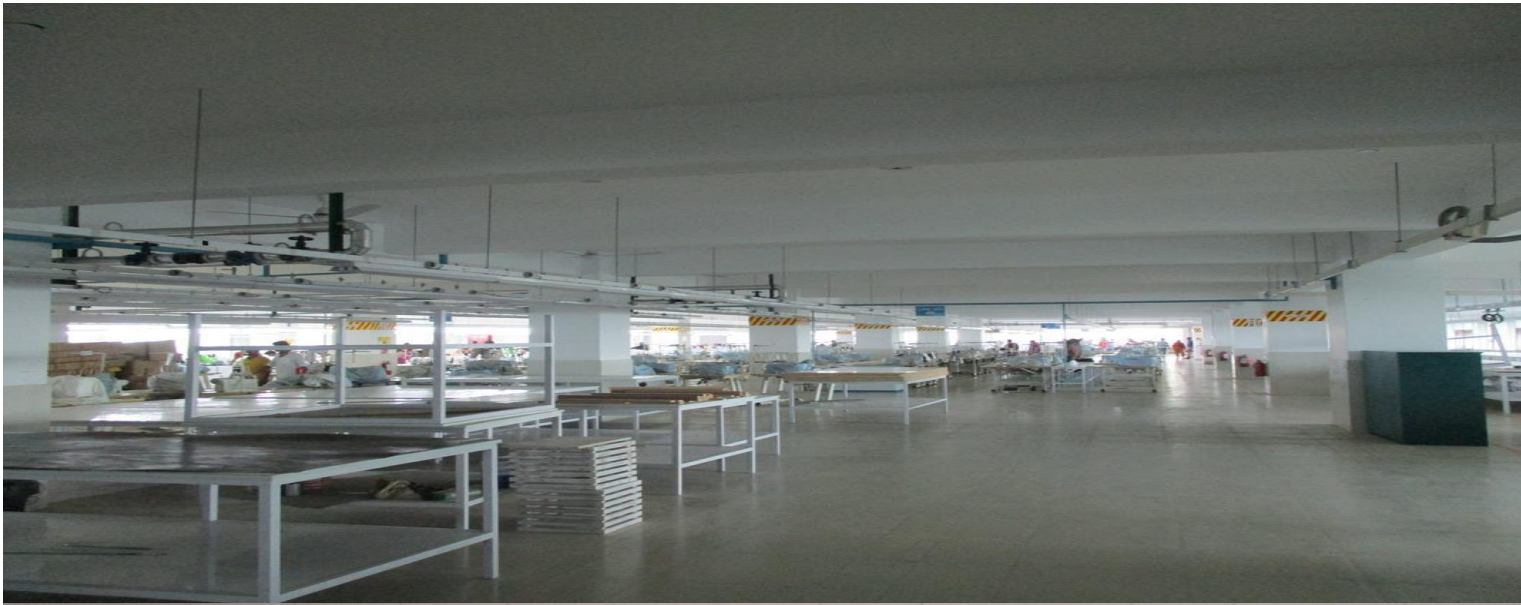
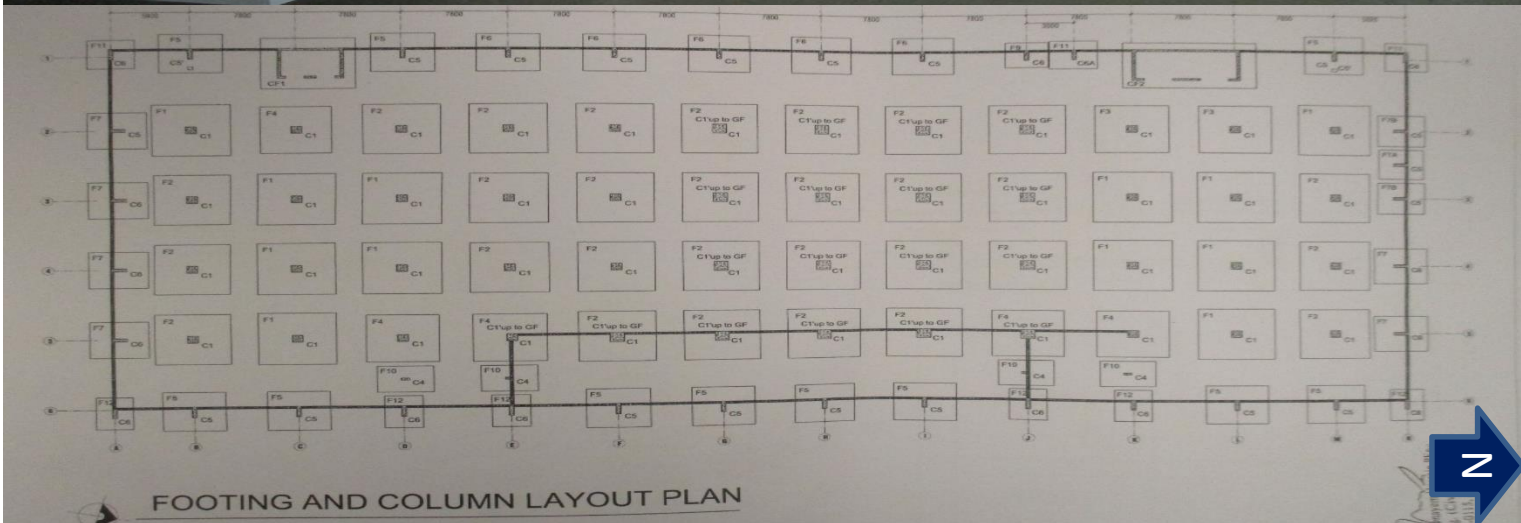
No movement joints for almost 100 m span building.

| Item No. | Observation | Recommended Action Plan | Recommended Timeline |
|---|---|---|---|
| 8 | Lack of movement joints | Building Engineer to check the static calculations for thermal and shrinkage effect of the 100m long structure system. | 6-weeks |

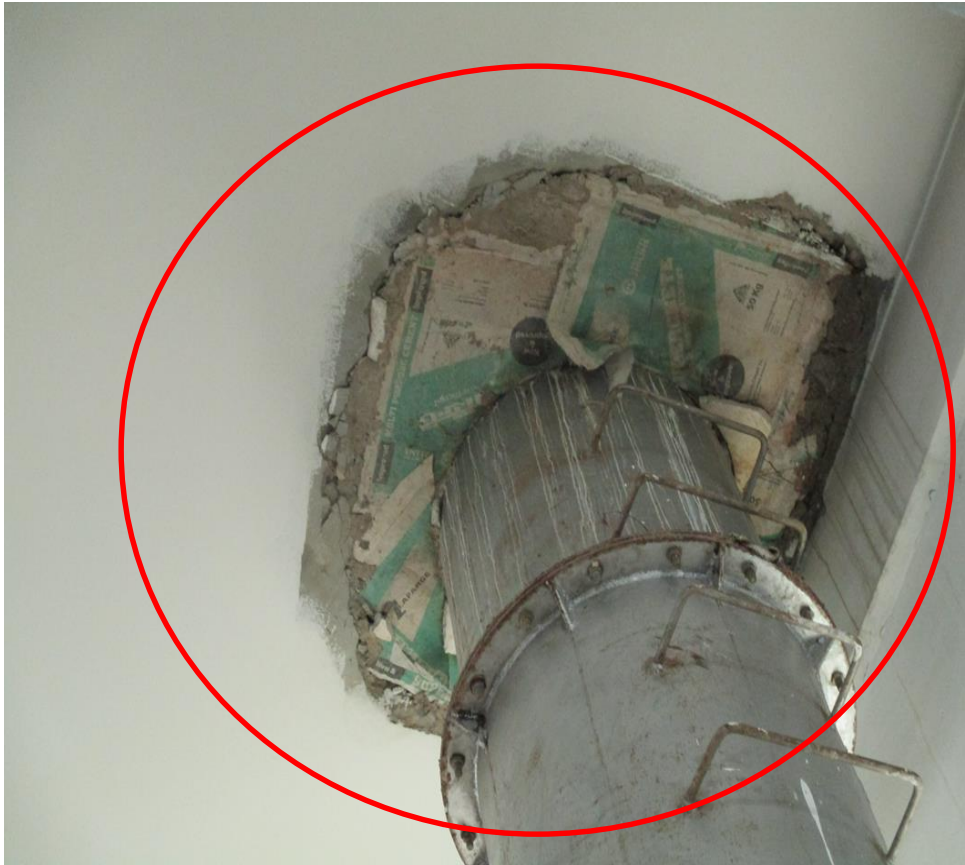
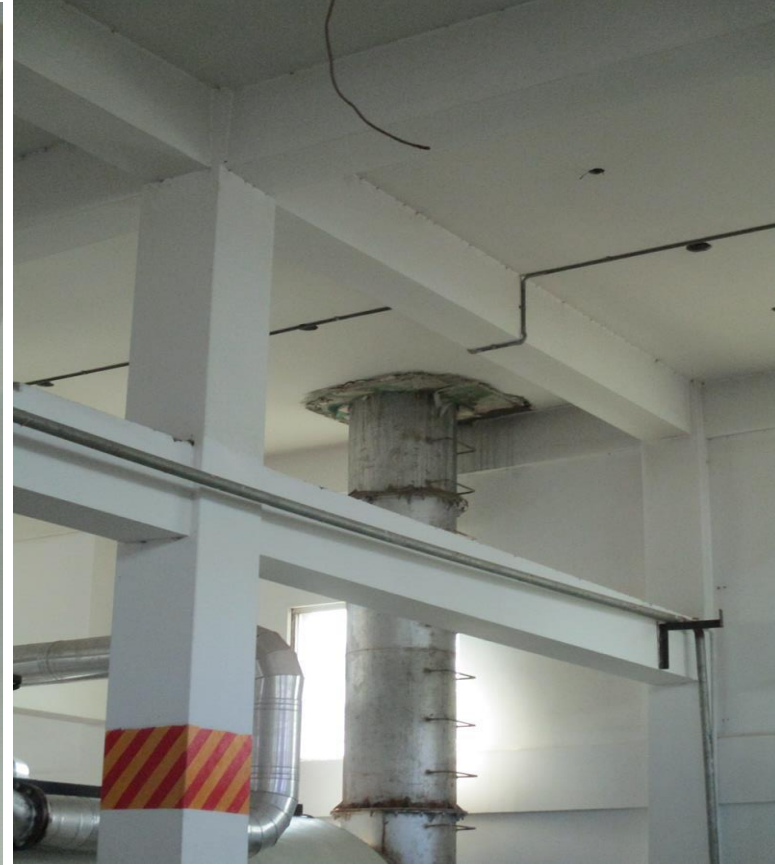
# Falling hazard at 1st floor roof due to boiler duct penetration at utility building

Due to boiler duct penetration at 1<sup>st</sup> floor surrounding concrete loosen up it may spalling down and its hazards for life safety.

| Item No. | Observation | Recommended Action Plan | Recommended Timeline |
|---|---|---|---|
| 9 | Falling hazard at 1st floor roof due to boiler duct penetration at utility building. | Carryout civil works in a safe manner around the penetration to prevent lose concrete Spalling. | 6-weeks |
