# Russel Garments Ltd.

Osman Tower, 56/1, S.M. Maleh Road, Narayanganj, Dhaka

20 April 2014

# Building Observations

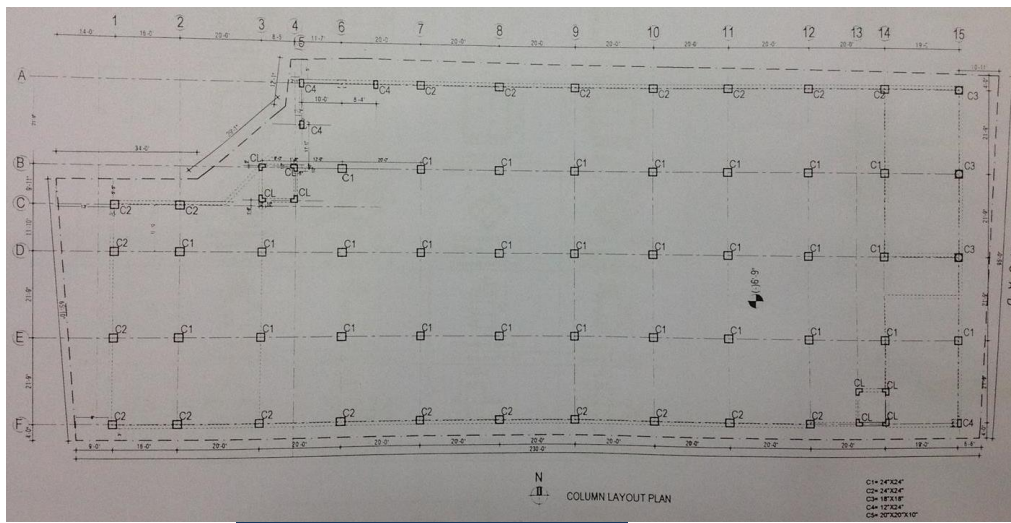
Typical column layout

**Columns appear to be stressed in excess of  
normal design limits**

Preliminary calculations indicate that working stress is at a high level for all columns.

A Detailed Engineering Assessment of the building is required (See attached Scope). Building engineer is to perform detailed calculations based on as constructed dimensions, loadings. Use material data from concrete tests to prove column size and in addition to the immediate actions noted in this report, if required:

- Reduce loads by vacating floors and removing undocumented structures, partition walls and floor finishes.
- Reinforce columns

| Item No. | Observation | Recommended Action Plan | Recommended Timeline |
|---|---|---|---|
| 1 | Column Stresses | Pending verification of column capacity by the building engineer remove storage loads on all floors from ground level to level 7 such that the maximum height of stacked material is 0.5m. Remove all construction and storage loading from level 8, 9 and 10. Ensure loading on all suspended floors does not increase. | Immediate - Now |
| 2 | Column Stresses | Do not complete fit out of levels, 8, 9 and 10 or recommence construction of the level 10 water tank | Immediate - Now |
| 3 | Column Stresses | Verify insitu concrete stresses either by cores (min 100mm diameter) or existing cylinder strength data for all the columns from a minimum of 4 non-critical columns. | Immediate - Now |
| 4 | Column Stresses | Accurately determine as built reinforcement grade, size, quantity and distribution. | Immediate - Now |
| 5 | Column Stresses | Building engineer to review design, loads and columns stresses for all columns. | Immediate - Now |
| 6 | Column Stresses | A Detail Engineering Assessment (DEA) of the factory to be commenced. DEA to focus on vertical structure loading and available member capacity. See attached scope. | Immediate - Now |

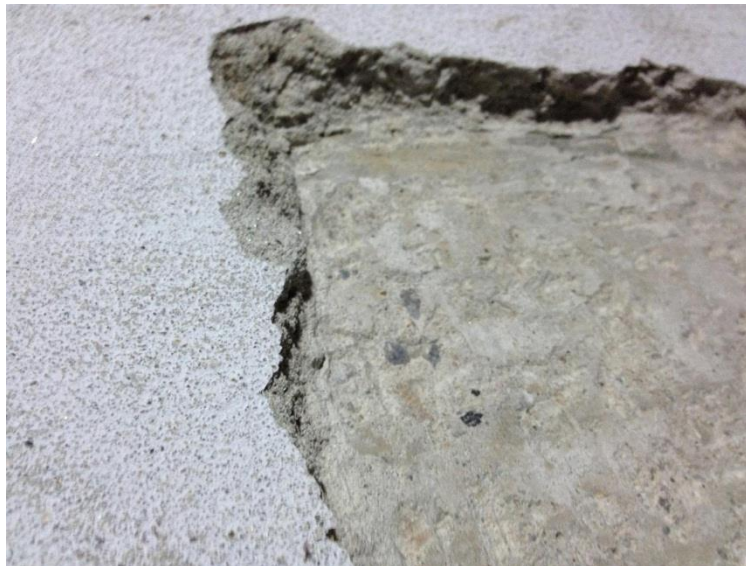
Tested Basement Floor Column – Stone Chips

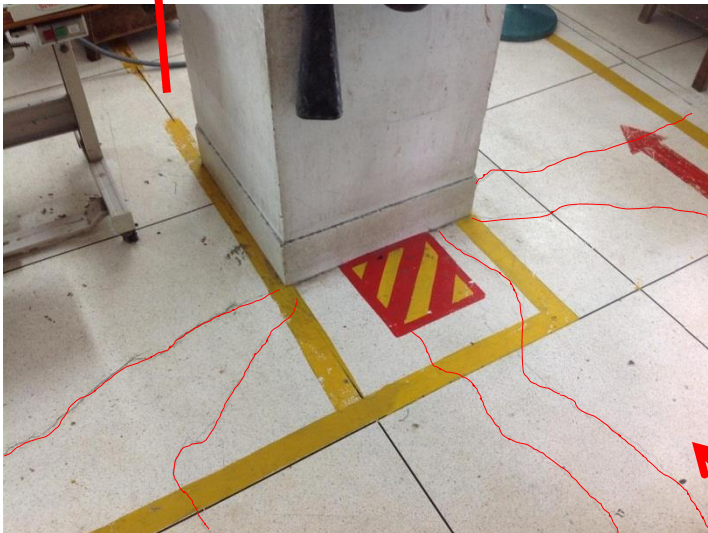
2nd Floor Slab

Cracks to be reviewed by removing floor finishes to investigate if they extend into structure.

| Item No. | Observation | Recommended Action Plan | Recommended Timeline |
|---|---|---|---|
| 11 | Cracking in slab finishes | Remove finishes to investigate if cracking extends into structure. | 6-weeks |
| 12 | Cracking in slab finishes | If the cracks do extend into structure engineer to review current loading and usage of adjacent areas with respect to what was assumed in design. | 6-weeks |

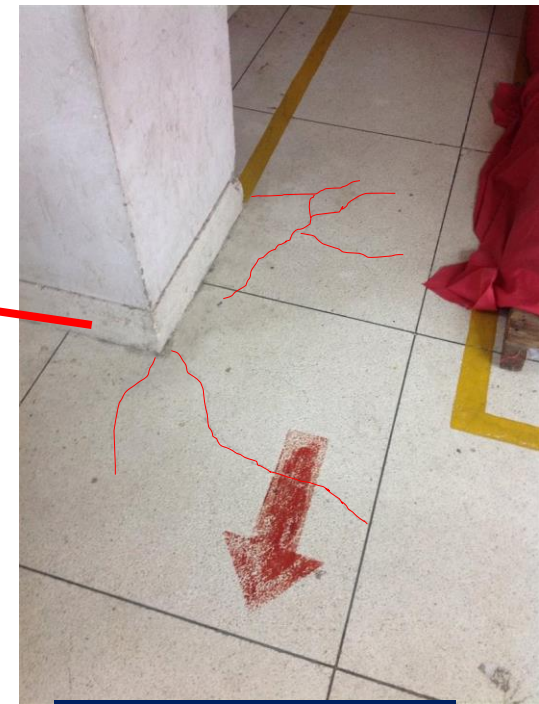
Ground Floor Slab

There was a toilet nearby with heavy buildup – engineer to confirm that this has been allowed for in design.

| Item No. | Observation | Recommended Action Plan | Recommended Timeline |
|---|---|---|---|
| 13 | Cracking in slab finishes | If necessary remove heavy plant in substation room on ground floor and toilet build-up on all floors deemed overloaded. | 6-weeks |

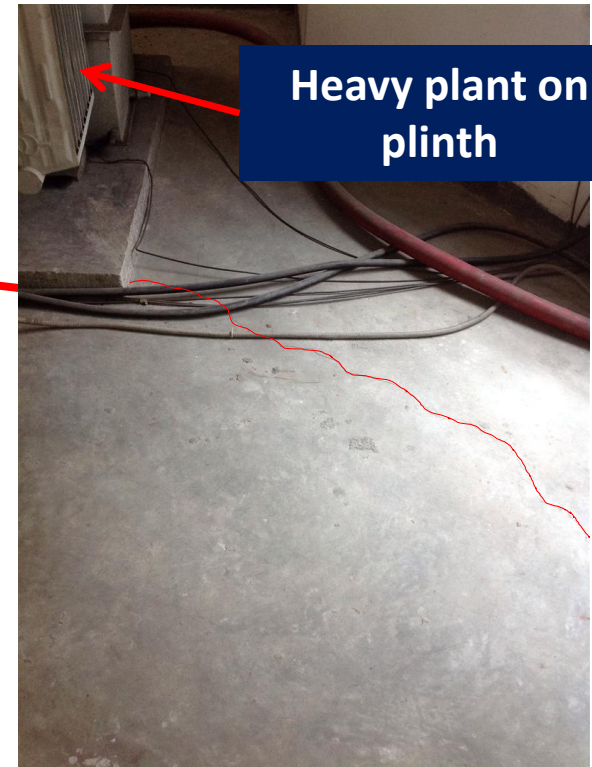
**Ground Floor Slab**

**Cracks to be reviewed by removing floor finishes to investigate if they extend into structure.**

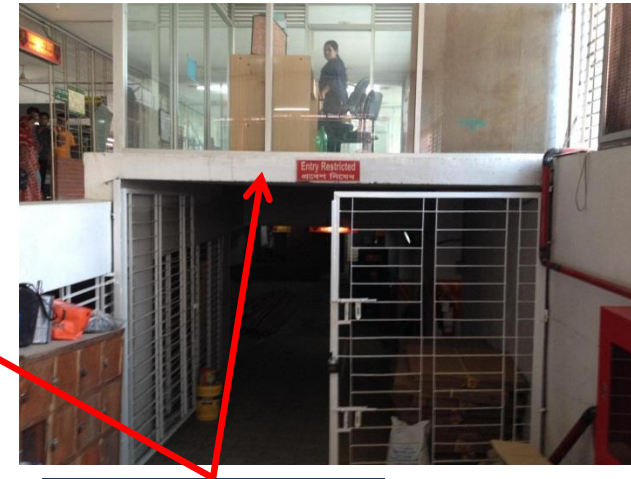
**Mezzanine**

**Load path for mezzanine structure over ramp is not logical and signs of distress in ground floor slab are evident.**

| Item No. | Observation | Recommended Action Plan | Recommended Timeline |
|---|---|---|---|
| 18 | Defects to ramp structure | Building engineer to review design of ramp structure, mezzanine floor and adjoining ground floor structure and design strengthening as required to support the codified design loading. | 6-weeks |
| 19 | Defects to ramp structure | Implement strengthening specified by the building engineer. | 6-months |

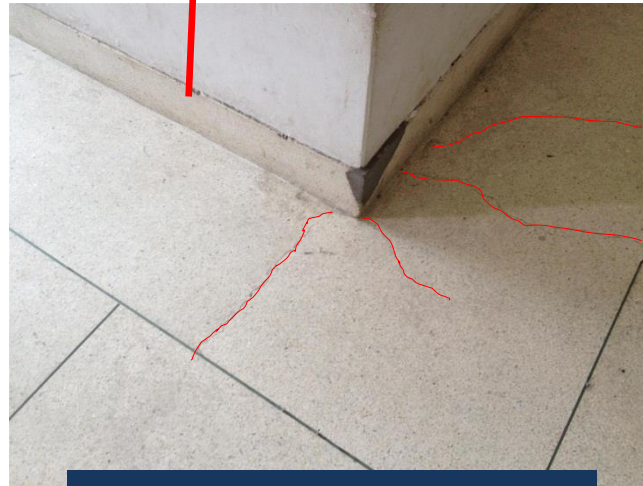
**Cracking to ground floor slab.**

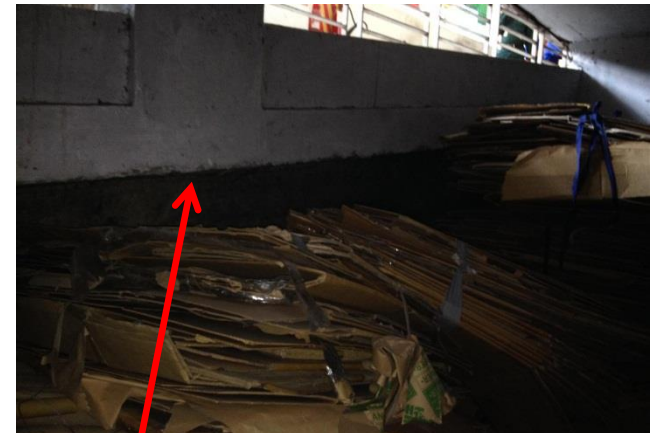
**Column built off edge of ramp slab (support?)**

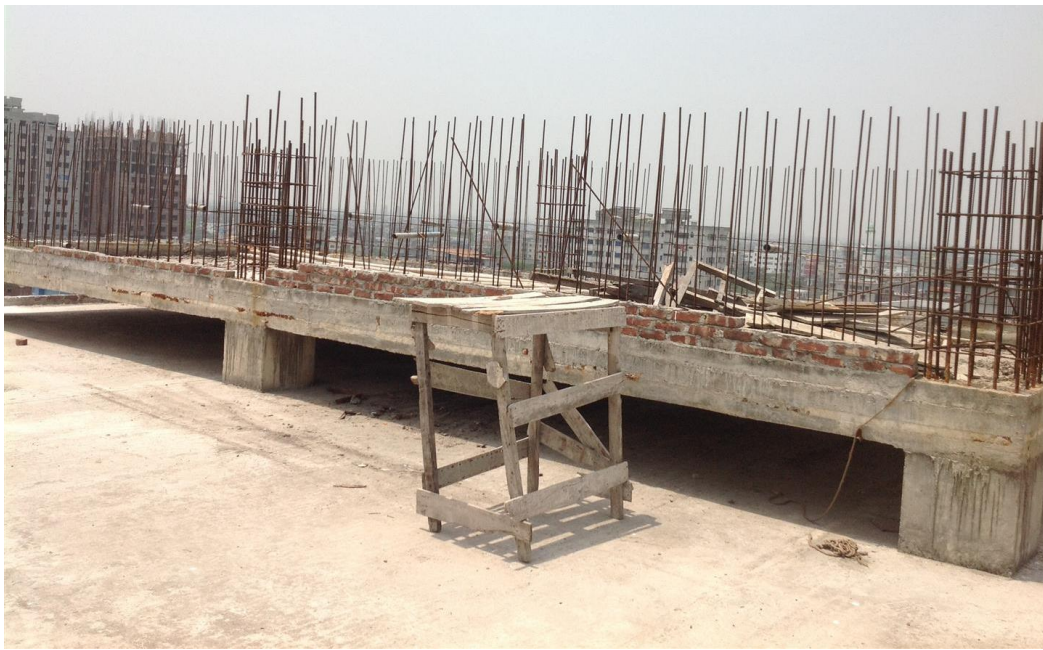
**Tank currently under construction on roof is bigger than shown on structural drawings.**

| Item No. | Observation | Recommended Action Plan | Recommended Timeline |
|---|---|---|---|
| 20 | Tank at roof level | We understand that the construction of the water tank has ceased and this should continue to be the case. | 6-weeks |
| 21 | Tank at roof level | Engineer to review adequacy of supporting elements to carry water tank, including slab and beams at roof level, and supporting columns down to basement level. | 6-weeks |
| 22 | Tank at roof level | Redesign tank to ensure slab and column capacity not exceeded. | 6-weeks |

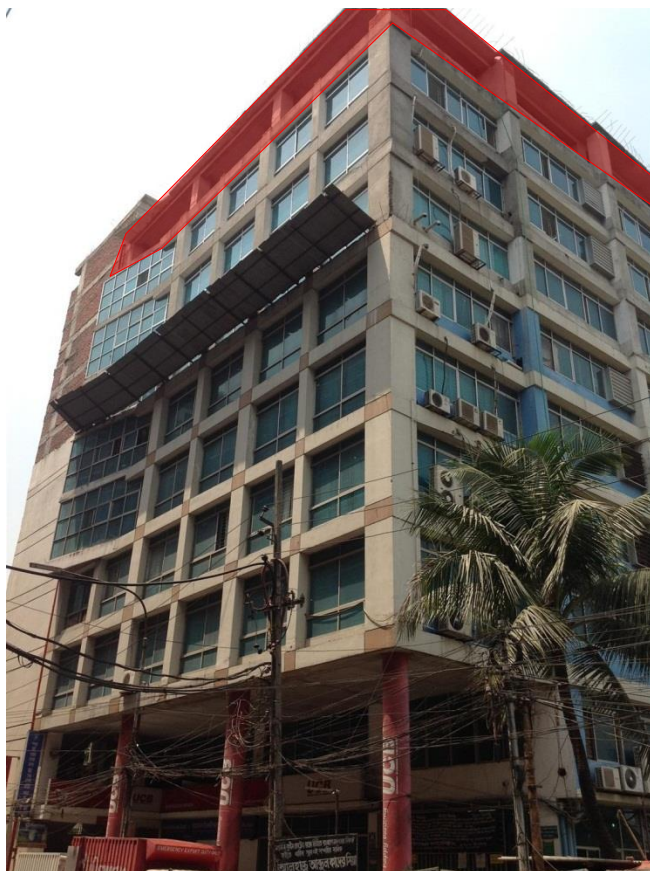
**East Elevation**

**Uppermost floor not documented within the structural drawings provided.**

**No structural information suitable for construction was provided for any structure above the 9<sup>th</sup> floor. This includes the 10<sup>th</sup> floor slab, the columns above the 9<sup>th</sup> floor, the overhead water tank, the stair core over runs and the lift core over runs.**

**The permit drawings also did not account for the uppermost floor.**

| Item No. | Observation | Recommended Action Plan | Recommended Timeline |
|---|---|---|---|
| 23 | Additional floor | Engineer to provide detailed calculations to prove adequacy of members supporting the undocumented structures throughout the building. | 6-weeks |
| 24 | Additional floor | If necessary supporting structures should be retrofitted in order to increase capacity or load should be reduced by removing structure. | 6-weeks |
| 25 | Additional floor | Drawings to be updated to reflect as-constructed building. | 6-months |

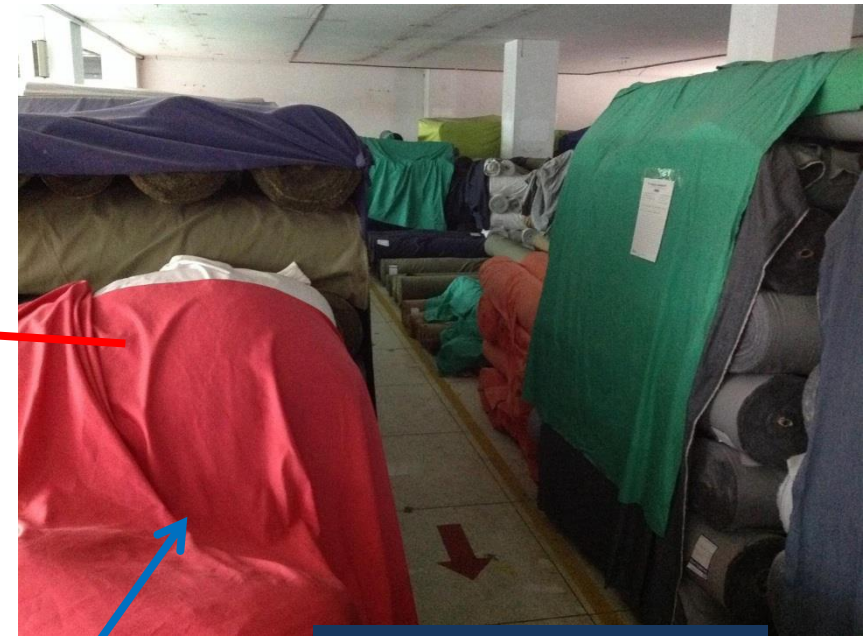
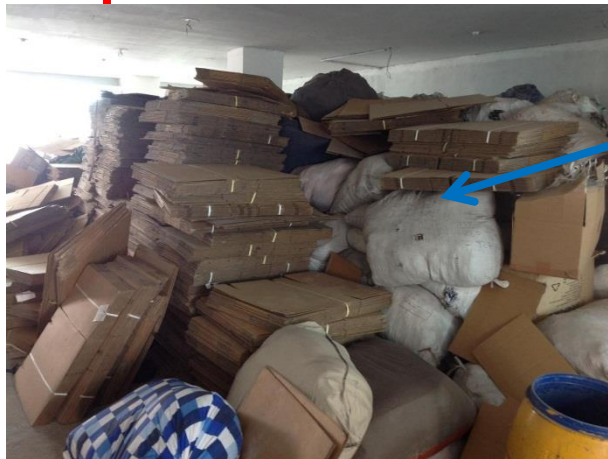
**Uncontrolled stacking of materials.**

**Areas of high loading on suspended structure. Floor load management system incomplete as no loading plans or loading height limits displayed.**

| Item No. | Observation | Recommended Action Plan | Recommended Timeline |
|---|---|---|---|
| 26 | Localised areas of high loading | Engineer to produce loading plans to be displayed at each floor level. Consideration to be given to all applied loads (imposed loads and super imposed dead loads), floor capacity and column capacity. | 6-weeks |
| 27 | Localised areas of high loading | Factory manager to actively manage floor usage in accordance with the loading plans. | 6-weeks |

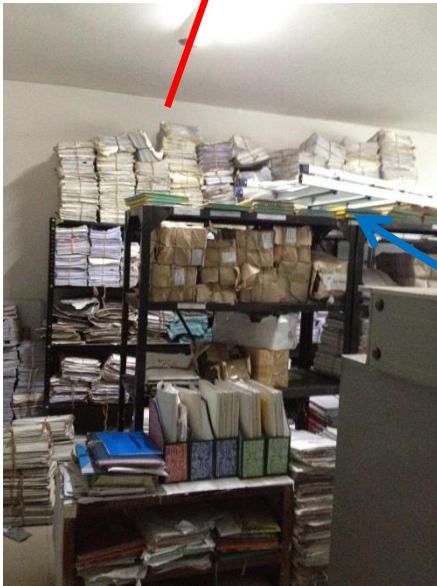
Uncontrolled stacking  
of materials in bank  
leading to cracking of  
infill brickwork wall.

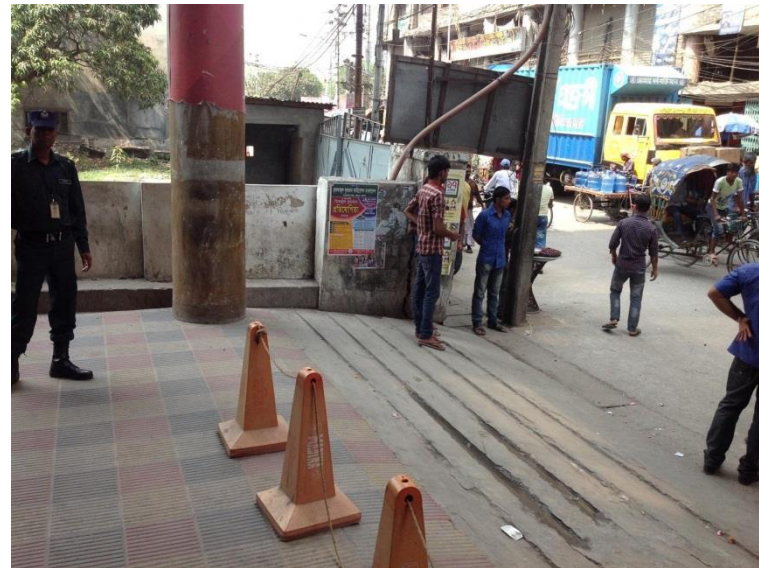
**Columns at front entrance are susceptible to impact loading from vehicles.**

| Item No. | Observation | Recommended Action Plan | Recommended Timeline |
|---|---|---|---|
| 28 | Columns susceptible to impact loading | Place temporary warning /protection (e.g. traffic cone, sand filled barrels as deemed appropriate by building engineer) at 1m from column faces. | Immediate - Now |
| 29 | Columns susceptible to impact loading | Building engineer to design appropriate impact protection for critical column within loading dock. | 6-weeks |
| 30 | Columns susceptible to impact loading | Construct and maintain protection to critical column and continue to assess likelihood of vehicle impact to critical elements. | 6-months |
