# East Coast Knitwear Pvt. Ltd.

Takkarmath, Sehachar, Fatullah, Narayanganj-1420, Bangladesh.

1st November, 2016

# Observations

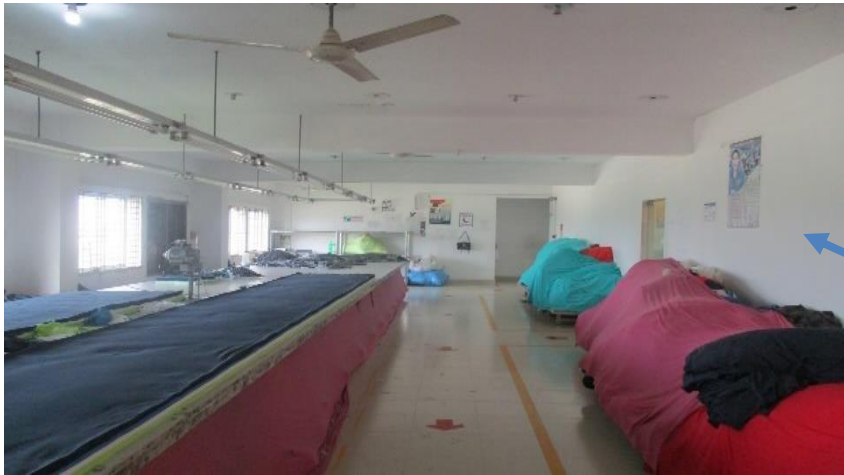
**125 mm masonry wall not shown in the drawings (1<sup>st</sup> floor)**

| Item No. | Observation | Recommended Action Plan | Recommended Timeline |
|---|---|---|---|
| 1 | Discrepancies with As-built drawings | Undertake a detailed as-built survey of the building and produce comprehensive as-built drawings. | 6-weeks |

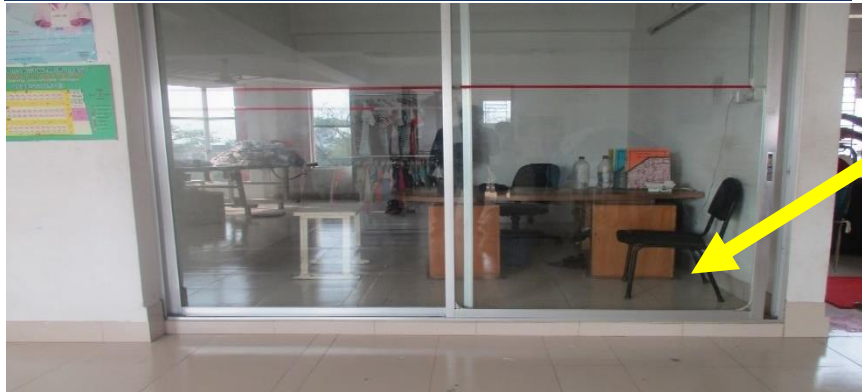
**slab casted instead of lift (all floors)**

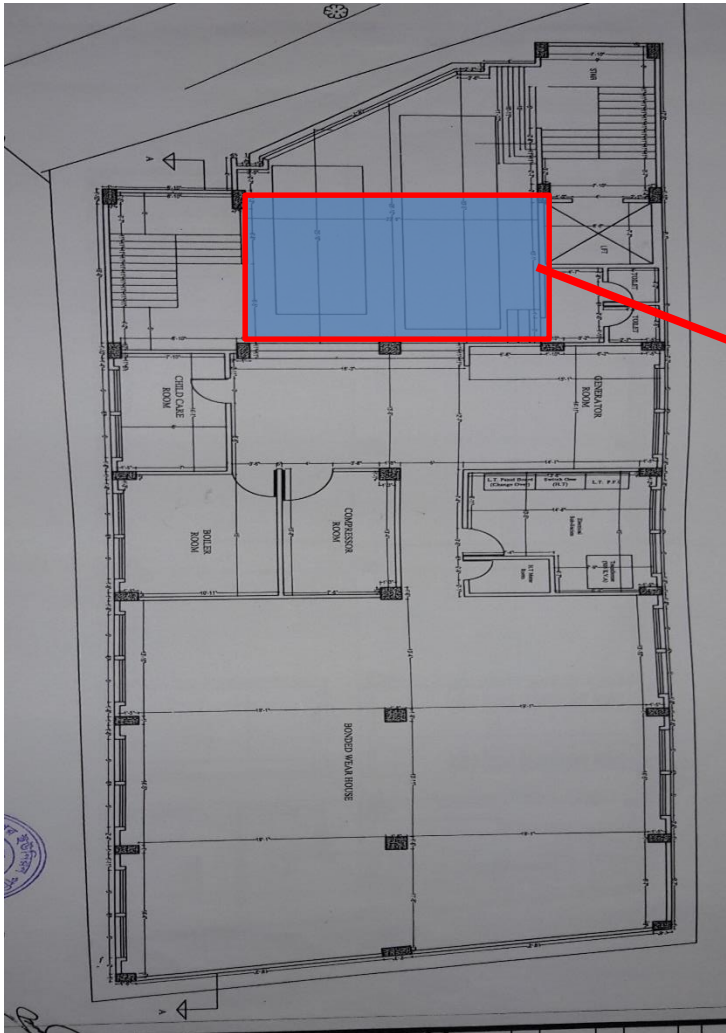
Location of UGWT

# **Underground Water Tank slab located under loading-unloading area**

| Item No. | Observation | Recommended Action Plan | Recommended Timeline |
|---|---|---|---|
| 2 | Underground Water Tank slab located under loading-unloading area | Building engineer to review that slab over UGWT is designed to carry the imposed impact load . | 6-weeks |
| 3 | Underground Water Tank slab located under loading-unloading area | Implement any actions arising from review. | 6-months |

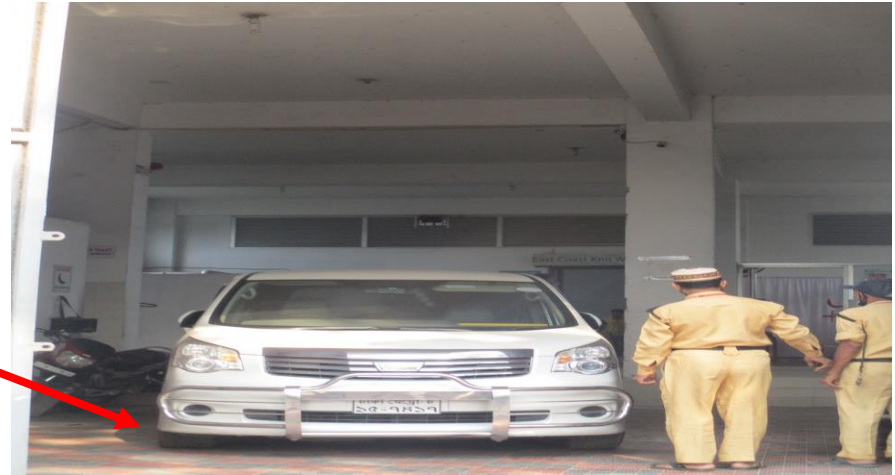
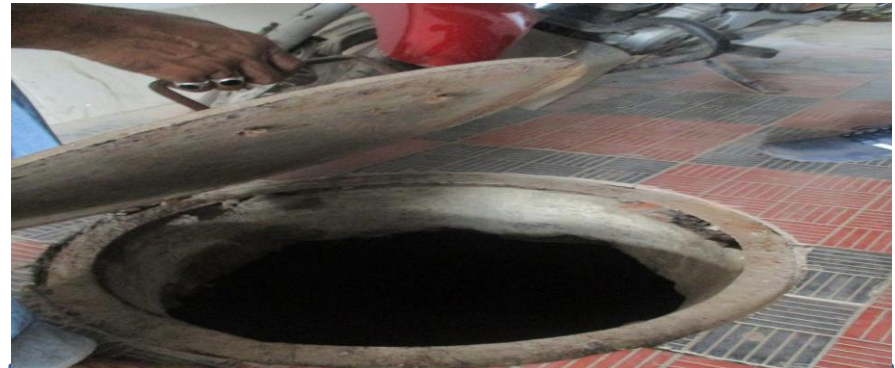
This place is being used as loading  
unloading area and parking place, which is  
likely to undergo huge impact load.  
Building engineer to verify slab capacity

**Underground Water Tank slab located under loading-unloading area**

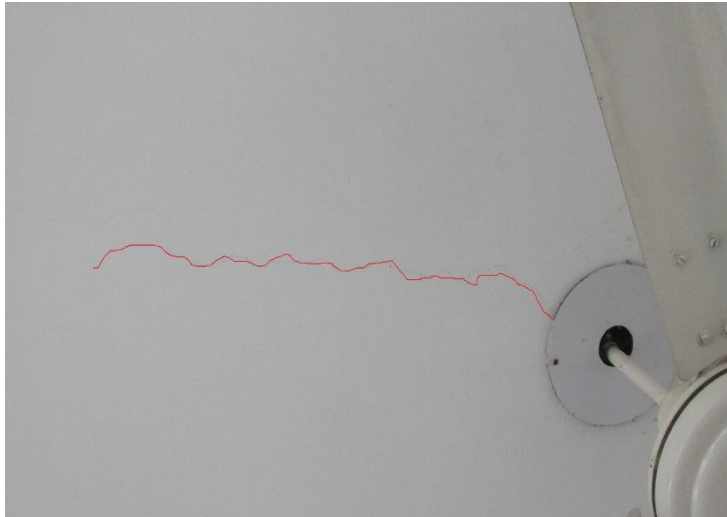
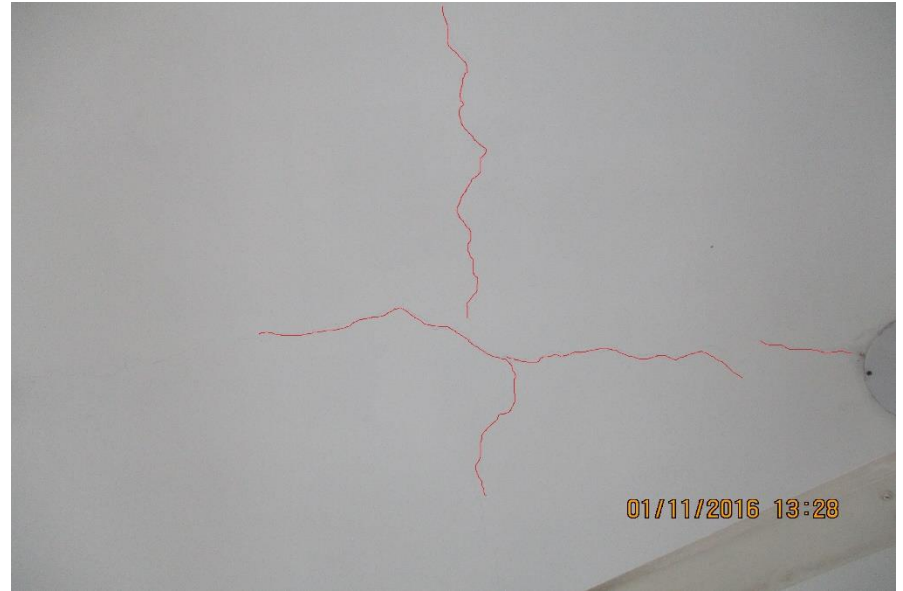
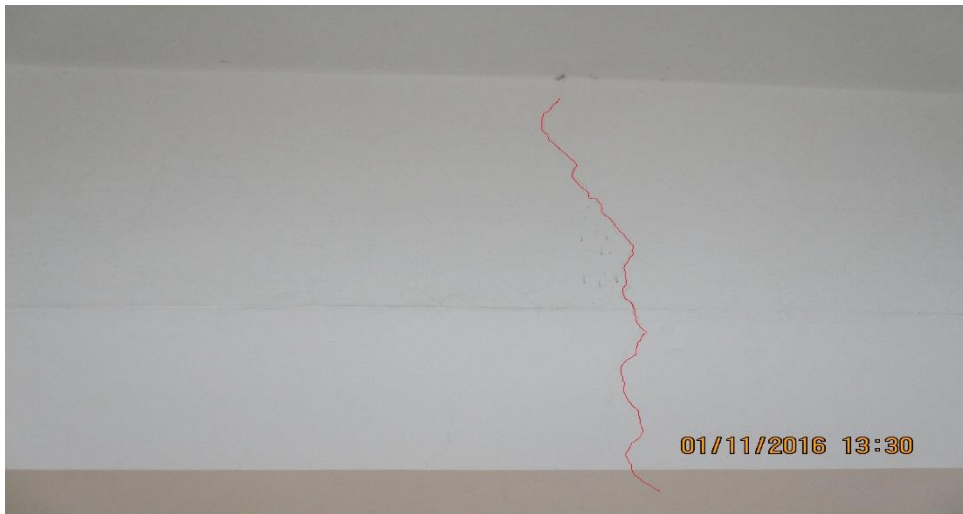
**Cracks observed on beam and  
slab soffits at 4<sup>th</sup> and 5<sup>th</sup> floor**

**Hairline cracks on beam and slab soffit**

| Item No. | Observation | Recommended Action Plan | Recommended Timeline |
|---|---|---|---|
| 4 | Hairline cracks on beam and slab soffit | Building Engineer to oversee removal of a section of plaster to soffit to access if crack is apparent in structural elements. | 6-weeks |
| 5 | Hairline cracks on beam and slab soffit | Carry out structural repairs as necessary to slab structure | 6-weeks |
| 6 | Hairline cracks on beam and slab soffit | Structural elements to be monitored for cracking on an ongoing basis. | 6-months |
