# Vintage Denim Apparel Ltd

Boherarchala, Sreepur, Gazipur-1740  
(24.191601N, 90.403731E)

4th January, 2017

# Observation

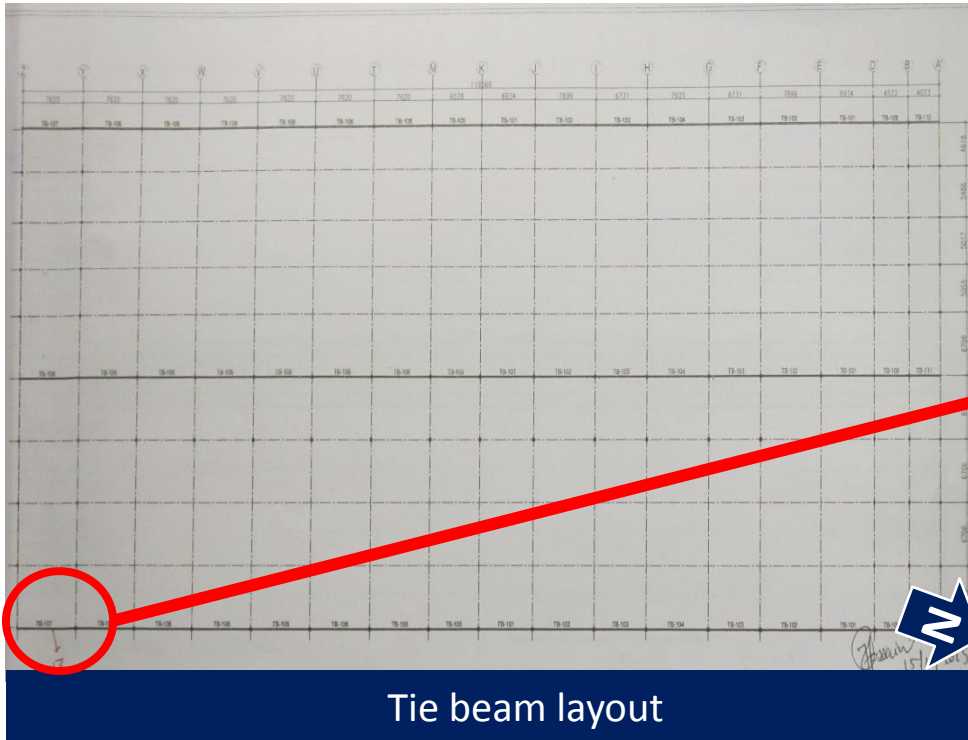
Tie beam layout

# Tie Beam Cut-off at shed-01

| Item No. | Observation | Recommended Action Plan | Recommended Timeline |
|---|---|---|---|
| 1 | Tie Beam Cut-off at shed-01 | Install discontinued tie beam as per drawing | 6-weeks |

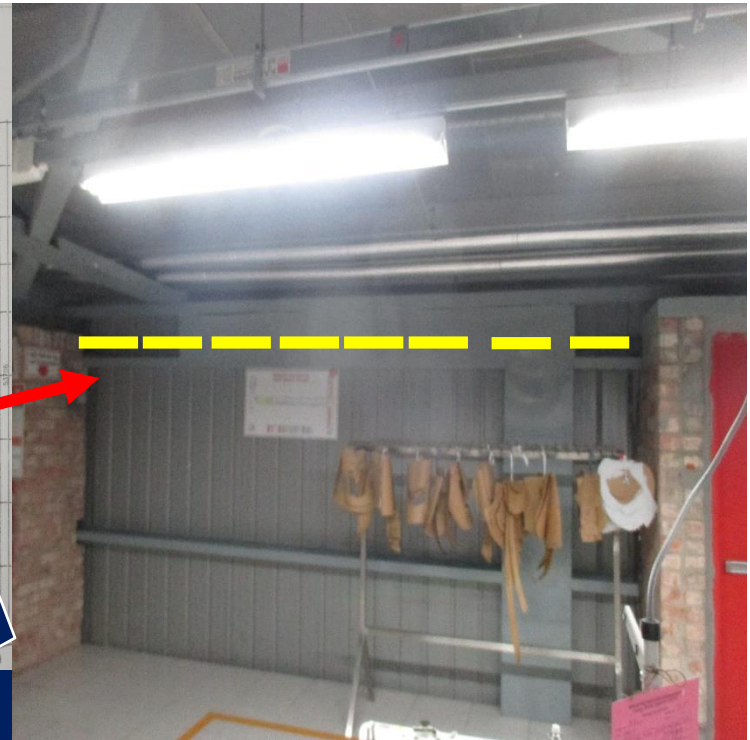
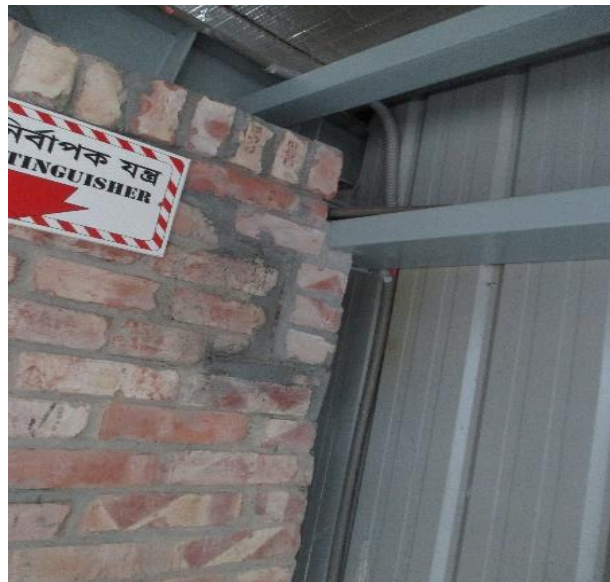
Tie beam discontinued at the highlighted area of Shed-01. Building engineer is required to take remedial measures.

| Item No. | Observation | Recommended Action Plan | Recommended Timeline |
|---|---|---|---|
| 2 | Tie Beam Cut-off at shed-01 | Carryout regular remedial works where necessary. | 6-months |

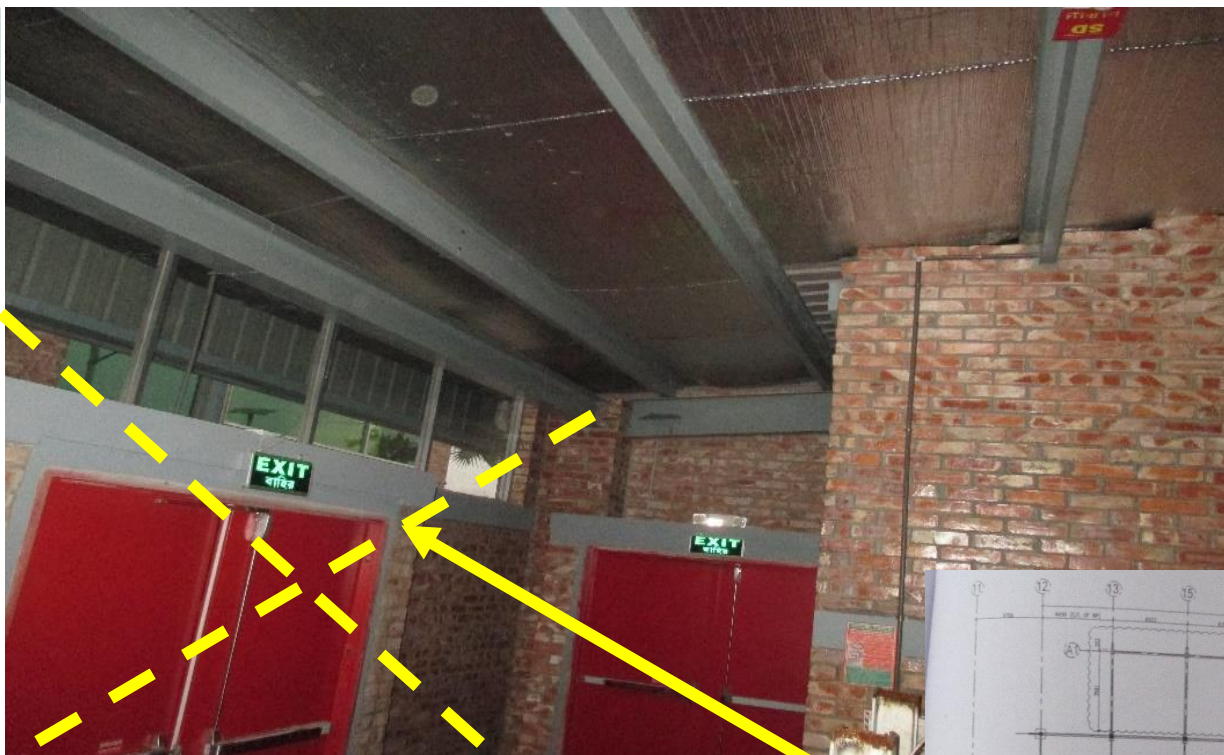
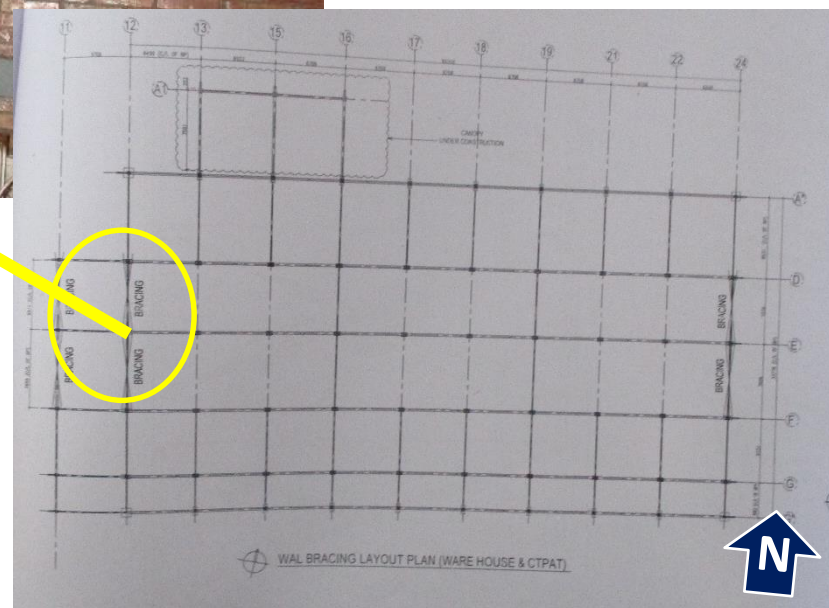
## Bracing missing at shed-03

Wall bracing missing at shed-03. Building engineer is required to carry out installation work of bracing where necessary.

| Item No. | Observation | Recommended Action Plan | Recommended Timeline |
|---|---|---|---|
| 3 | Bracing missing at shed-03 | Install discontinued bracing as per drawing | 6-weeks |
| 4 | Bracing missing at shed-03 | Carryout regular remedial works where necessary | 6-months |

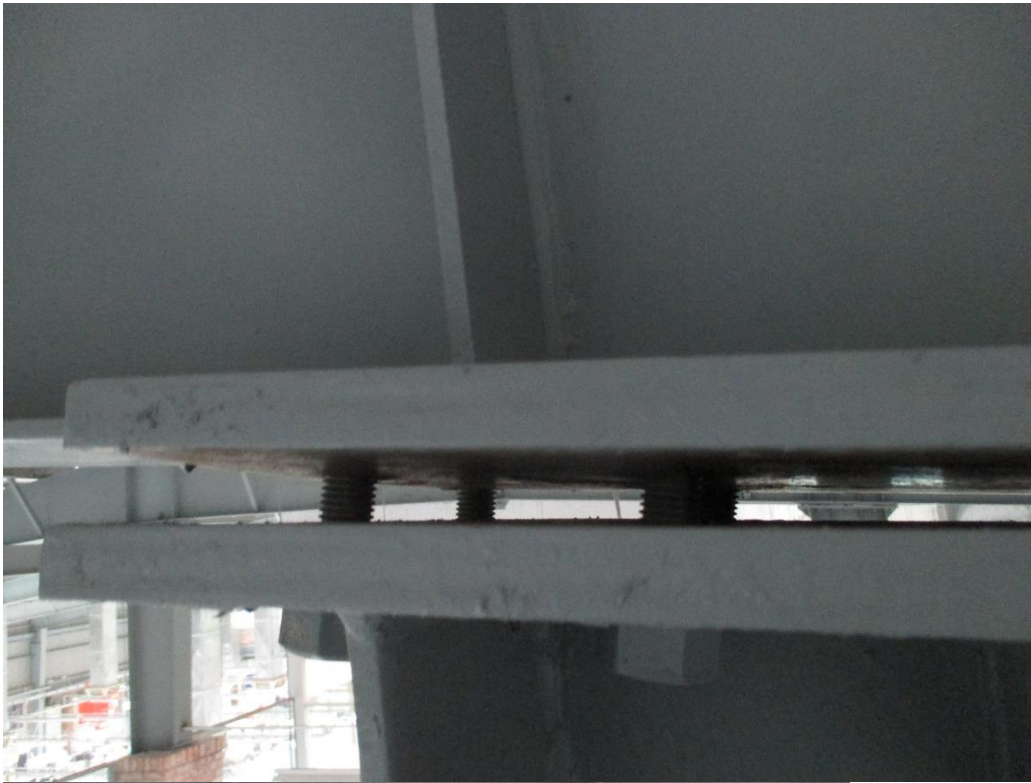
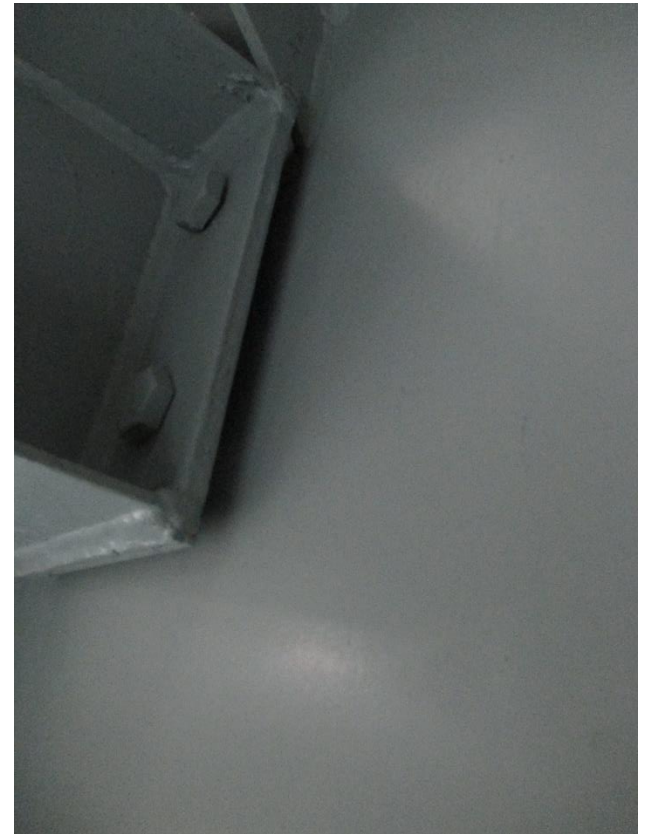
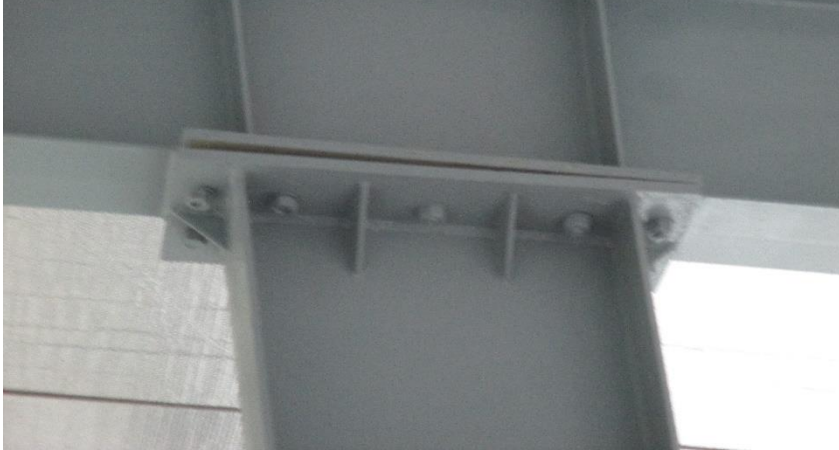
# Existence of significant gap at connection

Significant gaps were observed in column-rafter joint and column tie-beam joint at several location. Building engineer is required to carry out suitable remedial works.

| Item No. | Observation | Recommended Action Plan | Recommended Timeline |
|---|---|---|---|
| 5 | Existence of significant gap at connection | Carryout suitable repair works where necessary | 6-weeks |

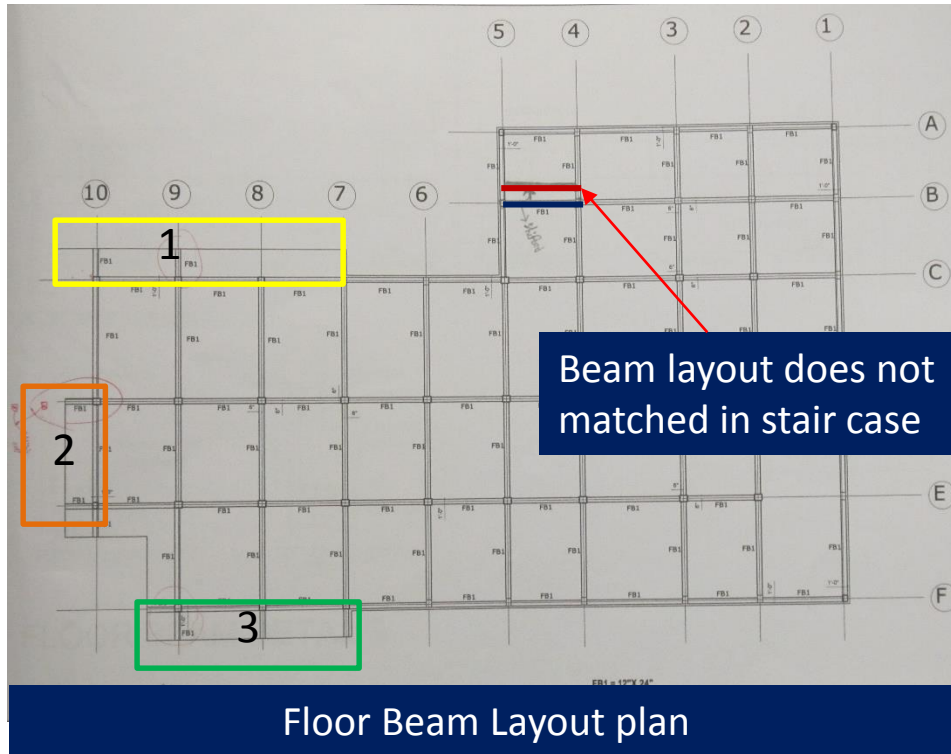
Floor Beam Layout plan

## **Inconsistency between drawings and on site observation(Building-3-Toilet, Dinning & Prayer Building).**

Inconsistency observed between drawings and on site condition. Building engineer is required to check the onsite condition and update as built drawings.

| Item No. | Observation | Recommended Action Plan | Recommended Timeline |
|---|---|---|---|
| 6 | Inconsistency between drawings and on site observation(Building-3-Toilet, Dinning & Prayer Building) | Engage a Building Engineer to survey the structure and update a full set of “as-constructed” drawings for dining building. | 6-weeks |

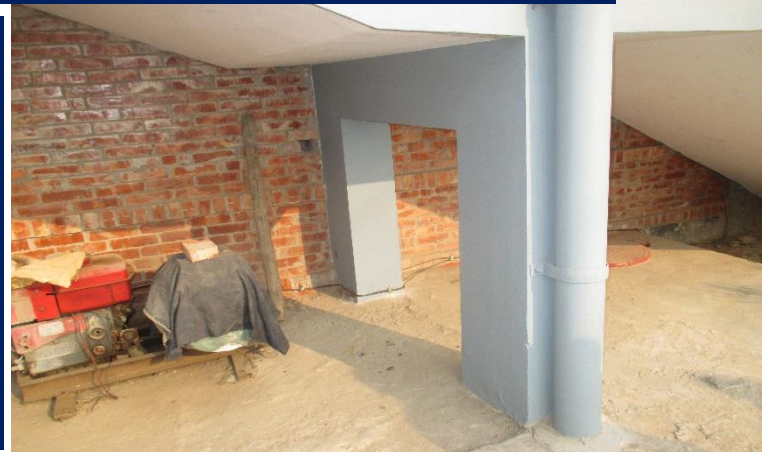
2. Additional columns were constructed which were not indicated on drawings.

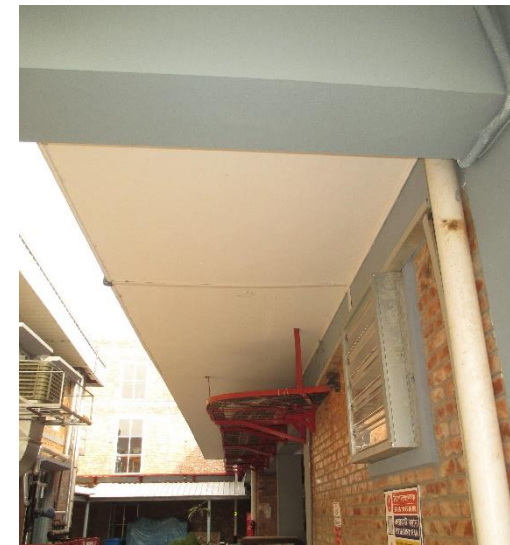
1. Missing Cantilever beams

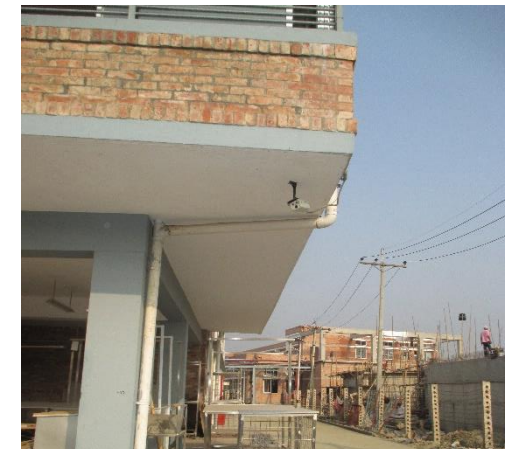
3. Missing Cantilever beams
