Knit Radix Ltd.

Shasongaon, Enayetnagar, Fatulla
(23.625139, 90.470706)

09th January 2017

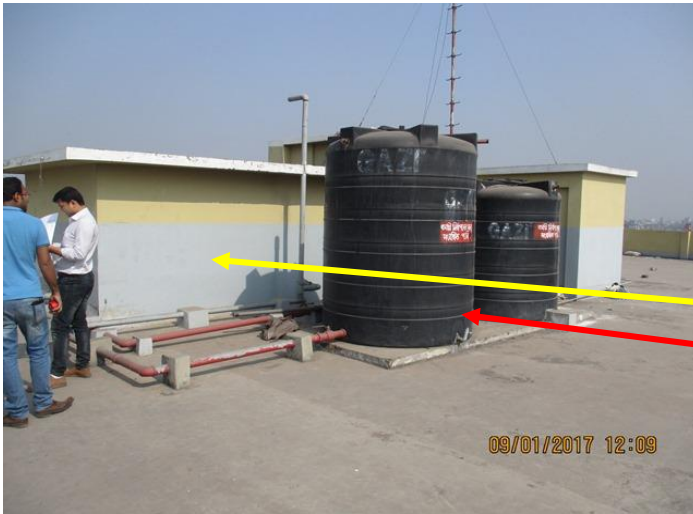
Column to be stressed above normal design limits

R.C.C & 2 nos. of Plastic water tank

Item No.	Observation	Recommended Action Plan	Recommended Timeline
1	Column to be stressed above normal design limits	Factory Engineer to review design, loads and columns stresses.	6-weeks
2	Column to be stressed above normal design limits	Verify in-situ concrete stresses by 100mm dia. cores from min. 4 no. column from ground floor level.	6-weeks
3	Column to be stressed above normal design limits	Produce and actively manage a loading plan for all floor plates within the factory giving consideration to floor capacity and column capacity.	6-weeks
4	Column to be stressed above normal design limits	Make any structural alterations as advised by Building Engineer.	6-months
5	Column to be stressed above normal design limits	Continue to implement loading plan.	6-months
6	Discrepancies between provided drawings and on site condition	Building Engineer to survey as-built structure and prepare accurate as-built survey information for steel part.	6-weeks

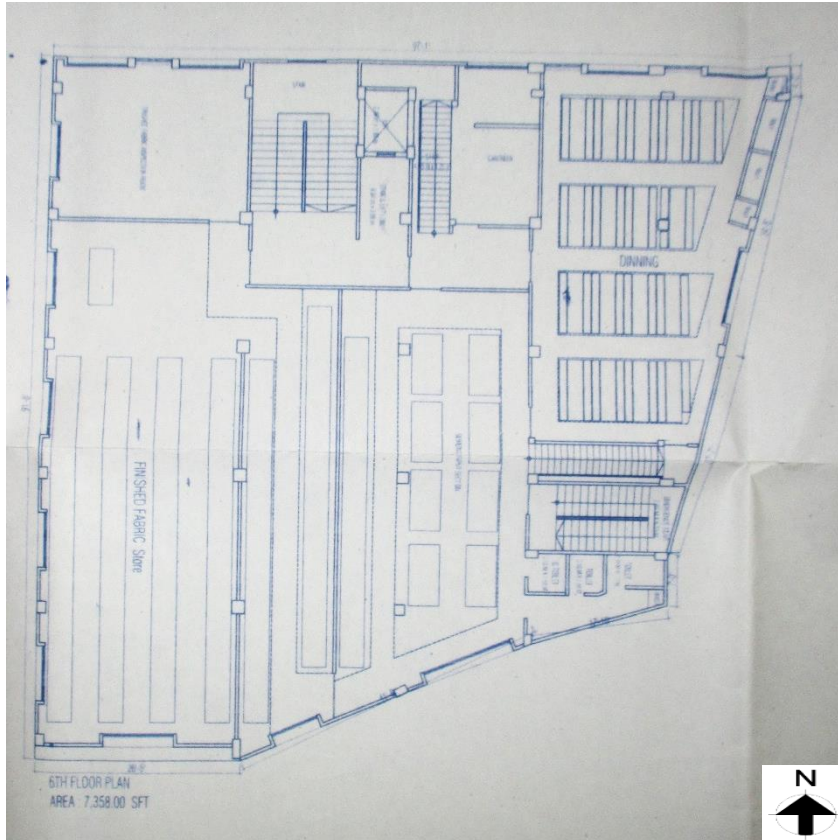
Layout plan

Discrepancies between provided drawings and on site condition

Steel beam size and thickness did not match with provided drawings as shown by red marking.

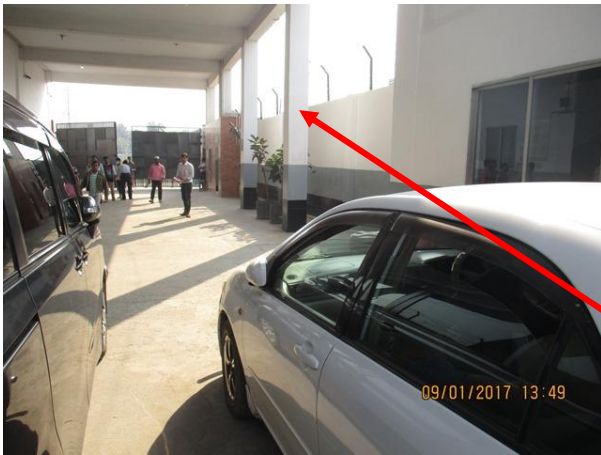
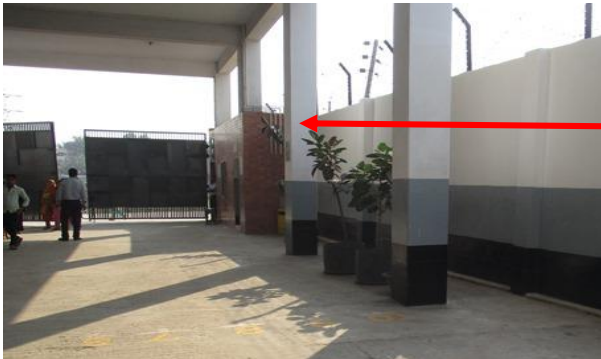
Columns susceptible to vehicle impact

Impact protection not provided to columns at loading –unloading area. Columns are susceptible to impact loading from vehicles.

7	Columns susceptible to vehicle impact	Install a barrier to prevent vehicle impact in column.	6-weeks
