# Renaissance Apparels (new building)

C-S Plot # 659 & 660, Mouza 93, Gazipur, Bangladesh  
(23.985252, 90.353014)  
30<sup>th</sup> November, 2016

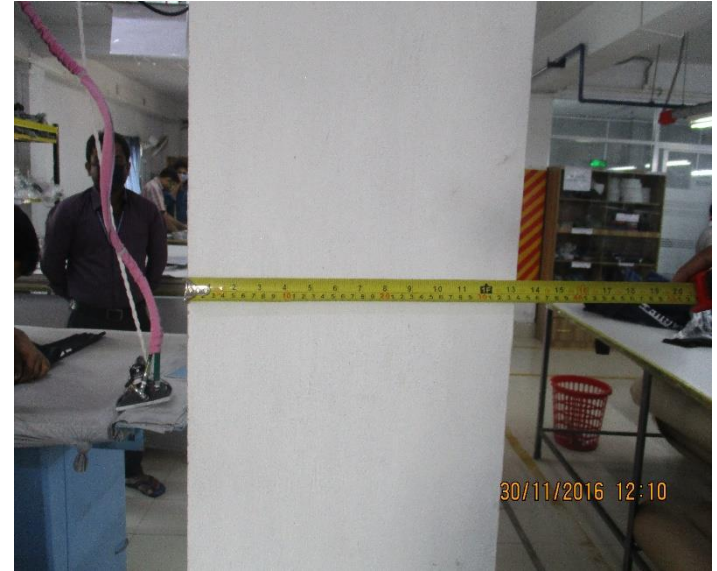
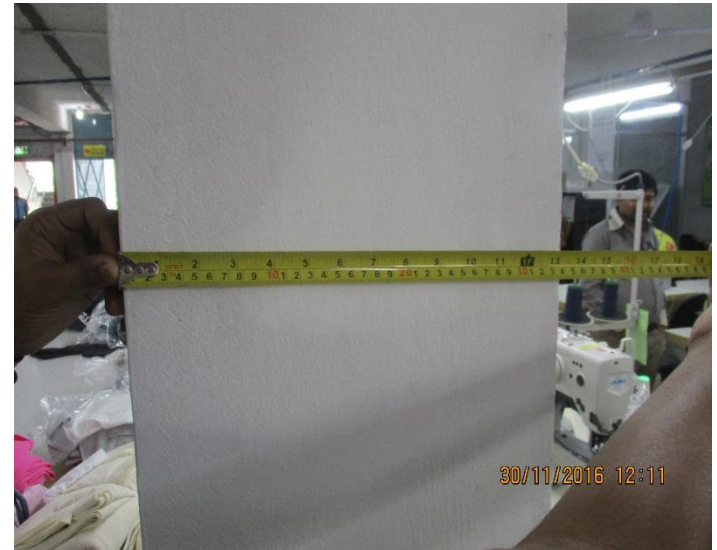
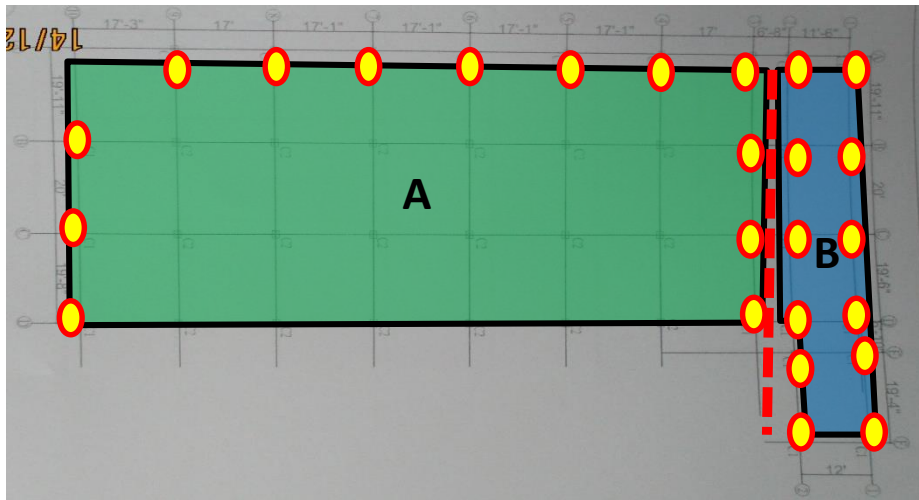
C1

Dimensions of Column C-1 is mentioned 10"X15" in drawings, but we found it to be "12X15" in Part-A and 12"X12" in Part-B

Column size discrepancy

Item No.	Observation	Recommended Action Plan	Recommended Timeline
1	Discrepancies on the as-built drawings	Building Engineer to produce a set of As Built Structural drawings as per As-built condition.	6-weeks
2	Exposed Rebar on roof	Remove the corroded portion and provide proper rust proof material	Immediate - Now
3	Exposed Rebar on roof	If further construction is intended, factory engineer to verify if the rebar's are in good condition and replace them if necessary.	6-weeks
4	Provision for future vertical Extension	If future vertical extension is intended, conduct DEA for the factory building following BNBC.	6-weeks
5	Provision for future vertical Extension	Implement any necessary remedial measures which will be the outcome of DEA.	6-months

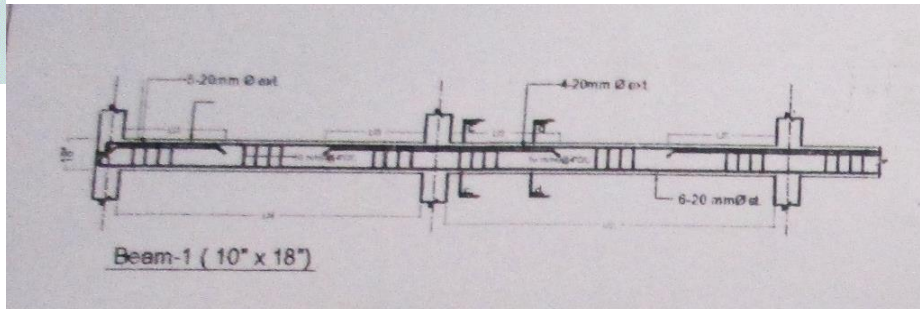
Dimensions of Beam-1 is mentioned 10"X18" in drawings, but we found it to be 12"X"20

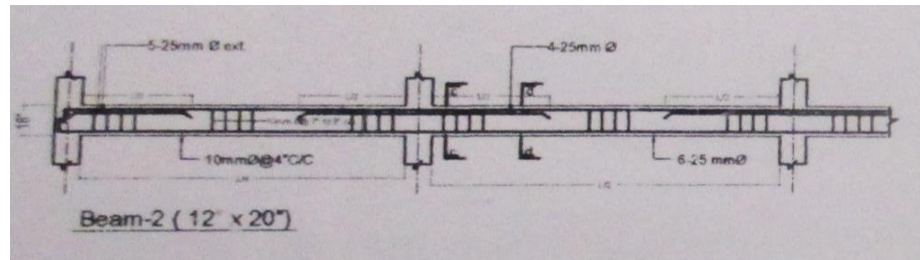
Dimensions of Beam-2 is mentioned 12"X20" in drawings, but we found it to be 10"X15"

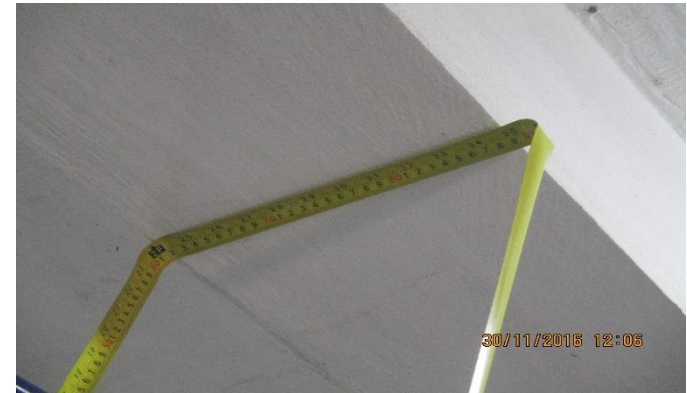
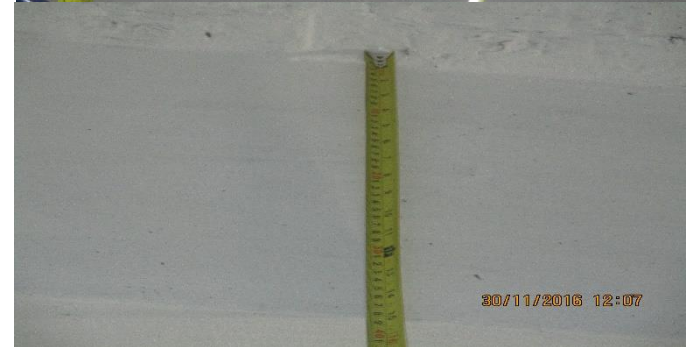
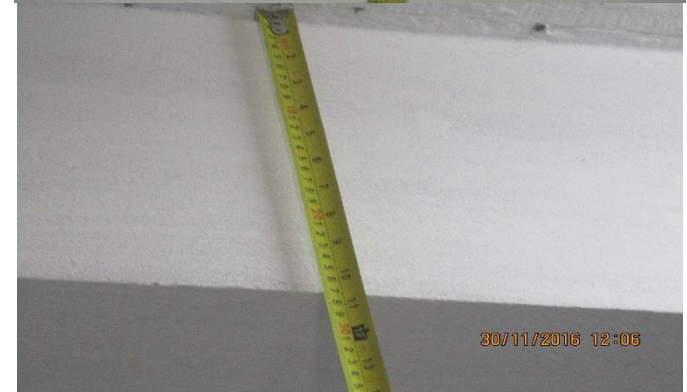
Beam size discrepancy

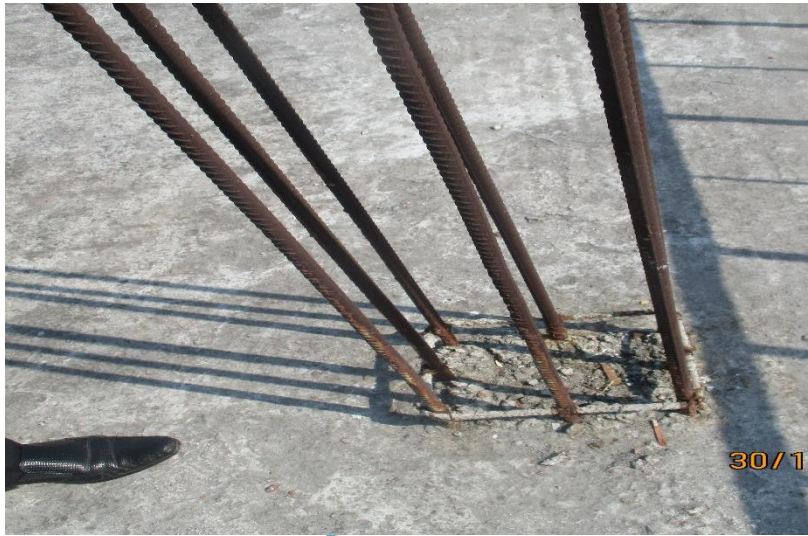
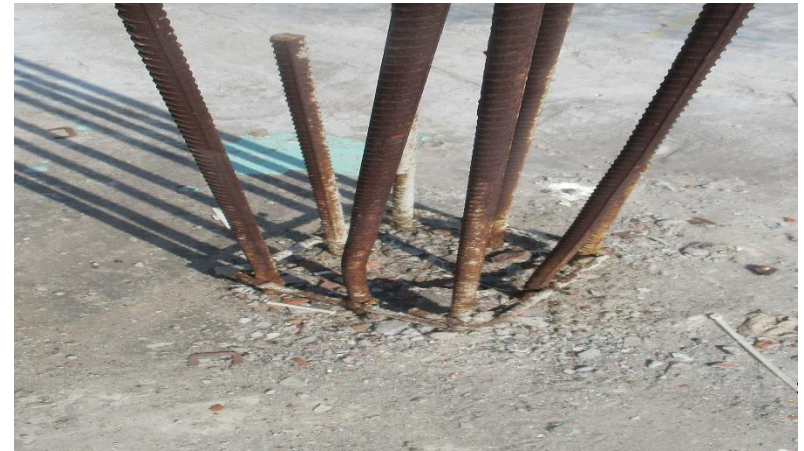
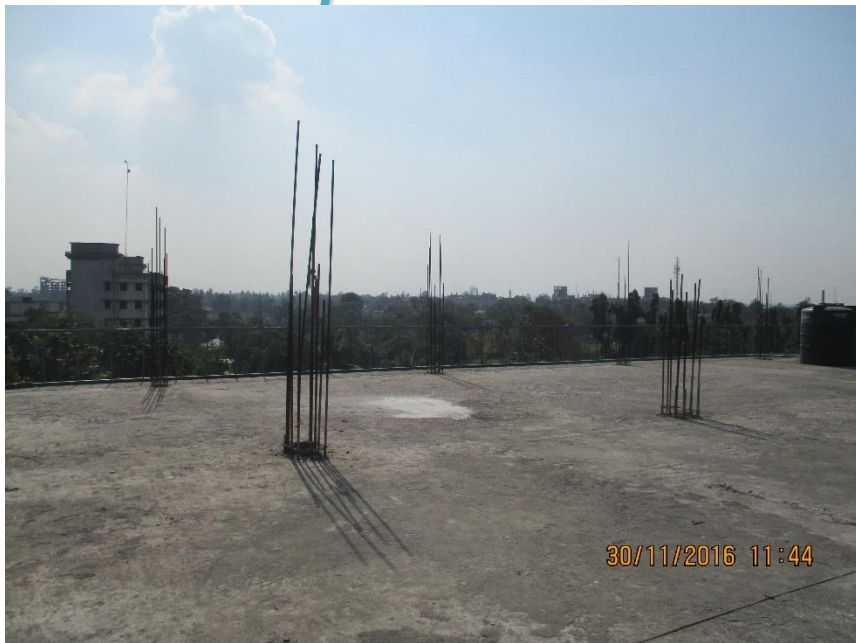
## Exposed Rebar on roof

Exposed rebar's were observed at roof. Factory management informed us they will extend vertically in future, that's why they were kept in this condition. Rebar's were found in corroded condition.

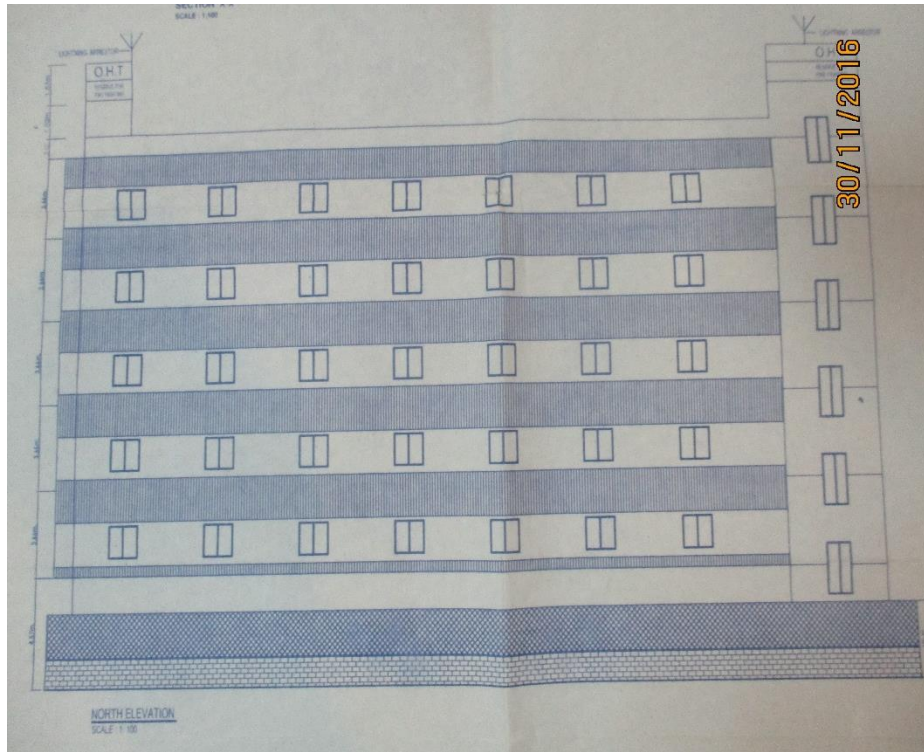
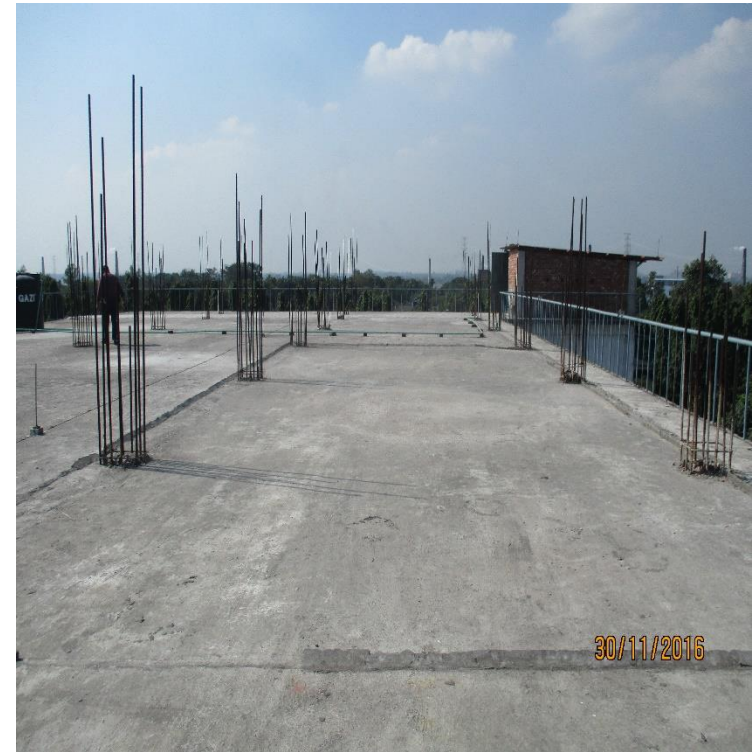
## Provision for future vertical Extension

The building was permitted as 5-Storeyed building from local authority. During inspection, factory management also confirmed that they are going to extend vertically.
