# Lumbini Ltd

Meghla, Bandarban, Chittagong  
(+22.178294N, 92.190958E)

24<sup>th</sup> June 2014

# Observations

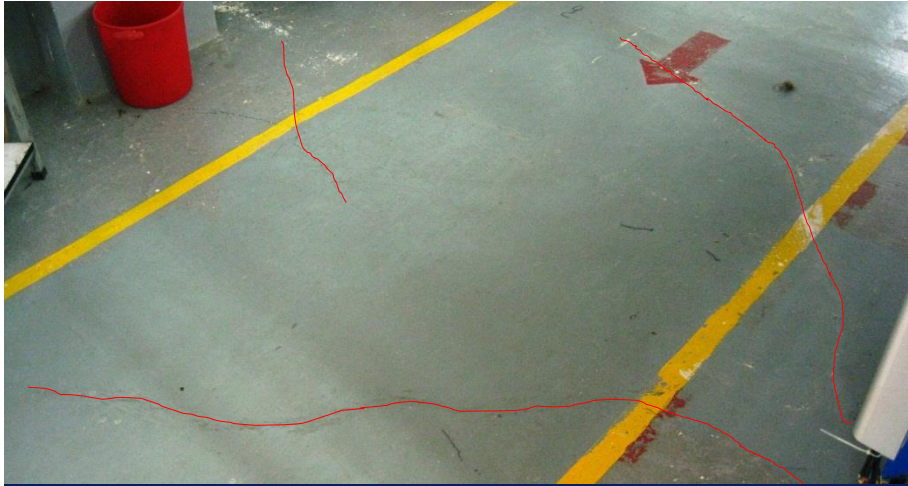
Extensive cracking of the floor slab was observed at all suspended floor levels. The cracking is in the structure, as the finishes are negligible. Repair works to cracks were also observed.

Cracking to top of slab

| Item No. | Observation | Recommended Action Plan | Recommended Timeline |
|---|---|---|---|
| 1 | Extensive cracking to the top and soffit of suspended floor slabs of the main building | Reduce loading on all floor plates to 2kPa pending review by Building Engineer. | Immediate - Now |
| 2 | Extensive cracking to the top and soffit of suspended floor slabs of the main building | Building Engineer to review extent of cracking to suspended floor slabs, and to prepare a schedule of actions, as required. | Immediate - Now |

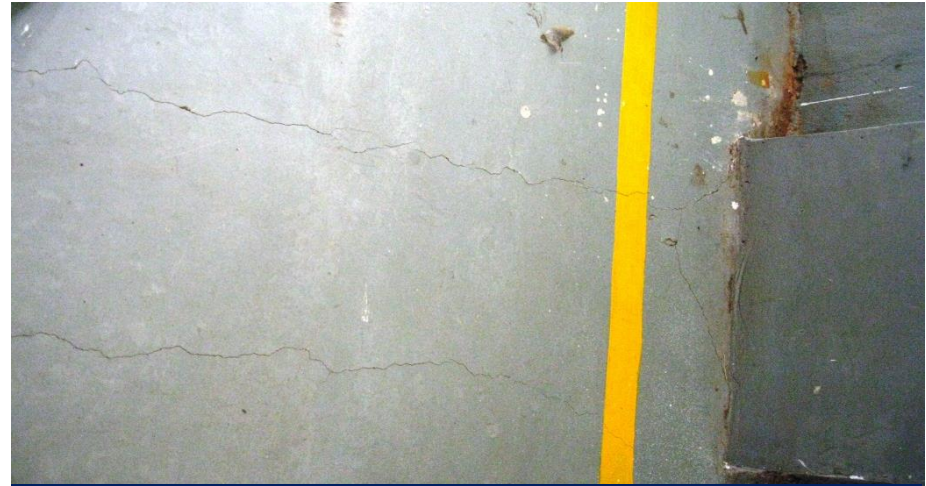
Cracking to top of slab

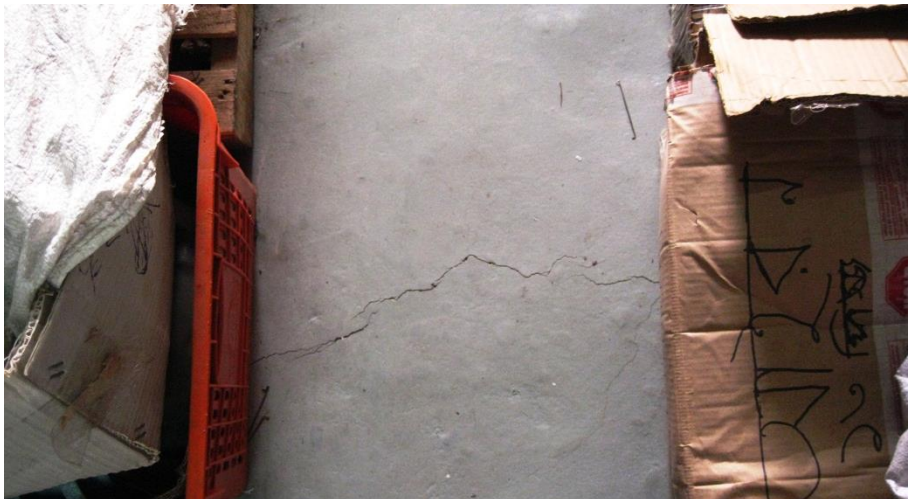
Cracking to top of slab

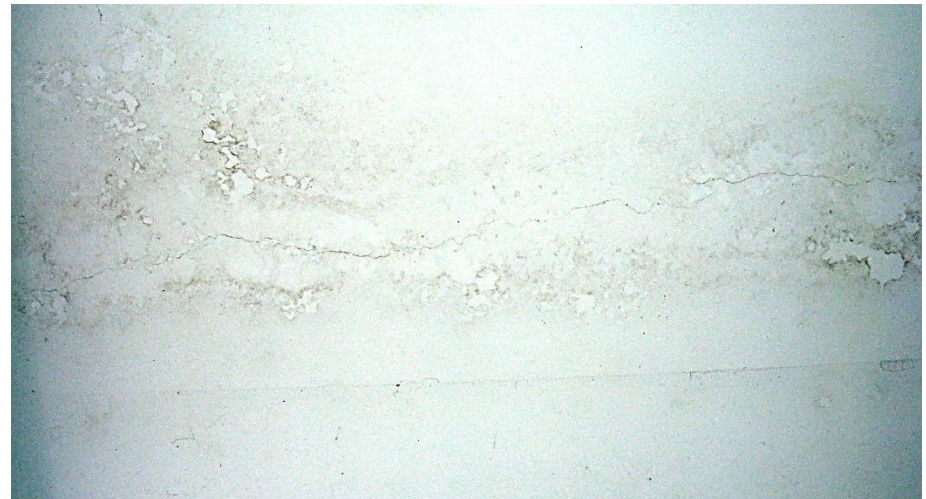
Cracking to soffit of the slab

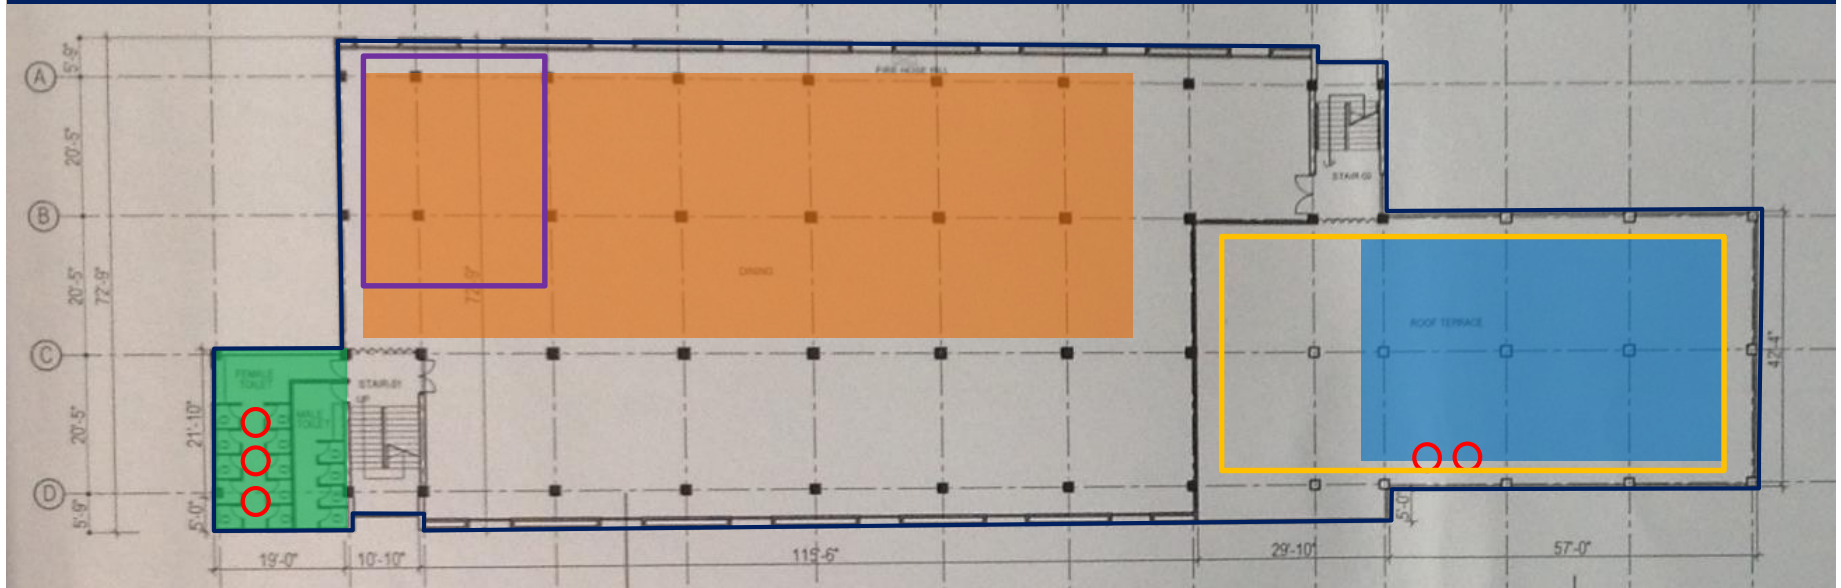
Typical Floor Plan

While floor loading limits were displayed, these did not appear to be implemented.

| Item No. | Observation | Recommended Action Plan | Recommended Timeline |
|---|---|---|---|
| 8 | Heavy floor loading and lack of a loading plan in the main building | Produce and actively manage a loading plan for all floor plates within the factory giving consideration to floor capacity and column capacity. | 6-weeks |

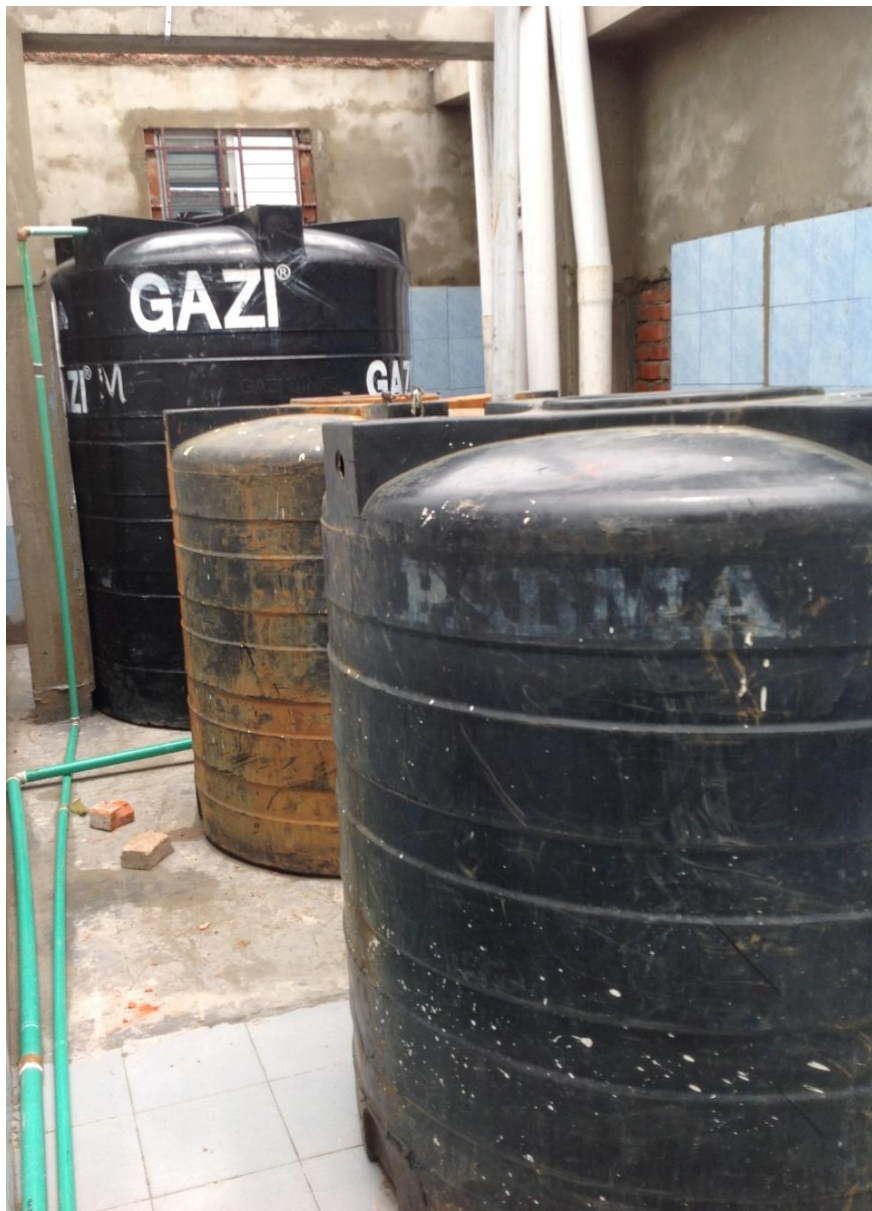
2,000 to 5,000 litre water tanks at 4th floor level

| Item No. | Observation | Recommended Action Plan | Recommended Timeline |
|---|---|---|---|
| 7 | Heavy floor loading and lack of a loading plan in the main building | As part of the Detail Engineering Assessment, Building Engineer to carry out a design check for loads due to water tanks, toilet areas, machines and storage areas (including temporary), and to advise on any necessary remedial works | 6-weeks |

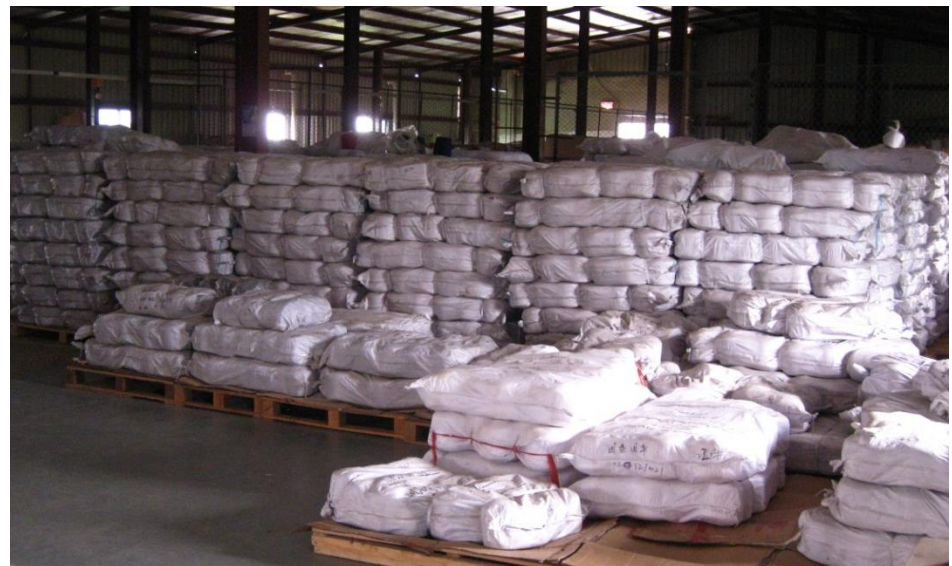
Yarn storage at 4<sup>th</sup> floor level

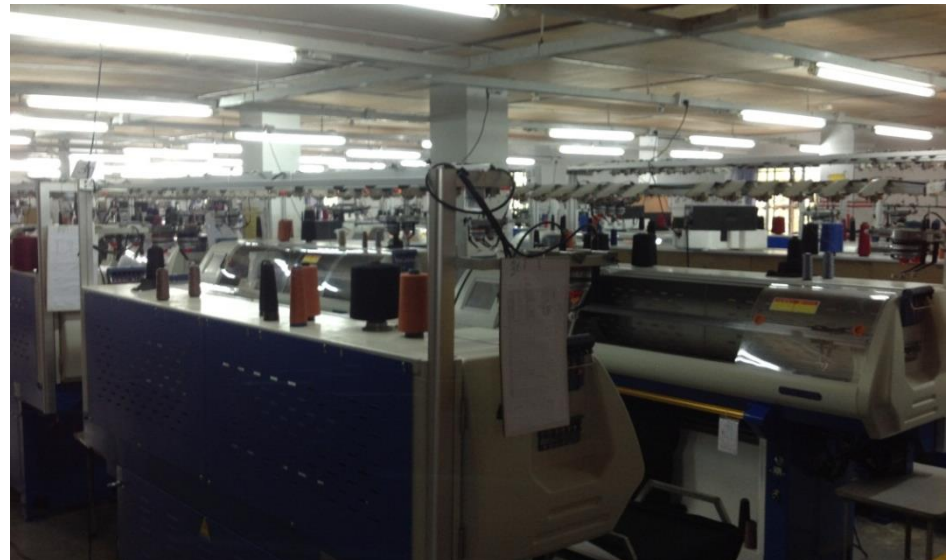
Jacquard machines at 2<sup>nd</sup> Floor level

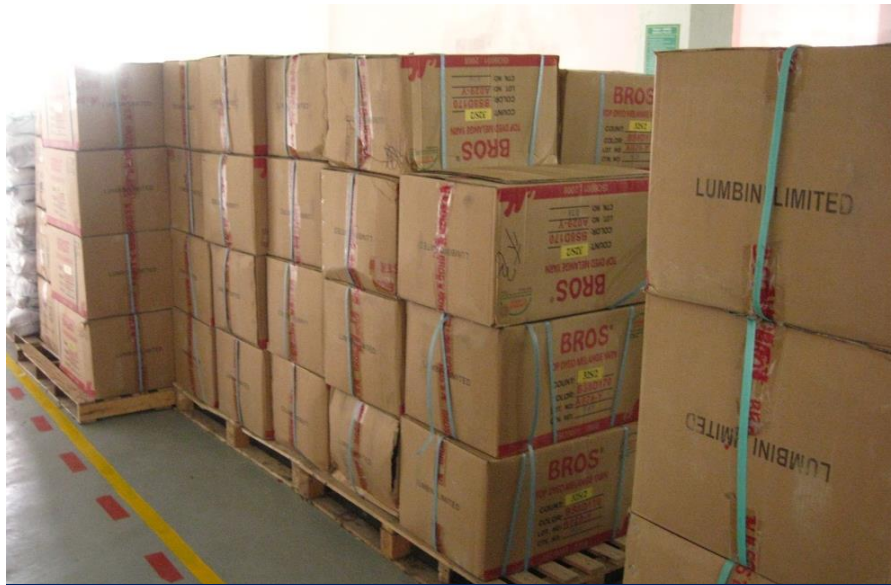
Storage area at 3<sup>rd</sup> floor level

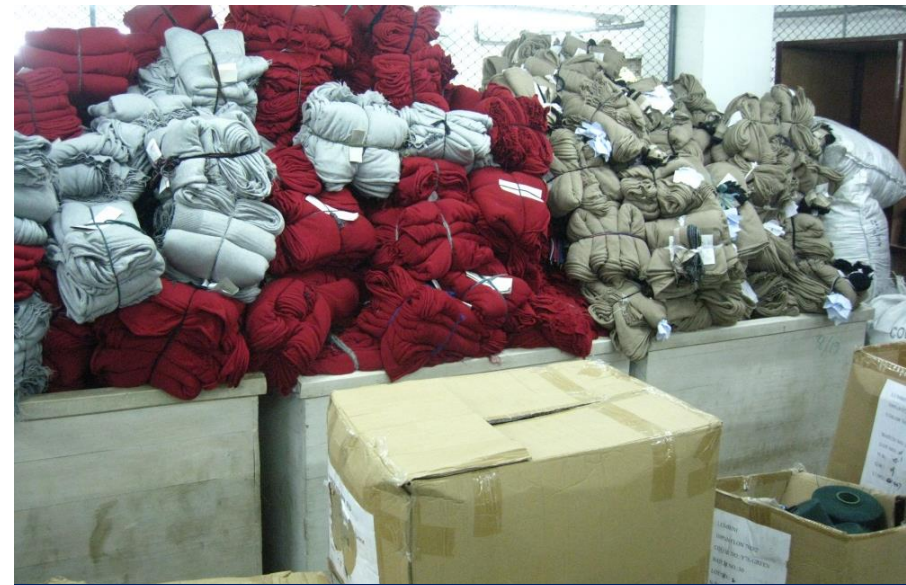
Storage distribution area at 2<sup>nd</sup> floor level

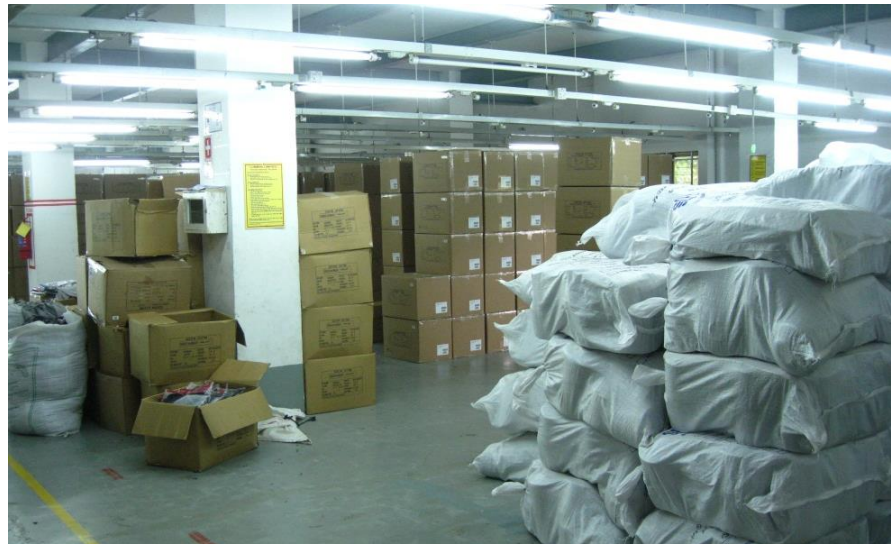
Storage area at 1<sup>st</sup> floor level

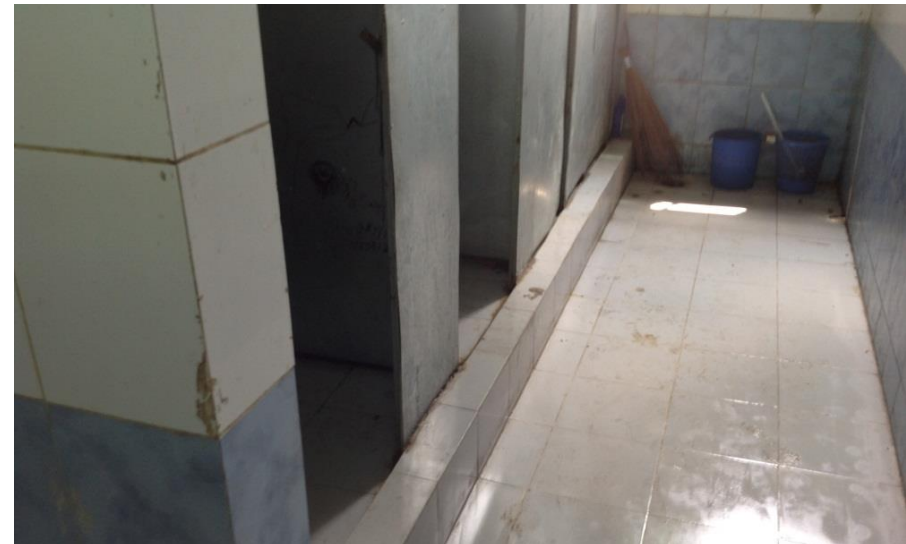
Toilet build-up at all floor levels

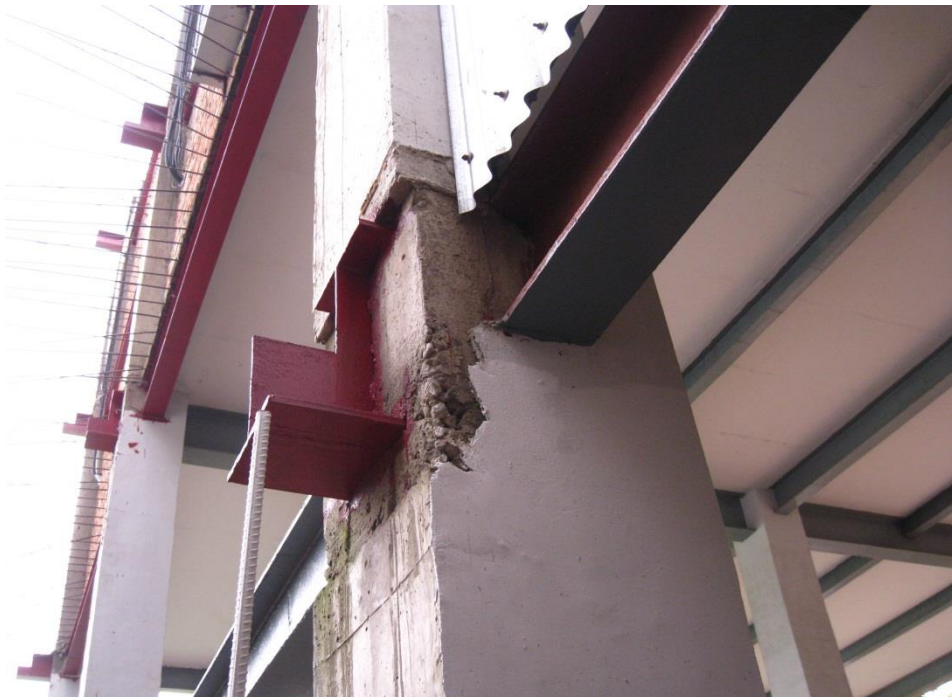
- There is a concern about the stability system for lateral loading conditions. The lateral stability of the building would appear to be provided primarily by moment-frame action; however, there is insufficient information in the design documents about the connection details between the primary steel beams and the RC columns – design check required.

Rigidity of RC column to beam connection is not clear

| Item No. | Observation | Recommended Action Plan | Recommended Timeline |
|---|---|---|---|
| 10 | Omissions and irregularities in design documentation | As part of the Detail Engineering Assessment, Building Engineer to carry out a design check to assess the safety and serviceability of the building, particularly in relation to lateral stability and element sizes. | Immediate - Now |

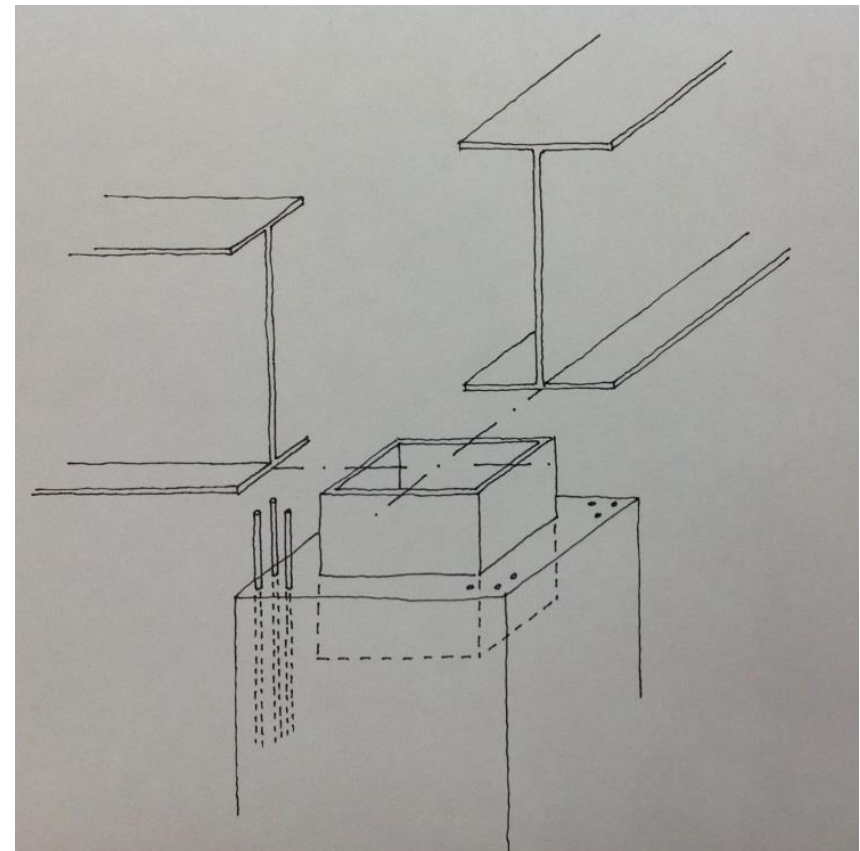
Sketch – Typical beam-column detail is unclear

Lateral stability concerns – There is insufficient information about the structure / connection between members to justify moment-frame action

| Item No. | Observation | Recommended Action Plan | Recommended Timeline |
|---|---|---|---|
| 11 | Omissions and irregularities in design documentation | Building Engineer to survey all areas of the building, collect information and prepare a full and accurate set of “as-constructed” drawings, with special emphasis on connection details. | 6-weeks |

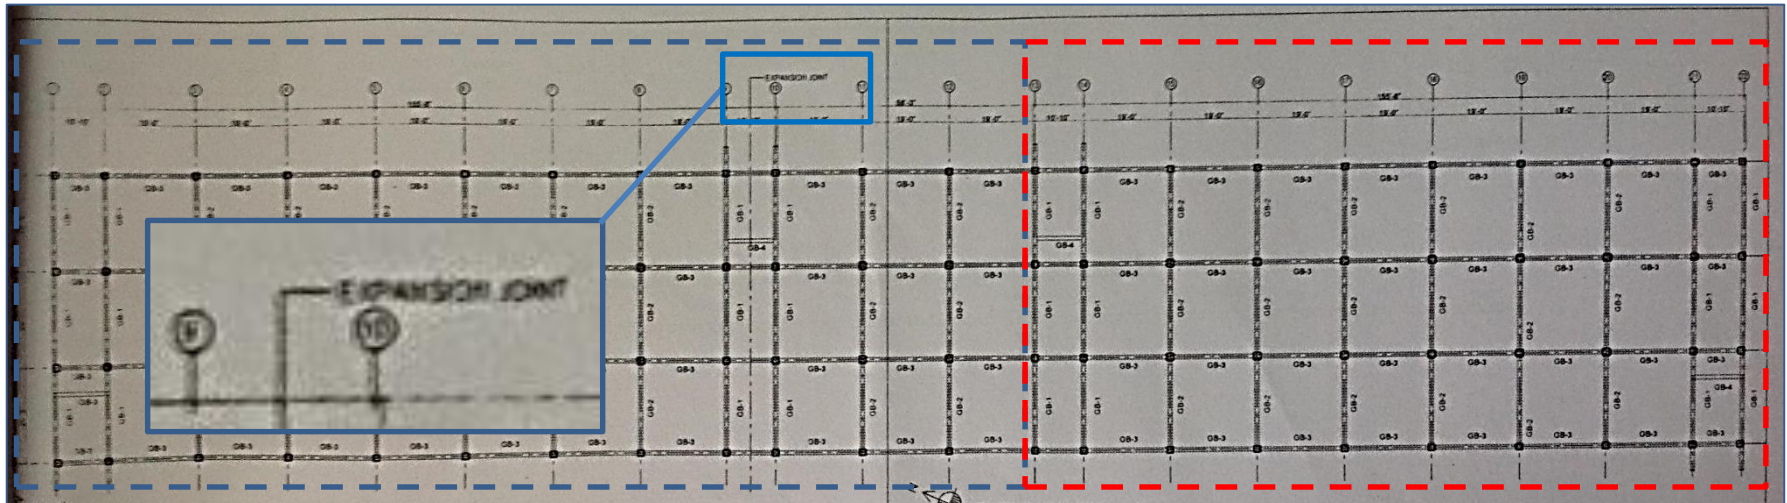
- The structural drawings indicate an expansion joint between gridlines 9 and 10, which does not appear to have been incorporated. It is planned that the building will be extended South beyond the proposed location of the movement joint – design check required.

Expansion joint indicated on the as-built structural drawings – not apparent on site

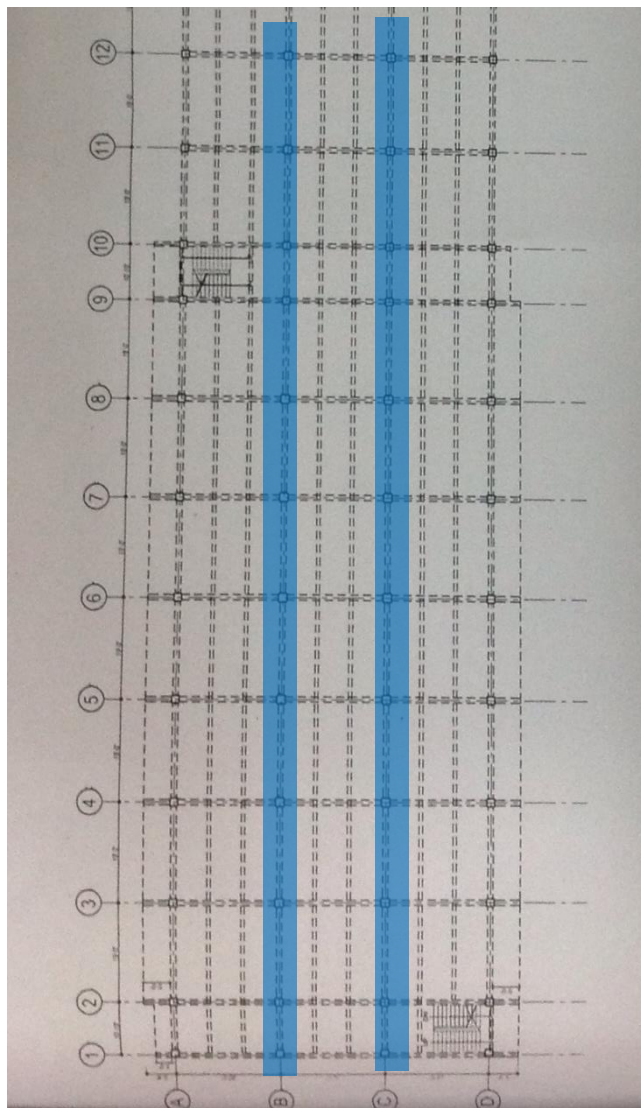
Column and beam layout

- A number of steel beams are smaller than specified: for example, the structural drawings indicate 400mm deep beams along gridlines B and C, whereas these were measured to be 300mm deep – design check required.

Steel beams along G.L. B and C – Specified as 400mm deep on the drawings, but measured as 300mm deep

| Item No. | Observation | Recommended Action Plan | Recommended Timeline |
|---|---|---|---|
| 12 | Omissions and irregularities in design documentation | Building Engineer to carry out comparison between design specified member sizes and as constructed structure. | 6-weeks |

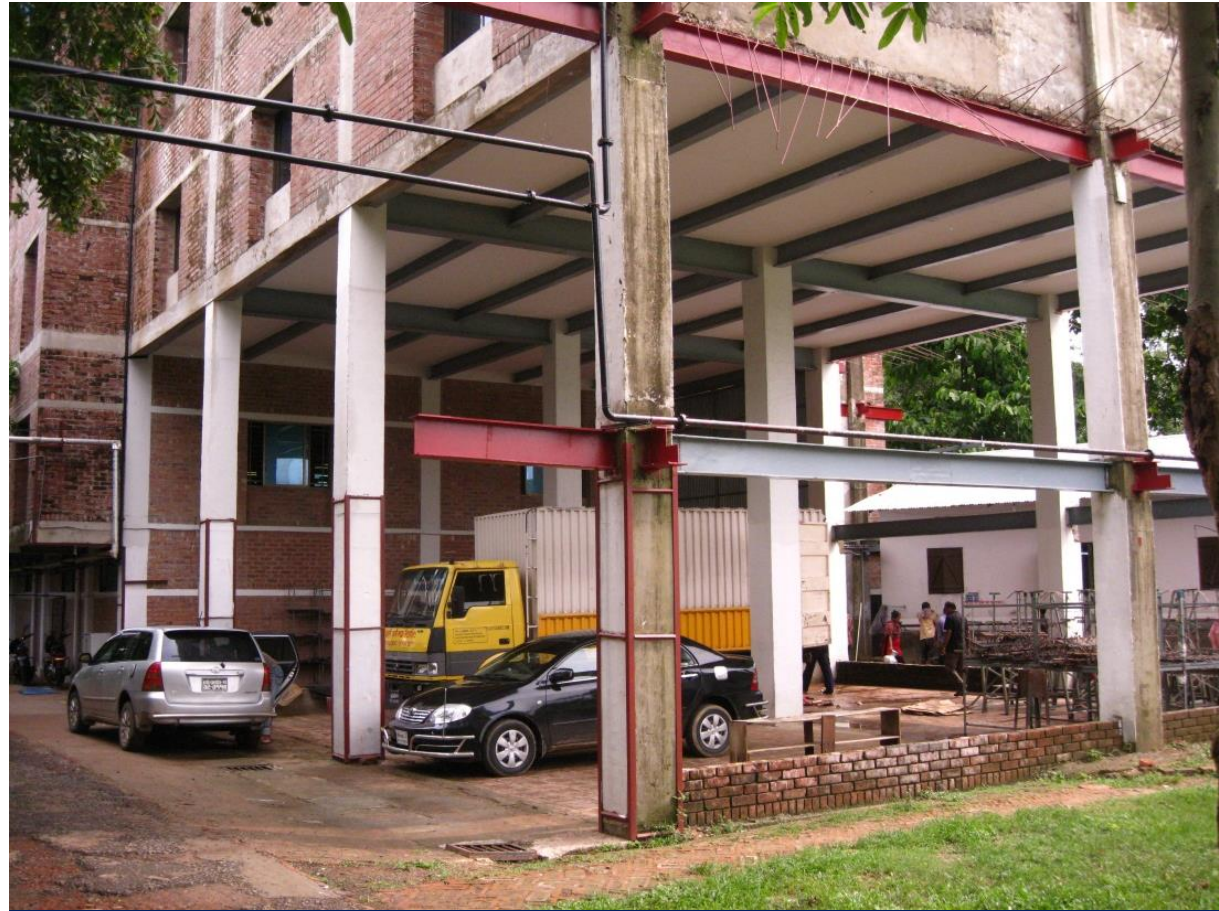
Columns adjacent to parking area

The double-height columns to the south of the building, adjacent to the delivery entrance, are at risk of being accidentally struck by a vehicle. The existing column protection appears inadequate.

Two-storey Ground Floor columns at risk of vehicle impact

| Item No. | Observation | Recommended Action Plan | Recommended Timeline |
|---|---|---|---|
| 14 | Double-height columns at risk of impact loading | As part of the Detail Engineering Assessment, Building Engineer to assess whether the columns have been adequately designed for impact loading. | 6-weeks |
| 15 | Double-height columns at risk of impact loading | Suitable column protection barriers to be designed and constructed. | 6-weeks |

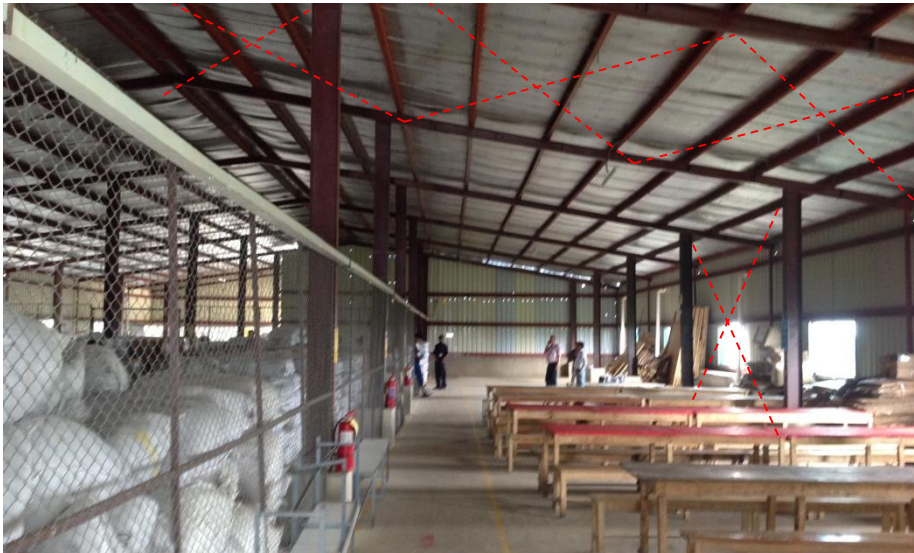
Roof shed - lack of horizontal bracing

| Item No. | Observation | Recommended Action Plan | Recommended Timeline |
|---|---|---|---|
| 16 | Lightweight and non-engineered structures | Building Engineer to review the design of all lightweight structures within the compound and assess their ability to withstand wind loading pressure, suction and uplift forces, with special emphasis on connections and bracing. | 6-weeks |

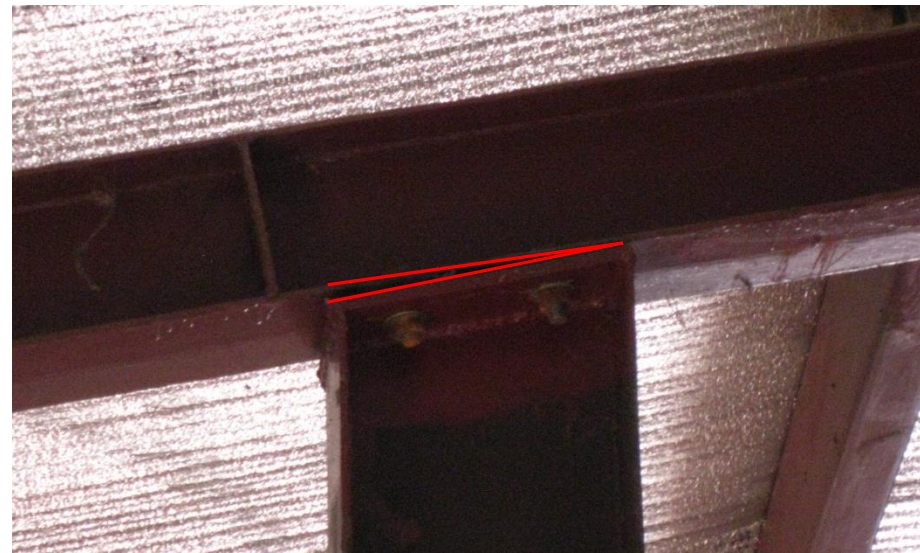
Inadequate bearing at beam-column connections

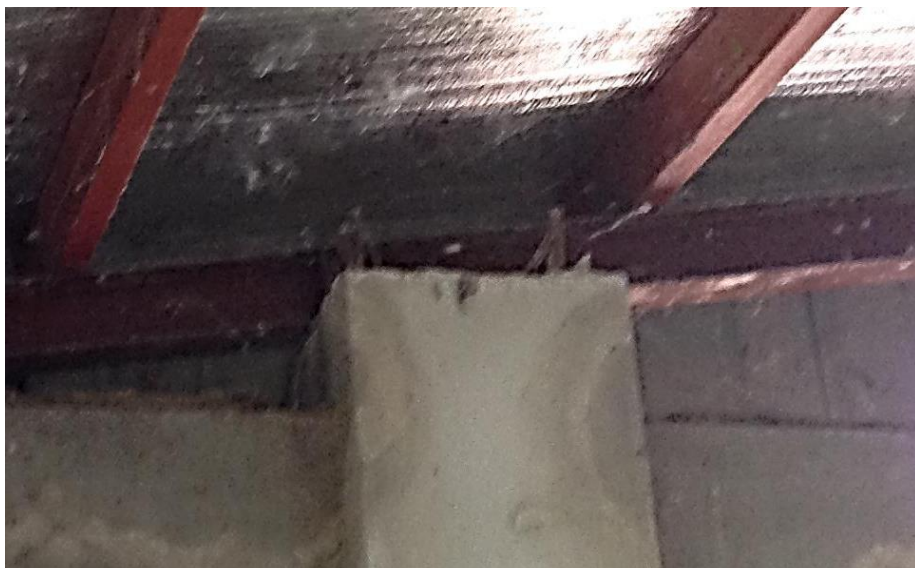
Shed to roof – Beam to RC column connection unclear

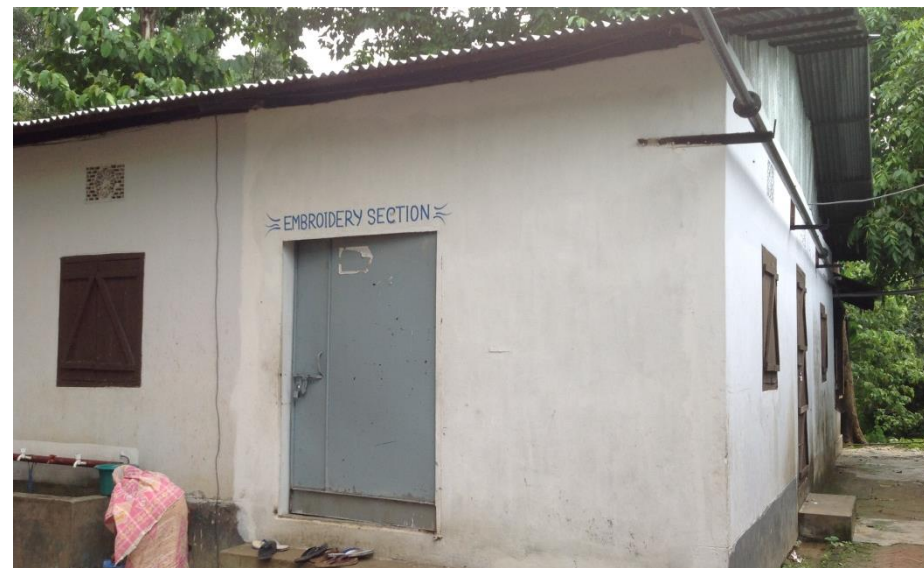
Embroidery building – corrugated roof on timber purlins

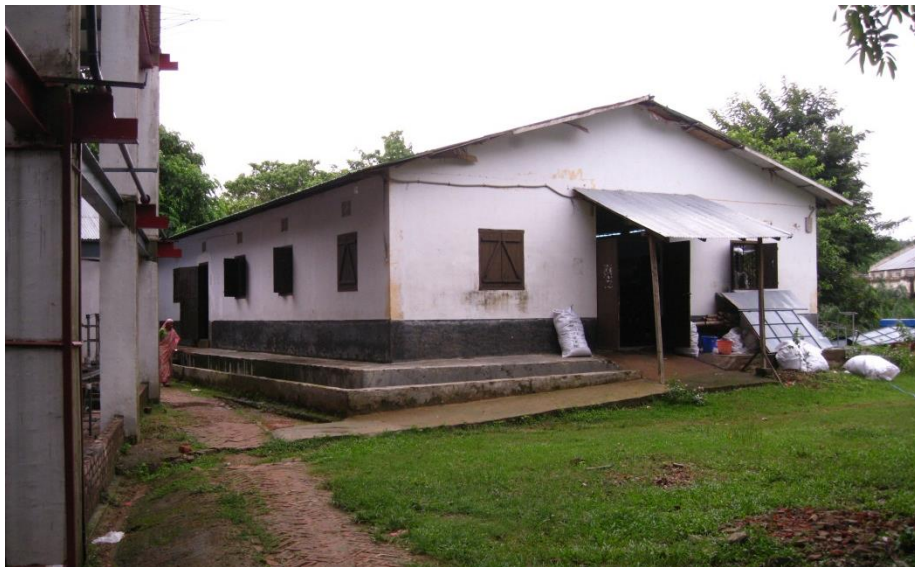
Winding building - corrugated roof on timber purlins

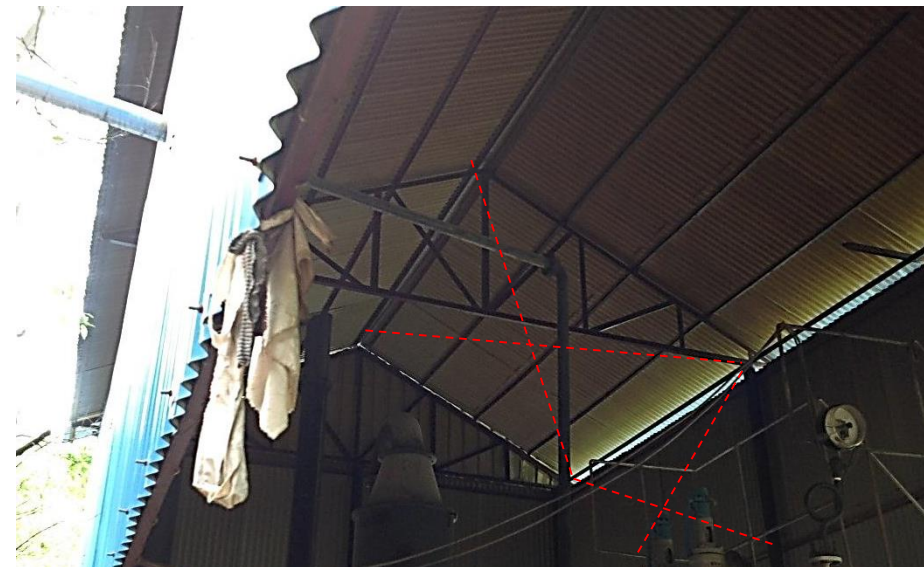
Boiler shed – Lack of horizontal and vertical bracing

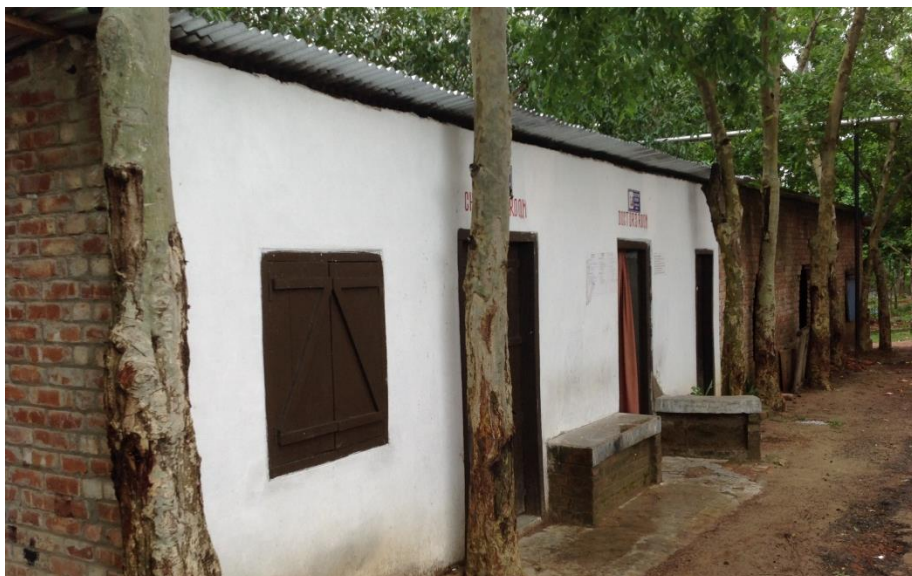
Welfare Shed – Corrugated roof on timber purlins

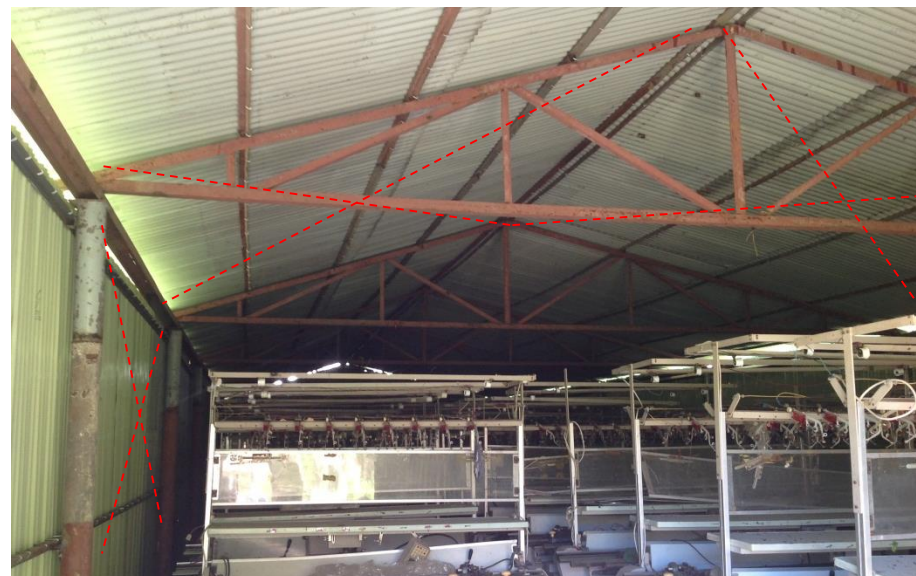
Store Shed – Lack of horizontal and vertical bracing

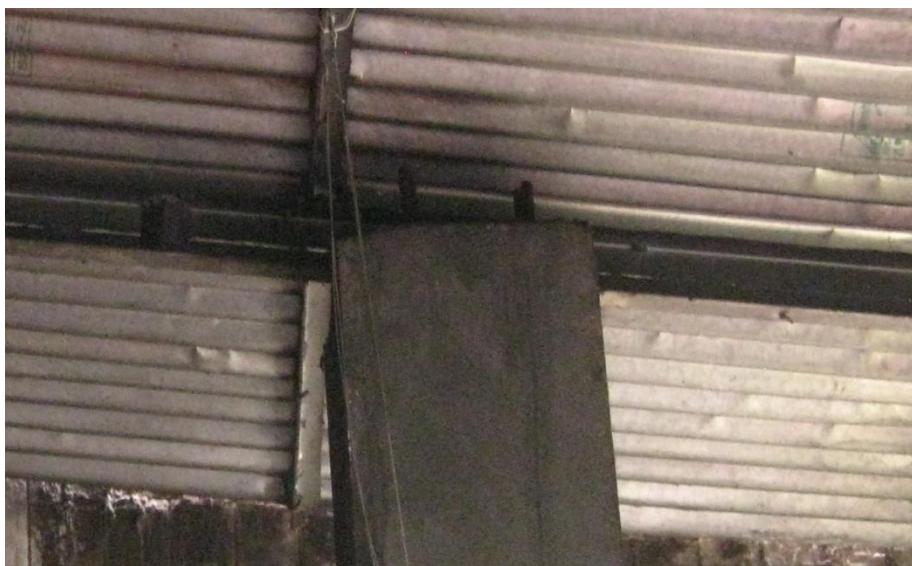
Generator Shed – Roof connection details unclear

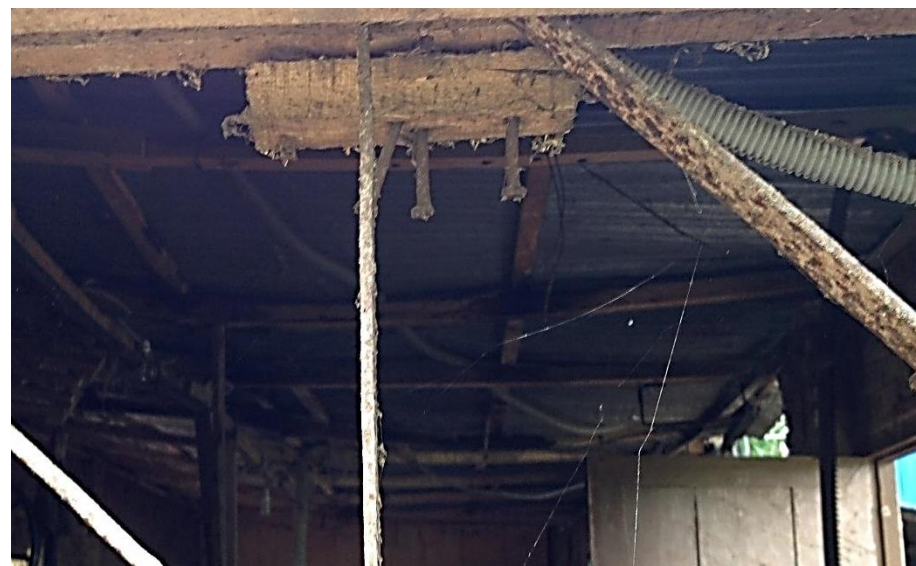
Wastage store – Sagging timber purlins
