# Epcot Apparels Ltd

# Epcot Jeans Ltd

Chandana, Joydebpur, Gazipur

11 May 2014

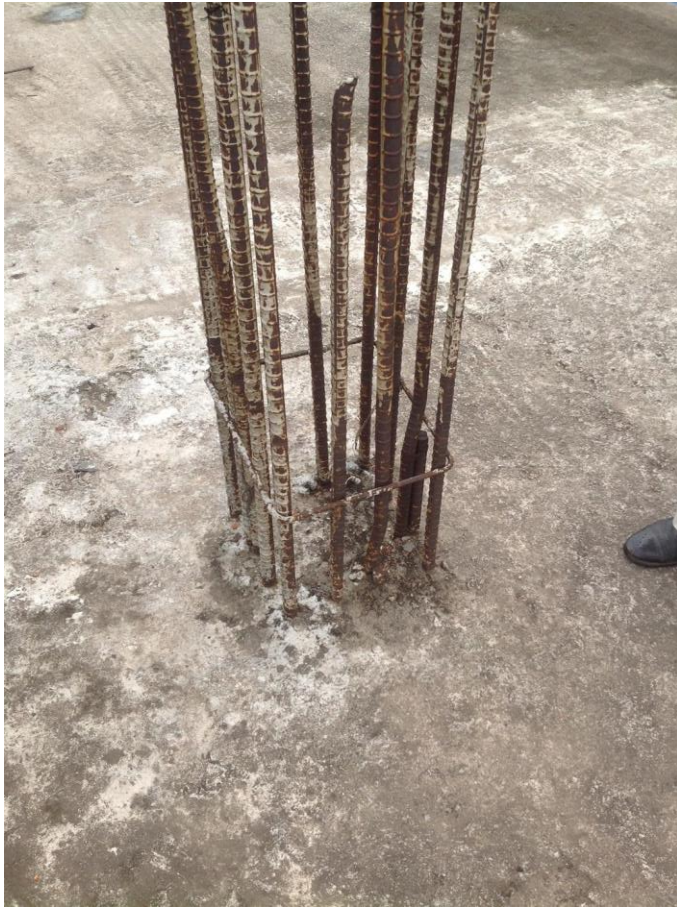
At roof level the typical internal columns in the North half of the building have 12 No. 20mm dia. bars compared to 8 No. 25mm dia. bars shown on the drawing. The cross sectional areas are the same and the structural engineer noted that 25mm dia. bars were not available at the time of construction.

**ITEM 1** - Check if columns are adequate for a possible future extension to 6 storeys.

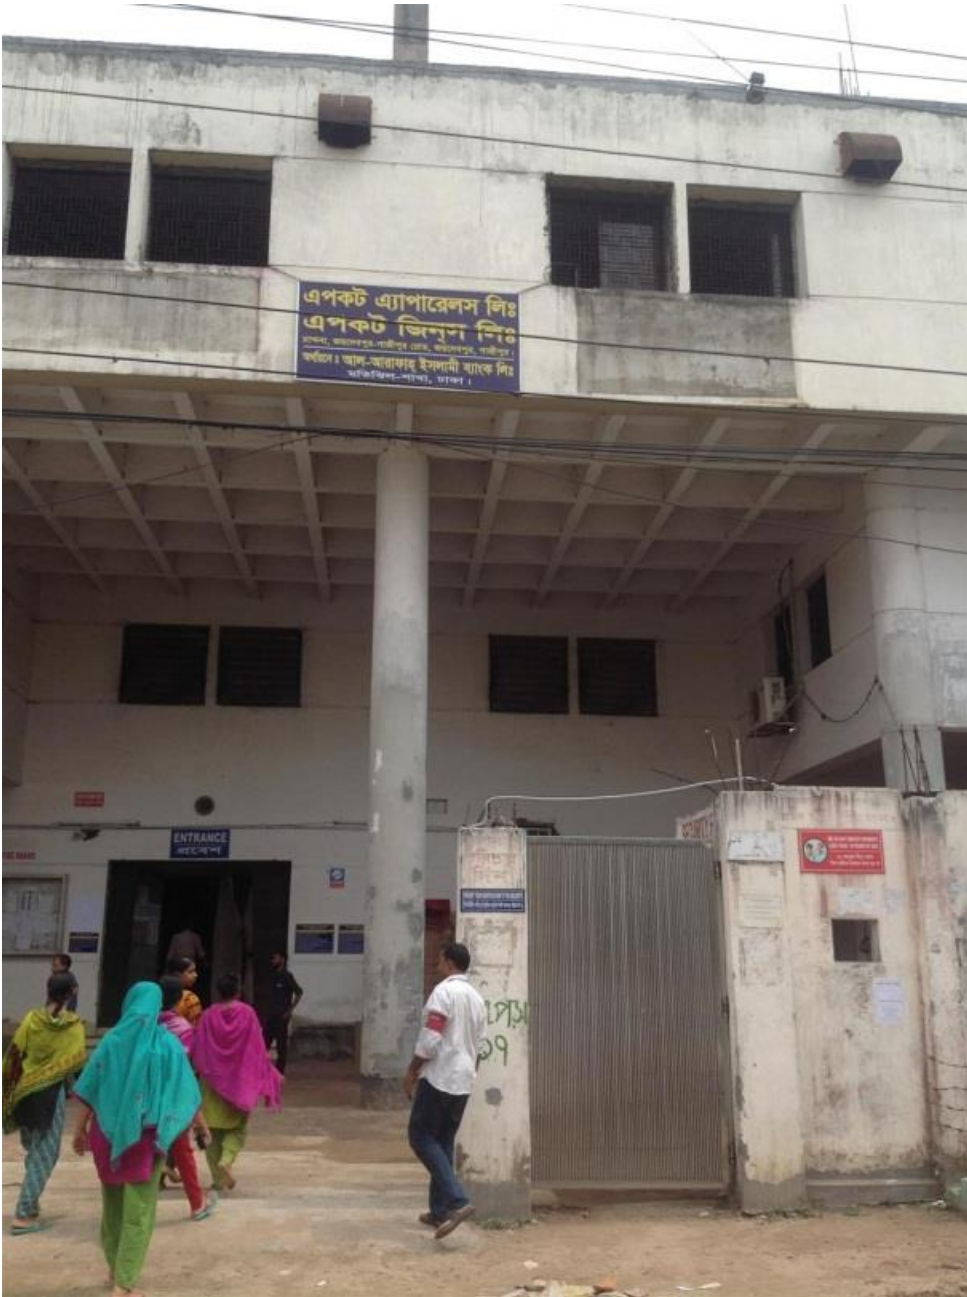
# Vulnerable column in loading bay

Two storey column in loading bay has no impact protection.

**ITEM 3** - Check loading bay column for impact and provide protection if necessary.

5	Check loading bay column for impact and provide protection if necessary	Check loading bay column for vehicle impact and provide protection if necessary.	6-months
6	Structural engineer to check connection between top of columns and steel roof to dining shed.	Structural engineer to check connection between top of columns and steel roof to dining shed.	6-months

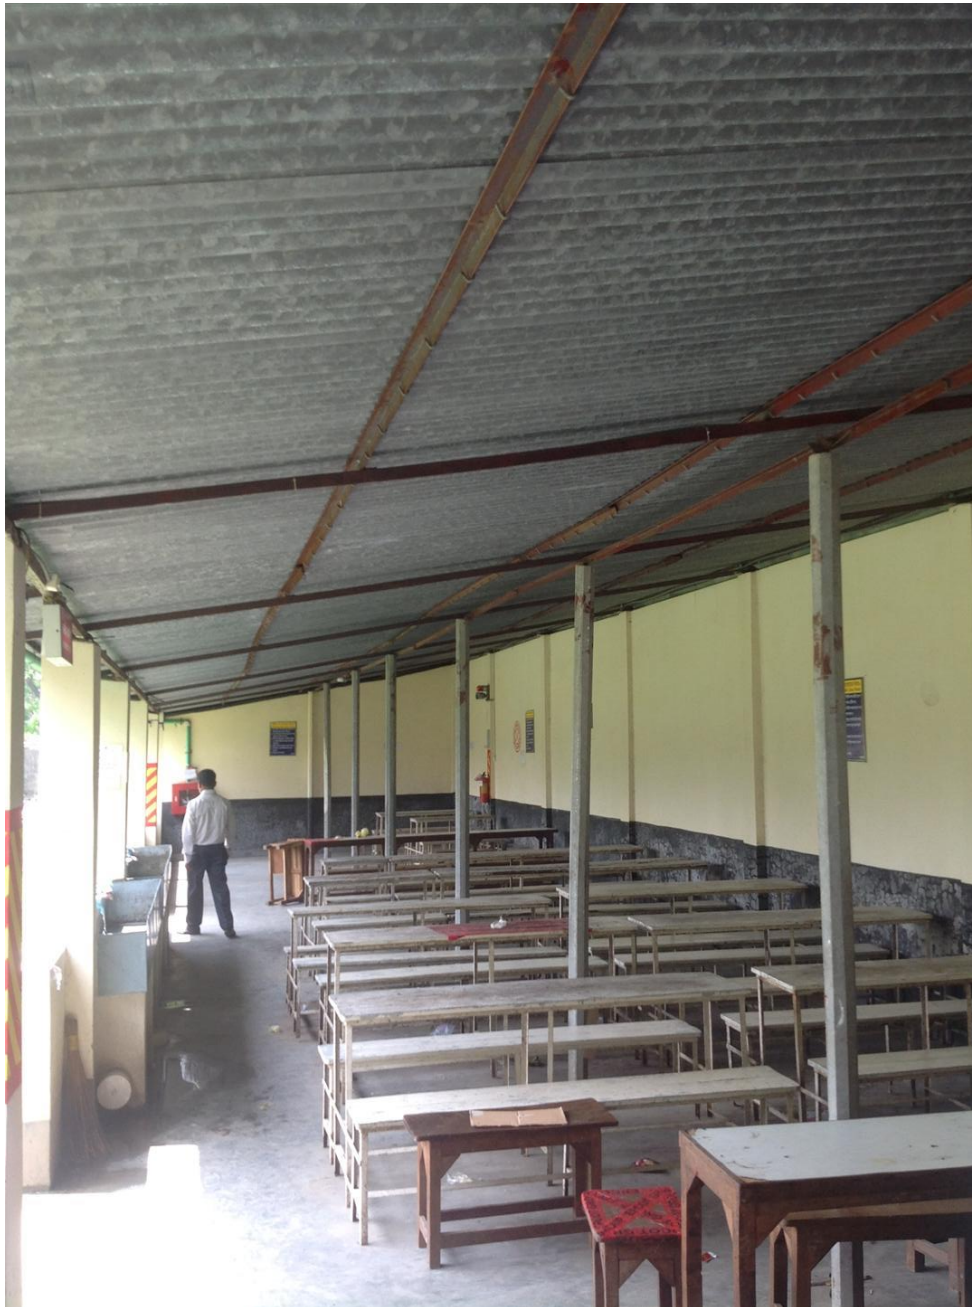
# Non-engineered steel shed

Dining hall appears to have been non-engineered; unclear whether the roof has adequate tie down and also if the heads of the precast internal columns are adequately restrained.

**ITEM 4** - Structural engineer to check connection between top of columns and steel roof to dining shed.

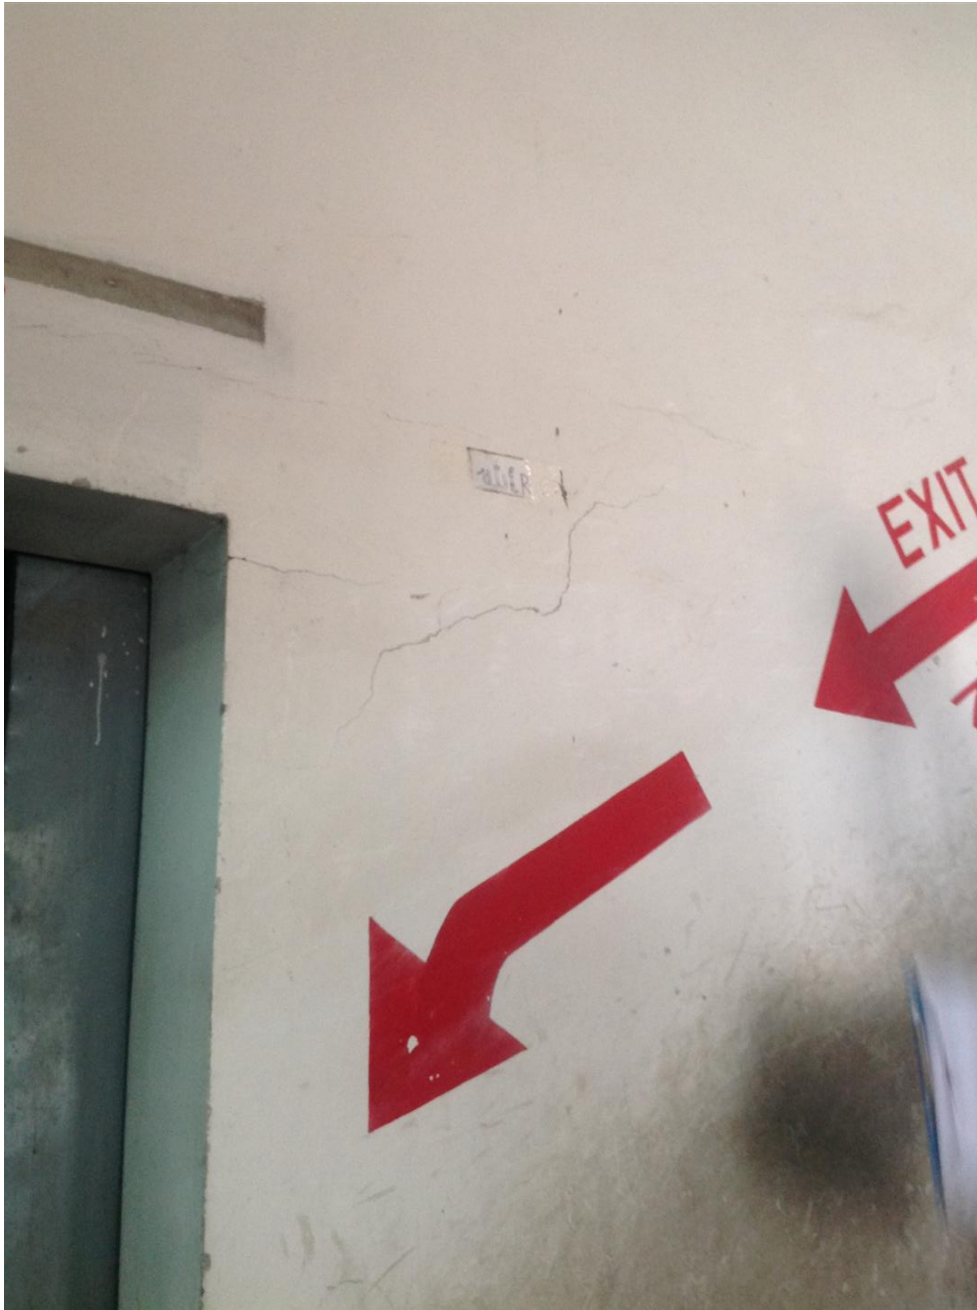
# Settlement cracking of ground floor masonry walls

Frequent minor cracking to ground floor masonry walls and facades, probably due to differential settlement between assumed shallow strip footings under the walls and deeper footings under the columns.

Structural drawings show shallow foundations except locally where there was reportedly a pond. Original soils report not available, but 2013 soils report states that shallow foundations are only adequate for a 3 storey building and that a 6 storey building would need to be piled. This conflicts with the statement made by the Structural Engineer that the foundations have been designed for a 6 storey building.

**ITEM 2** - Check if foundations are adequate for a possible future extension to 6 storeys.
