## Findings & Recommendations :

Table 1: Summarizes the major fire safety issues identified during the inspection. Recommendations have been provided to address each issue. An implementation schedule shall be developed by the factory to remediate each of the findings. The specific timing of improvements, including any requested extensions due to design / installation constraints, shall be submitted to the Accord for approval.

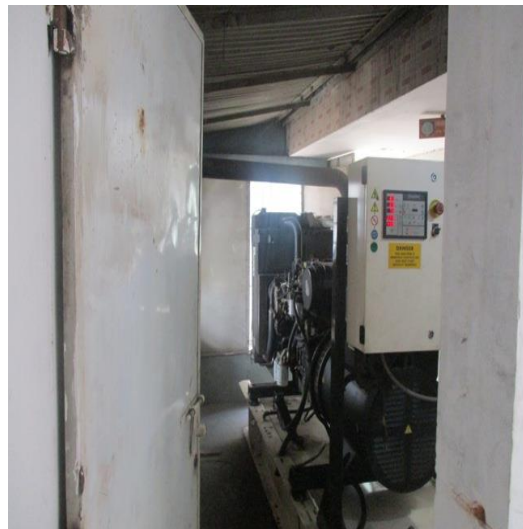
SI No.	Category	Findings	Required Action	Remediation Time Frame	Pictorial Evidence
1	Fire Rated Construction	Generator room is not properly separated by fire rated construction and is open directly to egress discharge at ground floor.	Generator room shall be separated from other occupancies by a minimum 2-hr fire rated construction (wall, floor, slab etc.). Seal all penetrations and to maintain required fire separation provide 1.5-hr fire rated materials in the openings (door, window etc.) if required. All exhaust systems shall discharge to the exterior of the building in a safe location.	Within 03 Months

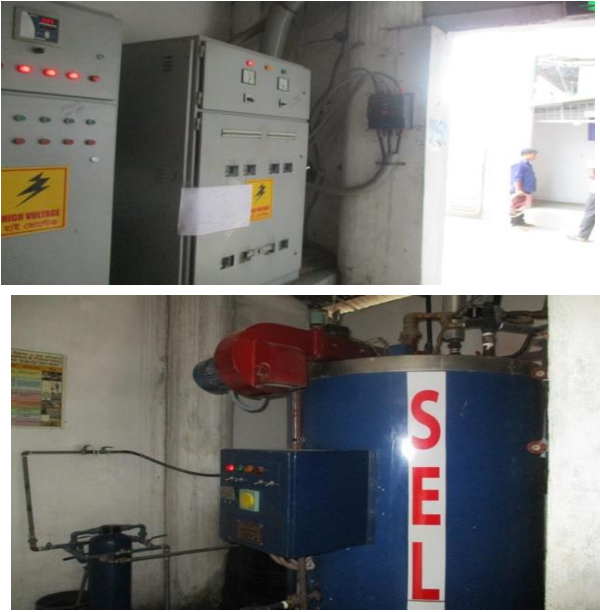
SI No.	Category	Findings	Required Action	Remediation Time Frame	Pictorial Evidence
2	Fire Rated Construction	Boiler & Switchgears room are not properly separated by fire rated construction from each others and is directly open to the egress discharge at ground floor.	Boiler & Switchgear room shall be separated from each other by a minimum 2-hr fire rated construction (wall, floor, slab etc.). Seal all penetrations and to maintain required fire separation provide 1.5-hr fire rated materials in the openings (door, window etc.) if required. All exhaust systems shall discharge to the exterior of the building in a safe location.	Within 03 Months

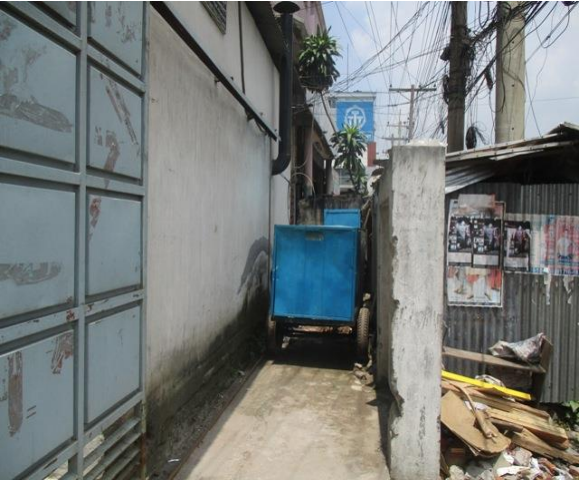
Sl No.	Category	Findings	Required Action	Remediation Time Frame	Pictorial Evidence
3	Fire Rated Construction	Liquefied or compressed gas cylinders were located within the factory at the intermediate place between two exit discharges.	The storage or use of liquefied or compressed flammable gas cylinders shall be prohibited within the factory building or shall be fire separated with 1-hr Fire construction.	Within 3 months

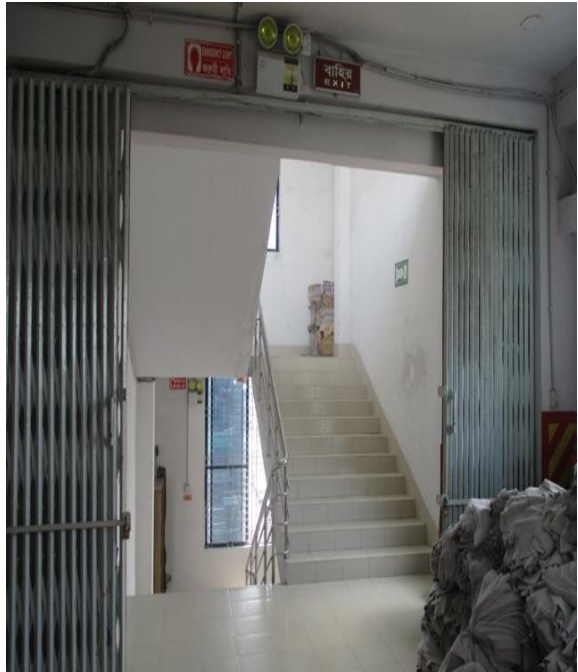
SI No.	Category	Findings	Required Action	Remediation Time Frame	Pictorial Evidence
4	Fire Rated Construction	The both exit stairs are not separated by fire-rated construction at all floor.	Provide minimum 1.5-hr fire rated doors and seal all unprotected openings to separate the exit stairs from work areas and other building spaces on all floor levels. Ensure that the fire doors are self-closing and positive latching and that they are provided with fire exit (panic) hardware where serving production floors. If fire doors are required to be held open for functional reasons, provide automatic closing devices tied to the fire alarm system	Within 03 Months

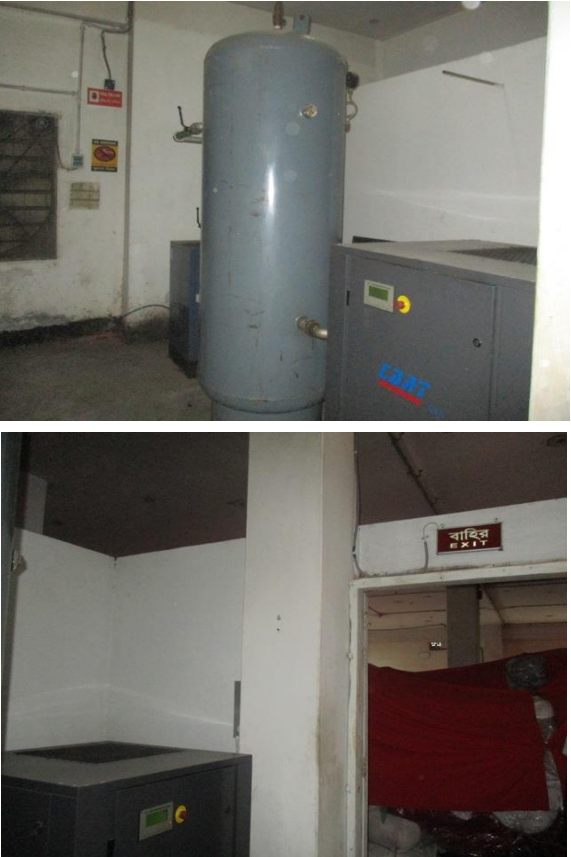
Sl No.	Category	Findings	Required Action	Remediation Time Frame	Pictorial Evidence
5	Fire Rated Construction	The air compressor room is not separated by fire rated construction and is open directly to the Store at ground floor.	Separate the air compressor room by a minimum 1-hr fire-rated construction for non-high rise, and 2-hr fire rated construction for high rise building. Seal and/or protect all openings to maintain the required fire separations. When located to the exterior of a building, 3m (10 ft.) separation is required. Provide proper ventilation and consult a qualified engineer.	Within 03 Months

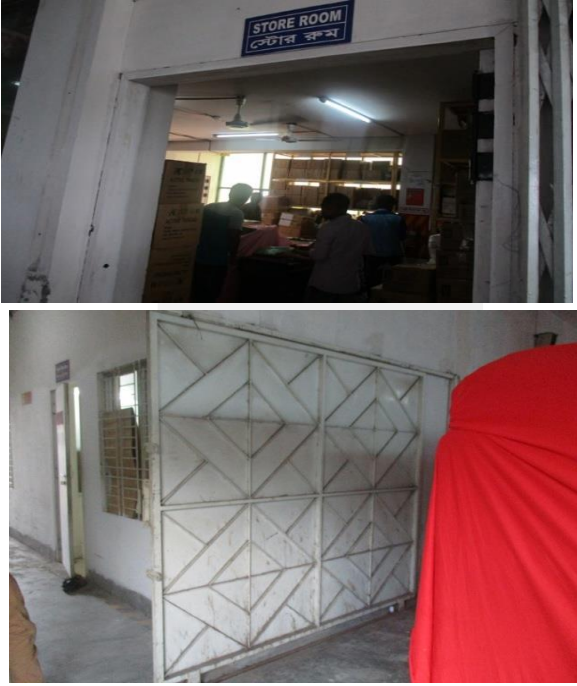
SI No.	Category	Findings	Required Action	Remediation Time Frame	Pictorial Evidence
6	Fire Rated Construction	Rooms used for storage of combustible materials are not separated from the surrounding occupancy and stair at fifth floor and ground floor	Store rooms shall be separated from the surrounding occupancy with a minimum 1 hour construction.	Within 03 Months

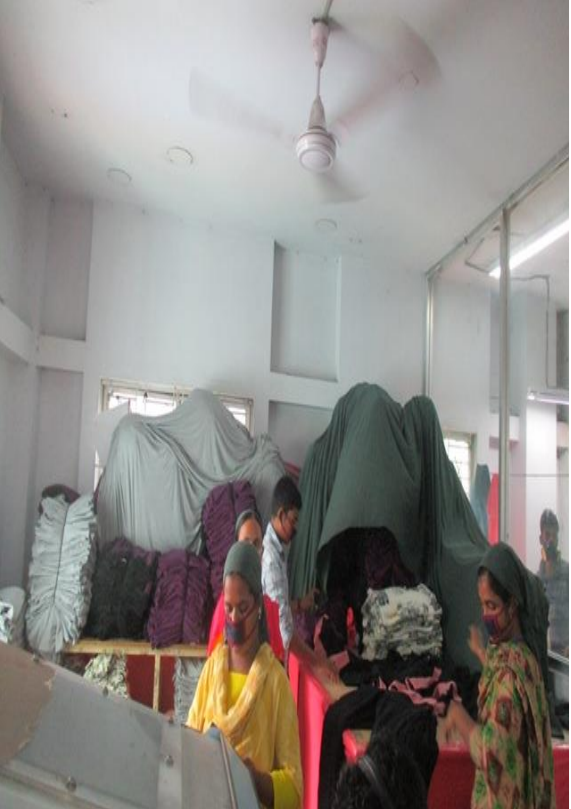
SI No.	Category	Findings	Required Action	Remediation Time Frame	Pictorial Evidence
7	Storage Areas	Areas used for in-process storage of combustible materials are open to the surrounding occupancy at several floors.	<p>Provide defined storage areas and limit the storage arrangement as follows:-</p> <p>1. <b>General Condition:</b> Maximum height of 2.4m and maximum area of 23m<sup>2</sup>. Separate areas of unenclosed combustible storage by a minimum clear distance of 3m. Or</p> <p>2. <b>If sprinkler protected:</b> maximum height of 3.66m and maximum area of 93m<sup>2</sup>. Separate areas of unenclosed combustible storage by a minimum clear distance of 3m. Or</p> <p>3. Enclose the storage area from the surrounding occupancy with a minimum 1 hour construction.</p>	Within 03 Months

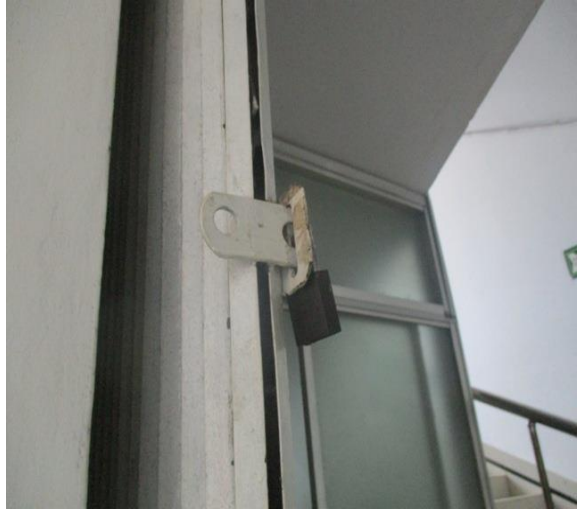
SI No.	Category	Findings	Required Action	Remediation Time Frame	Pictorial Evidence
8	Egress	Egress doors with locking features are provided at exit stairs and along egress routes. Egress gates with locking features are provided at building exits, exit stairs and along egress routes. All gates/doors were not open and unlocked during the inspection.	Remove non-compliant locking features from all egress doors and gates. If locks are required for security reasons, utilize special door locking features complying with NFPA 101 and ACCORD standard 6.8.2.	Immediately

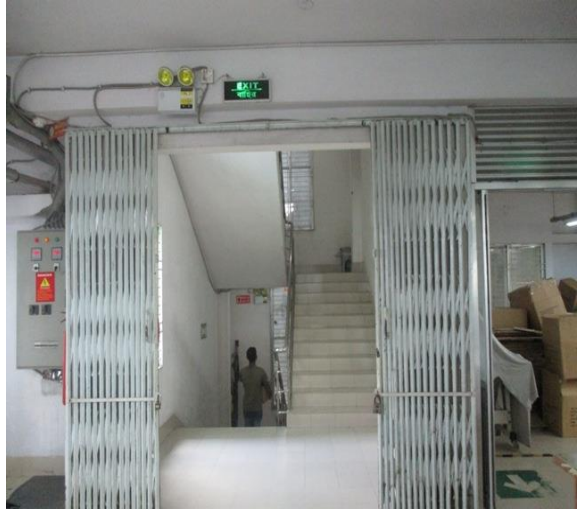
9	Egress	Collapsible gates / sliding doors/ rolling shutter are provided at building exits and exit stairs.	Replace all gates and sliding doors along the means of egress with side-hinged, swinging egress doors in accordance with ACCORD standard	Within 01 Month

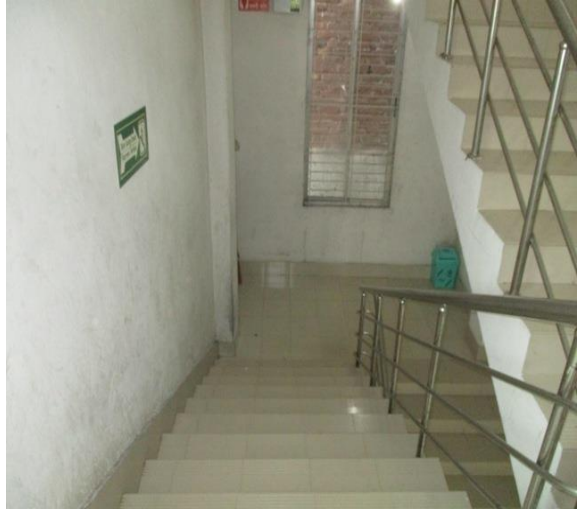
SI No.	Category	Findings	Required Action	Remediation Time Frame	Pictorial Evidence
10	Egress	Handrails are not provided on both sides of the exit stairs.	Provide handrails on both sides of the exit stair. New handrails shall have a minimum height of 865mm (34 in.) and a maximum height of 965 mm (38 in.) as measured from the leading edge of the tread. Intermediate handrails shall be provided when the stair width exceeds 2.2 m (87 in.)	Within 1 Month

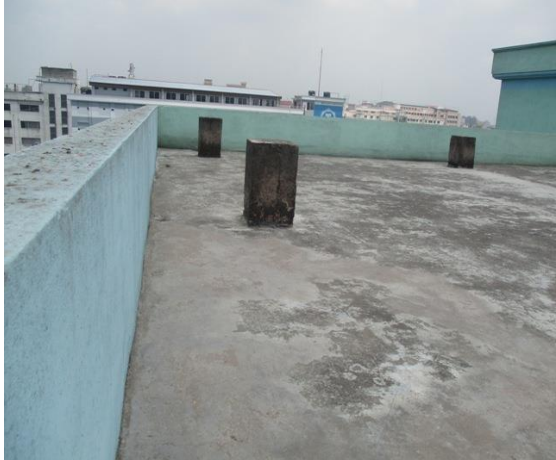
11	Egress	Parapets or guards provided in occupiable roof is less than 42 inches	Provide parapets or guards with a minimum height of 1067mm (42 inch.).	Within 3 months

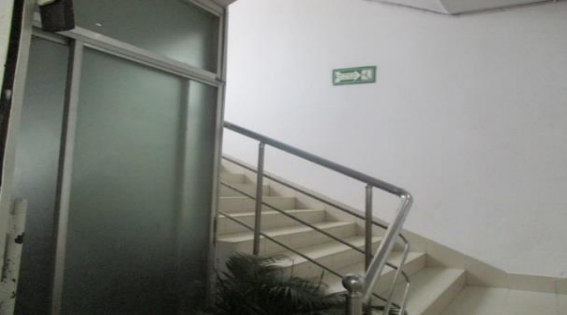
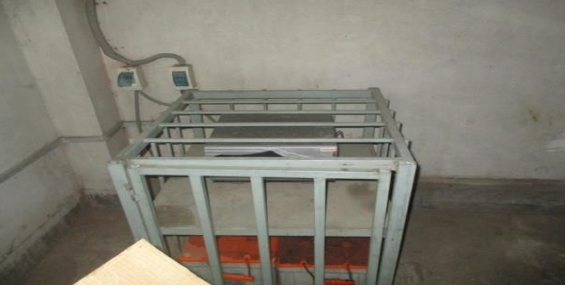
SI No.	Category	Findings	Required Action	Remediation Time Frame	Pictorial Evidence
12	Egress	IPS and small pentry was located in the east exit stair enclosure at ground floor.	Remove IPS and Pentry from the exit stair enclosure.	Immediately

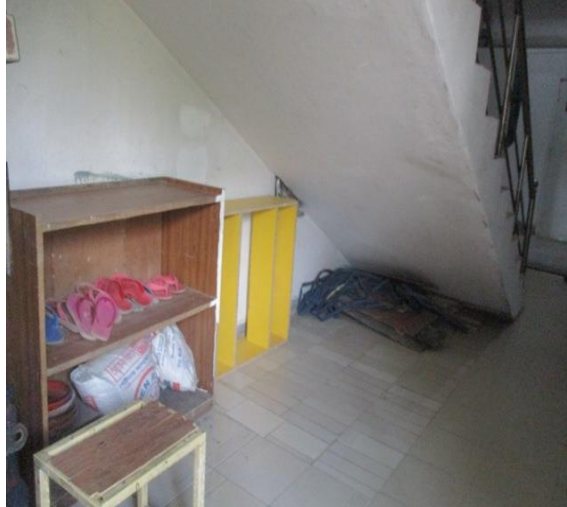
13	Egress	Storage was located in both the exit stairs at several floors.	Remove all storage from exit stairs.	Immediately

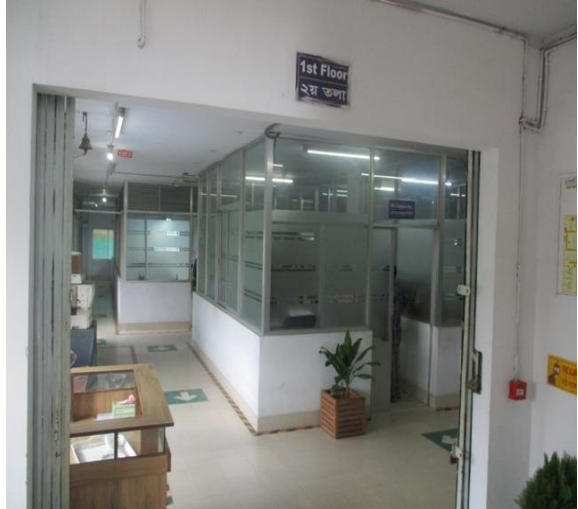
SI No.	Category	Findings	Required Action	Remediation Time Frame	Pictorial Evidence
14	Egress	Building did not have occupant load signs at required locations.	Provide occupant load signs at required locations.	Immediately

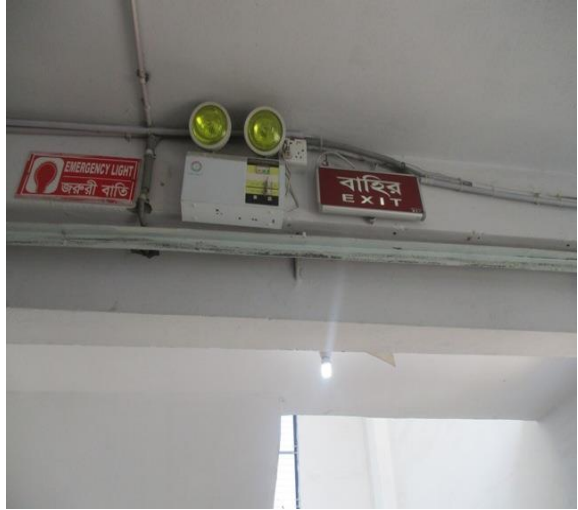
15	Egress Lighting	Manual on-off switch is provided for emergency lighting units.	Remove manual on/off switches from emergency lighting / exit signage units to prevent them from being switched off.	Within 03 Months

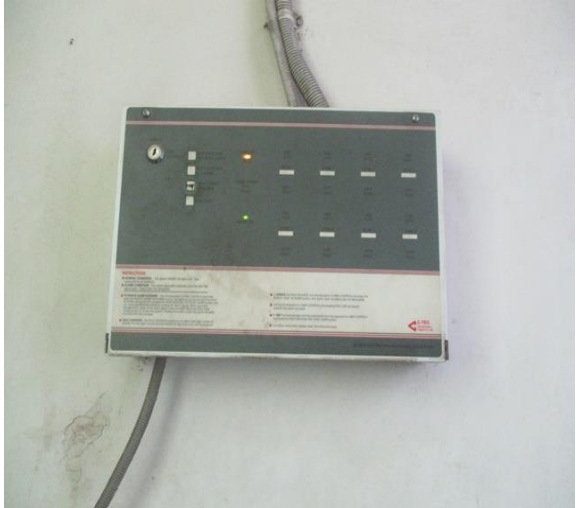
17	Fire Alarm & Detection System	The existing fire alarm & detection system is not a listed system and does not provide automatic alarm and notification features consistent with acceptable standards.	Replace the existing fire alarm & detection system with a new, listed addressable fire alarm system in accordance with NFPA 72.	Design within 04 Months & Installation Within 06 Months

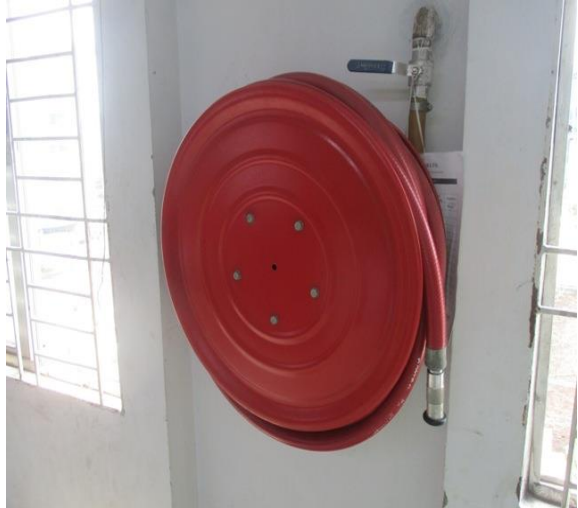
SI No.	Category	Findings	Required Action	Remediation Time Frame	Pictorial Evidence
18	Inspection, testing, and maintenance of the fire alarm system	Inspection, testing, and maintenance for the fire alarm system is not in accordance with NFPA 72 or as per Accord standard.	Inspect, test and maintain the fire alarm system, and keep written records on-site, in accordance with NFPA 72 or as per Accord standard.	Within 03 Months	ADD PHOTO
19	Water Based Fire Protection System	The existing factory building with an occupiable floor greater than 10 m (33 ft.) above the finished grade is not protected with an approved standpipe system.	Provide class-III standpipe system (both a 40 mm connection with attached hose and a 65 mm connection) throughout the building in accordance with NFPA 14.	Design within 04 Months & Installation Within 09 Months
