# Blue Planet Knitwear Ltd.

Mmawna, Mulaid, Polli Biddutroad, Gazipur, Bangladesh

01 April 2014

# Observations

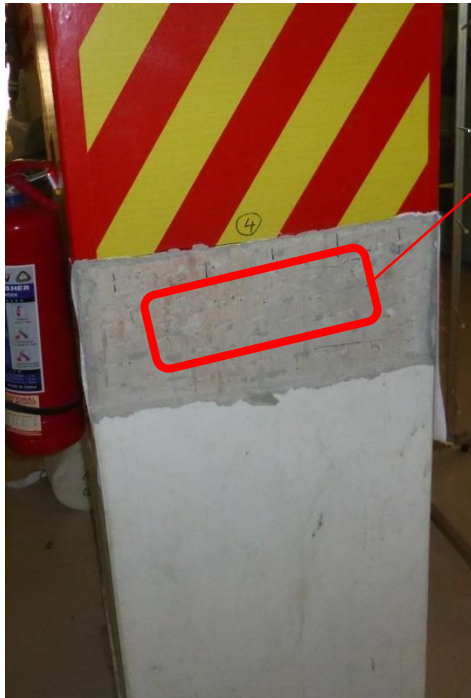
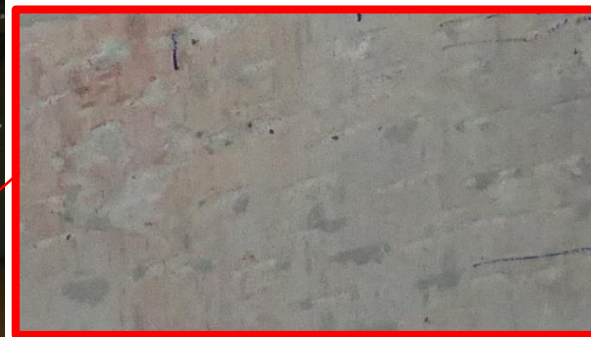
Preliminary calculations indicate that the working stresses in some columns are at a high level.

Concrete strength to be verified by core testing  
Stone aggregate observed.

Tested column at ground level- stone aggregate observed in a number of locations

| Item No. | Observation | Recommended Action Plan | Recommended Timeline |
|---|---|---|---|
| 3 | Highly stressed columns under toilets and water tanks<br>Verify concrete strengths in columns | Verify in situ concrete strength either by 100mm diameter cores (cores from a minimum of 4 columns) of or existing cylinder strength data. | <b>Immediate - Now</b> |

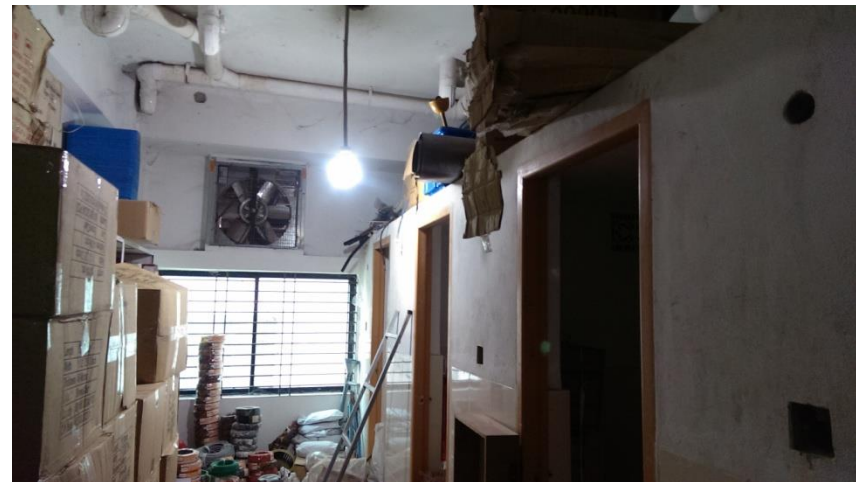
Unused toilet on 1<sup>st</sup> floor used for additional storage.

Additional storage loading on the 1<sup>st</sup> floor.

| Item No. | Observation | Recommended Action Plan | Recommended Timeline |
|---|---|---|---|
| 4 | Highly stressed columns under toilets and water tanks<br>Verify concrete strengths in columns | Current loading plans to be reviewed based on engineering assessment. Actively manage loading plan for all floor plates within the factory giving consideration to floor capacity and column capacity. | <b>6-weeks</b> |

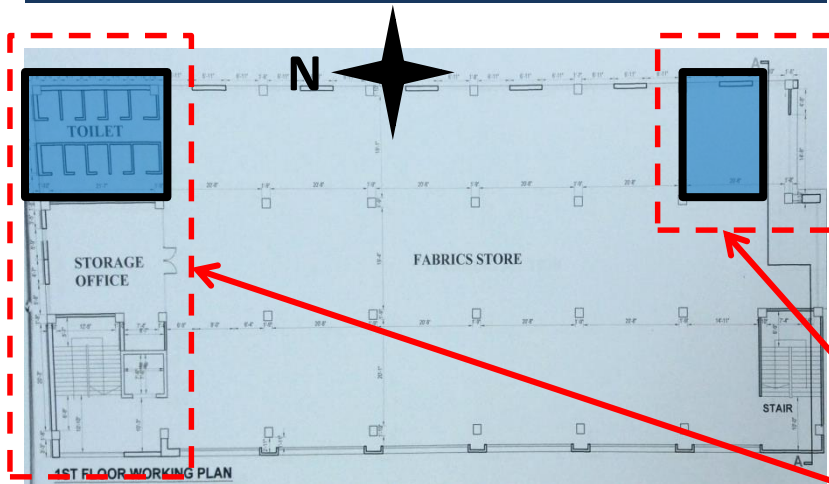
**Water Tank Locations**

**Water tank in north east corner of building located above toilet blocks with heavier loading leading to accumulation of heavy loads in this area.**

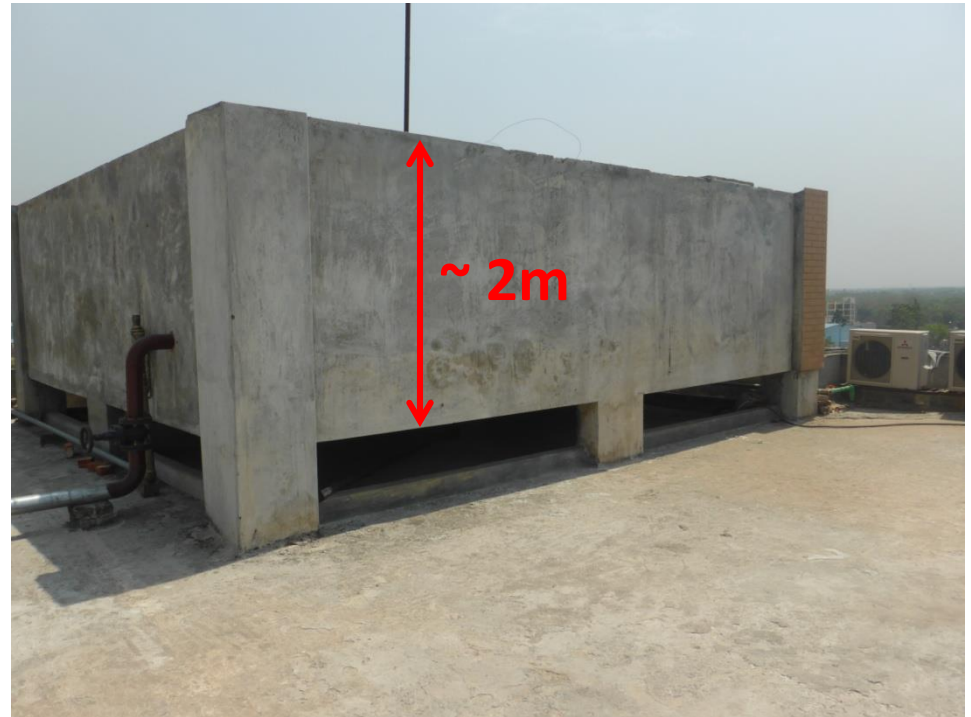
**Water tank at roof level.**

**Columns in these areas require immediate review due to high loading. Refer to Item 1 action.**

| Item No. | Observation | Recommended Action Plan | Recommended Timeline |
|---|---|---|---|
| 2 | Highly stressed columns under toilets and water tanks<br>Verify concrete strengths in columns | Factory Engineer to review design, loads and columns stresses particularly for areas of high loading identified. | <b>Immediate - Now</b> |

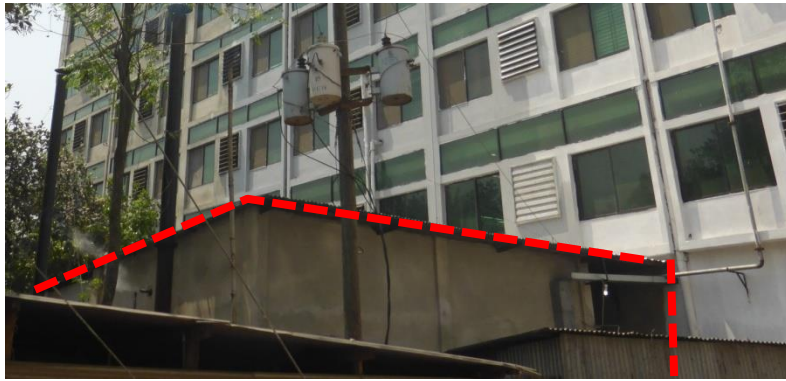
**Undocumented single storey plan annex building connected to main production building.**

**Roof structure appears not to be engineered and is likely to be subject to uplift.**

| Item No. | Observation | Recommended Action Plan | Recommended Timeline |
|---|---|---|---|
| 6 | Undocumented single storey plant room structure. | Building engineer to assess light weight roof structure and confirm its ability to withstand all wind loading pressure, suctions and uplift forces. | <b>6-weeks</b> |

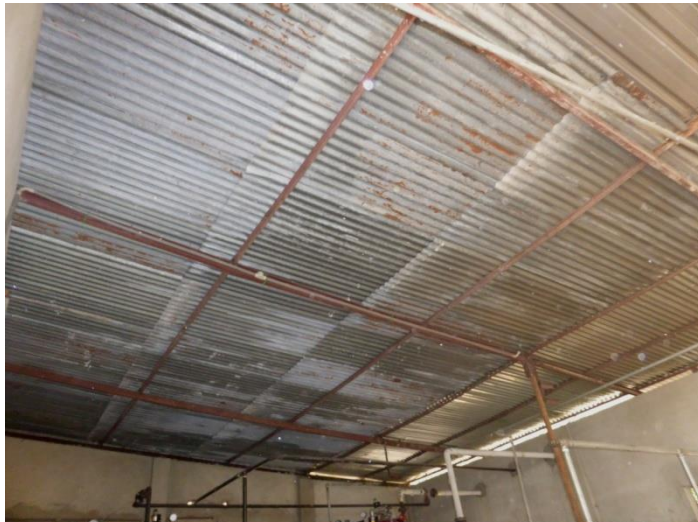
**Roof structure of building.**

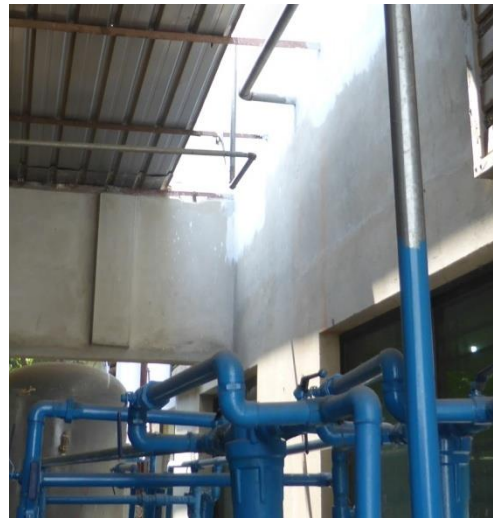
**Connection to main building**

| Item No. | Observation | Recommended Action Plan | Recommended Timeline |
|---|---|---|---|
| 7 | Undocumented single storey plant room structure. | Additional loading to main production building to be identified and incorporated in building assessment. | <b>6-weeks</b> |

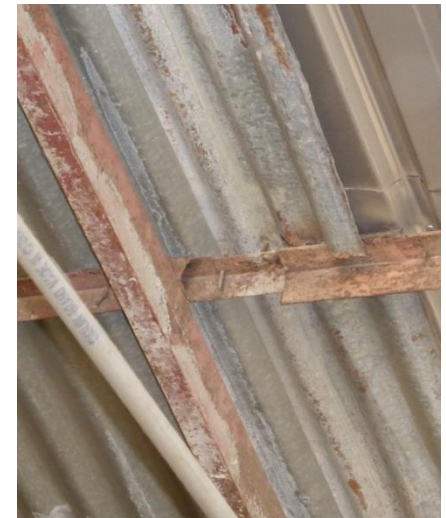
**Purlin connection detail**
