# **FIRE SAFETY INSPECTION REPORT**

**SQUARE FASHIONS LTD**

**ROKEYAPUR, JAMIRDIA, HABIR BARI, VALUKA**

July 16, 2014

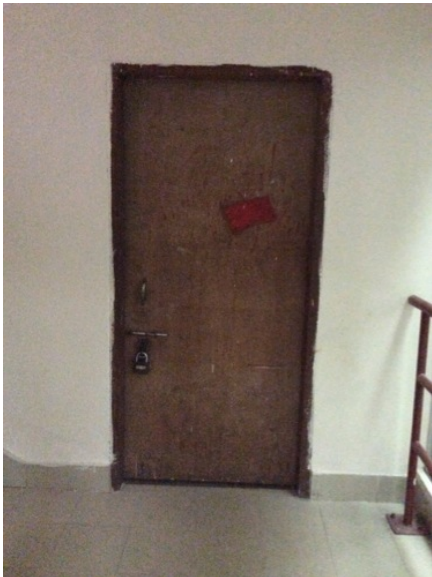
| No. | Category | Finding | Recommendation | Remediation Timeframe |
|---|---|---|---|---|
| F-1 | Fire Rated Construction | The chemical store room discharges to the west exit stair at mezzanine 1. | <p>Provide a 2-hr fire-rated vestibule from the storage room to the exit stair with a 1.5-hr fire door on the exit stair side and a 1-hr fire door on the storage room side.</p> <p>Alternately, provide access to the storage room by a route other than by means of the exit stair.</p> | Within 3 months |

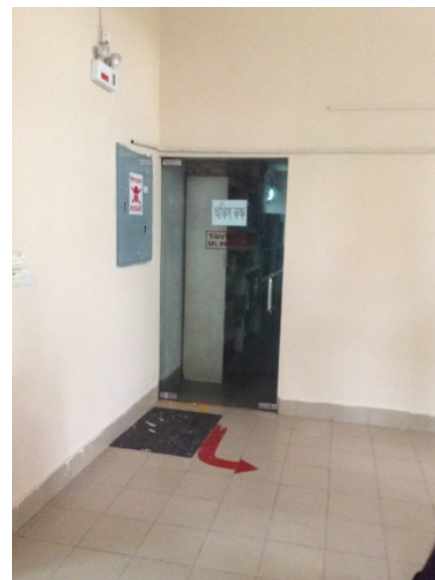
| F-2 | Fire Rated Construction | The exit stairs are not separated from work areas and other spaces on each floor by fire-rated construction. | Provide minimum 1.5-hr fire rated doors and seal all unprotected openings to separate the exit stairs from work areas and other building spaces on all floor levels. Ensure that the fire doors are self-closing and positive latching and that they are provided with fire exit (panic) hardware where serving production floors.<br><br>If fire doors are required to be held open for functional reasons, provide automatic-closing devices tied to the fire alarm system. | Within 3 months |

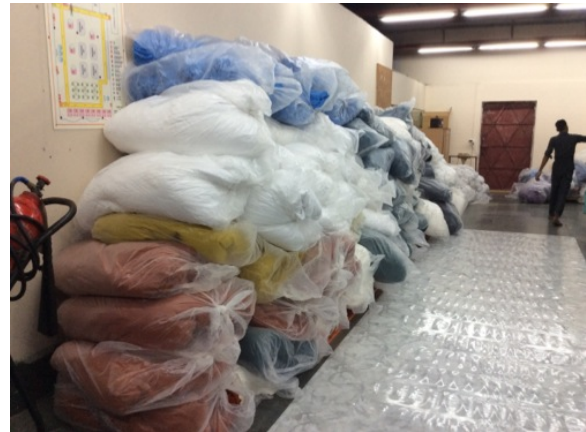
| F-3 | Fire Rated Construction | Areas used for combustible storage, open to the factory floor on the ground and second floors, were not separated by fire-rated construction. | <p>Provide dedicated storage rooms separated by minimum 1-hr fire-rated construction.</p> <p>Where separate storage rooms are not feasible, provide defined storage areas and limit the storage arrangement as follows:</p> <ul style="list-style-type: none"><li>- Maximum height of 2.4m and maximum area of 23m<sup>2</sup></li><li>- If sprinkler protected: maximum height of 3.66m and maximum area of 93m<sup>2</sup></li></ul> <p>Separate areas of unenclosed combustible storage by a minimum clear distance of 3m.</p> | Within 3 months |

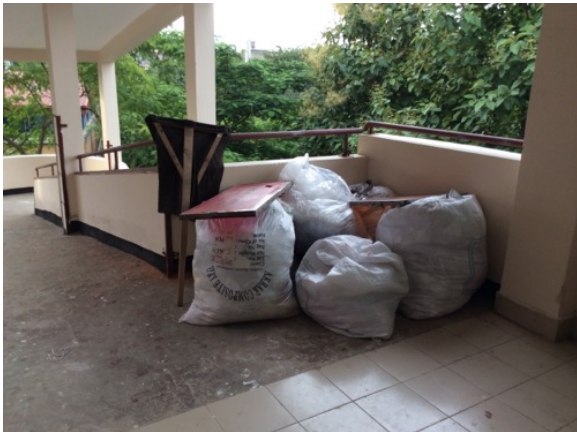
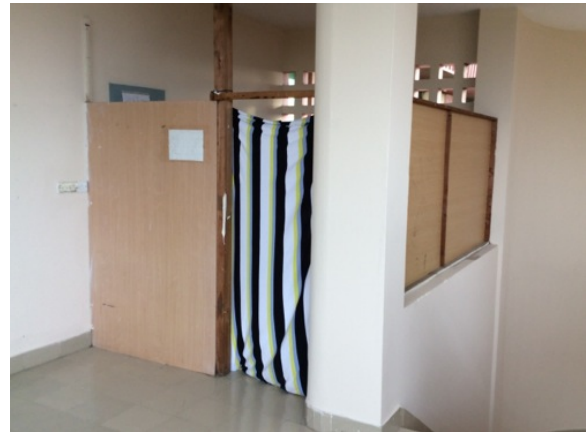
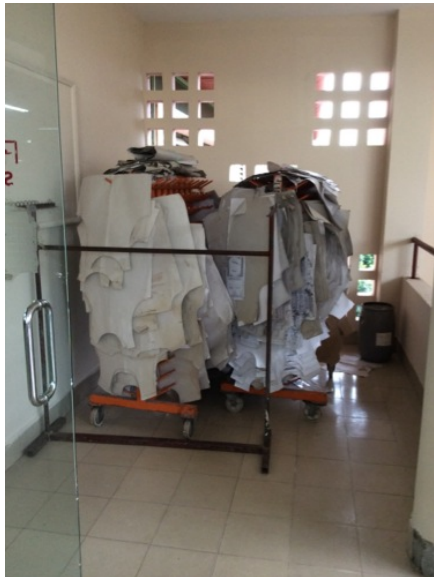
| F-6 | Egress | Storage was located in all exit stairs. | Remove all storage from exit stairs and egress paths. | Immediate |

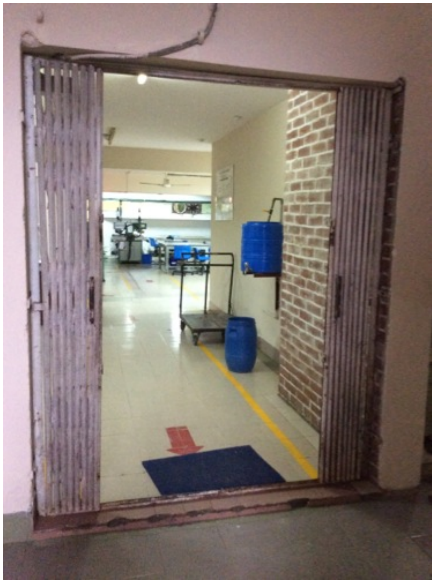
| F-7 | Egress | Collapsible gates are provided at building exits. | Replace all gates along the means of egress with side-hinged, swinging egress doors.<br><br>If locks are required for security reasons, utilize special door locking features complying with NFPA 101. | Within 1 month |

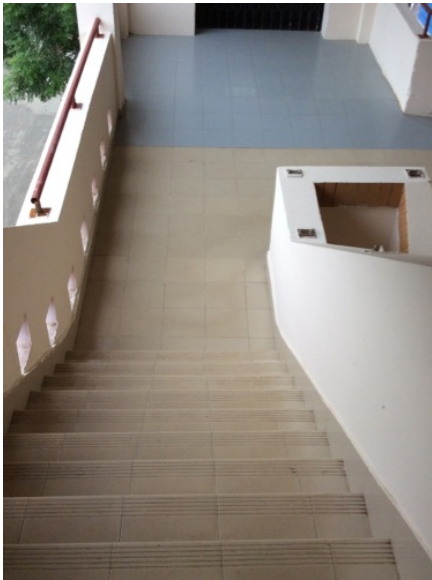
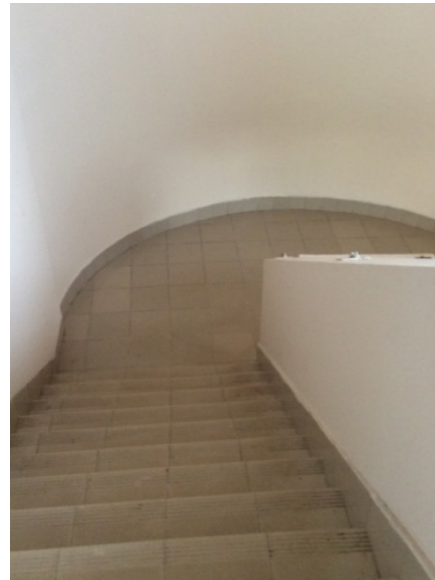
| F-9 | Egress | Handrails are not provided throughout the south exit stair. | Provide handrails on at least one side of exit stair. | Within 3 months |

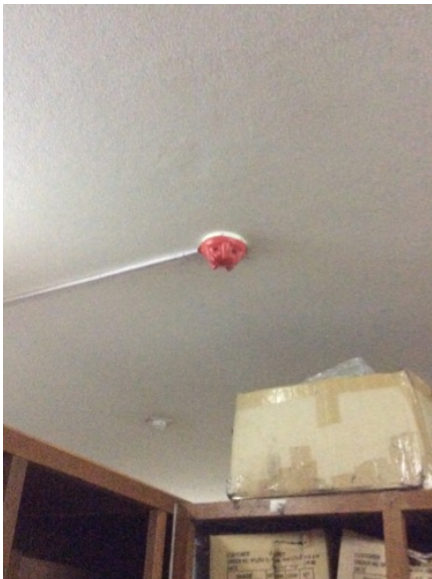
| F-10 | Fire Protection | During the inspection, many of the detectors observed still had covers on them that were not removed after installation. | Remove the covers from the smoke detectors so that they can function properly. | Immediate |

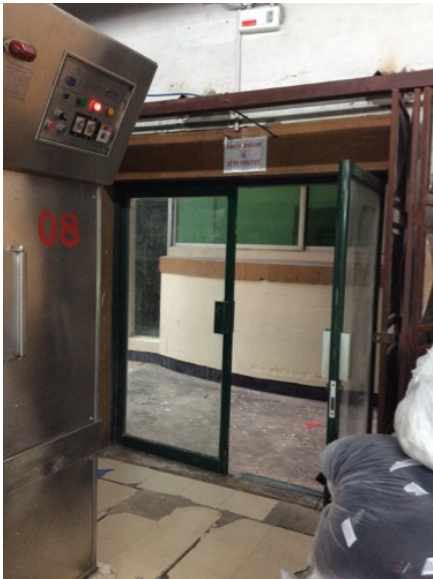
| F-13 | Egress Lighting | Lighted exit sign not provided at the ground floor exit from the washing room. | Provide exit signs above all exits to the exterior and all doors to the exit stairs. | Within 1 month |

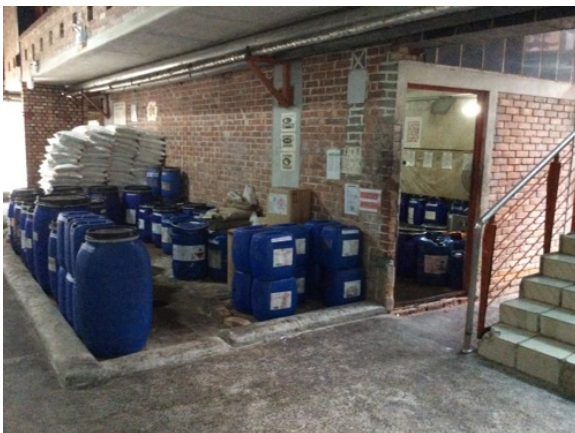
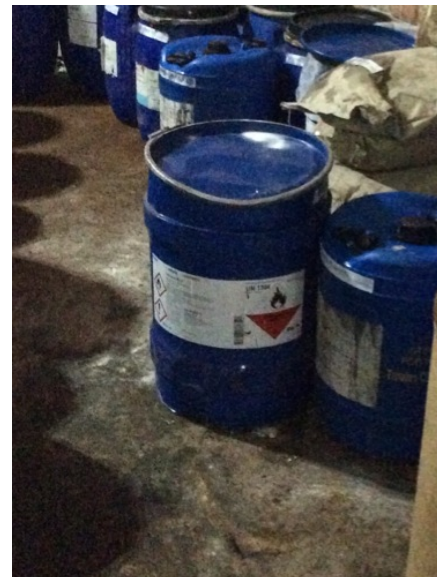
| No. | Category | Finding | Recommendation | Remediation Timeframe |
|---|---|---|---|---|
| F-1 | Fire Rated Construction | The hazardous materials/flammable liquid storage room and area on the ground floor is not separated by fire-rated construction. The room is not separated due to openings and a non-rated doors and the area outside the room is open to the factory floor. | Separate the hazardous materials/flammable liquid storage room and area by a minimum 2-hr fire-rated construction. Seal and/or protected all openings to maintain the required fire separations. | Within 3 months |

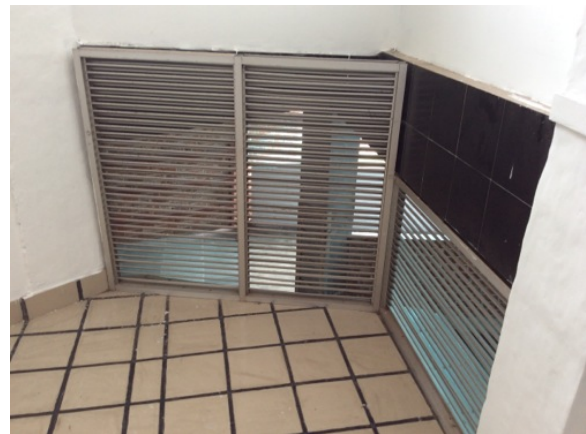
| F-2 | Fire Rated Construction | The exit stairs are not separated from work areas and other spaces on each floor by fire-rated construction. | Provide minimum 1.5-hr fire rated doors and seal all unprotected openings to separate the exit stairs from work areas and other building spaces on all floor levels. Ensure that the fire doors are self-closing and positive latching and that they are provided with fire exit (panic) hardware where serving production floors.<br><br>If fire doors are required to be held open for functional reasons, provide automatic-closing devices tied to the fire alarm system. | Within 3 months |

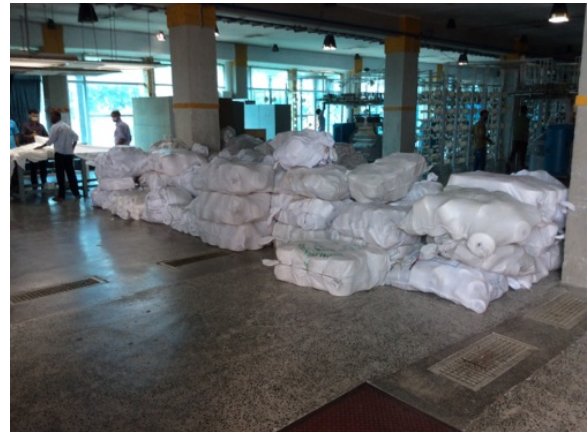
| F-3 | Fire Rated Construction | Areas used for combustible storage, open to the factory floor on the ground, first, and second floors, were not separated by fire-rated construction. | <p>Provide dedicated storage rooms separated by minimum 1-hr fire-rated construction.</p> <p>Where separate storage rooms are not feasible, provide defined storage areas and limit the storage arrangement as follows:</p> <ul style="list-style-type: none"><li>- Maximum height of 2.4m and maximum area of 23m<sup>2</sup></li><li>- If sprinkler protected: maximum height of 3.66m and maximum area of 93m<sup>2</sup></li></ul> <p>Separate areas of unenclosed combustible storage by a minimum clear distance of 3m.</p> | Within 3 months |

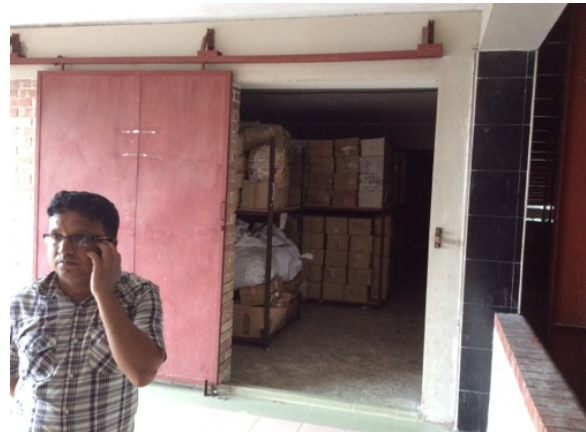
| F-4 | Fire Rated Construction | <p>Rooms used for combustible storage on the ground (engineering store, finished fabrics store), west mezzanine (fabric store), east mezzanine (accessory store), first (fabric store), and second (waste storage room) floors were not separated by fire-rated construction.</p> <p>The entire basement area was dedicated to storage and discharged to all six (6) exit stairs that served the building.</p> | <p>Provide dedicated storage rooms separated by minimum 1-hr fire-rated construction.</p> <p>Provide a 2-hr fire-rated vestibule where a storage room discharges to an exit stair. Provide a 1.5-hr fire door on the exit stair side and a 1-hr fire door on the storage room side.</p> | Within 3 months |

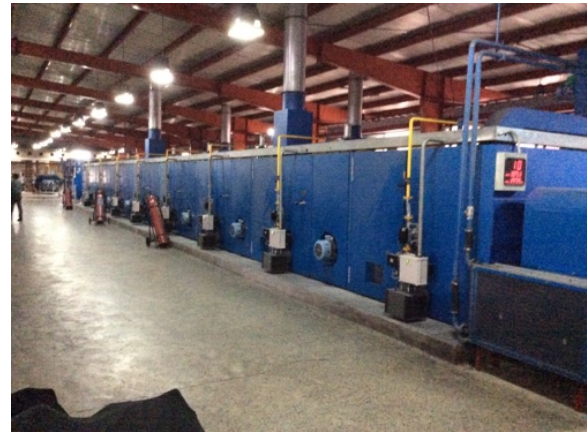
| F-6 | Fire Rated Construction | The two (2) stentor machines on the ground floor in the east shed extension are not separated by fire-rated construction and open to the surrounding factory areas. | Separate the stentor machines by a minimum 2-hr fire-rated construction. Seal and/or protected all openings to maintain the required fire separations | Within 3 months |

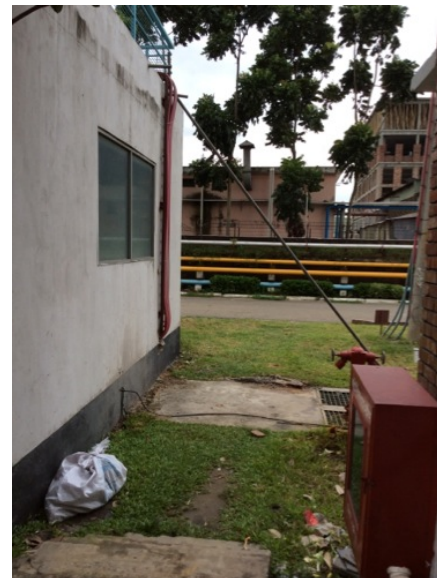
| F-7 | Fire Rated Construction | The exit discharge path serving a north door on the ground floor is less than 10 ft wide and is not separated from the sub station building interior. | Seal all penetrations and openings to the interior of the building along the discharge path, up to a height of 10 ft., to provide a minimum 1-hr fire separation. | Within 6 months |

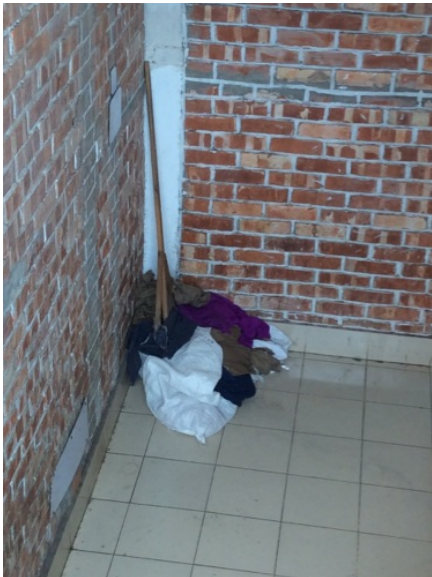
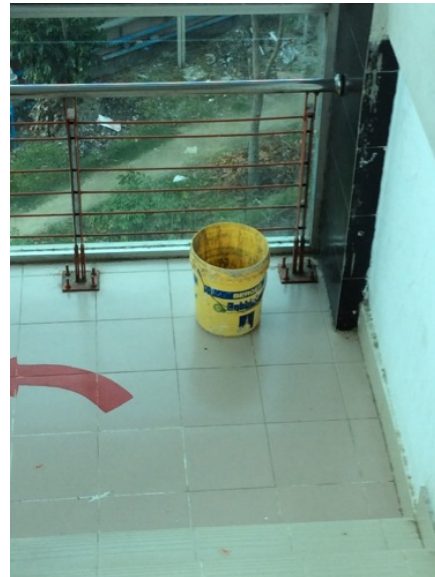
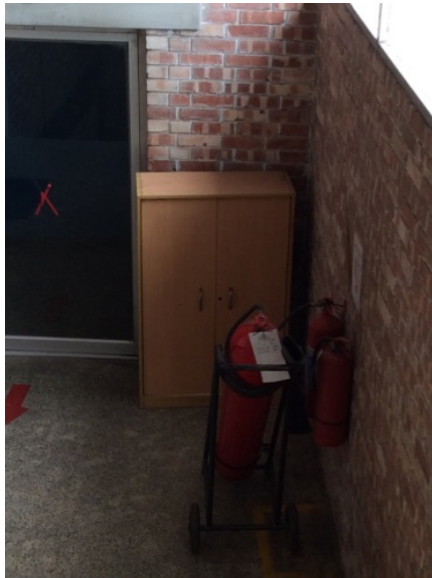
F-10 Egress

Storage was located in all exit stairs.

Remove all storage from exit stairs and egress paths.

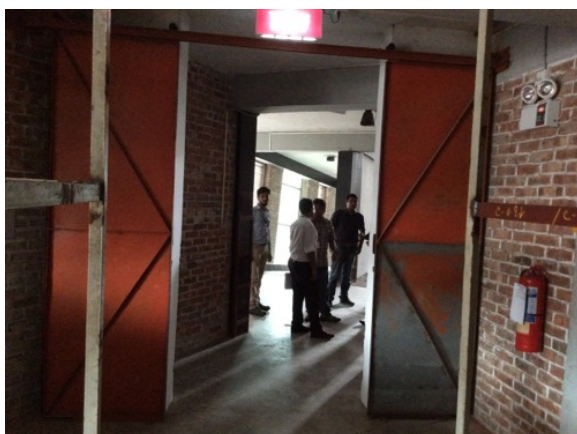
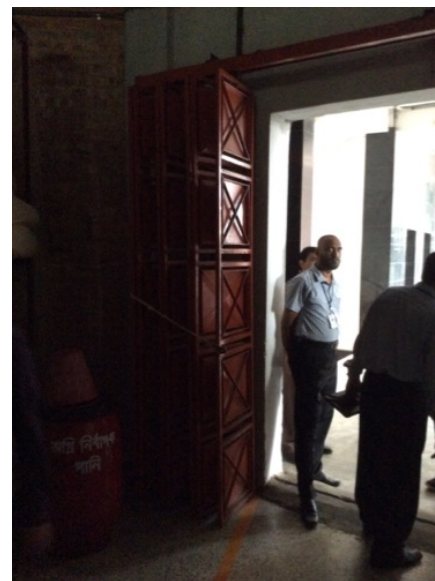
| F-11 | Egress | Sliding doors are provided along egress routes. | Replace all gates along the means of egress with side-hinged, swinging egress doors. | Within 1 month |

| | | If locks are required for security reasons, utilize special door locking features complying with NFPA 101. | | |

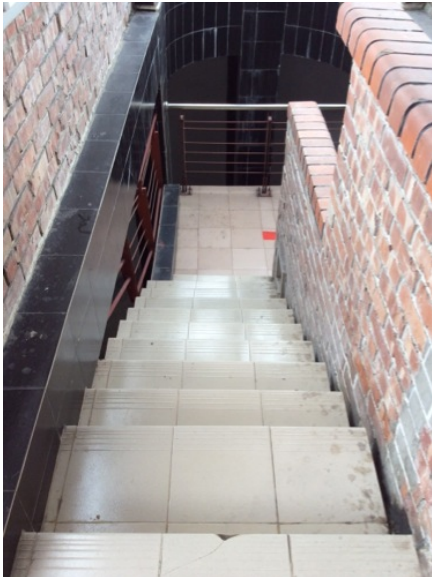
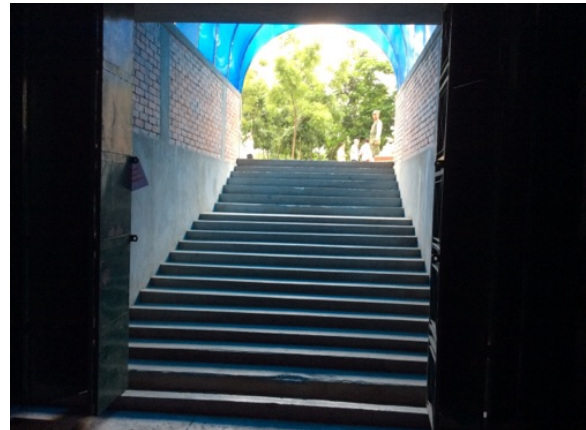
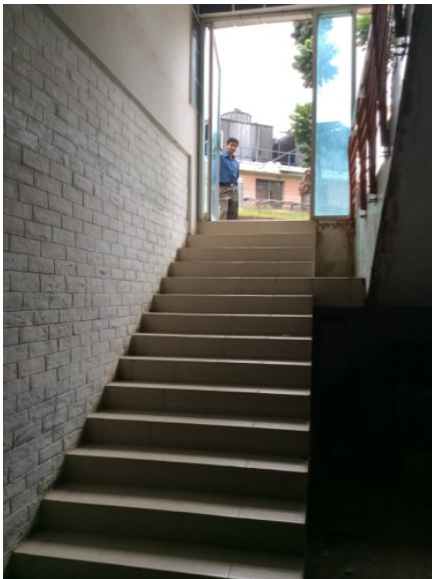
| F-12 | Egress | Handrails were missing from the east shed exit stair, a basement exit stair to the exterior, and in the northeast exit stair to the basement. | Provide handrails on at least one side of exit stair. | Within 3 months |

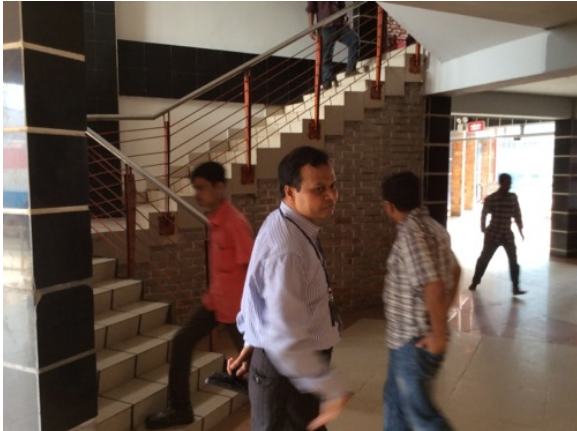
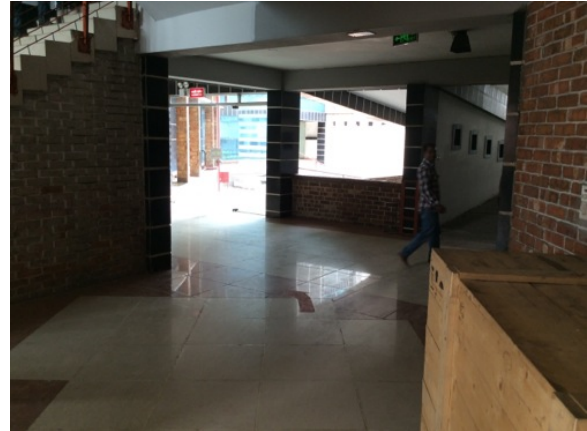
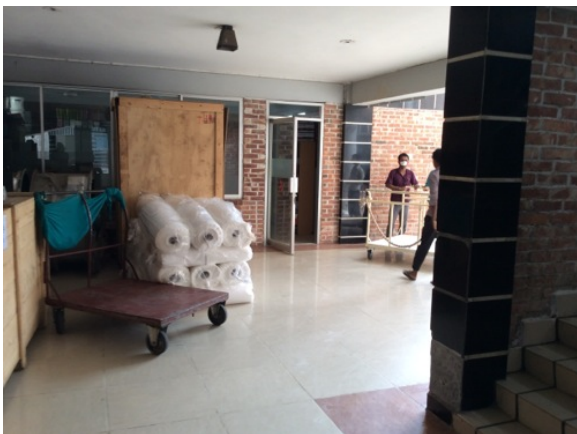
| F-14 | Egress | The southwest exit stairs discharge inside the building on the ground floor, adjacent to a store room and offices. | Provide 2-hr fire-rated exit passageway leading directly outside (vestibules to separate any storage areas). | Within 6 months |

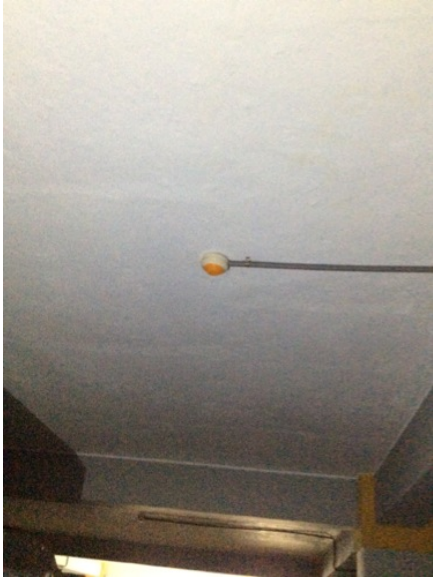
| F-15 | Fire Protection | During the inspection, many of the detectors observed still had covers on them that were not removed after installation. | Remove the covers from the smoke detectors so that they can function properly. | Immediate |

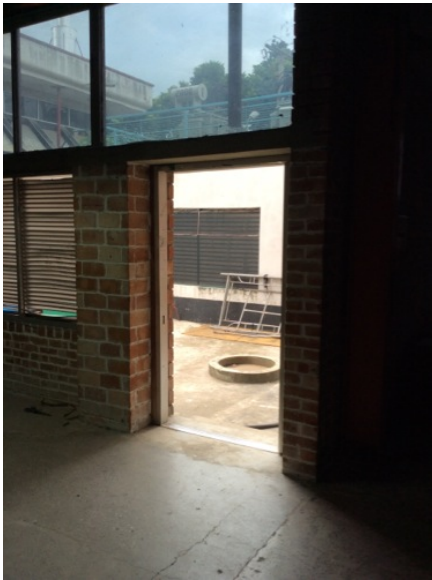
| F-18 | Egress Lighting | Lighted exit signs not provided in the entire basement area and from a ground floor exit to the exterior, on the north side of the building. | Provide exit signs above all exits to the exterior and all doors to the exit stairs. | Within 1 month |

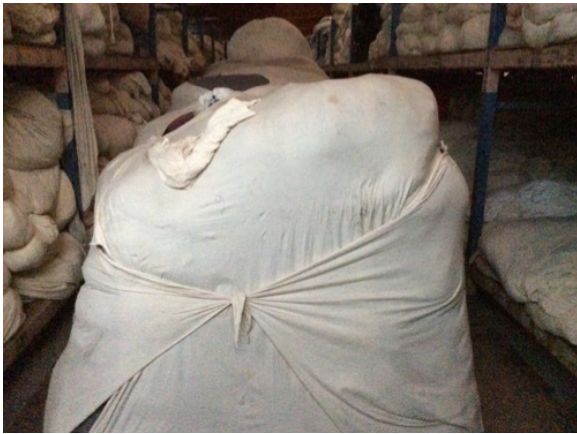
| F-3 | Egress | Storage was located in a egress path on the first floor. | Keep egress paths and stairs clear of storage. | Immediate |

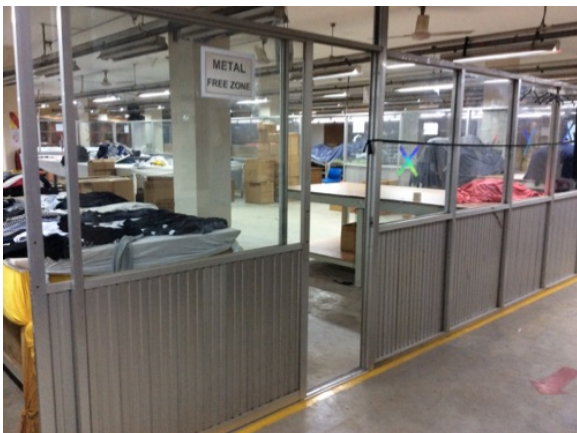
| F-4 | Egress | Sliding doors are provided along egress routes. | Replace all sliding doors along the means of egress with side-hinged, swinging egress doors. | Within 1 month |

If locks are required for security reasons, utilize special door locking features complying with NFPA 101.

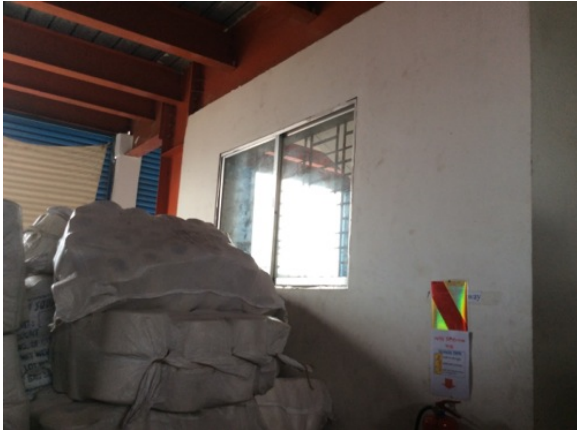
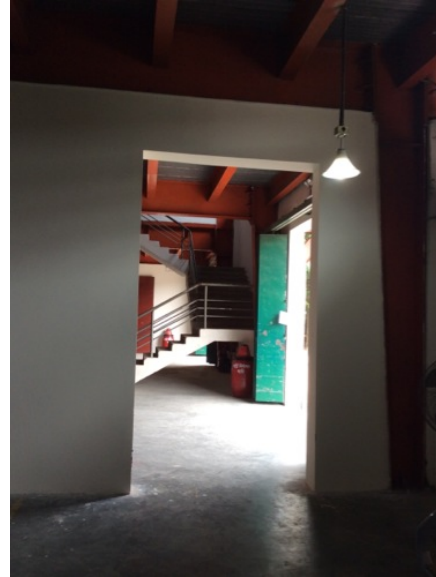
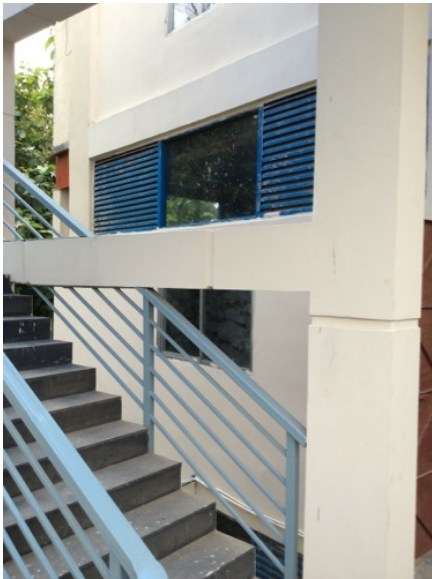
| No. | Category | Finding | Recommendation | Remediation Timeframe |
|---|---|---|---|---|
| F-1 | Fire Rated Construction | <p>The exit stairs are not separated from work areas and other spaces on each floor by fire-rated construction.</p> <p>The exterior exit stairs had unprotected openings to the building interior adjacent to and extending to a distance of 10 ft. beyond the ends of the exit stair.</p> | <p>Provide minimum 1.5-hr fire rated doors and seal all unprotected openings to separate the exit stairs from work areas and other building spaces on all floor levels.</p> <p>Ensure that the fire doors are self-closing and positive latching and that they are provided with fire exit (panic) hardware where serving production floors.</p> <p>If fire doors are required to be held open for functional reasons, provide automatic-closing devices tied to the fire alarm system.</p> <p>Seal all unprotected openings to the building interior, adjacent to and extending at a distance of 10 ft. beyond the ends of the east, exterior exit stair.</p> | Within 3 months |

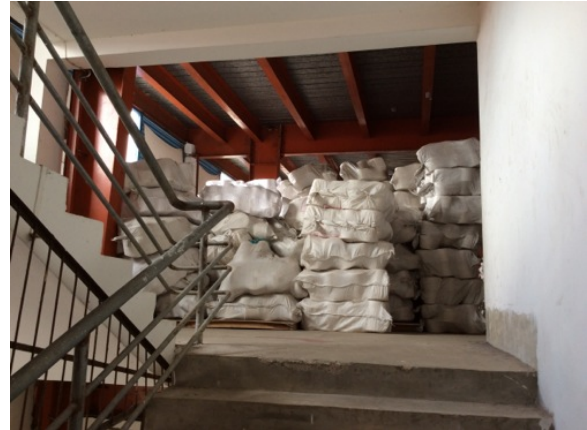
| F-2 | Fire Rated Construction | The interior exit stairs were not enclosed in fire-rated construction on any floor. | Enclose the interior exit stairs in 2-hr fire-rated construction on all floors. | Within 3 months |

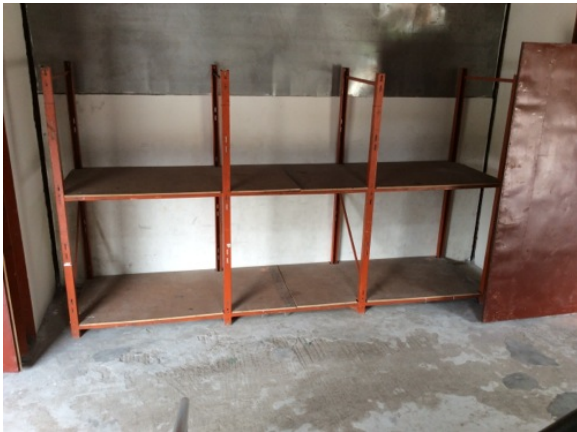
| F-5 | Egress | Storage was located in the southeast exit stair on the ground floor. | Remove all storage from exit stairs and egress paths. | Immediate |

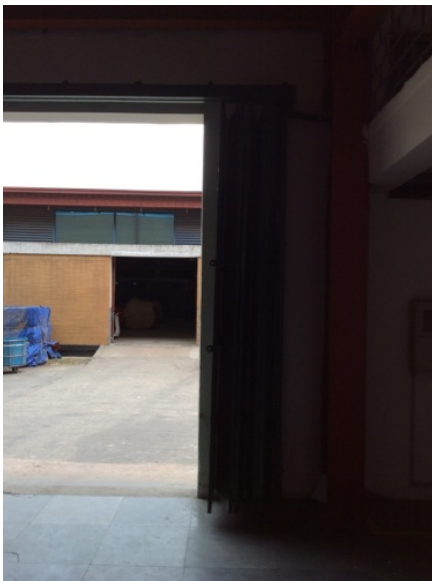
| F-6 | Egress | Sliding doors are provided at building exits. | Replace all sliding doors along the means of egress with side-hinged, swinging egress doors. | Within 1 month |

| | | | If locks are required for security reasons, utilize special door locking features complying with NFPA 101. | |

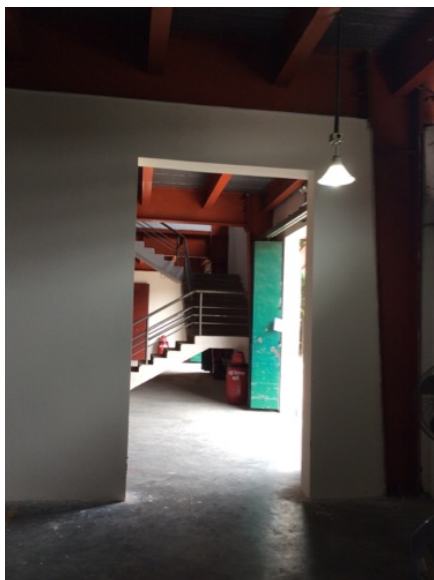
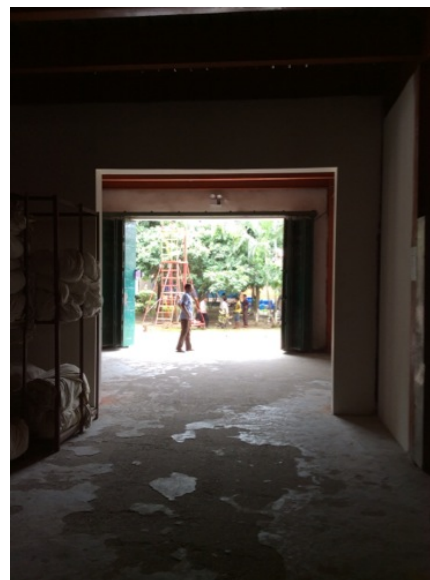
| F-9 | Egress Lighting | Lighted exit signs were not provided throughout the building. | Provide exit signs above all exits to the exterior and all doors to the exit stairs. | Within 1 month |

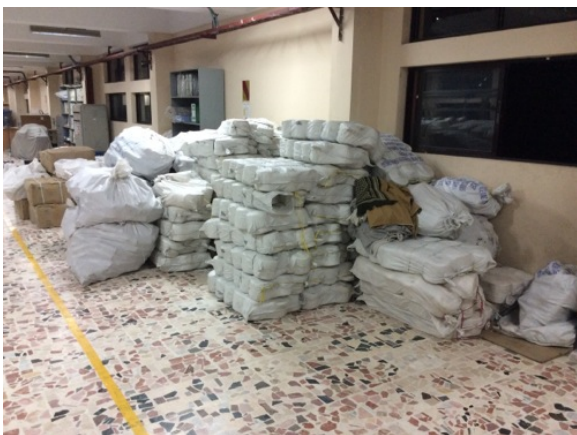
| No. | Category | Finding | Recommendation | Remediation Timeframe |
|---|---|---|---|---|
| F-1 | Fire Rated Construction | Areas used for combustible storage, open to the first floor, are not separated by fire-rated construction. | <p>Provide dedicated storage rooms separated by minimum 1-hr fire-rated construction.</p> <p>Where separate storage rooms are not feasible, provide defined storage areas and limit the storage arrangement as follows:</p> <ul style="list-style-type: none"> <li>- Maximum height of 2.4m and maximum area of 23m<sup>2</sup></li> <li>- If sprinkler protected: maximum height of 3.66m and maximum area of 93m<sup>2</sup></li> </ul> <p>Separate areas of unenclosed combustible storage by a minimum clear distance of 3m.</p> | Within 3 months |

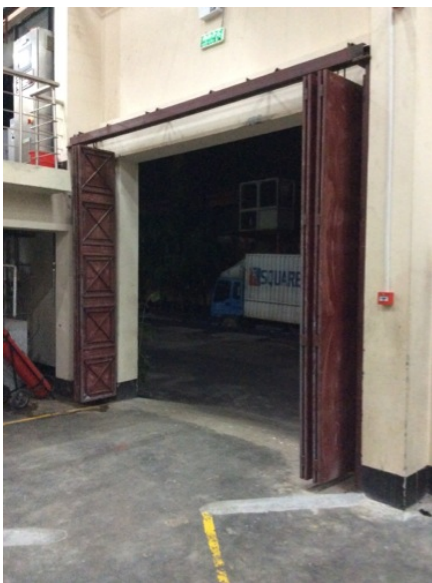
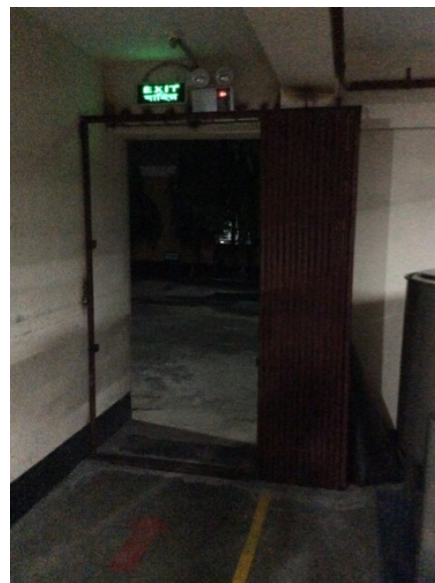
| F-6 | Egress | Sliding doors and gates are provided at building exits. | Replace all sliding doors along the means of egress with side-hinged, swinging egress doors. | Within 1 month |

| | | | If locks are required for security reasons, utilize special door locking features complying with NFPA 101. | |

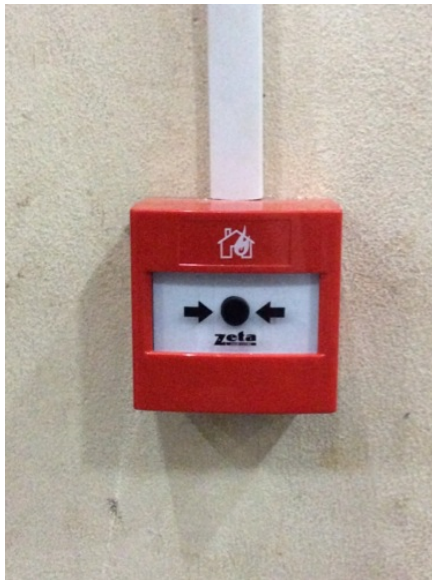
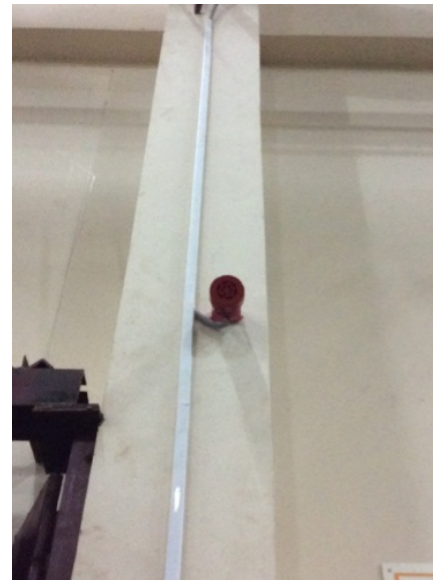
| F-7 | Fire Protection | The fire alarm system is antiquated, not a listed system, and does not provide alarm and notification features consistent with acceptable standards. | Replace the fire alarm system with a new, listed addressable fire alarm system in accordance with NFPA 72. | Design within 4 months, install within 9 months |

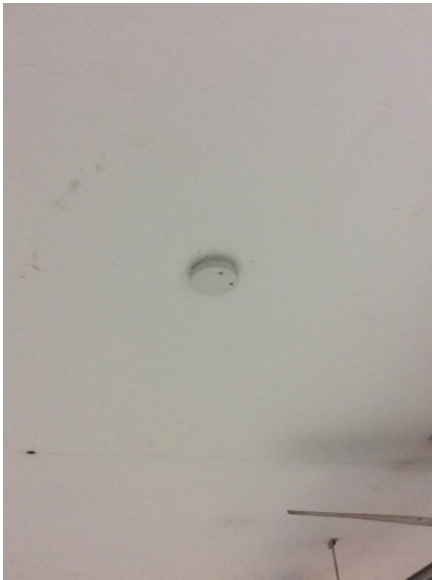
| F-9 | Fire Protection | No fire detection system was provided in the building. | Provide automatic smoke detection throughout the building, tied into the fire alarm system, in accordance with NFPA 72. | Within 6 months |

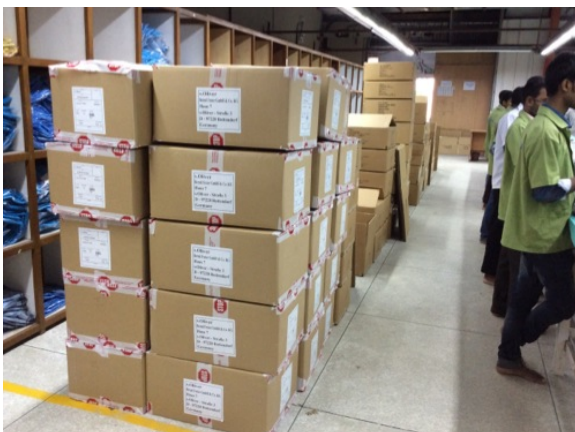
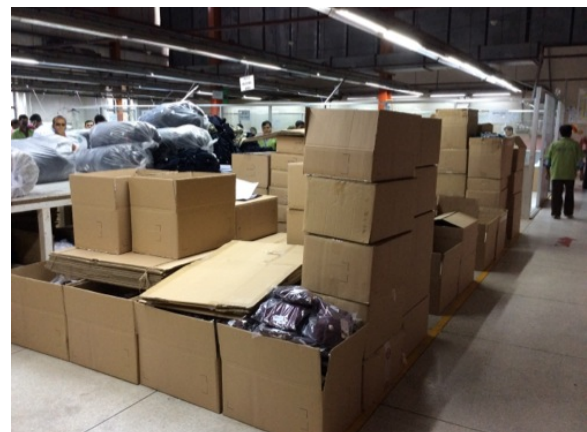
| No. | Category | Finding | Recommendation | Remediation Timeframe |
|---|---|---|---|---|
| F-1 | Fire Rated Construction | Areas used for combustible storage, open to the factory floor, were not separated by fire-rated construction. | <p>Provide dedicated storage rooms separated by minimum 1-hr fire-rated construction.</p> <p>Where separate storage rooms are not feasible, provide defined storage areas and limit the storage arrangement as follows:</p> <ul style="list-style-type: none"> <li>- Maximum height of 2.4m and maximum area of 23m<sup>2</sup></li> <li>- If sprinkler protected: maximum height of 3.66m and maximum area of 93m<sup>2</sup></li> </ul> <p>Separate areas of unenclosed combustible storage by a minimum clear distance of 3m.</p> | Within 3 months |

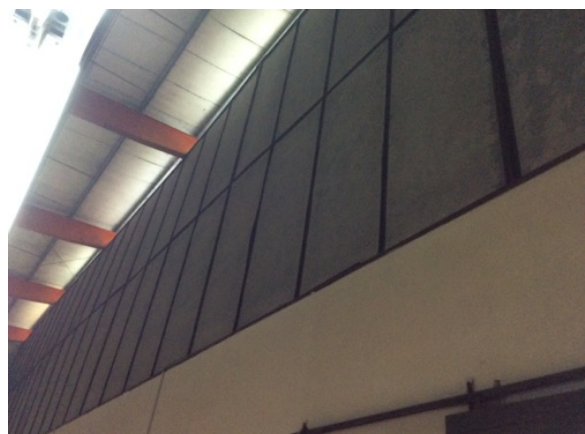
| F-2 | Fire Rated Construction | The entire finished fabrics and accessory store (ground and top two (2) mezzanines) was a room used for combustible storage and was not separated by fire-rated construction. | Provide dedicated storage rooms separated by minimum 1-hr fire-rated construction. | Within 3 months |

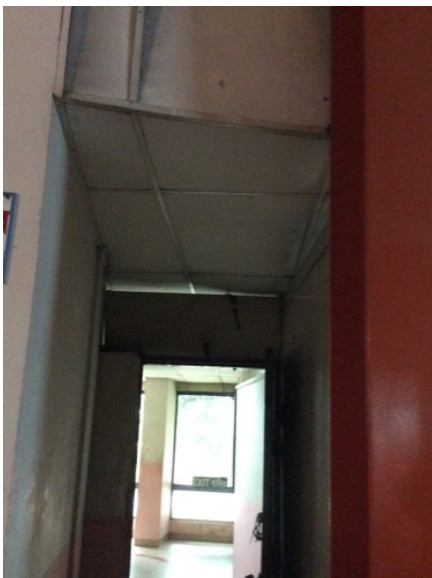
| F-5 | Egress | The exit capacity of the ground floor (3312) is not adequate for the reported occupant load (4062). An exit sign can be added along an available egress route, which will increase the exit capacity by 197, however an additional 87 in. of exit door width from the ground floor will still be required. | Immediately reduce occupant load of the ground floor to not more than available exit capacity.<br><br>Alternately, provide additional exits. | Immediate |

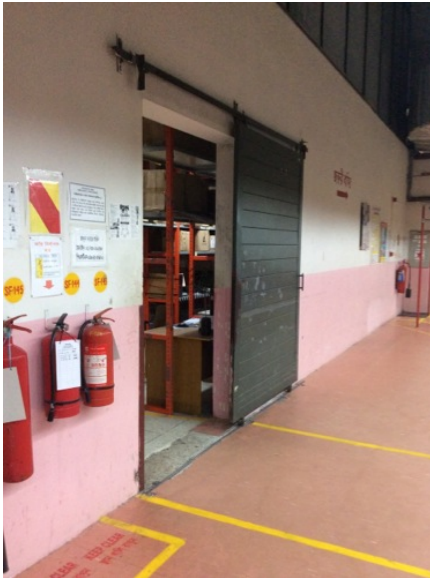
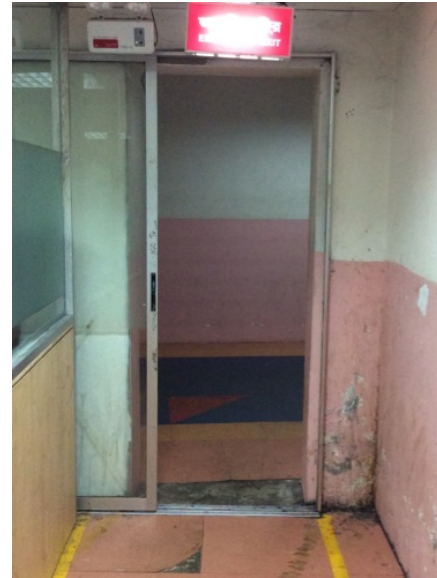
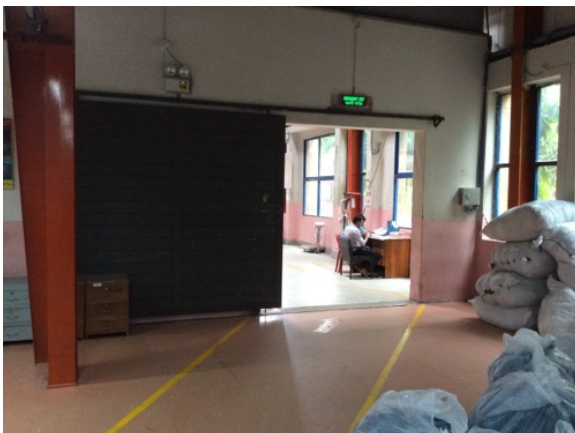
| F-6 | Egress | Sliding doors are provided along egress routes. | Replace all gates along the means of egress with side-hinged, swinging egress doors. | Within 1 month |

If locks are required for security reasons, utilize special door locking features complying with NFPA 101.

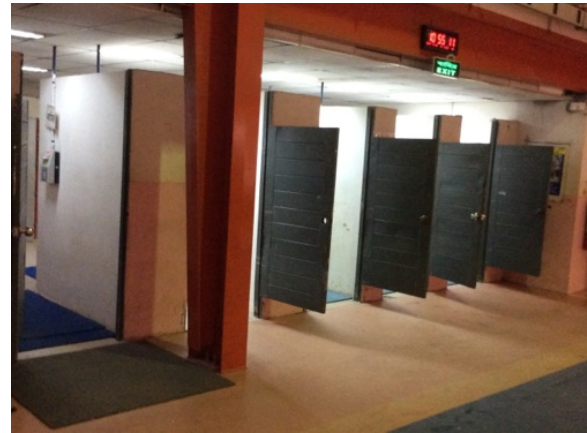
| F-7 | Egress | Both male and female general entrance doors (5 per each entrance) do not swing in the direction of egress travel. | Modify the egress door to swing in the direction of egress travel. | Within 3 months |

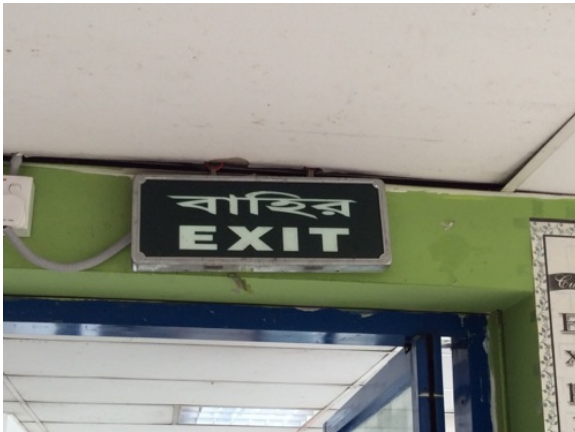
| F-13 | Egress Lighting | An exit sign at the east mezzanine was not illuminated (burned out, broken, etc.). | Regularly inspect all exit signage and replace/install lights as needed to illuminate signs. | Within 1 month |

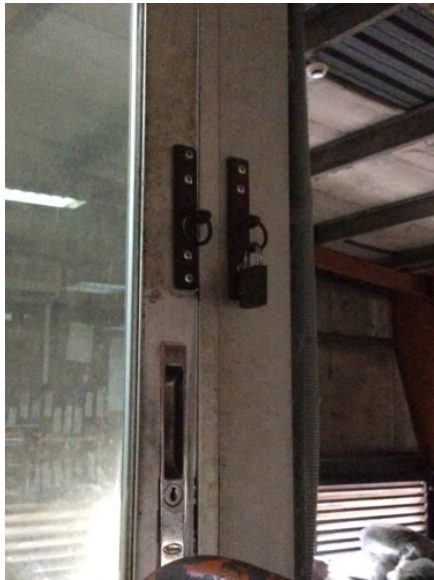
| F-4 | Egress | Egress doors with locking features are provided along egress routes. All doors were open and unlocked during the inspection. | Remove locking features from all egress doors.<br><br>If locks are required for security reasons, utilize special door locking features complying with NFPA 101. | Immediate |

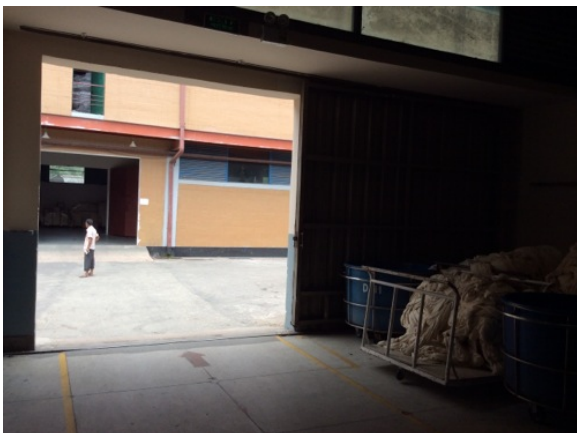
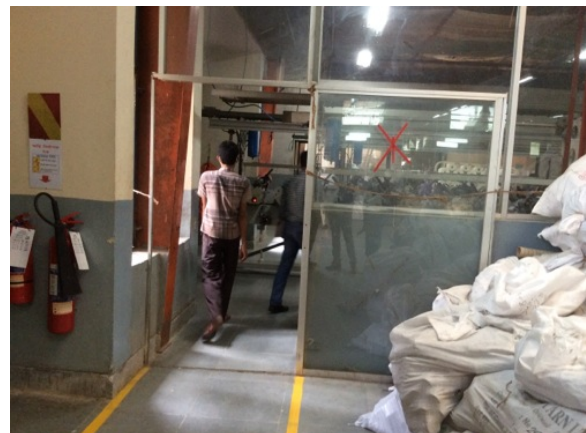
| F-5 | Egress | Sliding doors are provided at building exits and along egress routes. | Replace all gates along the means of egress with side-hinged, swinging egress doors. | Within 1 month |

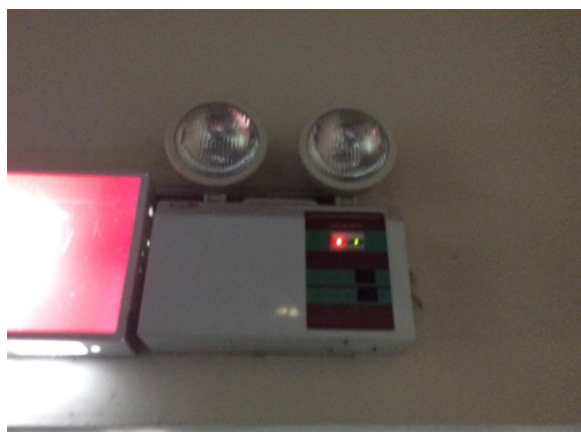
| F-11 | Egress Lighting | Emergency lighting on the factory floor did not function in test mode (burned out, broken, etc.). | Regularly test the emergency lighting system on each floor and replace/repair lights as needed. | Within 1 month |

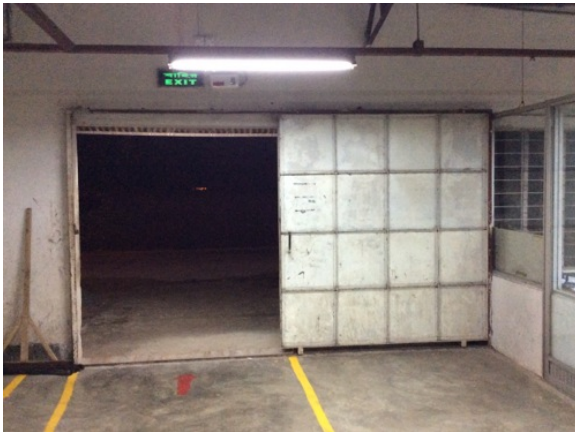
| No. | Category | Finding | Recommendation | Remediation Timeframe |
|---|---|---|---|---|
| F-2 | Egress | Sliding doors are provided at building exits. | <p>Replace all gates along the means of egress with side-hinged, swinging egress doors.</p> <p>If locks are required for security reasons, utilize special door locking features complying with NFPA 101.</p> | Within 1 month |
