FIRE SAFETY INSPECTION REPORT

**RENOWN APPARELS LTD.
BHATIARY LINK ROAD (SOUTH SIDE) BARODIGHIR
PAR, HATHAZARY**

ACCORD
on Fire and Building Safety in Bangladesh

July 19, 2014

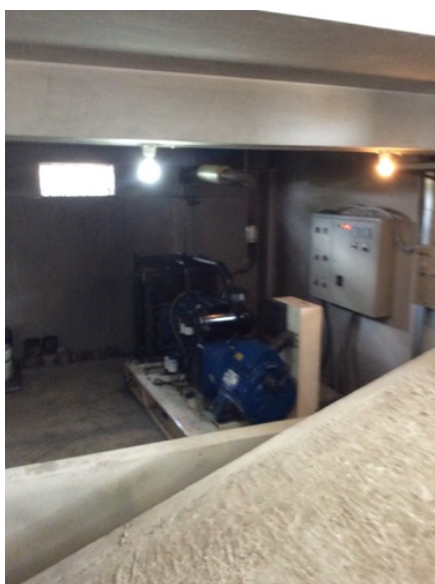
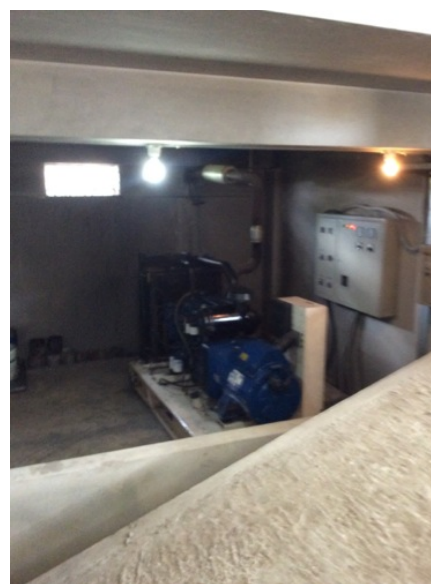
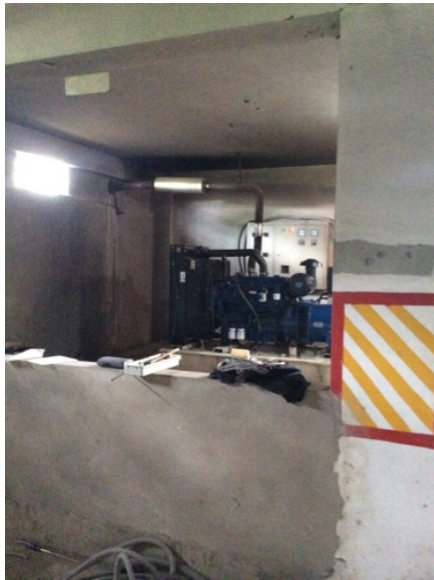
No.	Category	Finding	Recommendation	Remediation Timeframe
F-1	Fire Rated Construction	The generator room is not separated by fire-rated construction that is openings, non-rated doors, penetrations on basement floor.	Separate the generator room by a minimum 2-hr fire-rated construction. Seal and/or protected all openings to maintain the required fire separations	Within 3 months

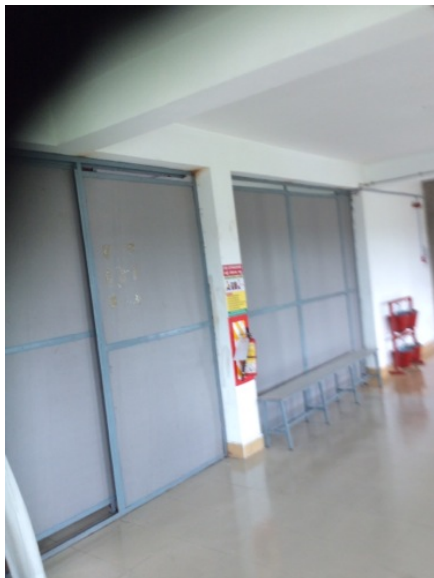
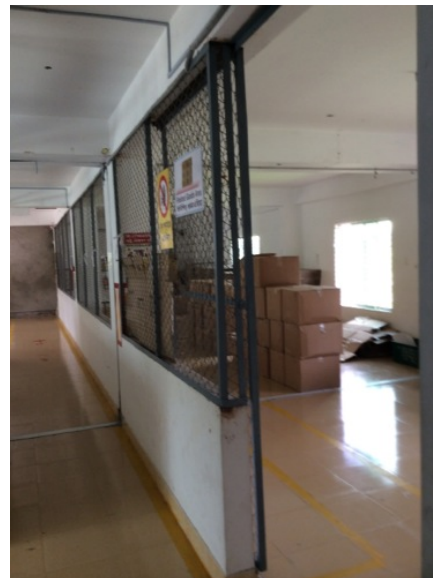
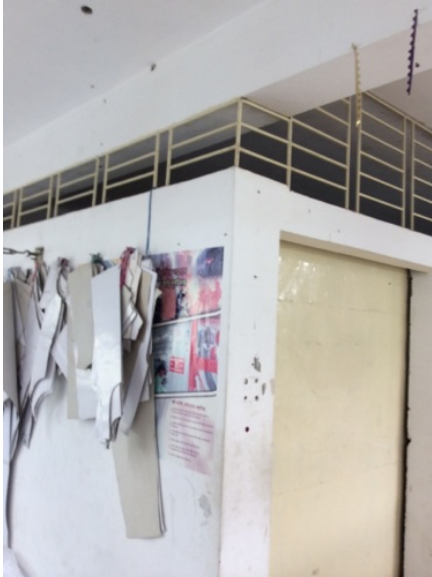
F-2	Fire Rated Construction	Rooms used for combustible storage are not separated by fire-rated construction on ground, 1st, 2nd and 3rd floors.	Provide dedicated storage rooms separated by minimum 1-hr fire-rated construction.	Within 3 months
-----	-------------------------	---	--	-----------------

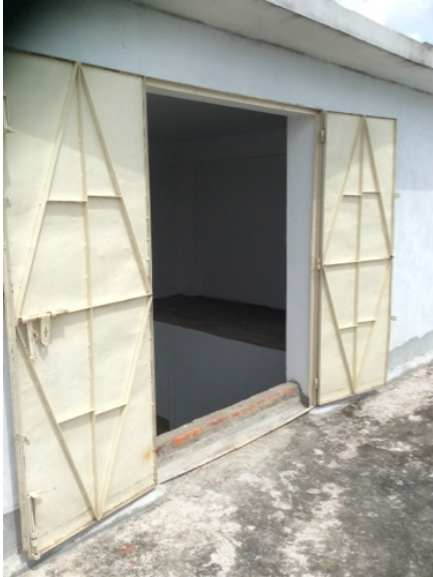
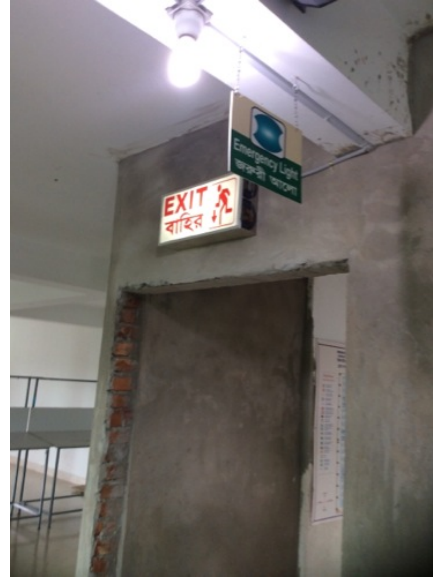
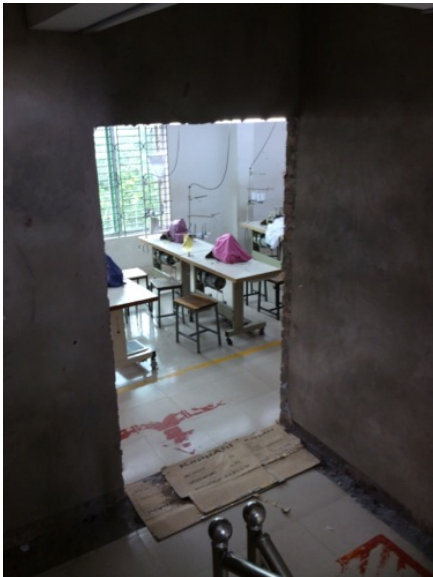
F-3	Fire Rated Construction	The exit stairs are not separated from work areas and other spaces on each floor by fire-rated construction.	Provide minimum 1.5-hr fire rated doors and seal all unprotected openings to separate the exit stairs from work areas and other building spaces on all floor levels. Ensure that the fire doors are self-closing and positive latching and that they are provided with fire exit (panic) hardware where serving production floors.	Within 3 months
			If fire doors are required to be held open for functional reasons, provide automatic-closing devices tied to the fire alarm system.

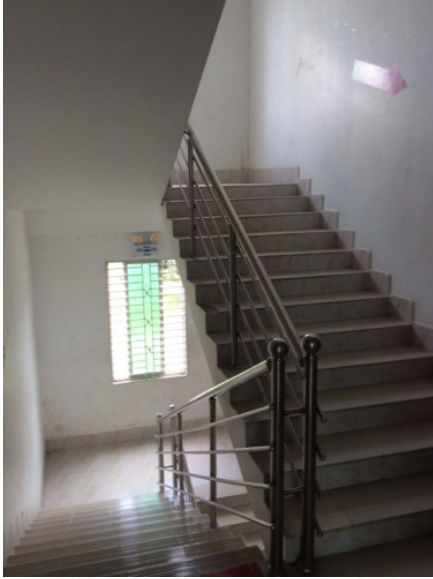
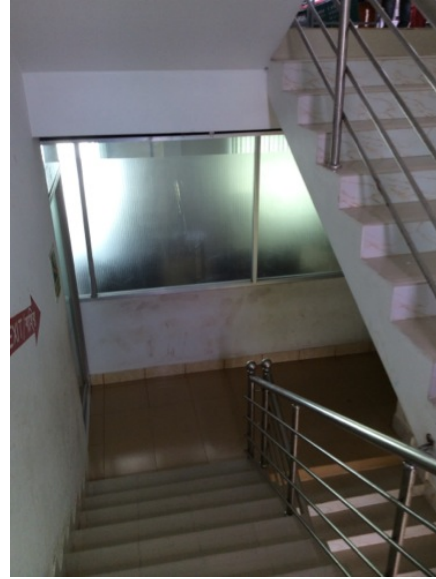
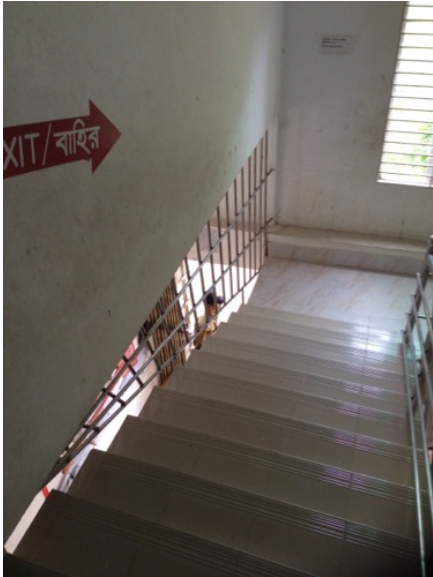
F-4	Fire Rated Construction	Unsealed penetrations and openings are located in exit stair enclosures.	Seal all penetrations and openings in exit stair enclosure walls to maintain the fire separation.	Within 3 months
-----	-------------------------	--	---	-----------------

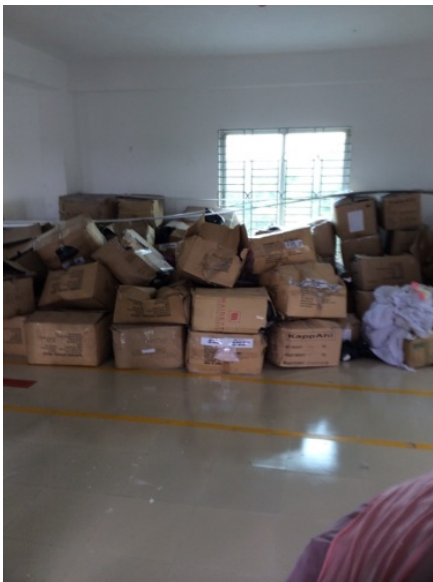
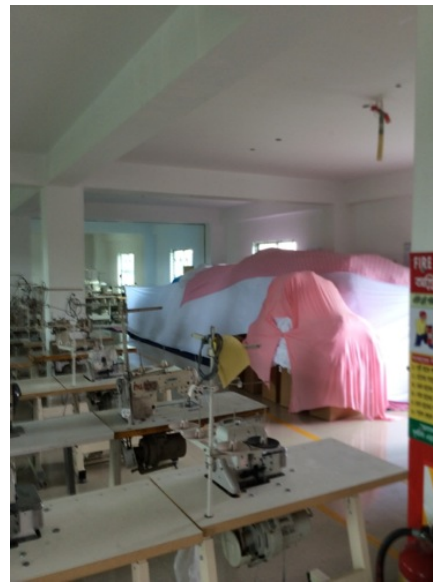
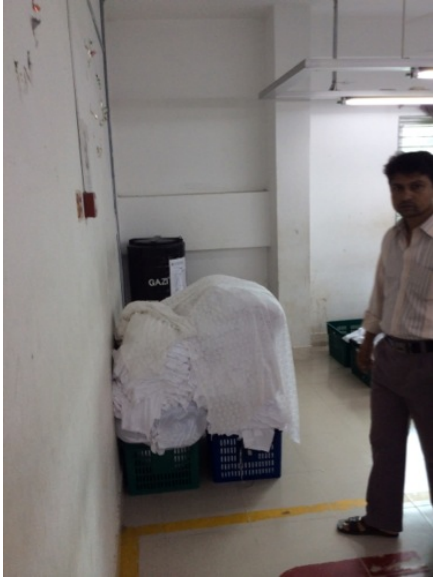
F-5	Fire Rated Construction	Areas used for combustible storage are not separated by fire-rated construction on ground, 1st, 2nd and 3rd floors.	Provide dedicated storage rooms separated by minimum 1-hr fire-rated construction. Where separate storage rooms are not feasible, provide defined storage areas and limit the storage arrangement as follows: - Maximum height of 2.4m and maximum area of 23m ² - If sprinkler protected: maximum height of 3.66m and maximum area of 93m ² Separate areas of unenclosed combustible storage by a minimum clear distance of 3m.	Within 3 months
-----	-------------------------	---	--	-----------------

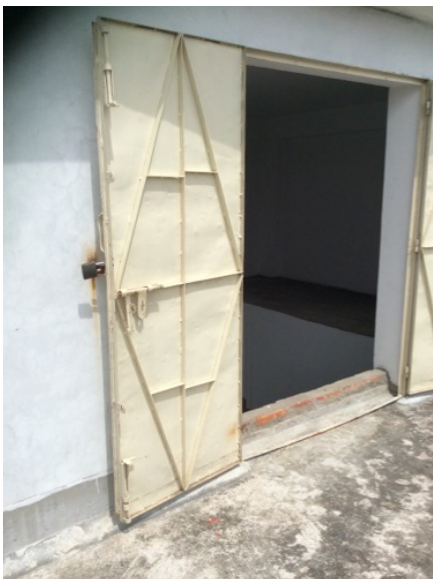
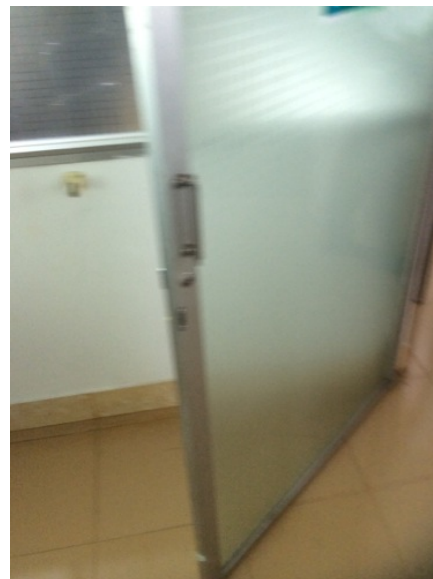
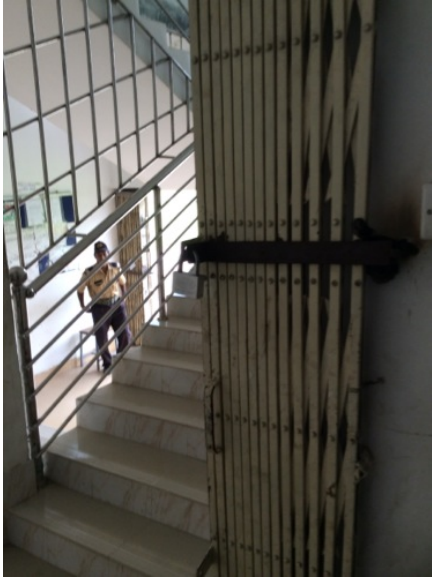
F-6	Egress	Egress doors / gates with locking features are provided at building exits, exit stairs, along egress routes and exit discharge on all floors. All gates/ doors were open and unlocked during inspection.	Remove locking features from all egress doors / gates. If locks are required for security reasons, utilize special door locking features complying with NFPA 101.	Immediate
-----	--------	--	--	-----------

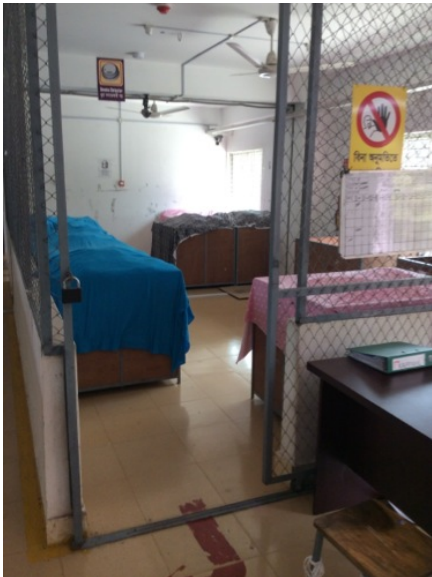
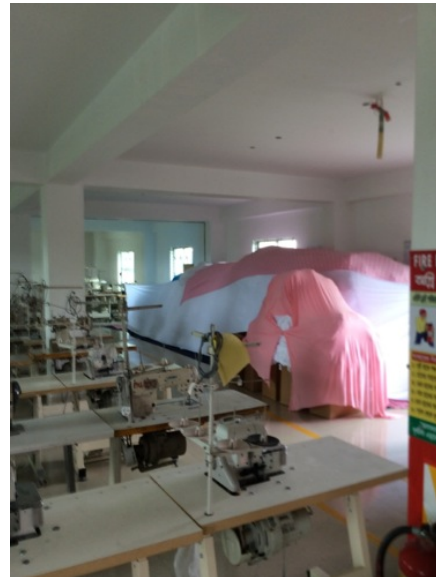
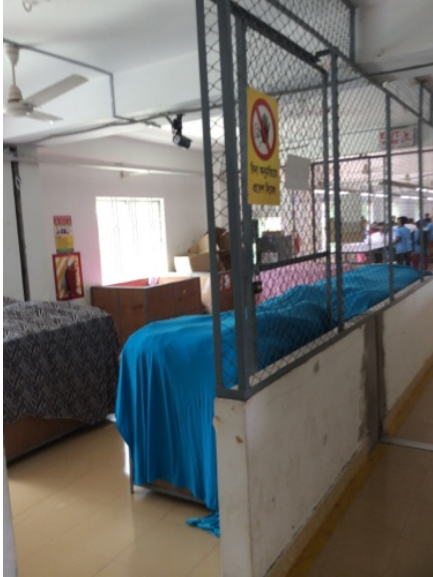
F-7	Egress	Storage was located in the egress path on 2nd and 3rd floors.	Keep egress paths and stairs clear of storage.	Immediate
-----	--------	---	--	-----------

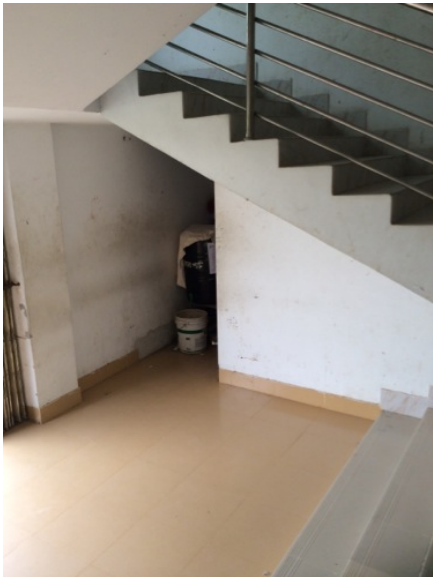
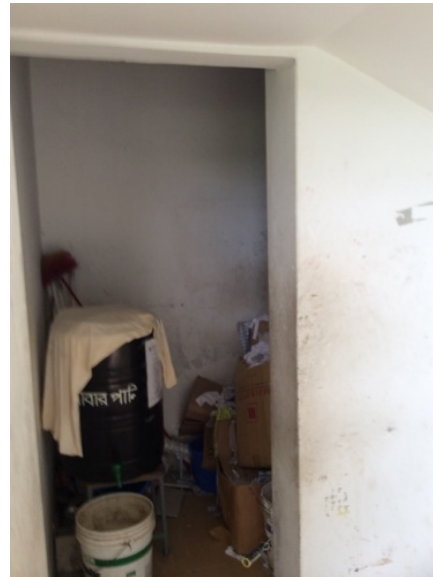
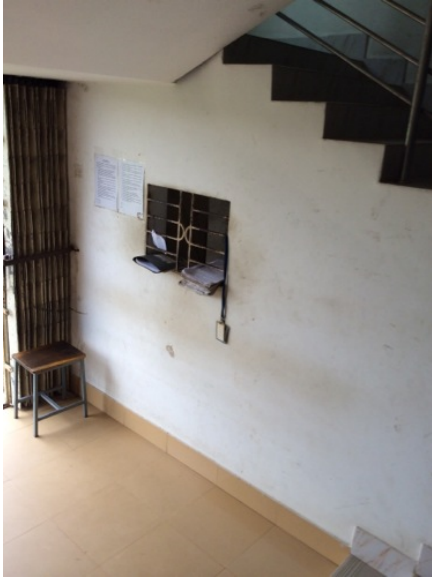
F-8 Egress

Storage was located in the exit stair on ground floor.

Remove all storage from exit stairs and egress paths.

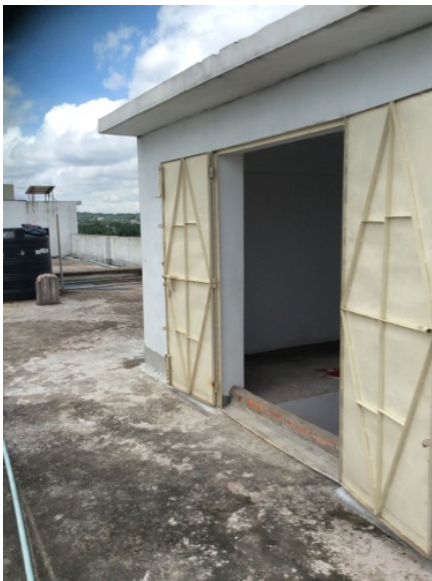
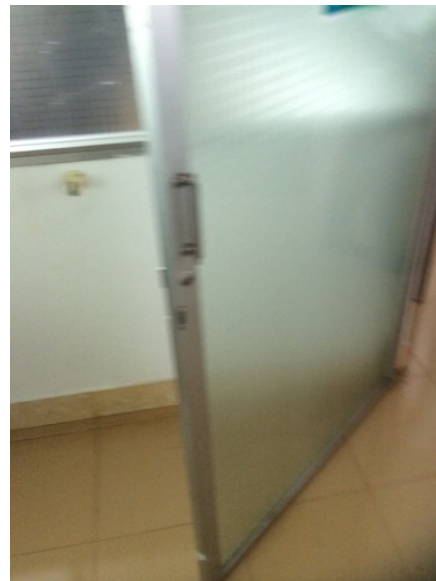
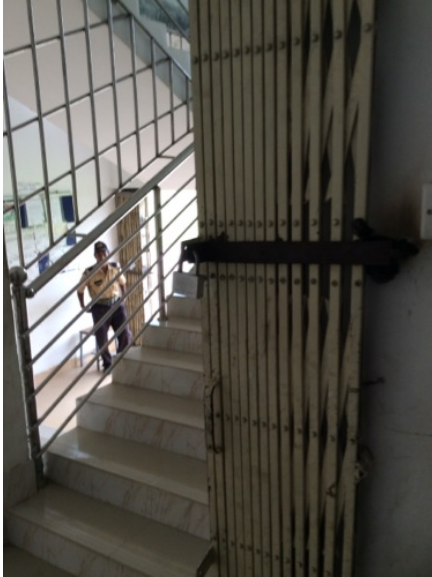
F-9 Egress

Collapsible gates / sliding doors are provided at building exits, exit stairs, along egress routes and exit discharge on all floors.

Replace all gates / sliding doors along the means of egress with side-hinged, swinging egress doors.

If locks are required for security reasons, utilize special door locking features complying with NFPA 101.

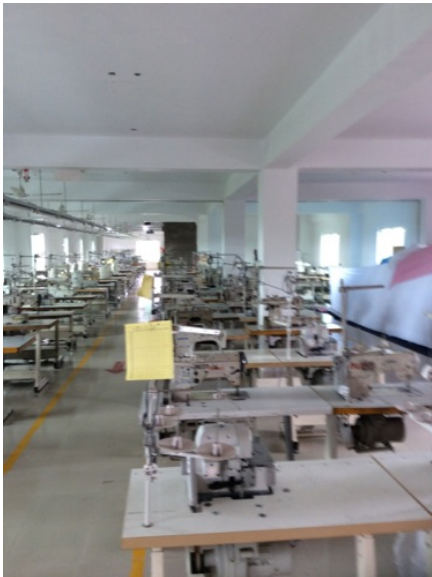
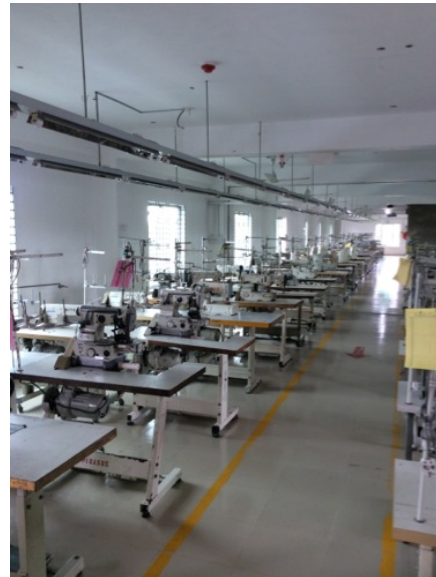
F-10	Egress	The width of egress aisles is less than 36-in. on first floor.	Provide minimum aisle widths of 36-in.	Within 3 months
------	--------	--	--	-----------------

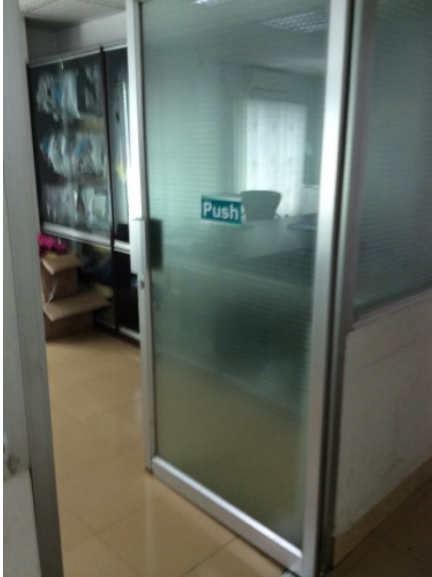
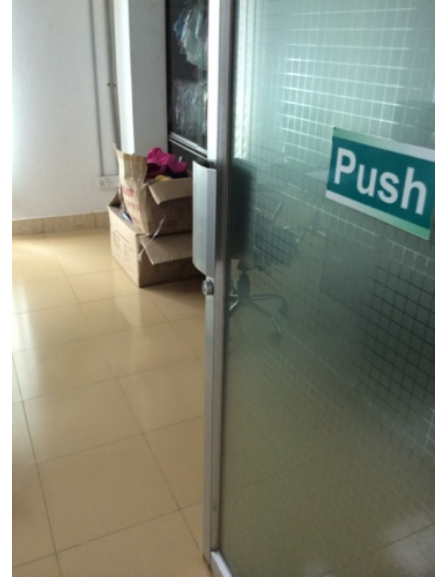
F-11	Egress	Egress door does not swing in the direction of egress travel on ground and first floors.	Modify the egress door to swing in the direction of egress travel.	Within 3 months
------	--------	--	--	-----------------

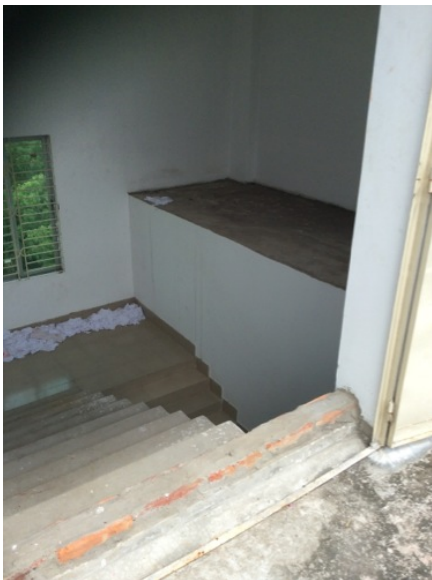
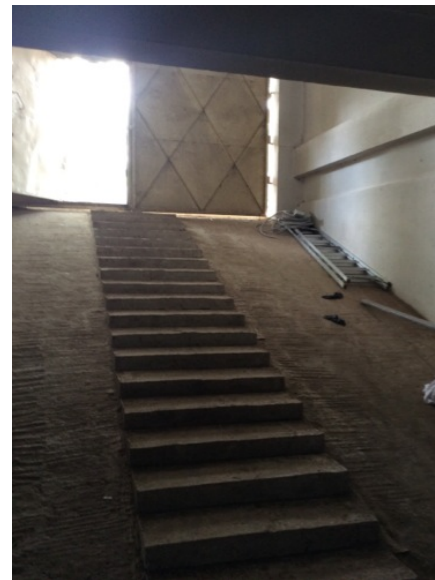
F-12	Egress	Handrails are not provided in the exit stair on basement and 6th floors.	Provide handrails on at least one side of exit stair.	Within 3 months
------	--------	--	---	-----------------

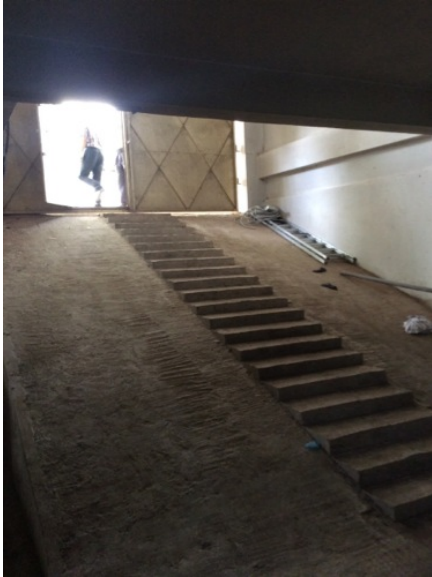
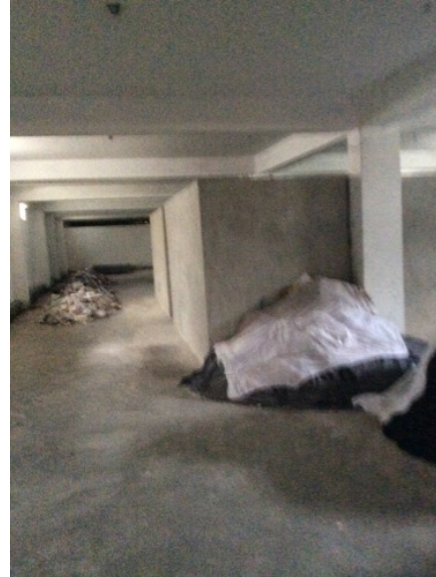
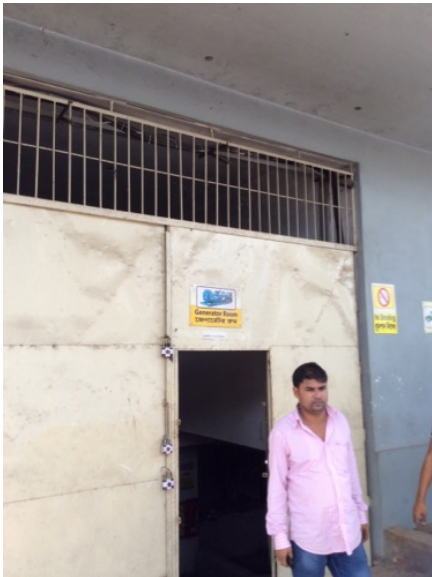
F-13	Egress	A single means of egress is provided on basement floor in the north exit.	Provide additional means of egress.	Within 3 months
------	--------	---	-------------------------------------	-----------------

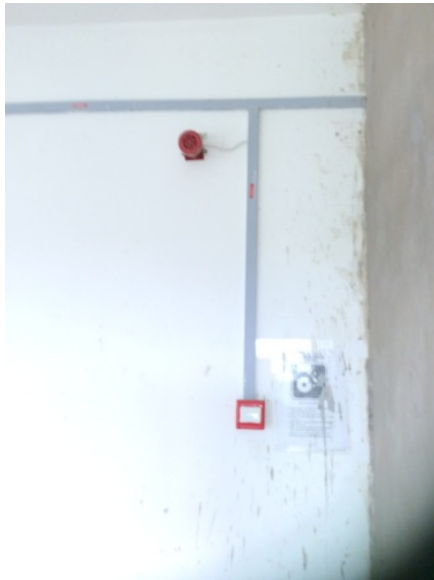
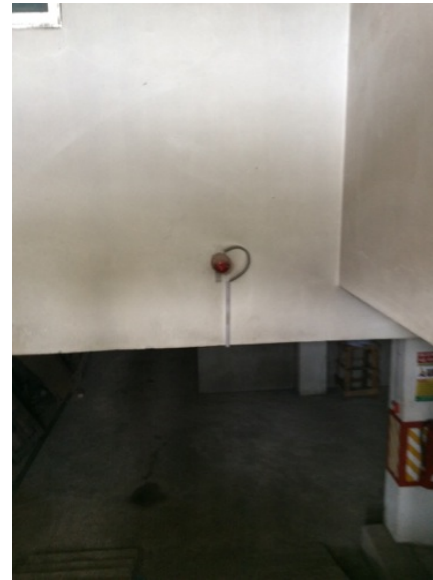
F-14	Fire Protection	The fire alarm system is antiquated, not a listed system, and does not provide alarm and notification features consistent with acceptable standards.	Replace the fire alarm system with a new, listed addressable fire alarm system in accordance with NFPA 72.	Design within 4 months, install within 9 months
------	-----------------	--	--	---

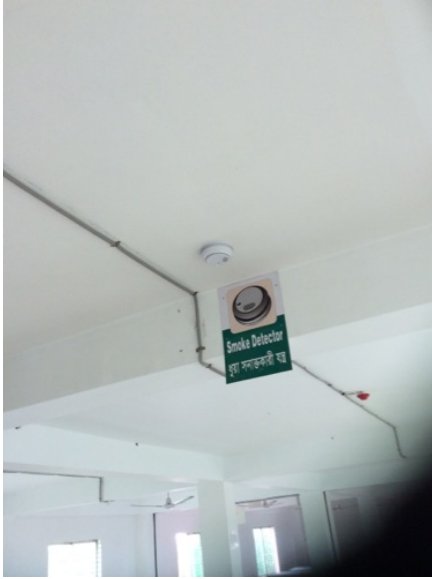
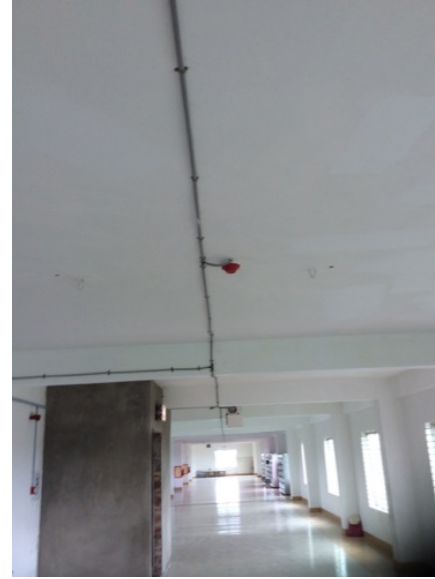
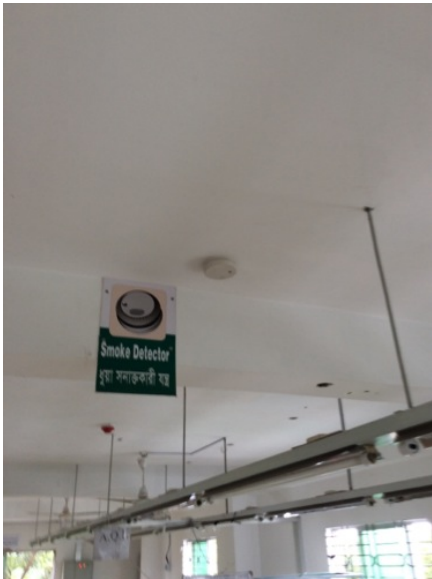
F-15	Fire Protection	Inspection, testing, and maintenance of the fire alarm system is not in accordance with NFPA 72.	Inspect, test and maintain the fire alarm system, and keep written records on-site, in accordance with NFPA 72.	Within 3 months
F-16	Fire Protection	The building is equipped with single-station smoke alarms. Smoke alarm activation sounds only a local alarm and does not provide automatic fire alarm notification of occupants.	Remove single-station smoke alarms. Provide automatic smoke detection throughout the building, tied into the fire alarm system, in accordance with NFPA 72.	Within 6 months
