# **FIRE SAFETY INSPECTION REPORT**

**JAY JAY MILLS ( BANGLADESH ) PVT  
LTD, UNIT-3  
UNIT-3, PLOT NO.9-11 & 2-4, SECTOR-7/A, CEPZ,  
CHITTAGONG**

**ACCORD**  
on Fire and Building Safety in Bangladesh

July 20, 2014

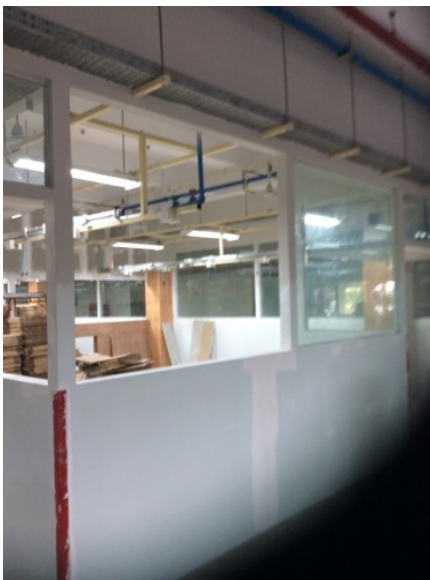
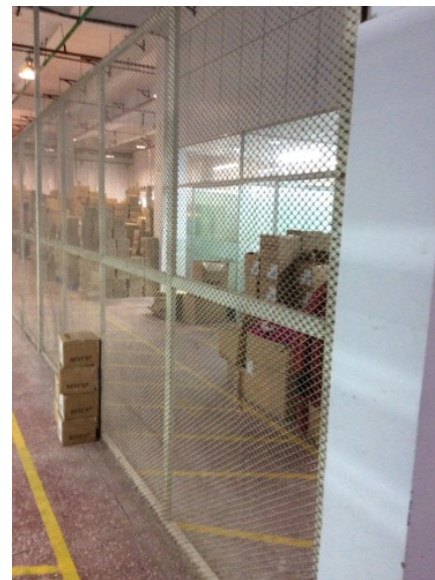
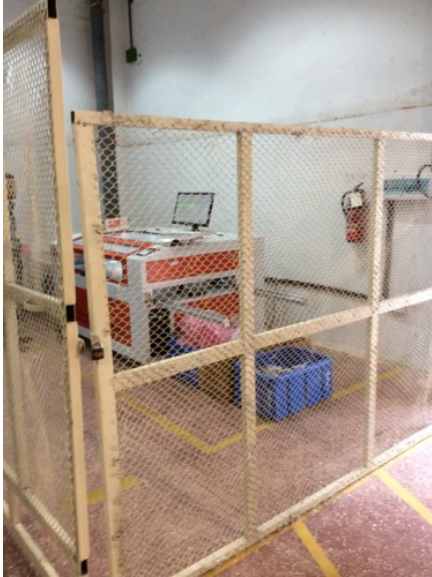
| No. | Category | Finding | Recommendation | Remediation Timeframe |
|---|---|---|---|---|
| F-1 | Fire Rated Construction | Rooms used for combustible storage are not separated by fire-rated construction on ground, 1st and 2nd floors. | Provide dedicated storage rooms separated by minimum 1-hr fire-rated construction. | Within 3 months |

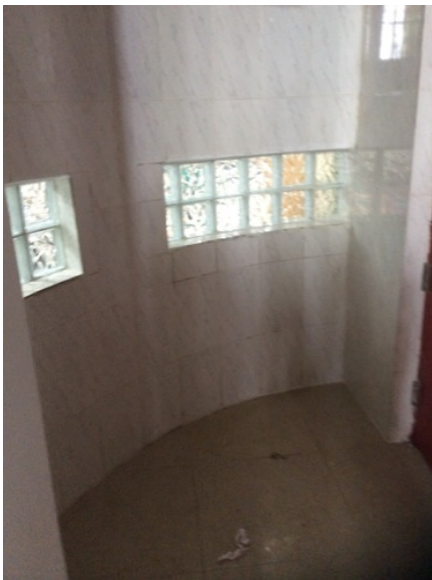
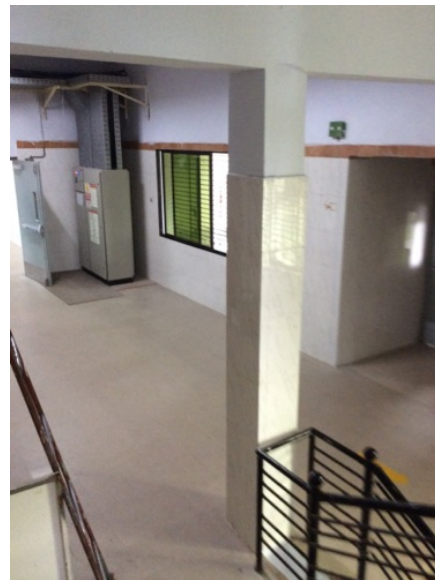
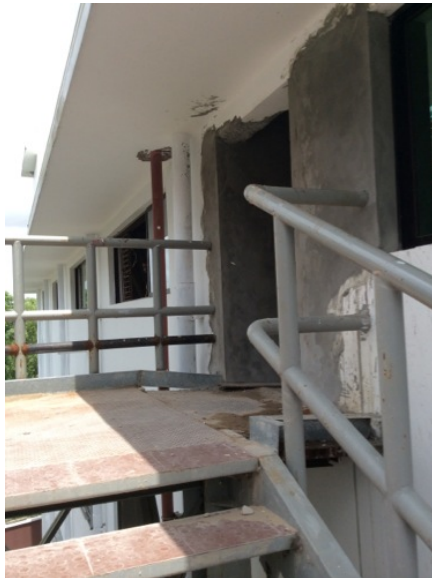
| F-2 | Fire Rated Construction | Unsealed penetrations and openings are located in exit stair enclosures. | Seal all penetrations and openings in exit stair enclosure walls to maintain the fire separation. | Within 3 months |

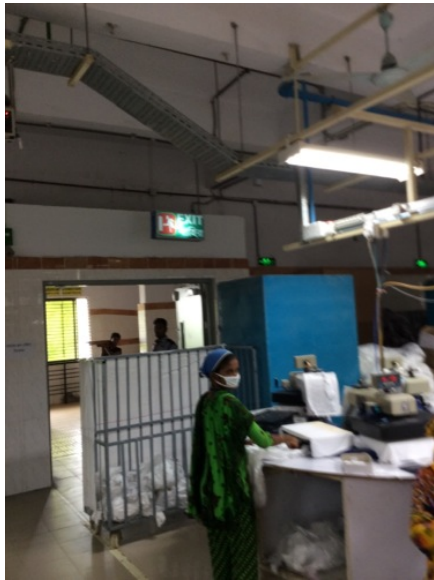
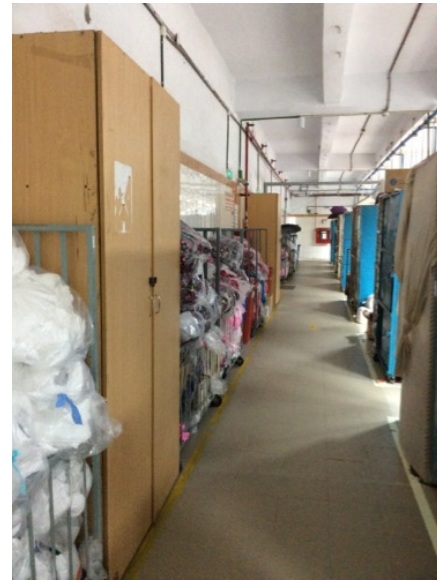
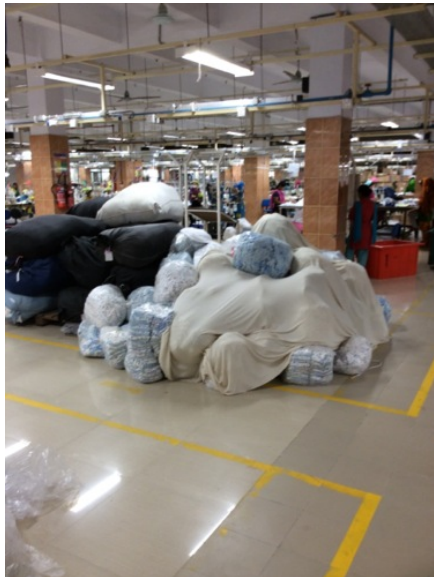
| F-3 | Fire Rated Construction | Areas used for combustible storage are not separated by fire-rated construction on ground, 1st and 2nd floors. | <p>Provide dedicated storage rooms separated by minimum 1-hr fire-rated construction.</p> <p>Where separate storage rooms are not feasible, provide defined storage areas and limit the storage arrangement as follows:</p> <ul style="list-style-type: none"> <li>- Maximum height of 2.4m and maximum area of 23m<sup>2</sup></li> <li>- If sprinkler protected: maximum height of 3.66m and maximum area of 93m<sup>2</sup></li> </ul> <p>Separate areas of unenclosed combustible storage by a minimum clear distance of 3m.</p> | Within 3 months |

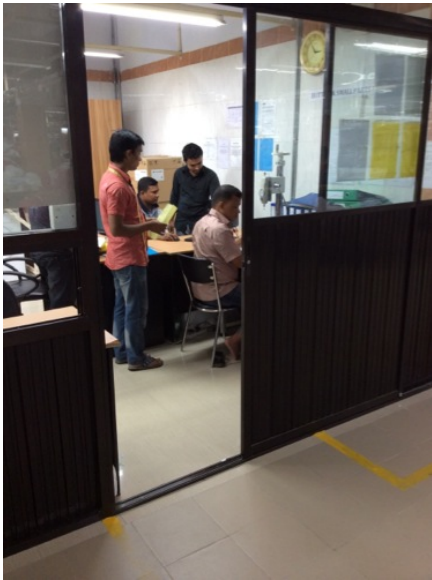
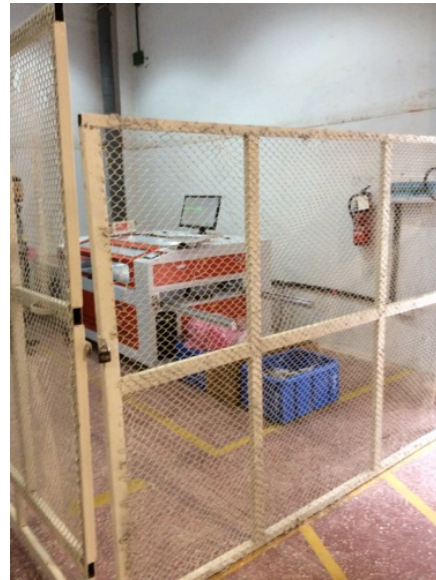
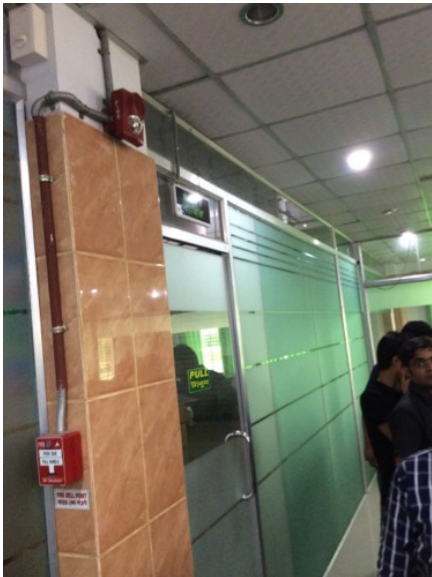
| F-4 | Egress | Egress doors / gates with locking features are provided at along egress routes on ground, 1st and 2nd floor. All gates/doors were open and unlocked during inspection. | Remove locking features from all egress doors / gates.<br><br>If locks are required for security reasons, utilize special door locking features complying with NFPA 101. | Immediate |

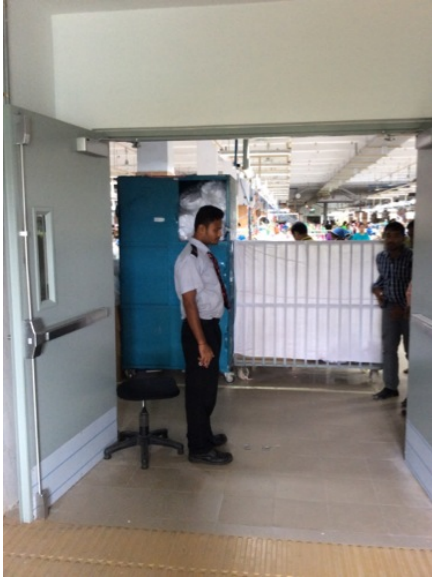
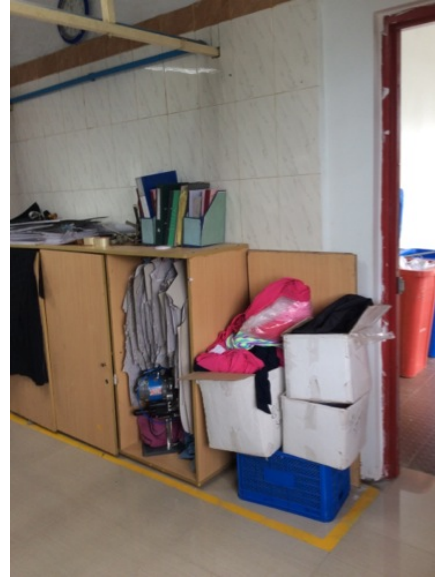
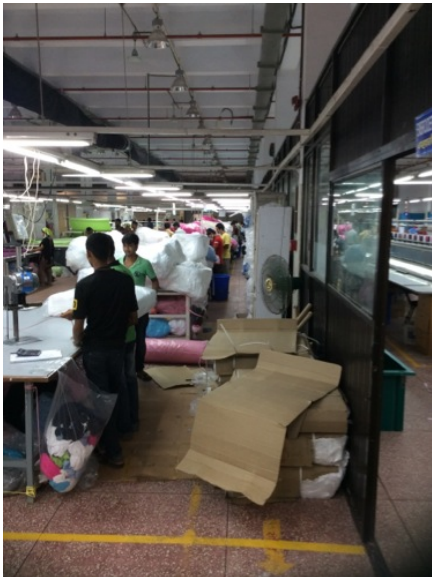
| F-5 | Egress | Storage was located in the egress path on ground, first and second floor. | Keep egress paths and stairs clear of storage. | Immediate |

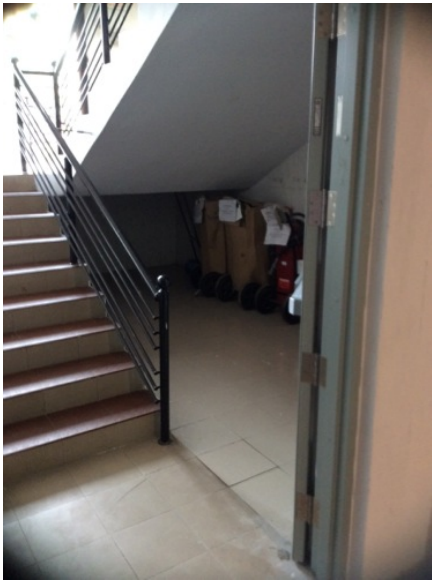
| F-6 | Egress | Storage was located in the exit stair on ground floor. | Remove all storage from exit stairs and egress paths. | Immediate |

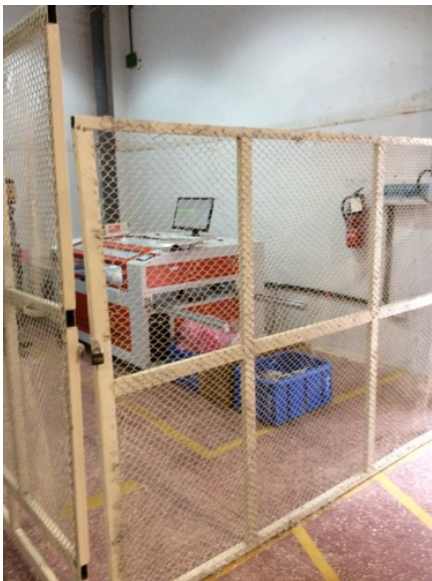
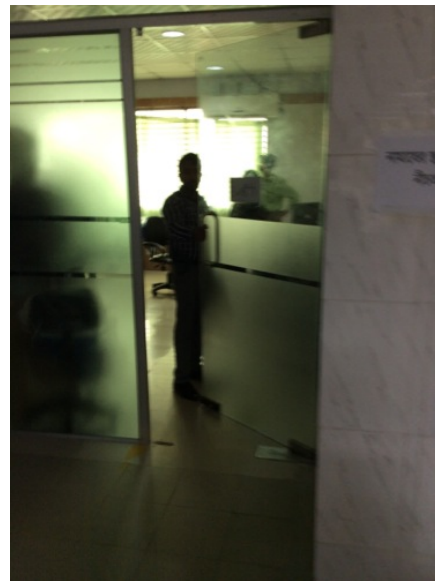
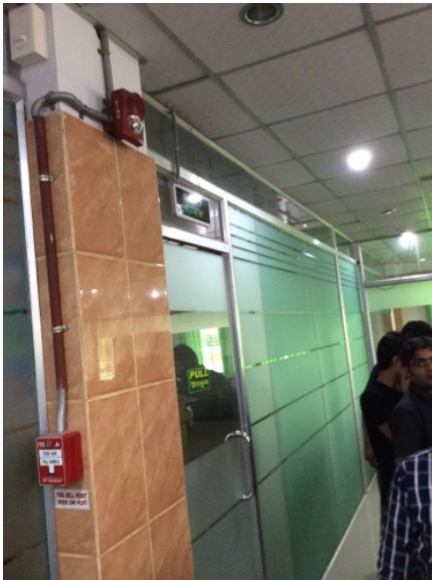
| F-7 | Egress | Collapsible gates / sliding doors are provided at along egress route on ground, 1st and 2nd floors. | Replace all gates / sliding doors along the means of egress with side-hinged, swinging egress doors.<br><br>If locks are required for security reasons, utilize special door locking features complying with NFPA 101. | Within 1 month |

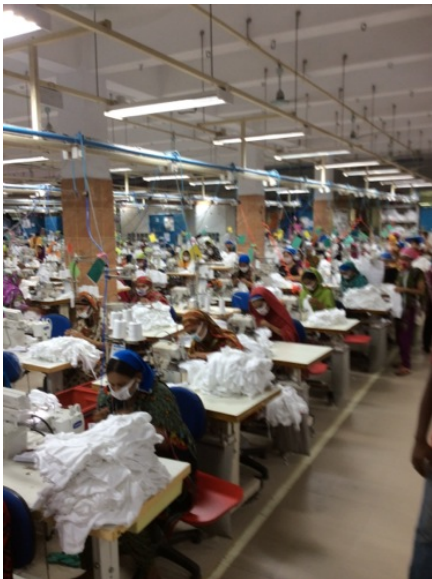
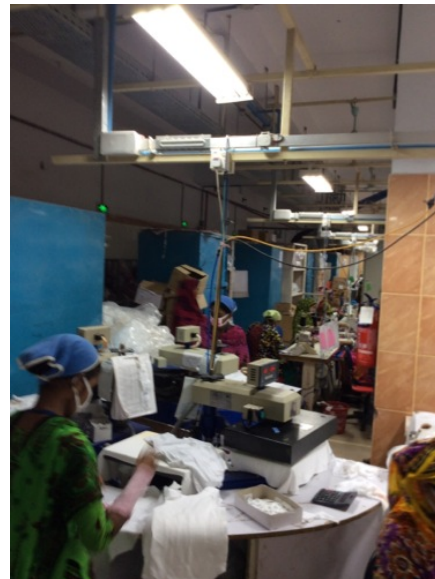
| F-8 | Egress | The width of egress aisles between factory equipment is less than 36-in. on 1st and 2nd floors. | Provide minimum aisle widths of 36-in. | Within 3 months |

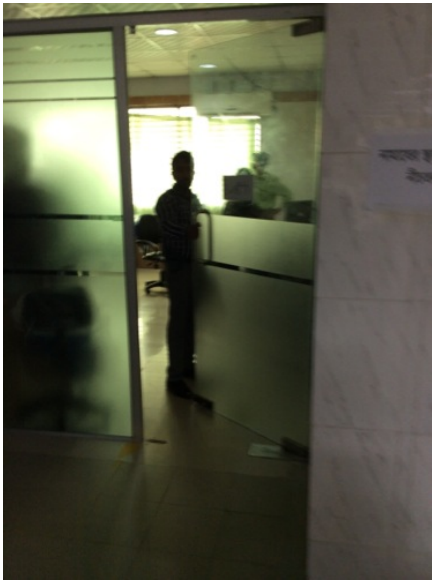
| F-9 | Egress | Egress door does not swing in the direction of egress travel on 2nd floor. | Modify the egress door to swing in the direction of egress travel. | Within 3 months |

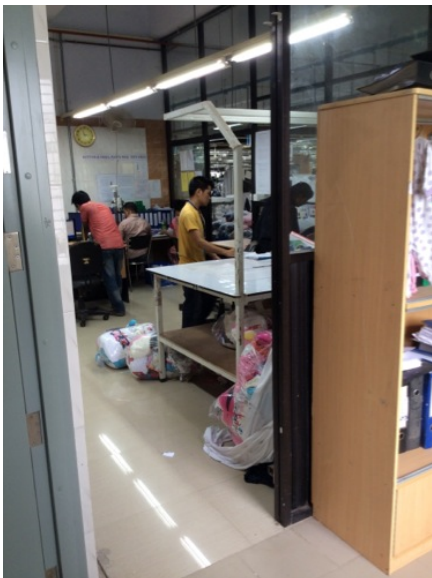
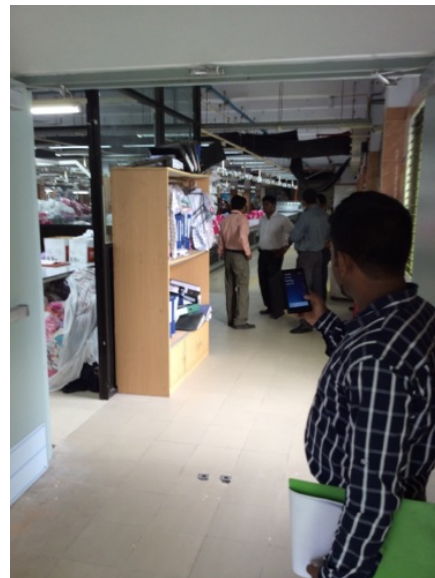
| F-10 | Egress | The exits are not remotely located from each other such that a single fire event could compromise both exits on 2nd floor east exit stair. | Modify exit arrangement. | Within 6 months |
