# **FIRE SAFETY INSPECTION REPORT**

**VINTAGE DENIM LTD**  
**GILARCHALA, SREEPUR,GAZIPUR**

**ACCORD**  
on Fire and Building Safety in Bangladesh

July 24, 2014

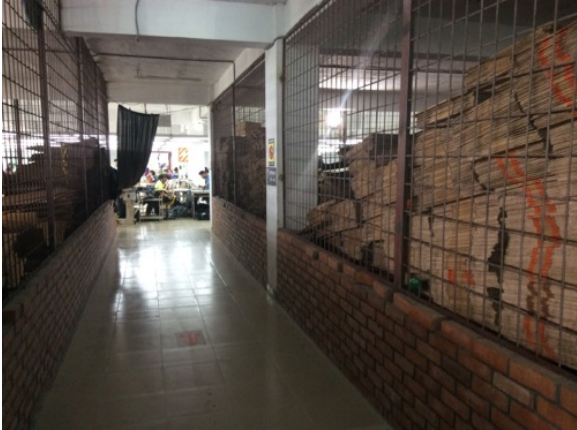
| No. | Category | Finding | Recommendation | Remediation Timeframe |
|---|---|---|---|---|
| F-1 | Fire Rated Construction | Rooms used for combustible storage are not separated by fire-rated construction on every floor. | Provide dedicated storage rooms separated by minimum 1-hr fire-rated construction. | Within 3 months |

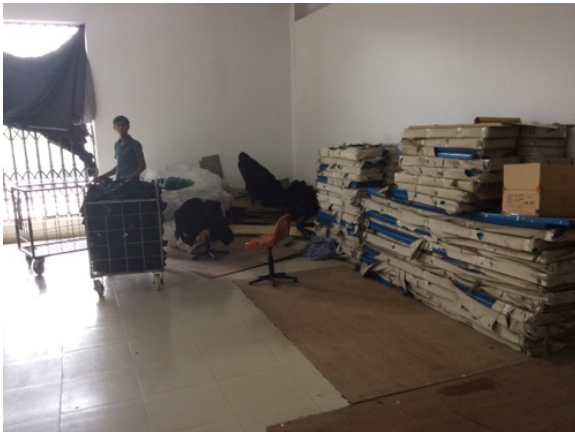
| No. | Category | Finding | Recommendation | Remediation Timeframe |
|---|---|---|---|---|
| F-2 | Fire Rated Construction | Areas used for combustible storage are not separated by fire-rated construction on every floor. | <p>Provide defined storage areas and limit the storage arrangement as follows:</p> <ul style="list-style-type: none"> <li>- Maximum height of 2.4m and maximum area of 23m<sup>2</sup></li> <li>- If sprinkler protected: maximum height of 3.66m and maximum area of 93m<sup>2</sup></li> </ul> <p>Separate areas of unenclosed combustible storage by a minimum clear distance of 3m.</p> | Within 3 months |

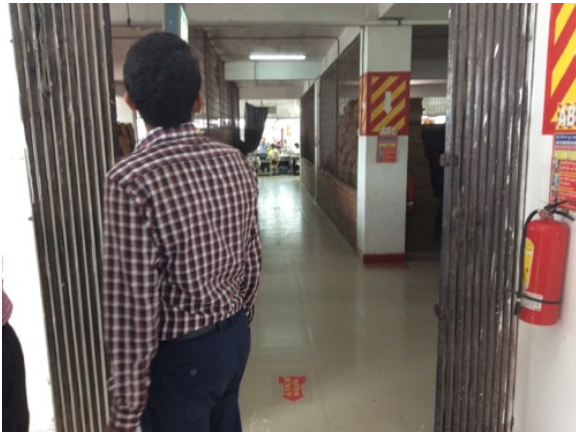
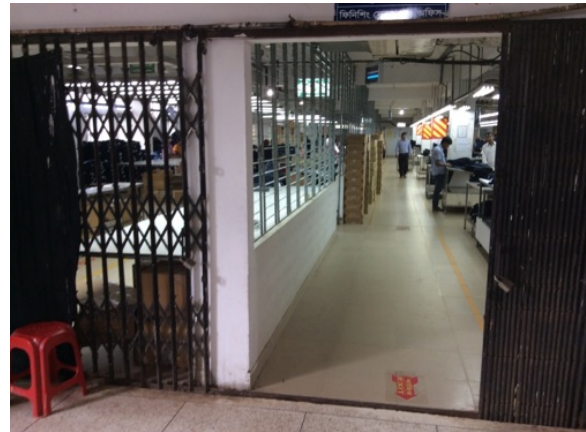
| F-3 | Fire Rated Construction | The exit stairs are not separated from work areas on each floor by fire-rated construction. | <p>Provide minimum 1.5-hr fire rated doors and seal all unprotected openings to separate the exit stairs from work areas and other building spaces on all floor levels. Ensure that the fire doors are self-closing and positive latching and that they are provided with fire exit (panic) hardware where serving production floors.</p> <p>If fire doors are required to be held open for functional reasons, provide automatic-closing devices tied to the fire alarm system.</p> | Within 3 months |

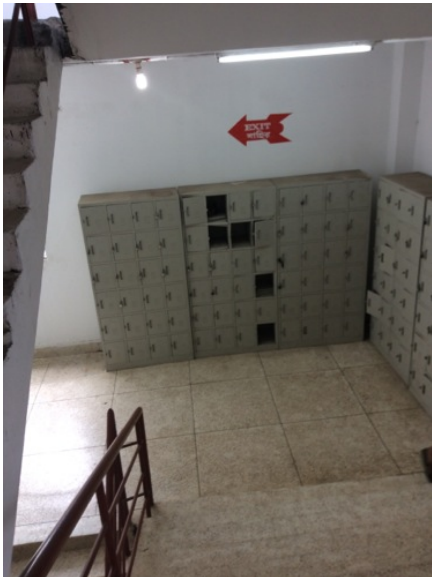
| F-4 | Egress | Storage was located in the exit stair on every floor. | Remove all storage from exit stairs and egress paths. | Immediate |
