Muazuddin Textile Ltd. (9998)

Plot # 235/236, East Chandura, Shafipur, Kaliakor, Gazipur

12.APRIL.2014

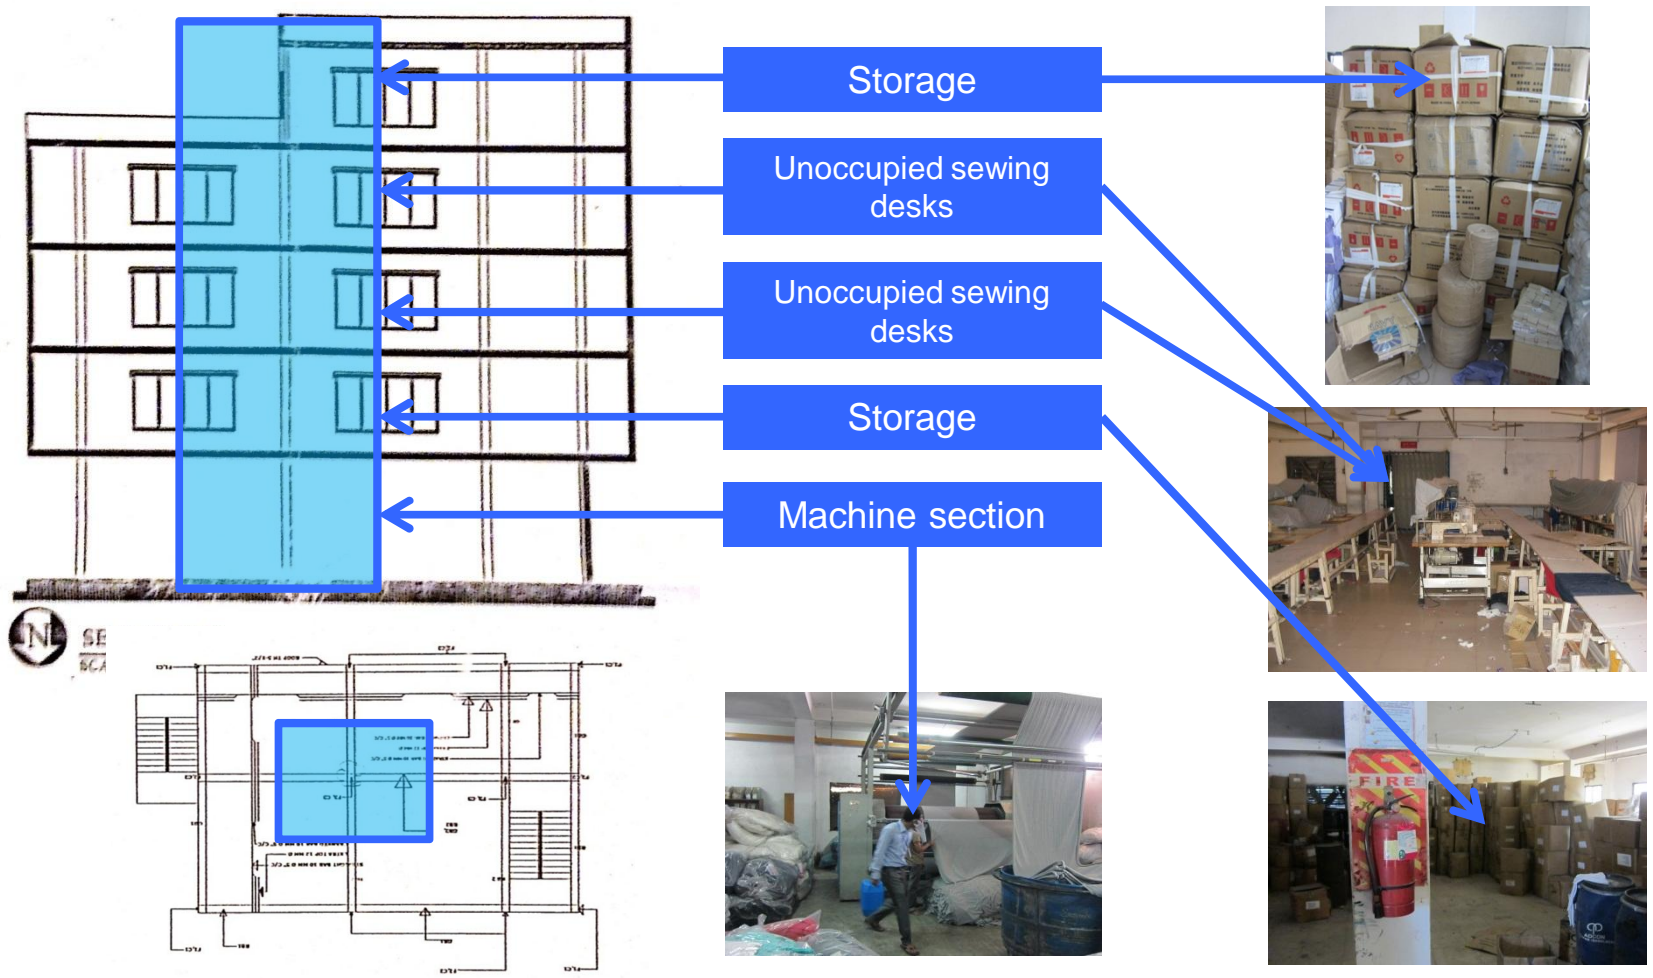
1st Priority 1 Concern

The interior column was supporting part the 4 part 5 storey building section above. However its size beneath the ground floor (column pier) was only 300x300mm - as specified in the drawing. From the calculation check, this column appears to be overstressed.

- Remove loading on 4th floor immediately and reduce stacking height to ensure total load does not exceed 1.0kPa on 1st floor to 3rd floor.
- Factory Engineer to review design, loads and columns stresses in area identified above.
- Verify in-situ concrete stresses either by cores or existing cylinder strength data for [the identified columns / cores from 4 columns]. Core sizes to be a minimum of 100 mm diameter.
- A Detail Engineering Assessment of Factory to be commenced immediately.

- Produce and actively manage a loading plan for all floor plates within the factory giving consideration to floor capacity and column capacity.
- *A Detailed Engineering Assessment to be completed.*

- Continue to implement load plan.

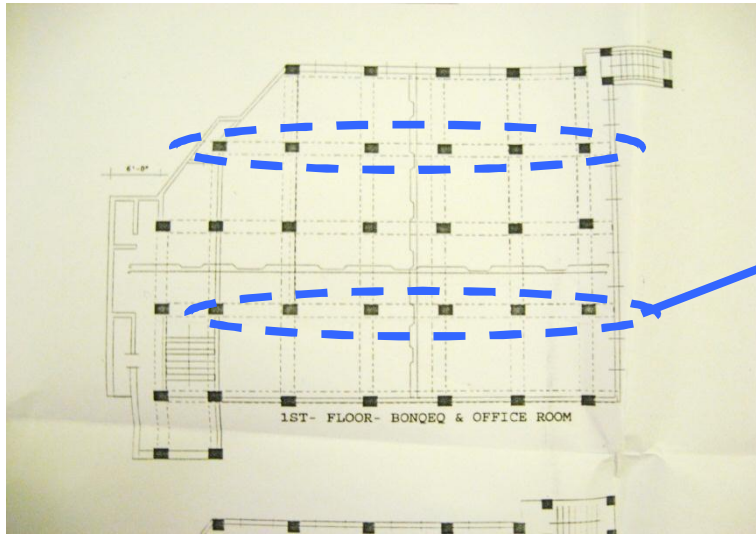
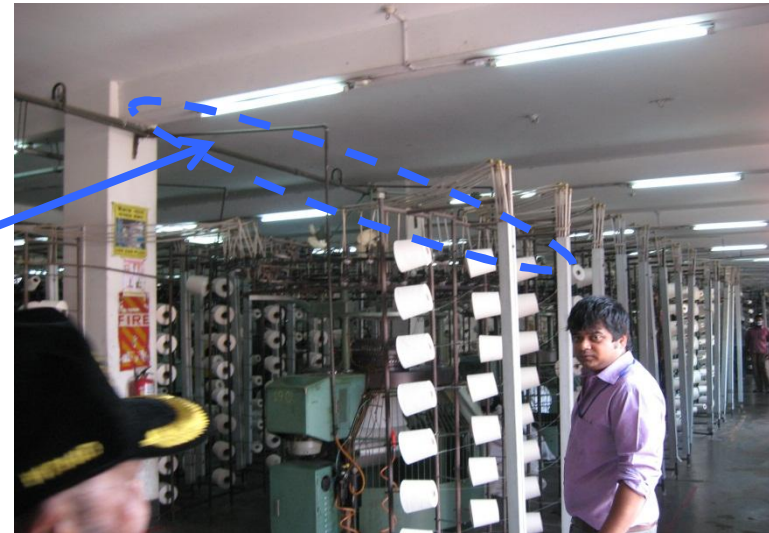
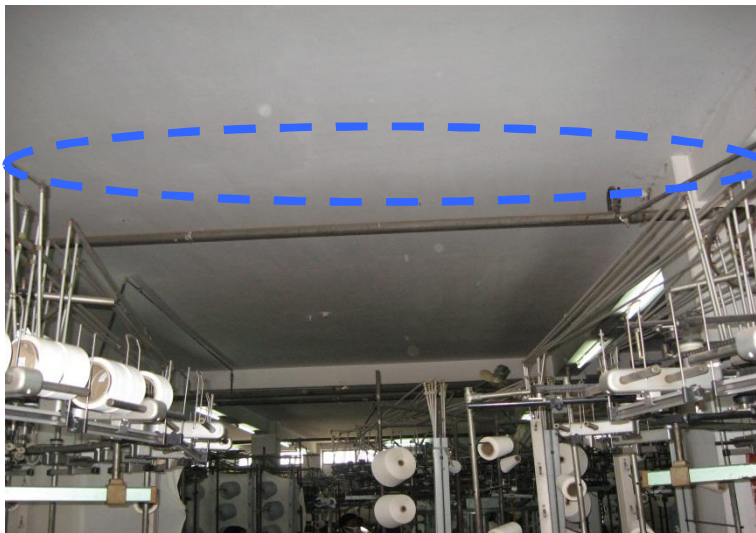
2nd Priority 1 Concern

Two lines of the beam at 1st floor of Building 1 are not present. This is inconsistent with what specified on the provided drawings.

- Remove all storage loading from these areas.
- Factory Engineer to review design, loads, columns stresses to confirm suitability for applied loads.

- Verify in-situ concrete stresses either by cores or existing cylinder strength data for affected zone.
- Detail Engineering Assessment to be completed.
- Produce and actively manage a loading plan for all floor plates within the storage building giving consideration to floor capacity and column capacity.

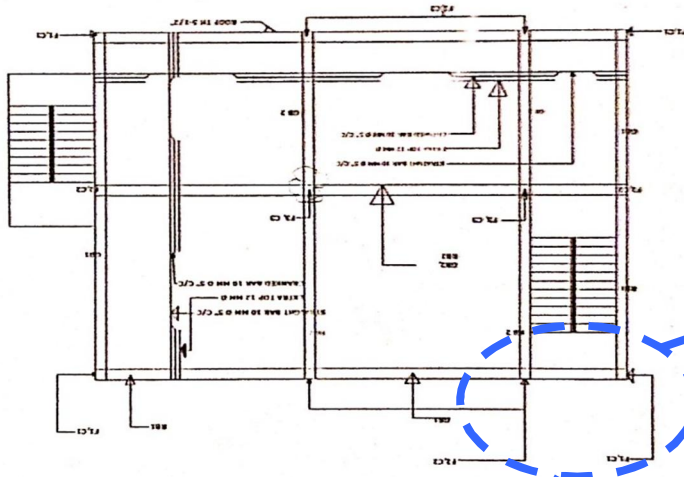
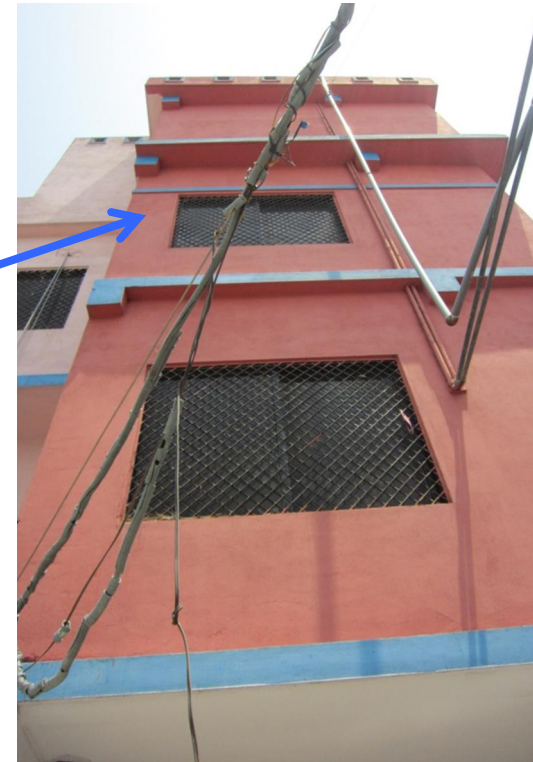
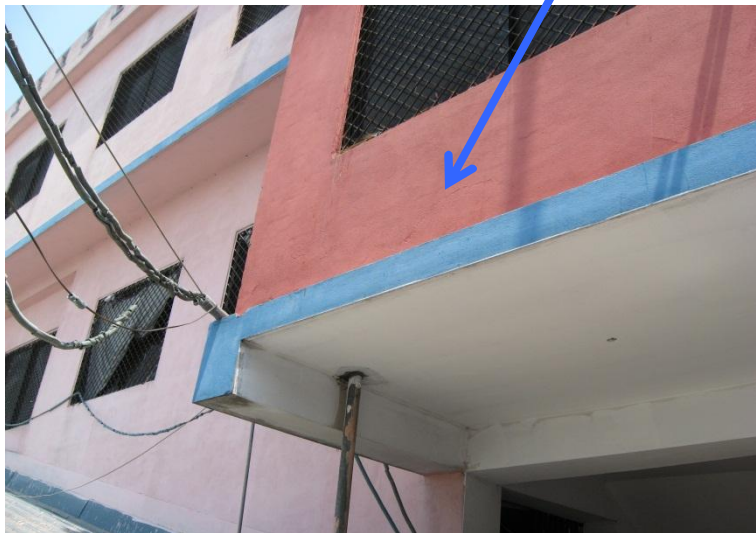
3rd Priority 1 Concern

There are cantilevered slabs that do not appear on the structural drawings for Building 2.

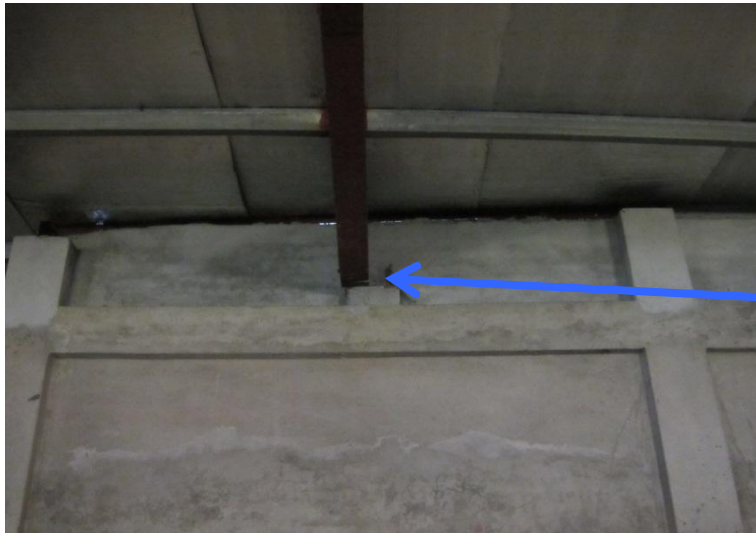
1st Priority 2 Concern

Concerns on roof's point load acting in the middle of RC beam where the depth of the beam is 250 mm spanning 3.50 m.

- Factory Engineer to review design, loads, roof and supports in area identified.
- Engineer to inspect roof supports and structure related to their function and propose a suitable repair if necessary.

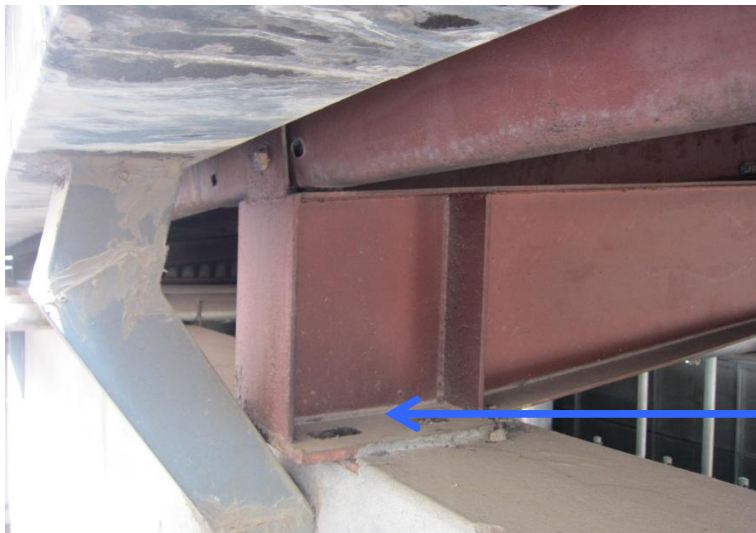
Slots for the support of steel rafters for boiler building are provided but there are no anchor bolts installed.

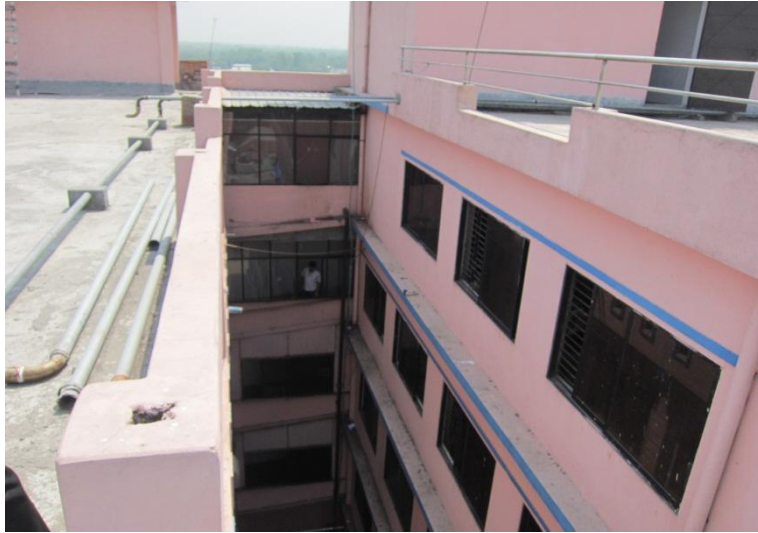
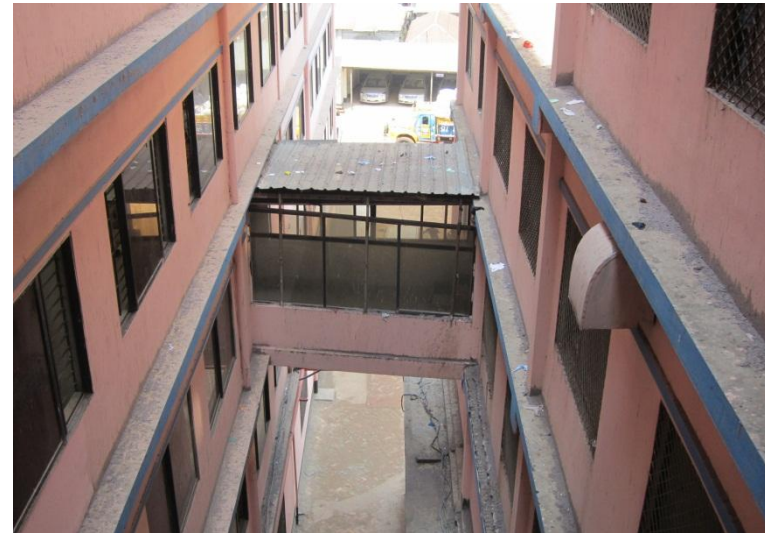
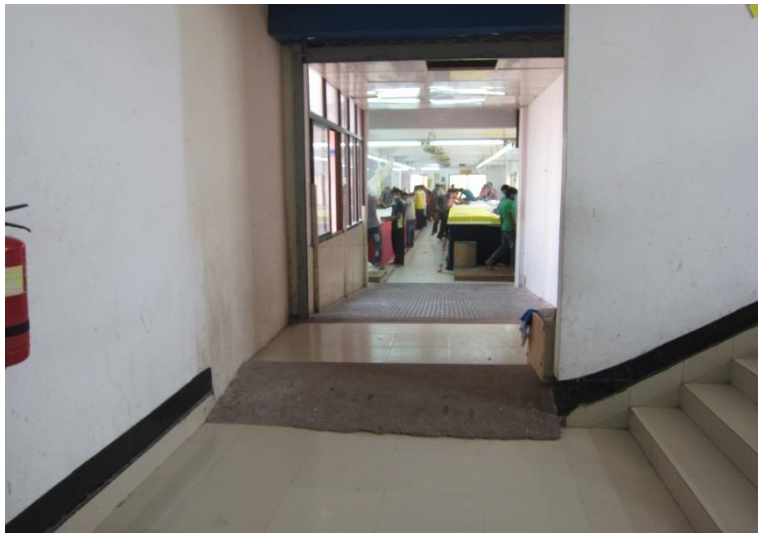
2nd Priority 2 Concern

There are connecting bridges between Building 1 of Muazuddin Textile Ltd. and Muazuddin Knit Fashion Ltd. Building. The stability and capacity of these elements and the related structure should be investigated.

- Detail Engineering Assessment to be carried out in particular the stability and capacity of connecting bridge.

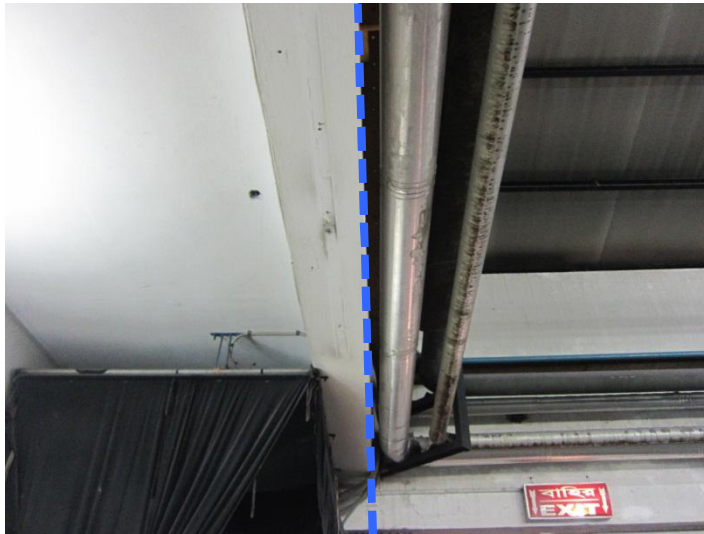
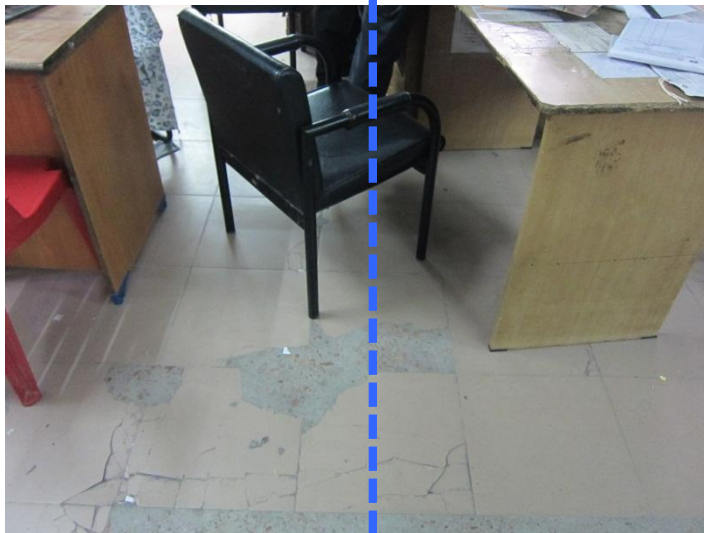
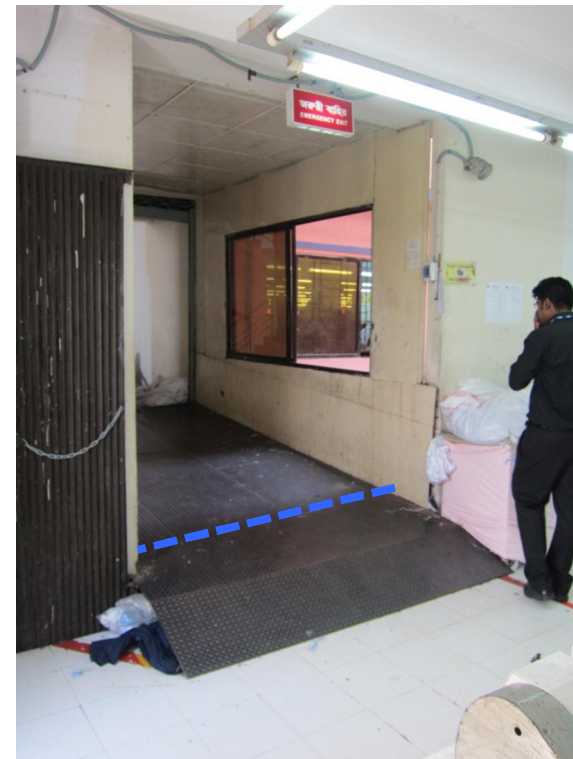
3rd Priority 2 Concern

The factory buildings were constructed separately but no movement joint appears in the attached zone, between them.

----- Movement joint to be established properly

- The Factory's Building Structural Engineer should carry out a Detailed Engineering Assessment to prove the capacity of the building in its existing state, a further building approval should be gained for the building as it exists, as altered since the original approval. Alternatively, the extension building should be separated by a non-structural joint and allowed to act as a fully structurally independent structure.

- Do not construct any further buildings connected to the existing factory, without thorough structural design and full building approval.

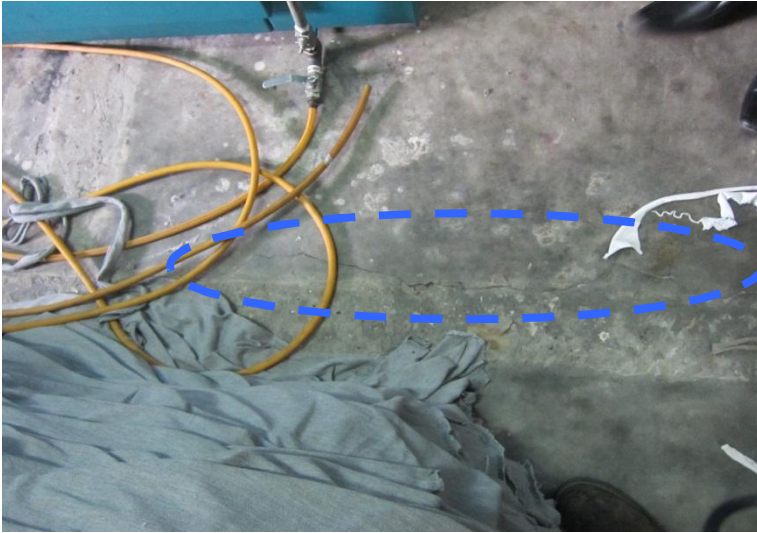
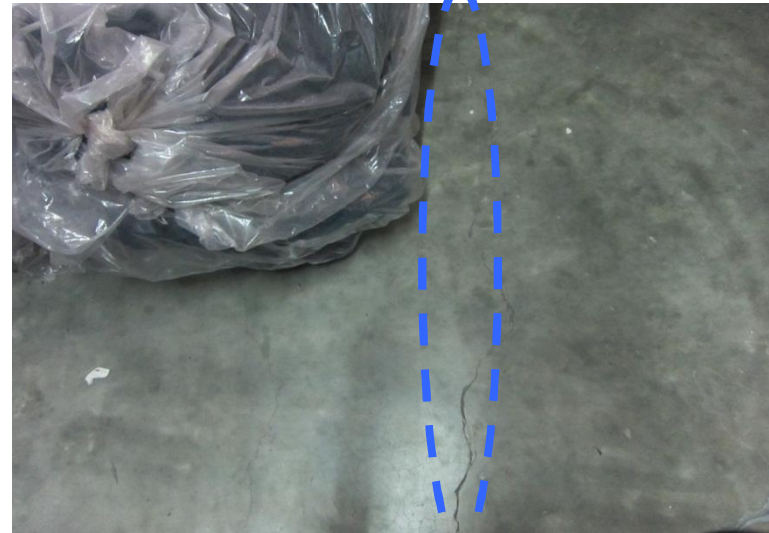
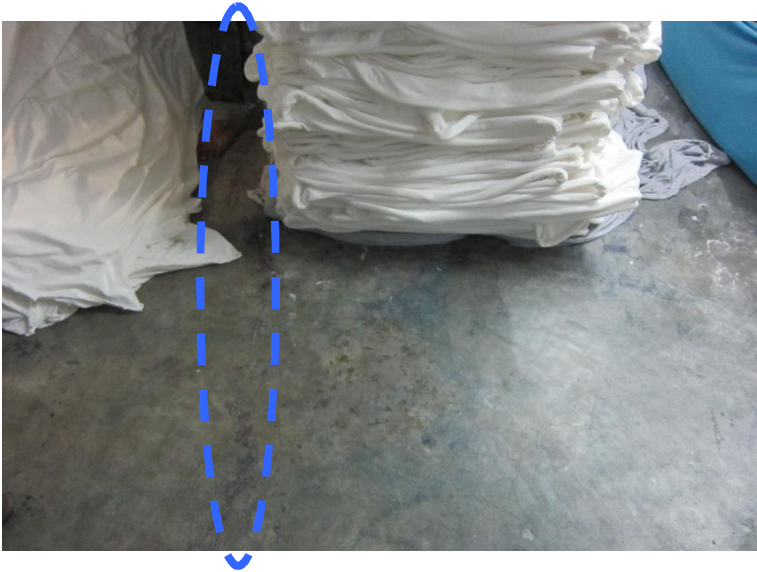
4th Priority 2 Concern

There are cracks on the top of ground floor slabs in Building 2. The ground floor slab is suspended.

- The Detail Engineering Assessment of this area to be carried out.
- The distress found is recommended to be repaired with proper methods. Repair by simple over-plastering work is not allowed.

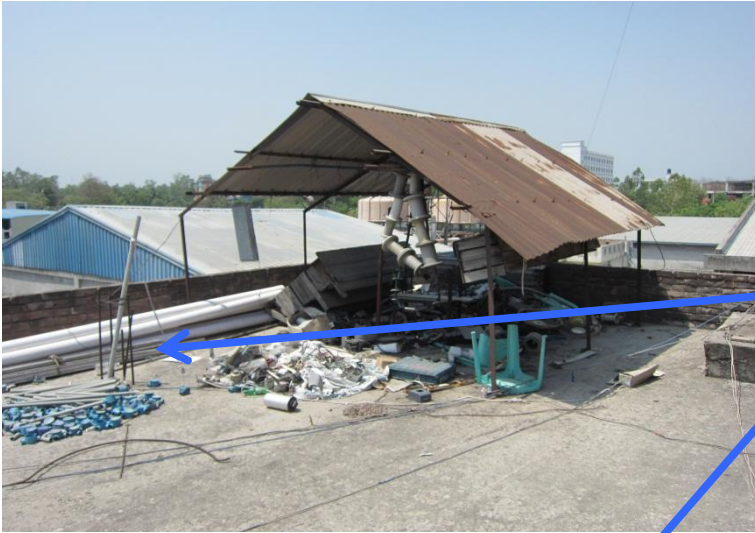
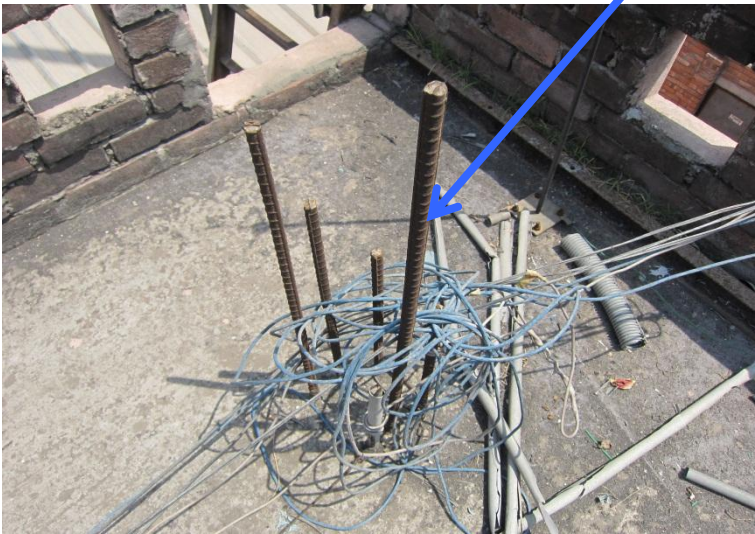
Reinforcement is left exposed. It is unclear whether rust proof paint is applied.

- Engineer to inspect the reinforcement where corrosion has occurred.
- For both durability and serviceability, rust proof paint is recommended.

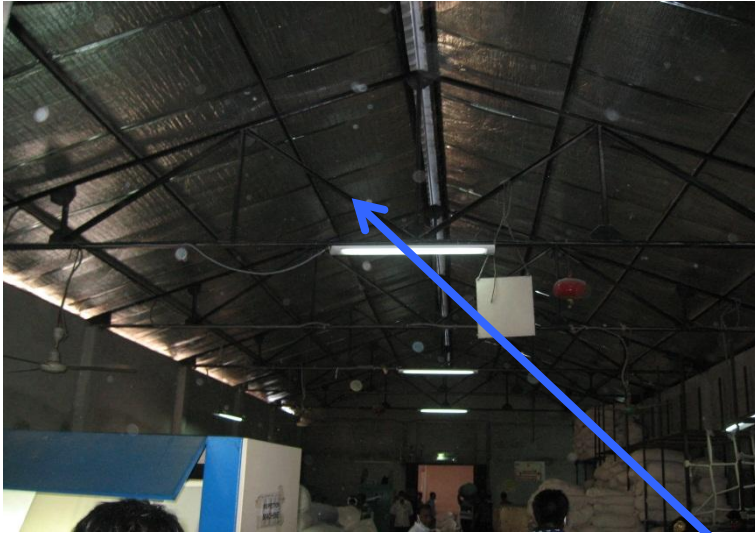
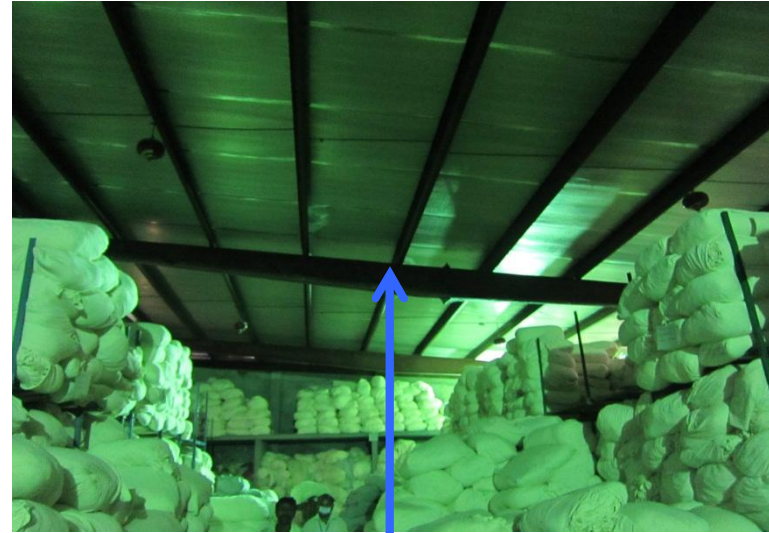
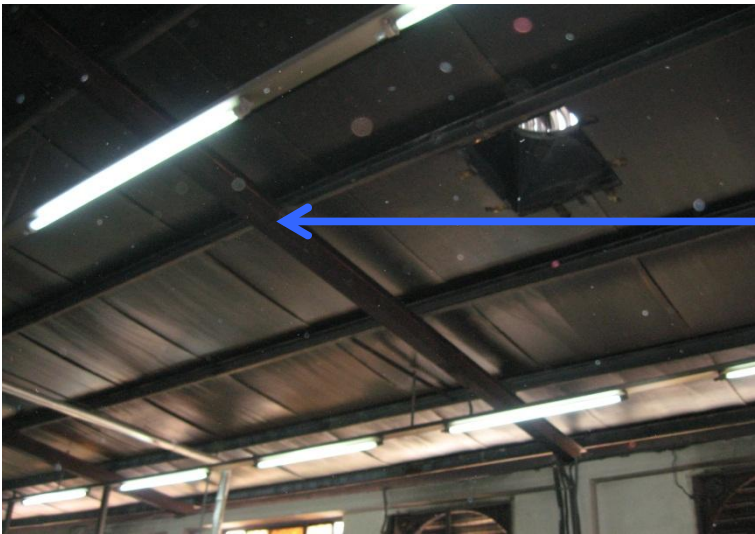
2nd Priority 3 Concern

Structural steel elements in all buildings - confirmation whether fire proofing material is required.

- Fireproofing material for structural steel element is to be applied if required.
- Maintain standard of quality control.

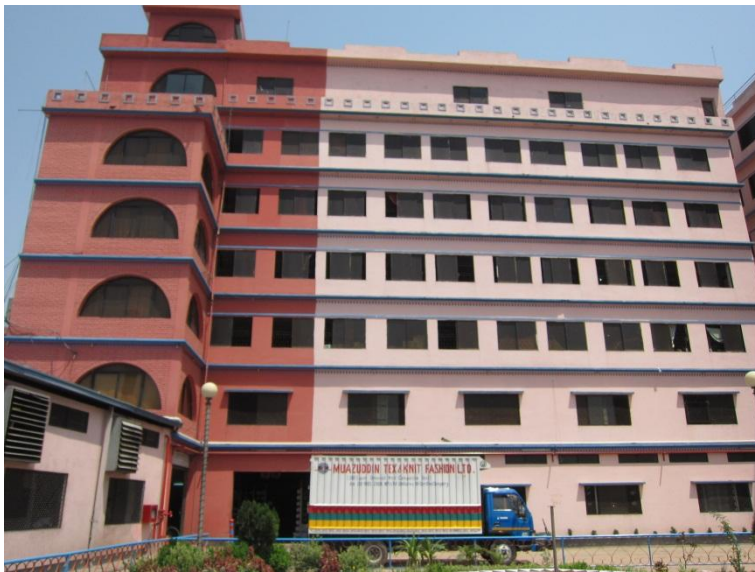
Overall stability system / moment frame capacity

Concerns on the stability system for lateral loading and seismic loading. Façade brickwork walls - lack of moment capacity in connections between columns and beams.

We require that these items be investigated in a Detail Engineering Assessment.

- Request that the Detail Engineering Assessment of the overall building to be carried out and in particular, stability and foundation aspects should be investigated in detail.

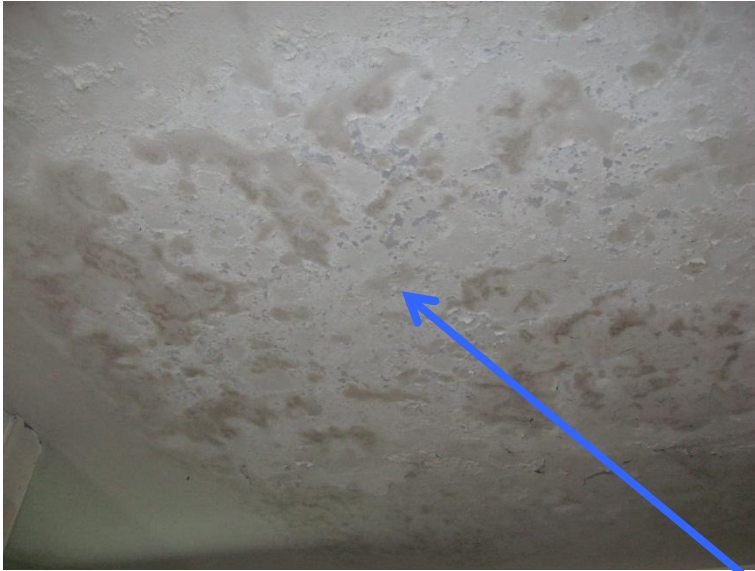
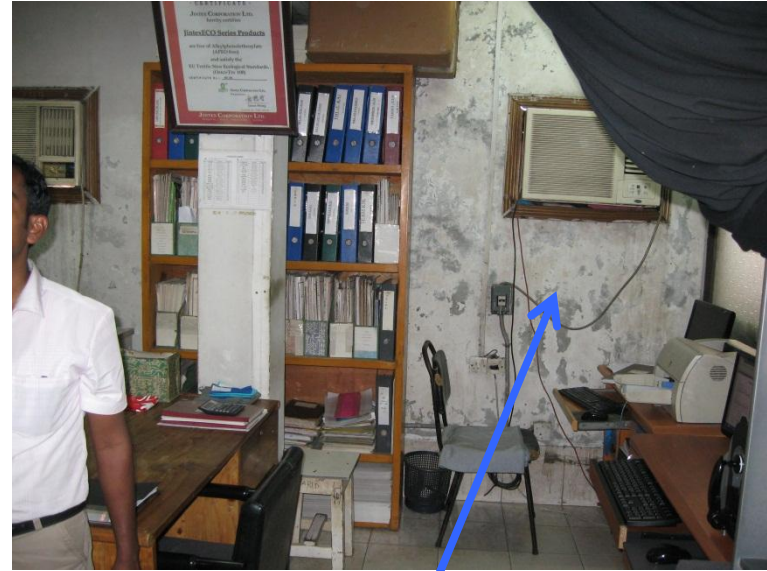
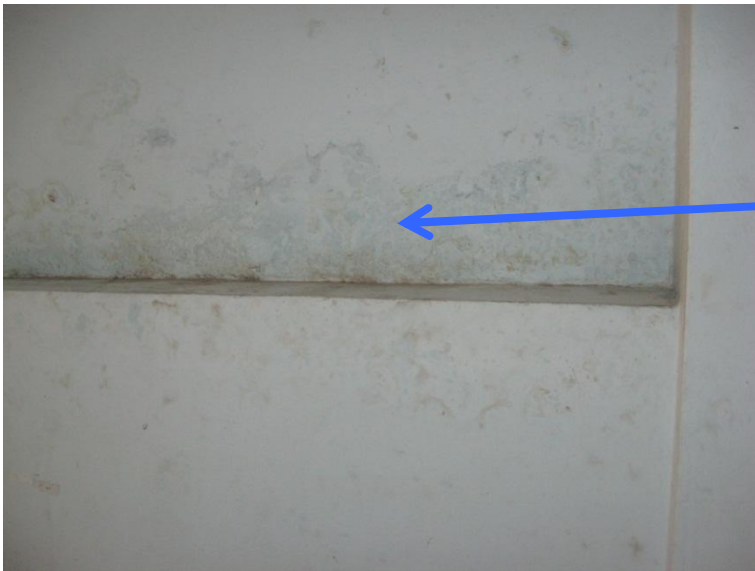
Water ingress

Evidence of water ingress was found. Some areas have mould. These may lead to deterioration and/or spalling of concrete in the future.

- For both serviceability and durability, it's recommended to repair the ingresses found with suitable methods.
- After repairing, suitable waterproofing material should be applied.

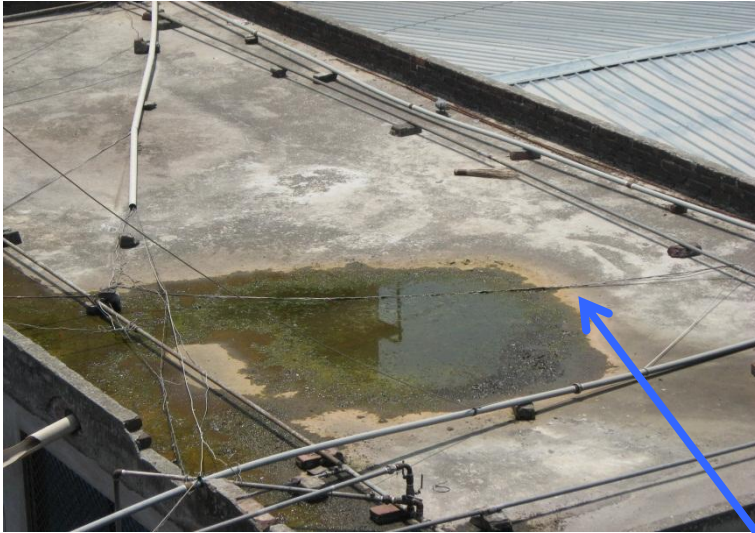
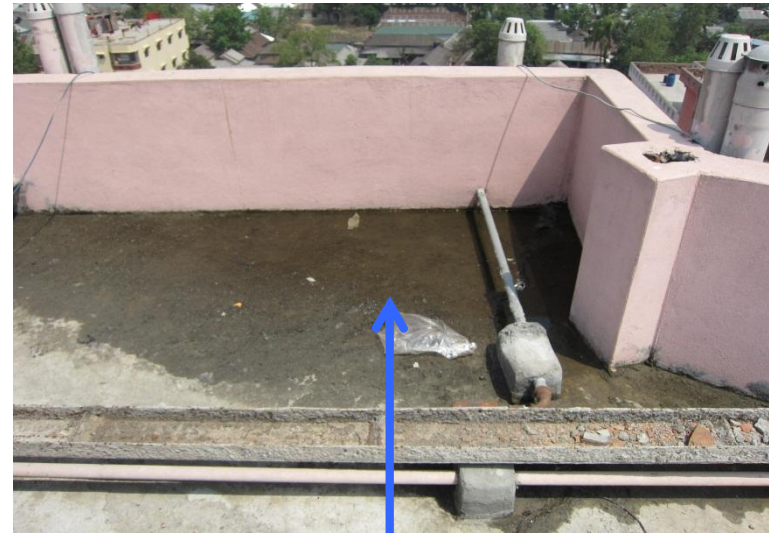
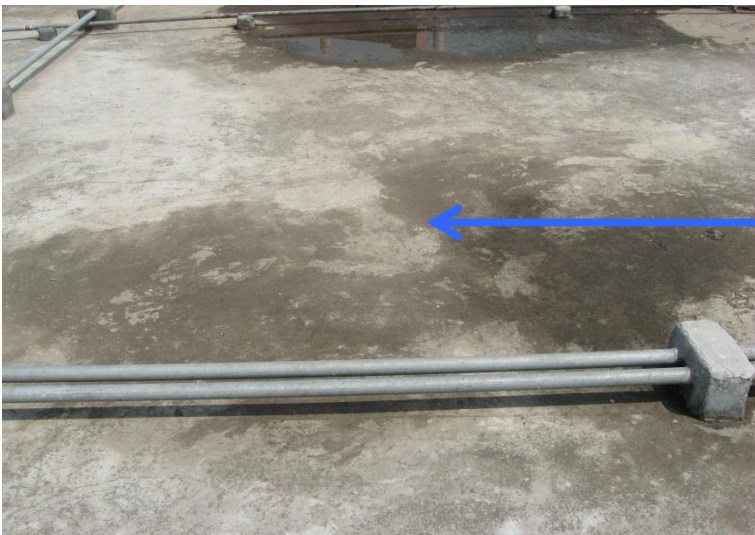
Water ponding was found on the roof slab. And no waterproofing material was applied in this area.

- Engineer to inspect water damaged structure including the exterior and propose a suitable repair.
- For both durability and serviceability, waterproofing on the roof slab is recommended. Moreover the roof slab drainage system should be investigated.
