# Shrabony Knitwear Ltd.

17<sup>th</sup> November, 2016

# Observations

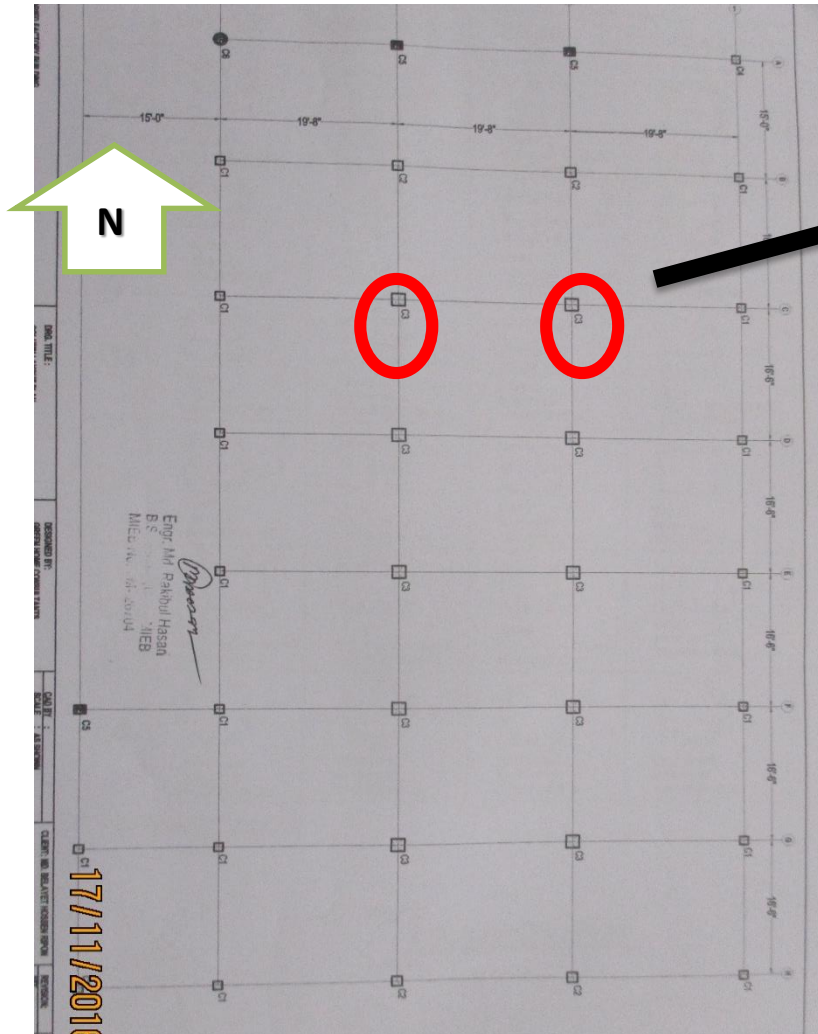
# High stress levels in columns (Main Production Building)

Cursory calculations indicate that the working stress in these internal columns are in excess of normal design limits.

Factory Engineer to perform a Detail Engineering Assessment (see attached scope) and concrete tests to prove adequacy of column sizes

| Item No. | Observation | Recommended Action Plan | Recommended Timeline |
|---|---|---|---|
| 1 | High stress levels in columns (Main Production Building) | Building Engineer to review design, loads and column stresses in all columns for Main Production Building. | <b>Immediate - Now</b> |
| 2 | High stress levels in columns (Main Production Building) | Verify in-situ concrete stresses by 100mm dia. cores from 4 min. columns in the building. | <b>Immediate - Now</b> |
| 3 | High stress levels in columns (Main Production Building) | A Detail Engineering Assessment of Main Production Building to be commenced (see attached Scope). | <b>Immediate - Now</b> |
| 4 | High stress levels in columns (Main Production Building) | Detail Engineering Assessment to be completed | <b>6-weeks</b> |
| 5 | High stress levels in columns (Main Production Building) | Produce and actively manage a loading plan for all floor plates within the Building | <b>6-weeks</b> |
| 6 | High stress levels in columns (Main Production Building) | Actions identified in the Detail Engineering Assessment to be implemented. | <b>6-months</b> |
| 7 | High stress levels in columns (Main Production Building) | Continue to implement the load management plan. | <b>6-months</b> |

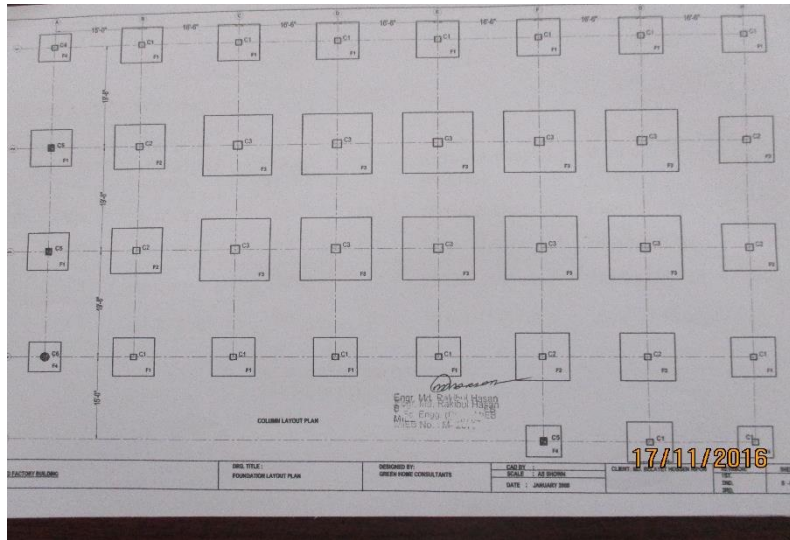
**As- Built Drawings not available**

Structural drawings were available for Main production building only, but architectural drawings were not available

| Item No. | Observation | Recommended Action Plan | Recommended Timeline |
|---|---|---|---|
| 13 | As- Built Drawings not available | Comprehensive As-Built drawings are to be produced for all buildings. | 6-weeks |

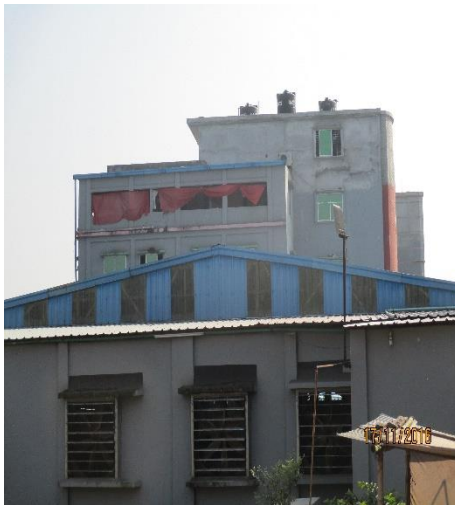
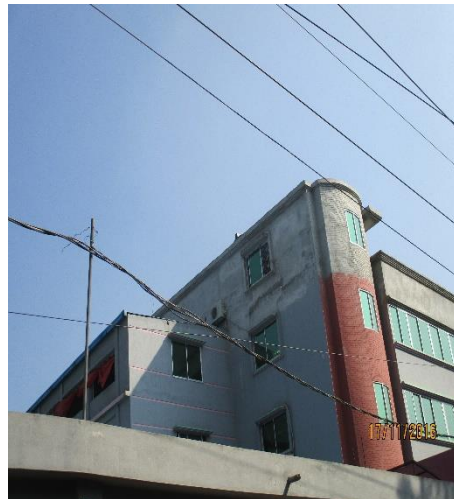
No detail drawings (As built structural) were found for other structures during inspection.

As- Built Drawings not available

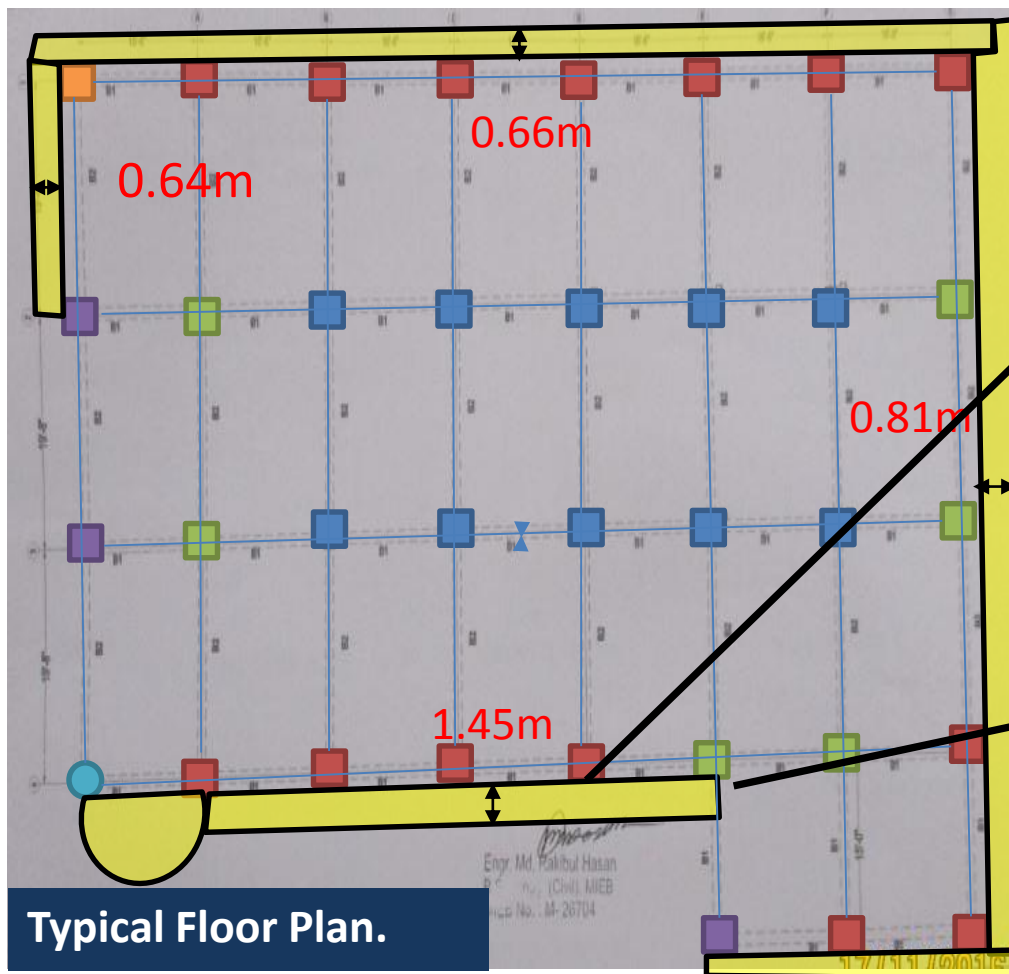
**Typical Floor Plan.**

# Cracks on masonry wall of cantilevered portion at first floor

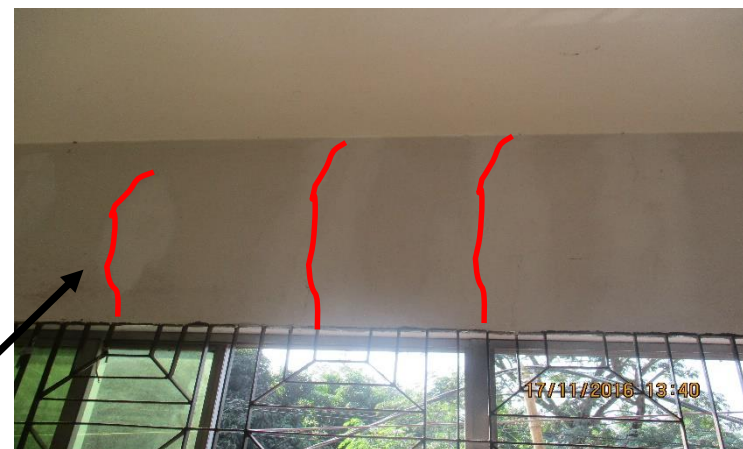
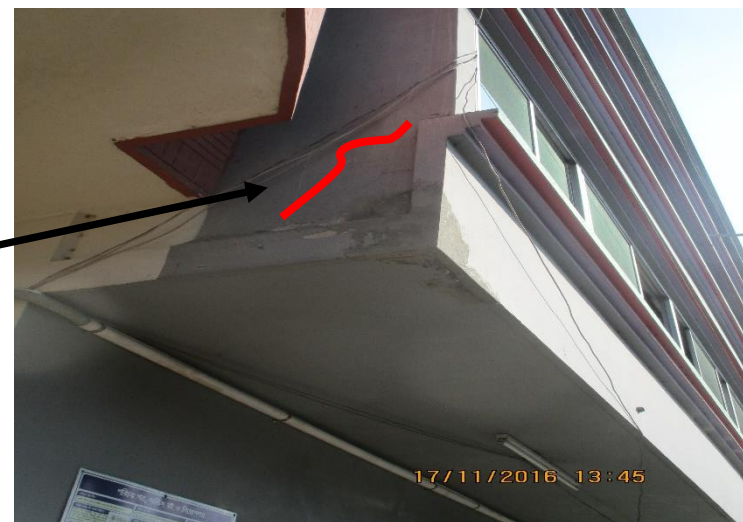
### **Cantilever portion**

Cantilever portions were observed in Main Production Building

Cracks were observed during inspection at 1<sup>st</sup> floor of front cantilever portion.

**Cracks on masonry wall of cantilevered portion at first floor**

| Item No. | Observation | Recommended Action Plan | Recommended Timeline |
|---|---|---|---|
| 8 | Cracks on masonry wall of cantilevered portion at first floor | Building Engineer to verify reasons behind cracking and check if the deflection is within the limit. | 6-weeks |
| 9 | Cracks on masonry wall of cantilevered portion at first floor | Propose any remedial measures required. | 6-weeks |
| 10 | Cracks on masonry wall of cantilevered portion at first floor | Produce and actively manage a loading plan for all cantilever portions within the Building. | 6-weeks |
| 11 | Cracks on masonry wall of cantilevered portion at first floor | Implement any remedial measures suggested by the engineer. | 6-months |
| 12 | Cracks on masonry wall of cantilevered portion at first floor | Continue to implement the load management plan | 6-months |

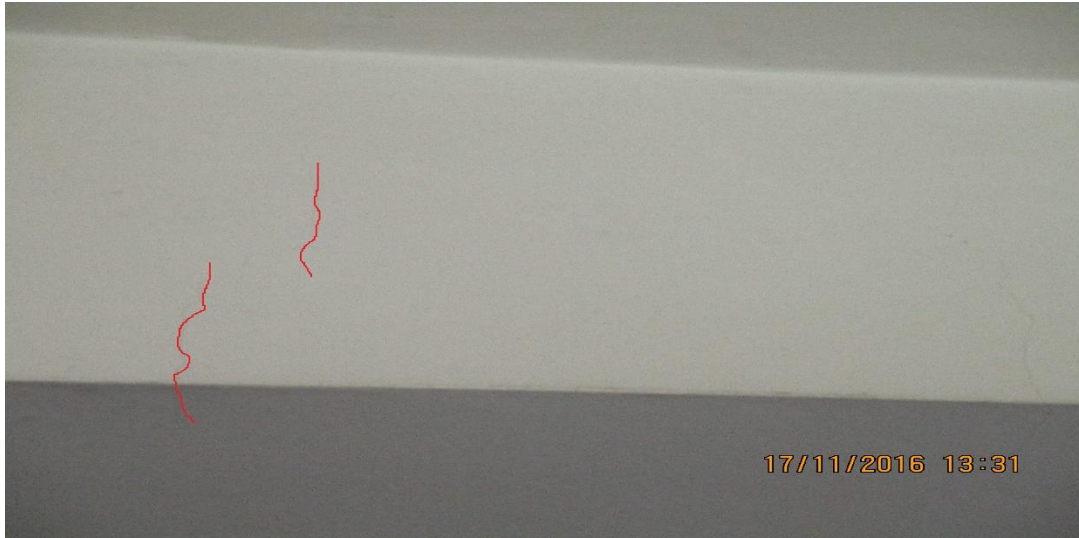
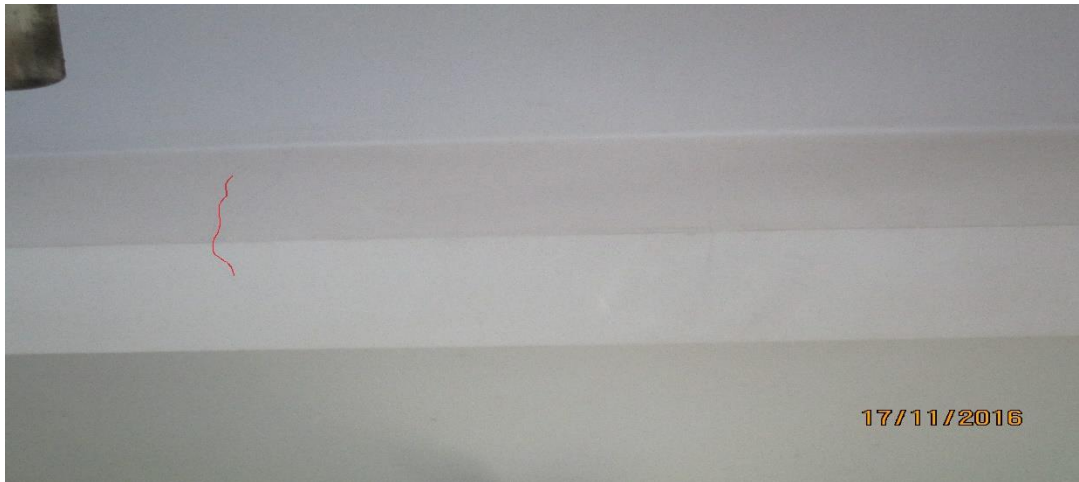
# Hairline cracking on beams at Main production building

Hairline cracks  
found in beams at  
1<sup>st</sup> and 2<sup>nd</sup> floor.  
The cause of  
cracking must be  
checked by  
engineer

| Item No. | Observation | Recommended Action Plan | Recommended Timeline |
|---|---|---|---|
| 14 | Hairline cracking on beams at Main production building | Sections of plaster finish to beams and slab to be removed to investigate if cracks penetrate the building structure. | 6-weeks |
| 15 | Hairline cracking on beams at Main production building | As part of the Detail Engineering Assessment (see Item 1), Building Engineer to carry out design check on beams and slabs | 6-weeks |
| 16 | Hairline cracking on beams at Main production building | Carry out any structural remedial works to cracks as required following assessment. | 6-months |

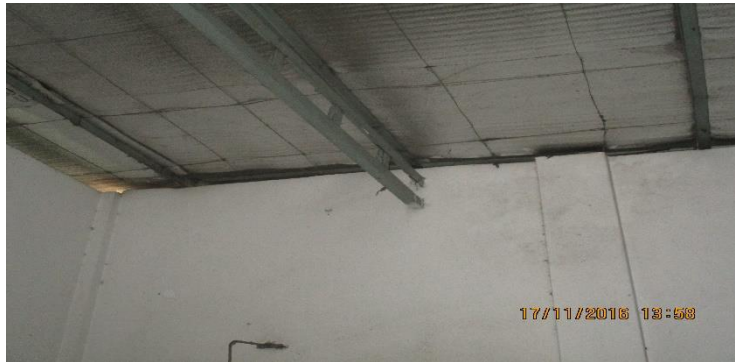
Non engineered connection (Fabric Storage, Production Shed)

Non engineered connections were observed. Besides no structural drawings were available

| Item No. | Observation | Recommended Action Plan | Recommended Timeline |
|---|---|---|---|
| 17 | Apparently Non-Engineered roof of extended portion & Production shed | A Detail Engineering Assessment of Production Shed (all portions) and Extended portion to be commenced (see attached Scope). | <b>Immediate - Now</b> |
| 18 | Apparently Non-Engineered roof of extended portion & Production shed | Foundation details should be covered as part of DEA. | <b>6-weeks</b> |
| 19 | Apparently Non-Engineered roof of extended portion & Production shed | Lateral Stability for all non –engineered shed/connections to be checked as part of DEA. | <b>6-weeks</b> |
| 20 | Apparently Non-Engineered roof of extended portion & Production shed | Detail Engineering Assessment to be completed | <b>6-weeks</b> |
| 21 | Apparently Non-Engineered roof of extended portion & Production shed | Produce and actively manage a loading plan for all floor plates of Extended portion. | <b>6-weeks</b> |
| 22 | Apparently Non-Engineered roof of extended portion & Production shed | Implement any remedial measures suggested by the engineer. | <b>6-months</b> |
| 23 | Apparently Non-Engineered roof of extended portion & Production shed | Continue to implement the load management plan at Extended portion | <b>6-months</b> |

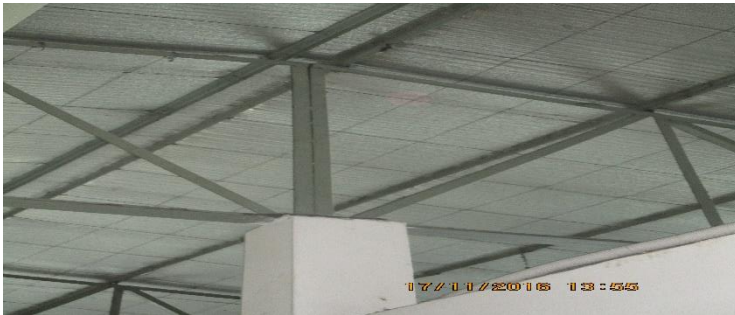
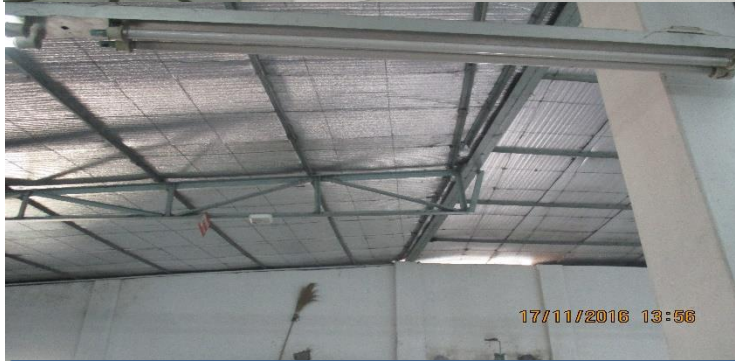
Non engineered connection (Finishing and Cutting Section, Production Shed)

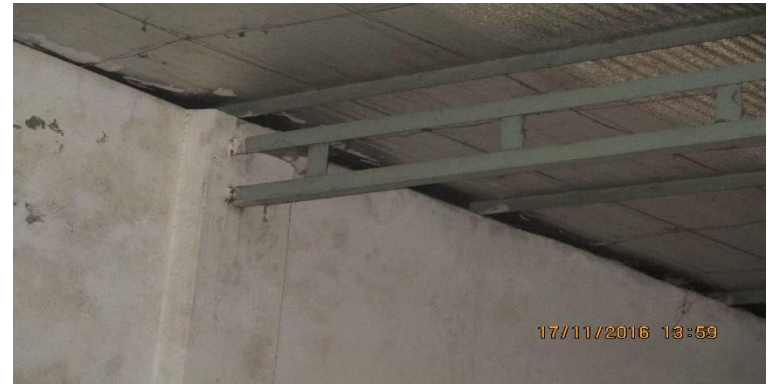
Non engineered connection (Fabric Storage, Production Shed)

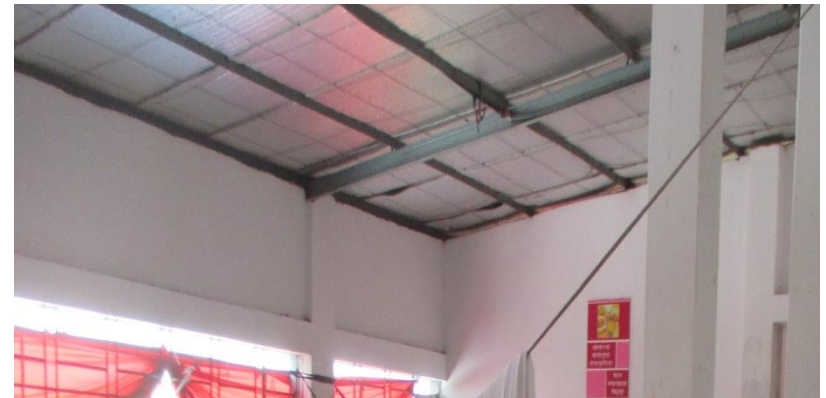
Non engineered roof (Extended portion)

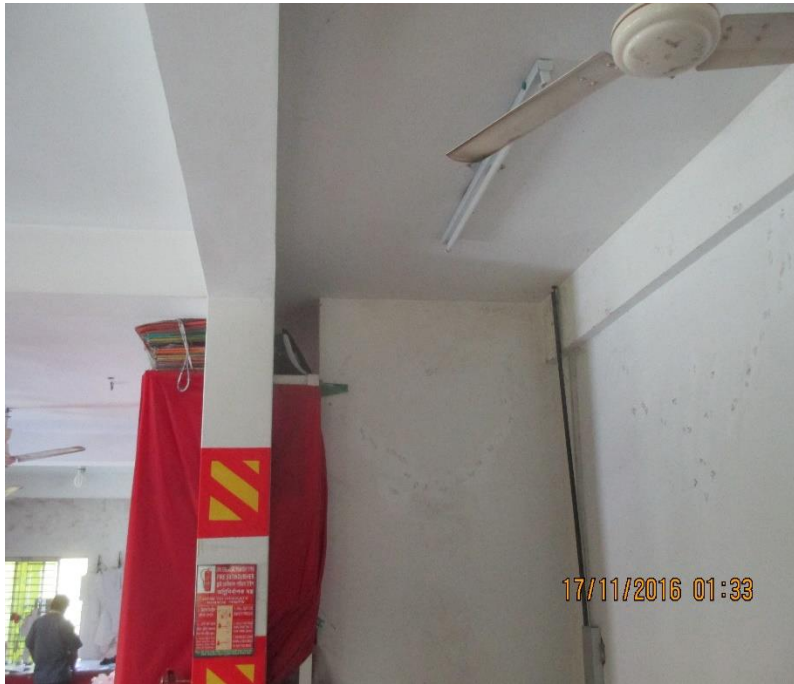
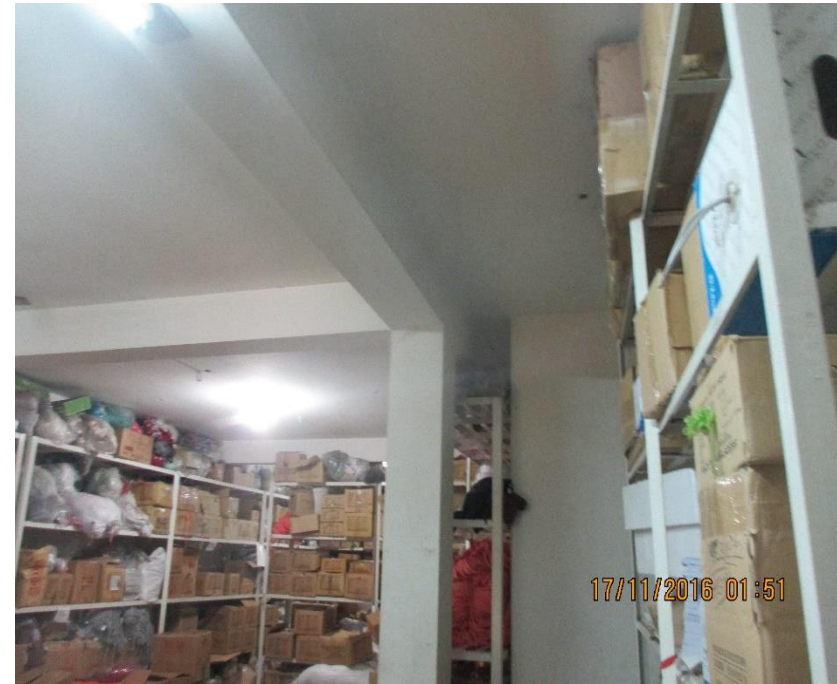
# **No Proper Expansion Joint Between Main Production Building and Extended Portion**

Main Production building and Extended portion were constructed without establishing proper Expansion joint. Factory management also confirmed this information that slab of these two buildings are connected. Although, no severe cracks were visible, but Factory engineer to look into this matter to clarify the load transfer path in case of lateral loading .

| Item No. | Observation | Recommended Action Plan | Recommended Timeline |
|---|---|---|---|
| 24 | No Proper Construction Joint Established Between Main Production Building and Extended Portion | Factory engineer to clarify the load transfer path in case of lateral loading and check adequacy of the connecting slab . | 6-weeks |
| 25 | No Proper Construction Joint Established Between Main Production Building and Extended Portion | Propose remedial measures if required. | 6-weeks |
| 25 | No Proper Construction Joint Established Between Main Production Building and Extended Portion | Carry out remedial works which will be the outcome of the assesment | 6-months |

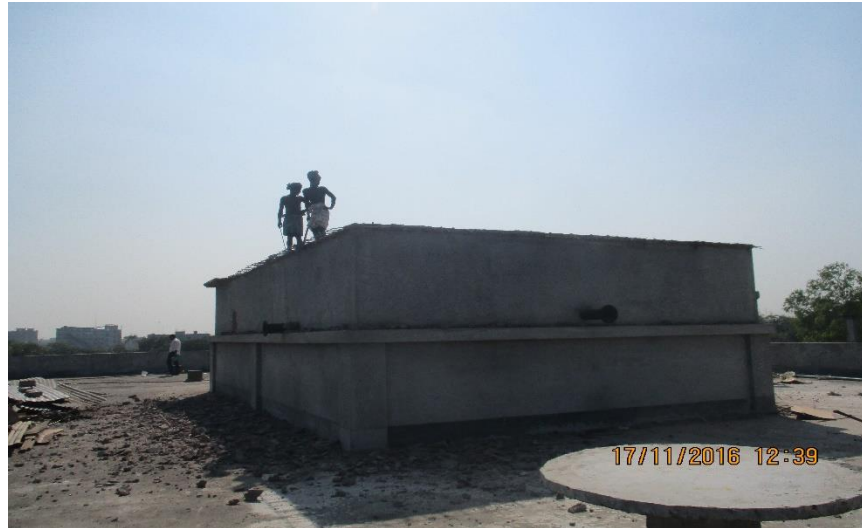
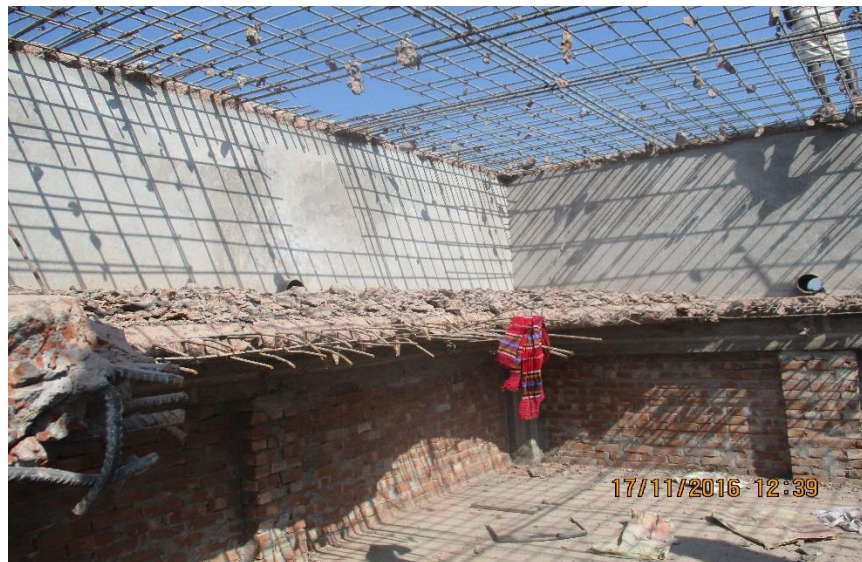
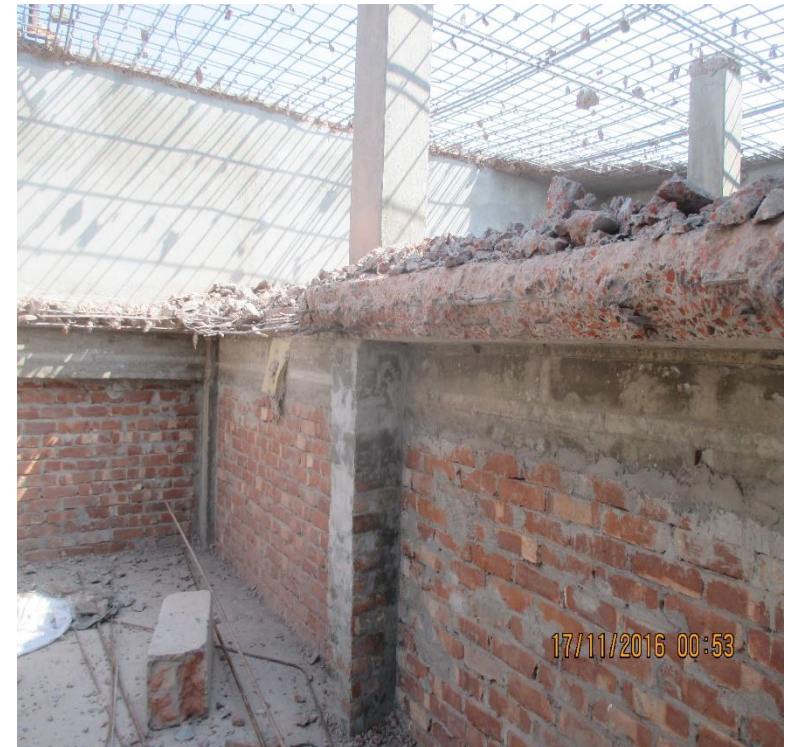
# Ongoing Demolition work

We observed demolition of an RC water tank was going on at the roof top of Main production building. However, no safety measures were taken

| Item No. | Observation | Recommended Action Plan | Recommended Timeline |
|---|---|---|---|
| 25 | Ongoing Demolition work | Carry out all demolition works taking all necessary safety measures (Like safety net etc.) | Immediate - Now |
| 25 | Ongoing Demolition work | Finish demolition of RC water tank. | 6-weeks |
