Silken Sewing Ltd - New building

Baniar Chala (Member Bari), Vobanipur, Gazipur

13th February, 2017

Observations

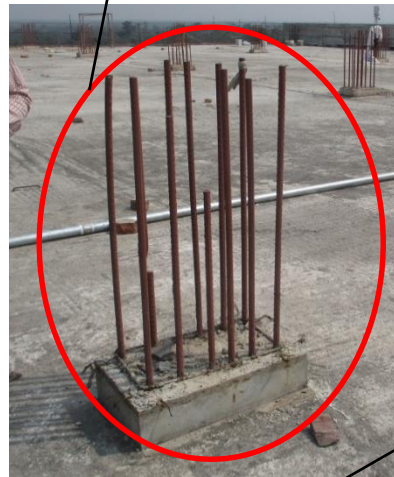
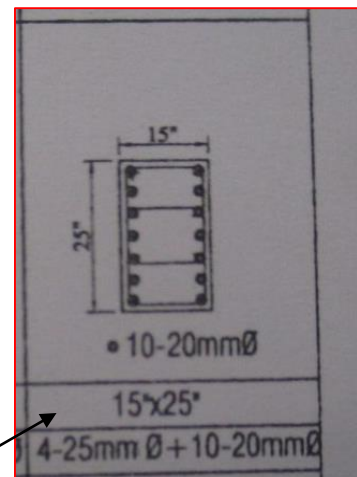
Found 12-20mm dia rebar in C-16 column on roof top but in column schedule, the rebar was different

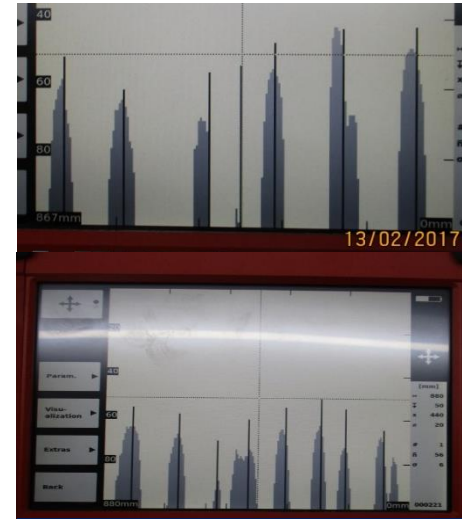
Found 7 nos. and 8 nos. re-bars on first floor instead of 9 bars in column schedule of C-16 on long direction of column

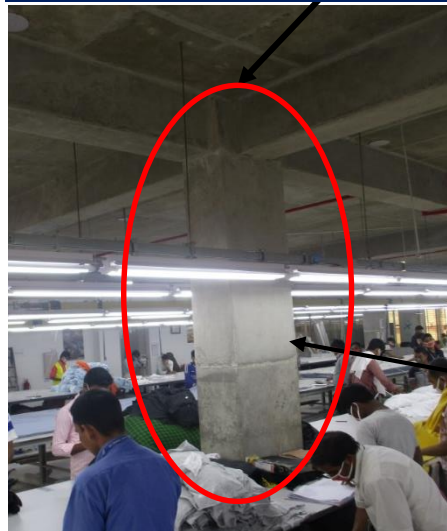
Found 6nos. rebar in C-15 column at one face on 1st floor but in column schedule, the rebar was shown 7nos.

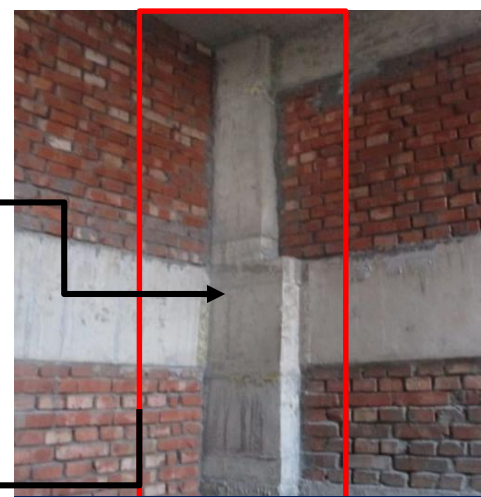
C-12 column at 1st floor on stair case

C-12 column size found different in stair case but according to provided column schedule, the size of column was shown same on Ground floor to roof top.

Item No.	Observation	Recommended Action Plan	Recommended Timeline
1	Inconsistent and missing documents	Engage a Building Engineer to survey the structure and update a full set of “as-constructed” drawings	6-weeks
2	Appearance Hairline crack observed on beams	Engage a Building Engineer to investigate if cracks penetrate the building structure.	6-weeks
3	Appearance Hairline crack observed on beams	Building Engineer to carry out design check on beam to confirm that these cracks are non-structural.	6-weeks
4	Appearance Hairline crack observed on beams	Carry out remedial works resulting from engineering assessment if necessary.	6-months

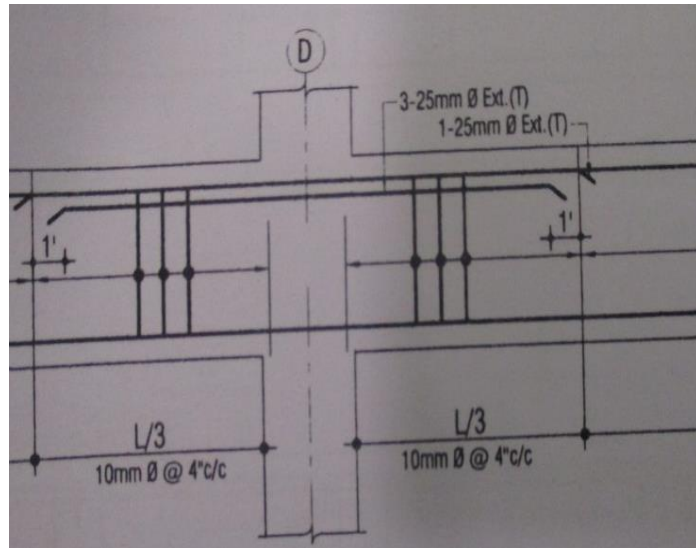
In provided drawing, the FB-3A beam has 6-25mm rebar as top bar and 3-25mm rebar as bottom bar

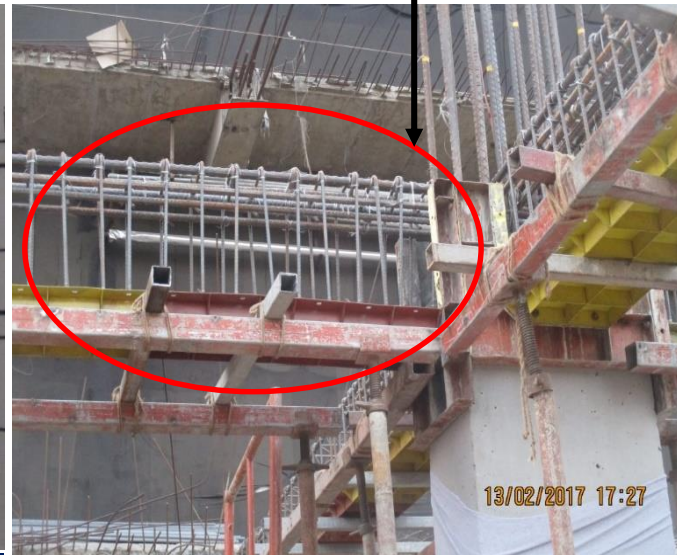
Found 3-25mm & 3-20mm re bar as top bar and 2-25mm & 1-20mm re bar as bottom bar on Fb-3A

The reinforcements in FB-3A was found less than in provided drawing

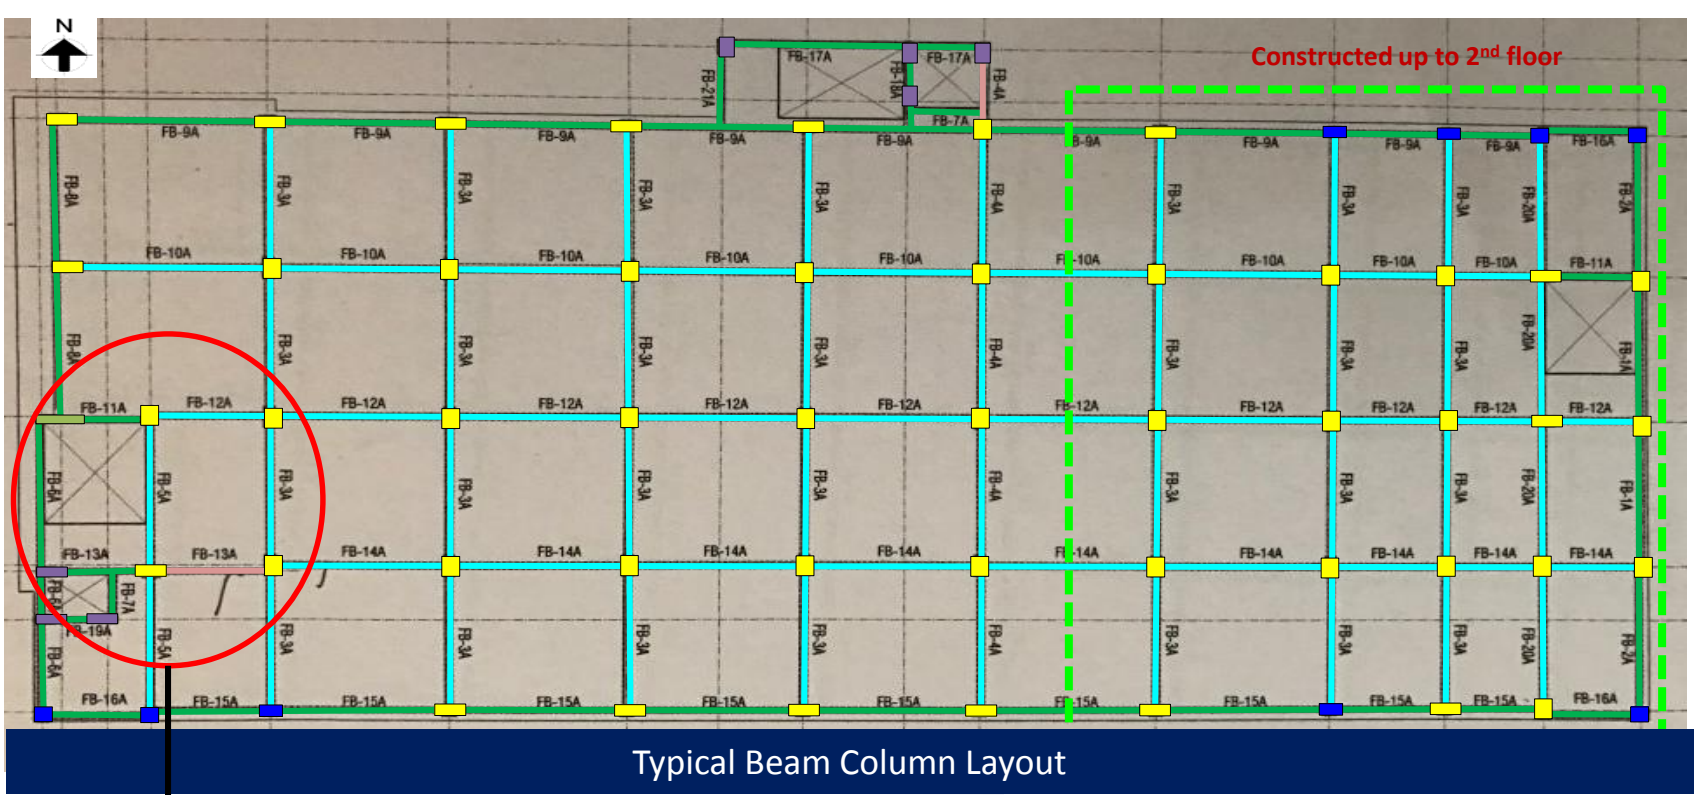
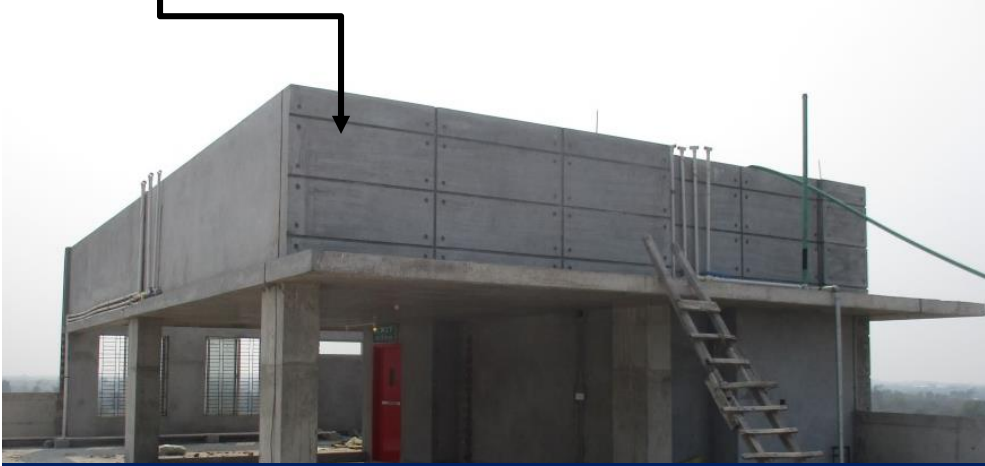
Found single RCC over head water tank on stair case

In provided drawing, no detail of over head water tank was found

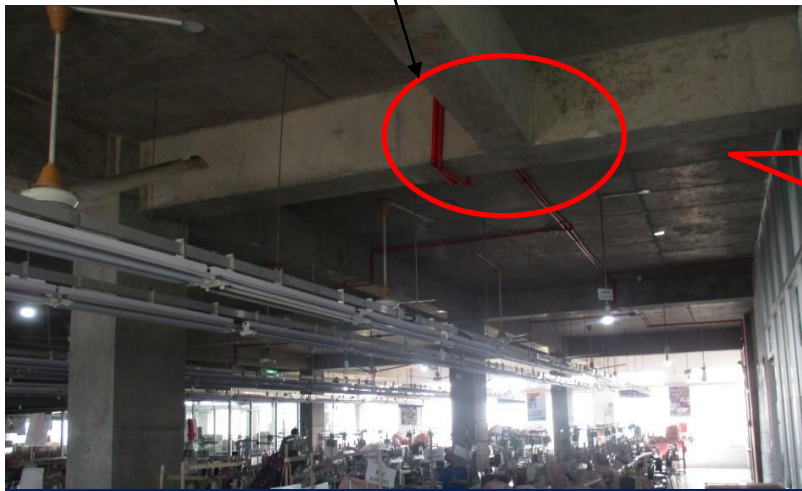
Crack observed on the joint of two beam

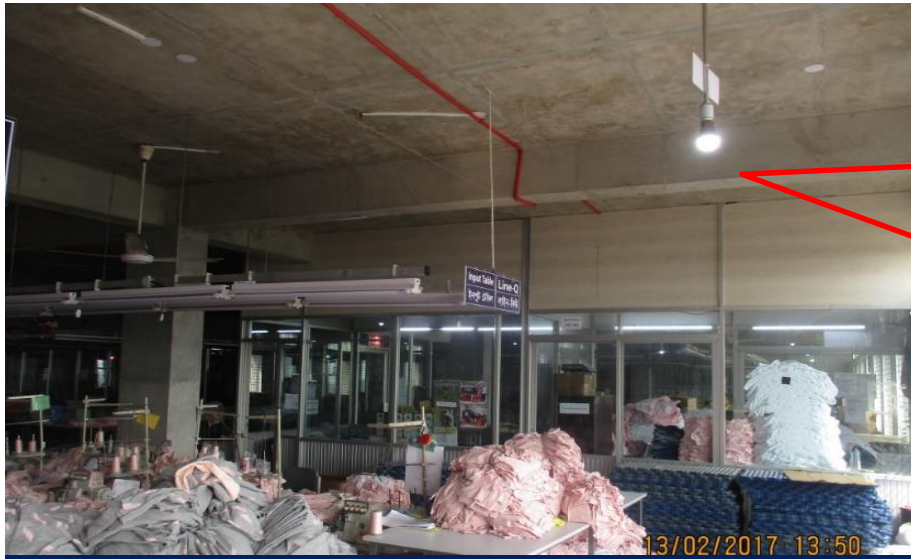
13/02/2017 13:50

Crack observed on the several beam of 5th floor

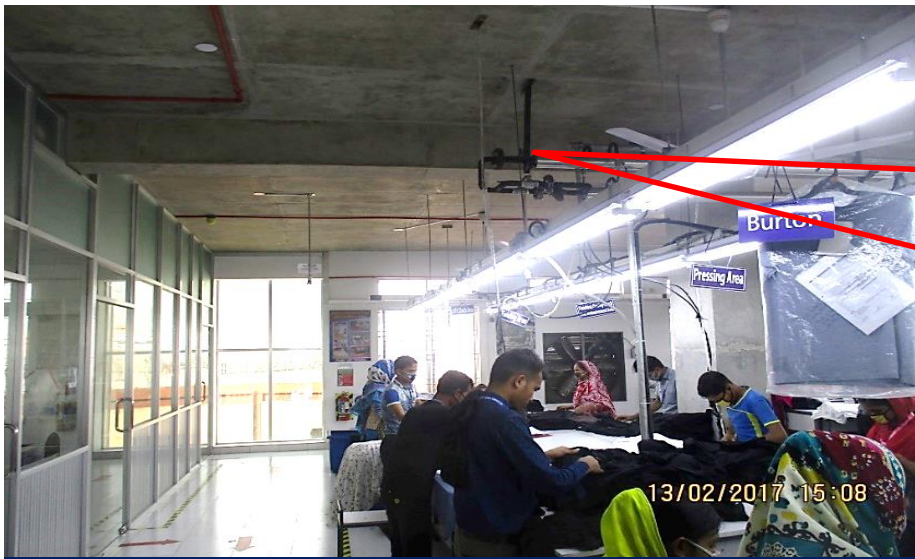
13/02/2017 15:08

Crack observed on the several beam of 3rd floor
