# Comptex Textiles Ltd. (New Building)

Vulta, Rupgonj, Narayangonj  
(23.771919N,90.560803E)  
16<sup>th</sup> February 2017

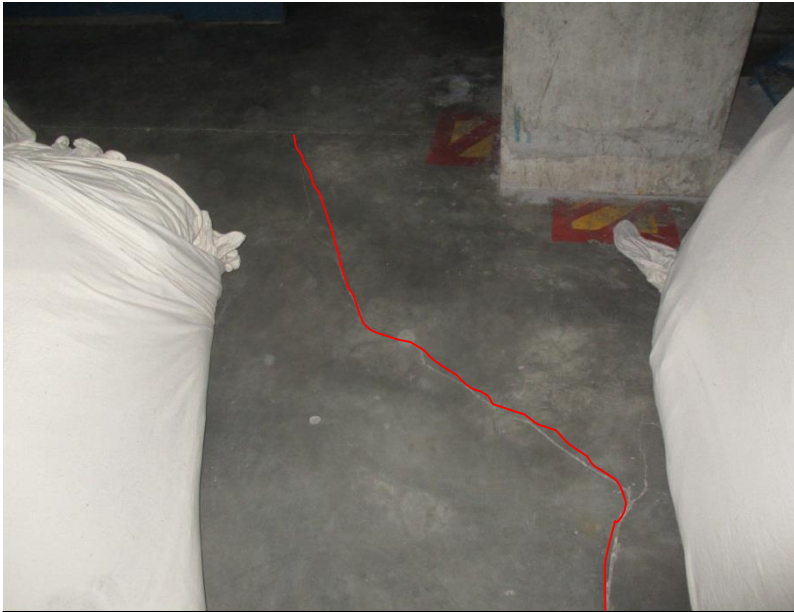
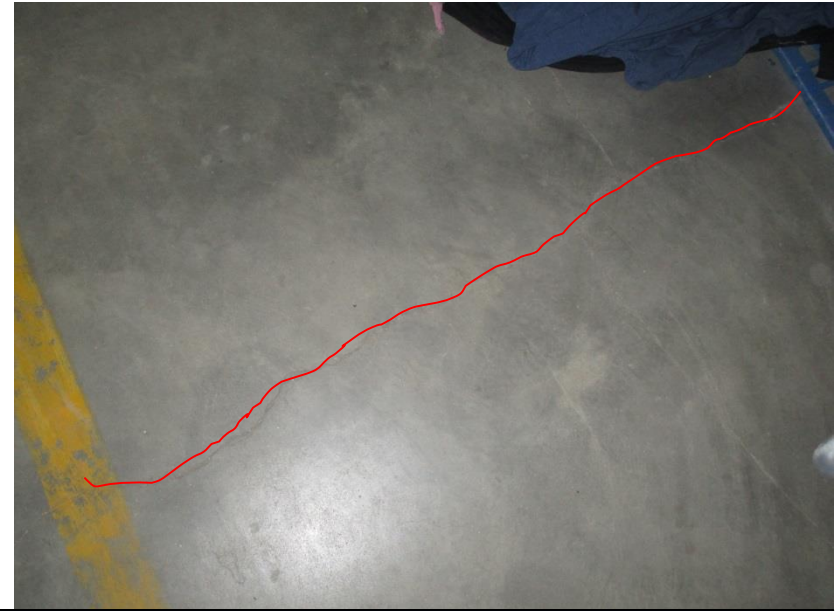
Hairline crack on slab

# Appearance of cracks on slab

Hairline crack appeared on ground floor slab on top surface at several locations. Building engineer to investigate the extend of cracks and check the capacity of slab against existing floor load.

| Item No. | Observation | Recommended Action Plan | Recommended Timeline |
|---|---|---|---|
| 1 | Appearance of cracks on slab | Building engineer is required to investigate the extent of cracks and check the capacity of slab against existing floor load. | 6-weeks |
| 2 | Appearance of cracks on slab | Carry out remedial works if and where required. | 6-months |

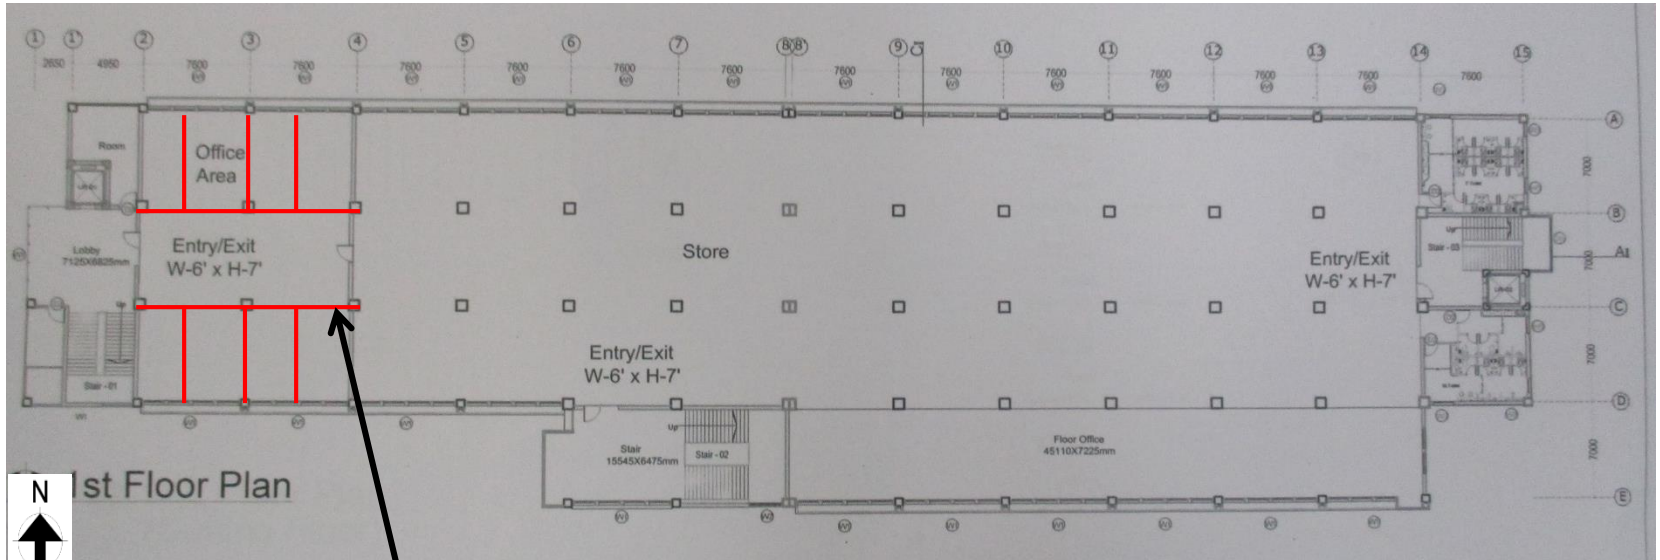
1st Floor Plan

The internal wall was not shown in As- built drawing. Factory engineer to update As-built drawings.

| Item No. | Observation | Recommended Action Plan | Recommended Timeline |
|---|---|---|---|
| 3 | Paucity of As-built drawing. | Engage a Building Engineer to survey the structure and update a full set of “as-constructed” drawings. | 6-weeks |
