# **FIRE SAFETY INSPECTION REPORT**

**Disney Sweater Ltd.**

**ACCORD ID: 12672**

**Date: 22 February, 2017.**

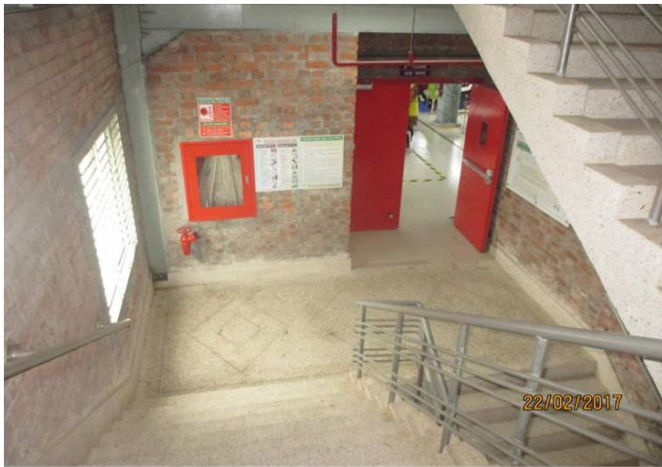
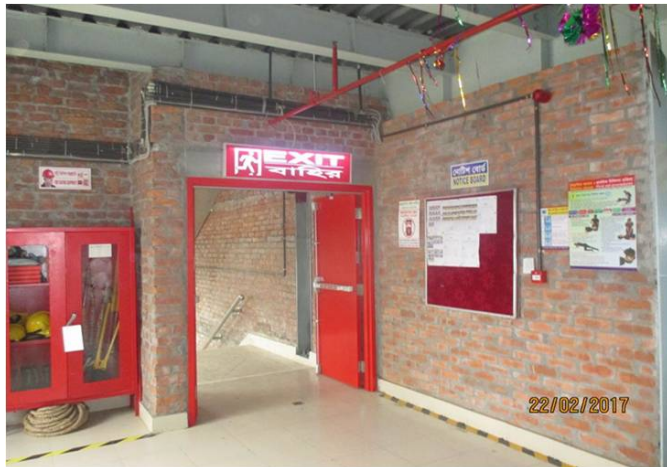
| SI No. | Category | Findings | Required Action | Remediation Time Frame |
|---|---|---|---|---|
| 1 | Fire Rated Construction | The exit stair enclosures are not separated from work areas and other spaces on each floor by fire-rated construction (Non rated doors, unsealed penetrations & openings etc.). | Provide minimum 1.5-hr fire rated doors and seal all unprotected openings to separate the exit stairs from work areas and other building spaces on all floor levels. Ensure that the fire doors are self-closing and positive latching and that they are provided with fire exit (panic) hardware where serving production floors. If fire doors are required to be held open for functional reasons, provide automatic closing devices tied to the fire alarm system. | Within 3 months |

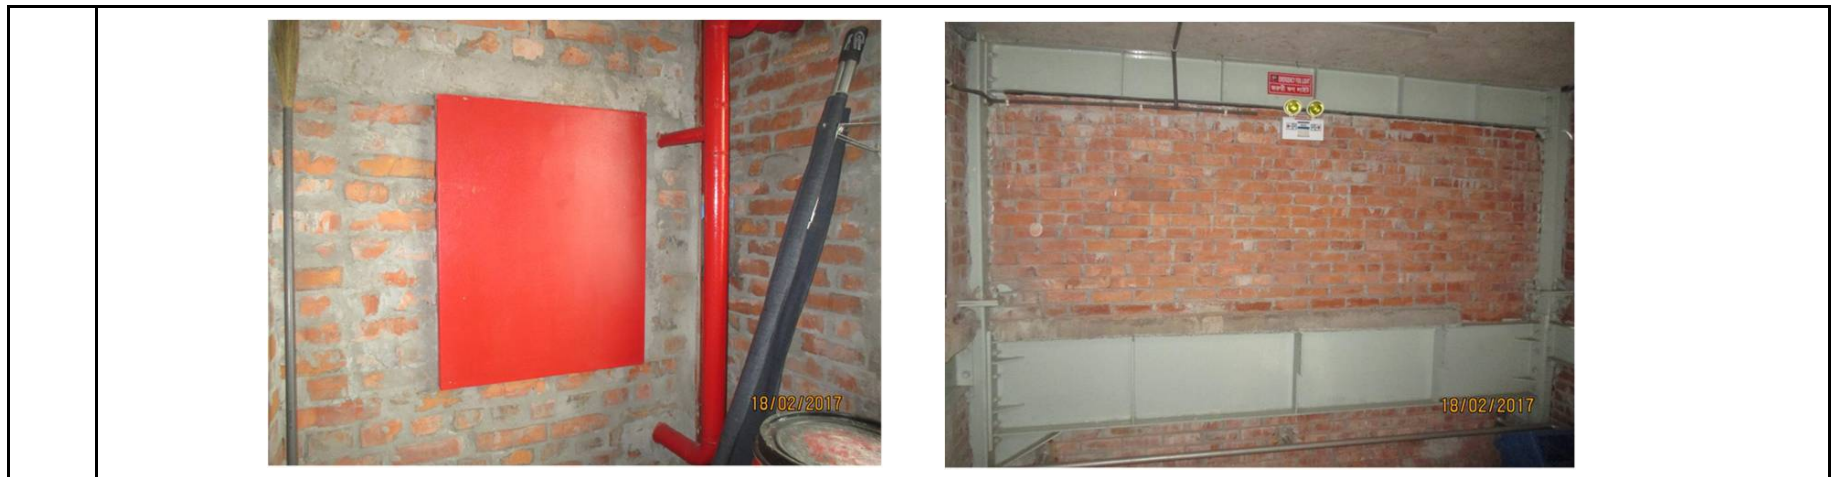
| 2 | Fire Rated Construction | Unsealed penetrations and openings are located in exit stair enclosures. | <p>Seal all penetrations and openings in the wall of exit enclosure walls (full thickness of the wall) by fire rated materials to maintain the fire resistance rating.</p> <p>Within 3 months</p> |

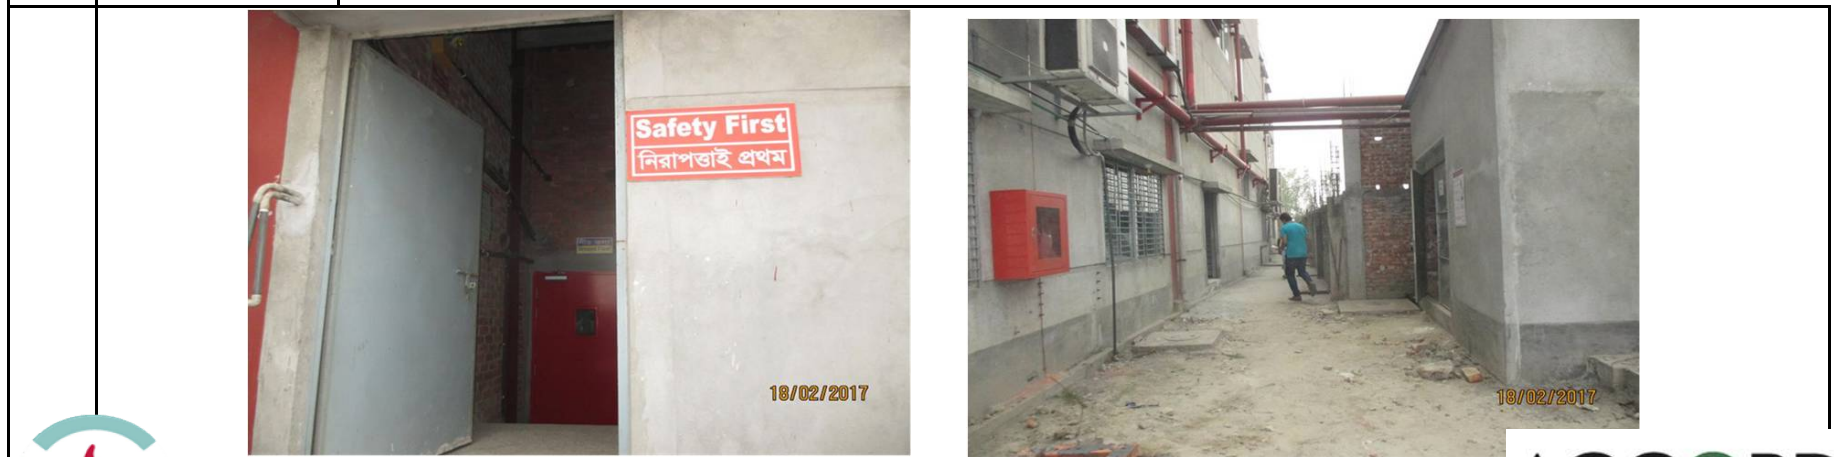
| 3 | Fire Rated Construction | <p>Pump room is not properly separated by fire rated construction from the egress passage way of the factory premises.</p> <p>Pump room shall be separated from the stair by a minimum 2-hr fire rated construction (wall, floor, slab etc.). Seal all penetrations and openings (door, window etc.) shall be protected by 1.5-hr fire rated materials to maintain the fire separation if required. All exhaust systems shall discharge to the exterior of the building in a safe location.</p> <p>Within 3 months</p> <p>Or, relocate the pump room in a safe place.</p> |

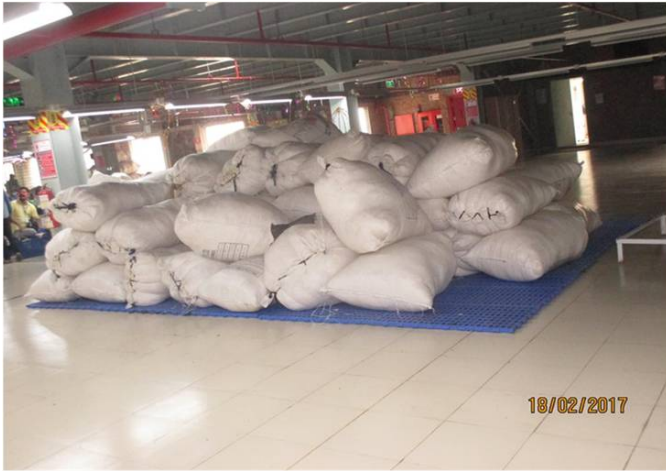
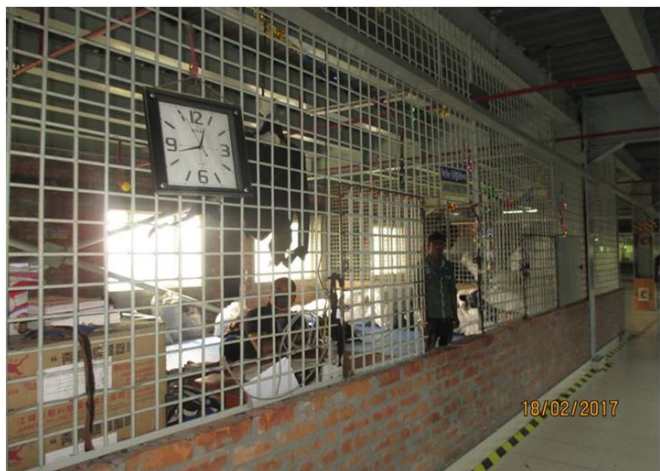
| 4 | Fire Rated Construction | <p>Areas used for in-process storage (Inspection Goods) of combustible materials are open to the surrounding occupancy. Location: Distribution Area in main building and In process Store in Shed Building.</p> <p>Provide defined storage areas and limit the storage arrangement as follows:-</p> <ol style="list-style-type: none"> <li>1. General Condition: Maximum height of 2.4m and maximum area of 23m<sup>2</sup>. Separate areas of unenclosed combustible storage by a minimum clear distance of 3m.</li> <li>2. If sprinkler protected: maximum height of 3.66m and maximum area of 93m<sup>2</sup>. Separate areas of unenclosed combustible storage by a minimum clear distance of 3m.</li> </ol> <p>Within 2 months</p> |

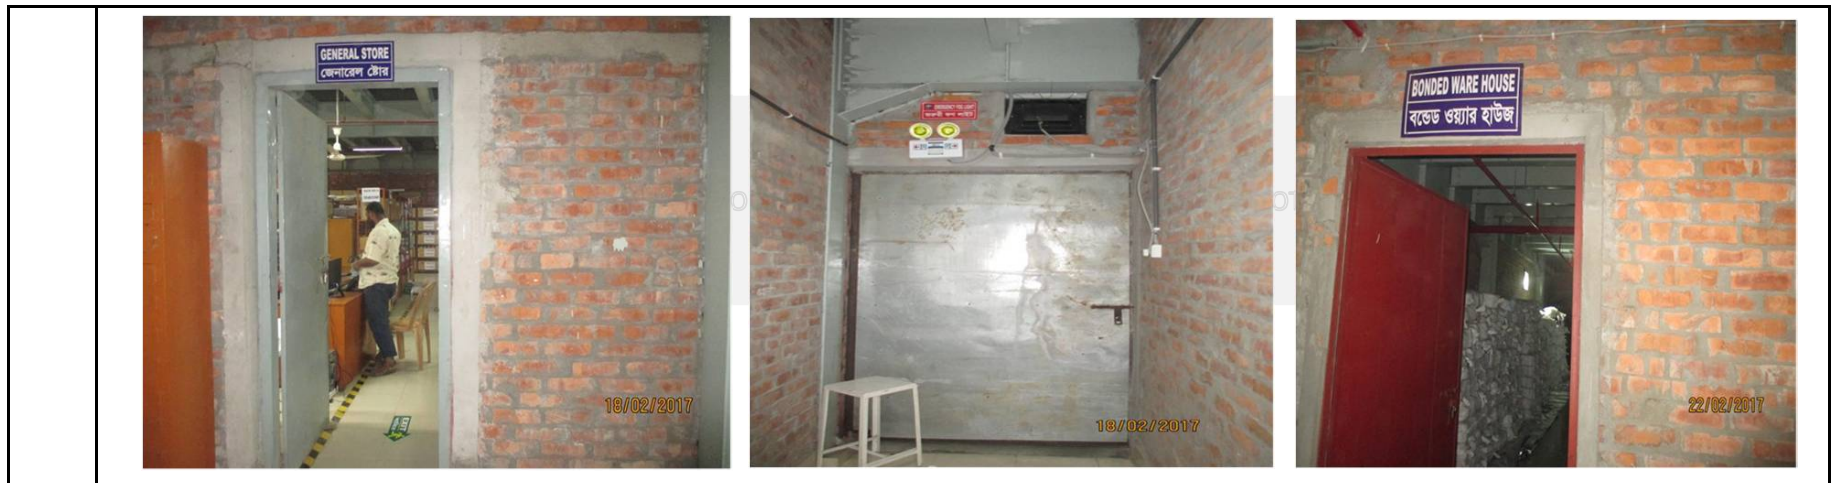
| 5 | Fire Rated Construction | <p>Room used for storage of combustible materials (Bonded ware house &amp; General Store room) is not separated from the surrounding occupancy. Location: 1st floor.</p> <p>Rooms used for storage of combustible materials shall be separated from the surrounding occupancy with a minimum 1 hour construction.</p> <p>Within 3 months</p> |

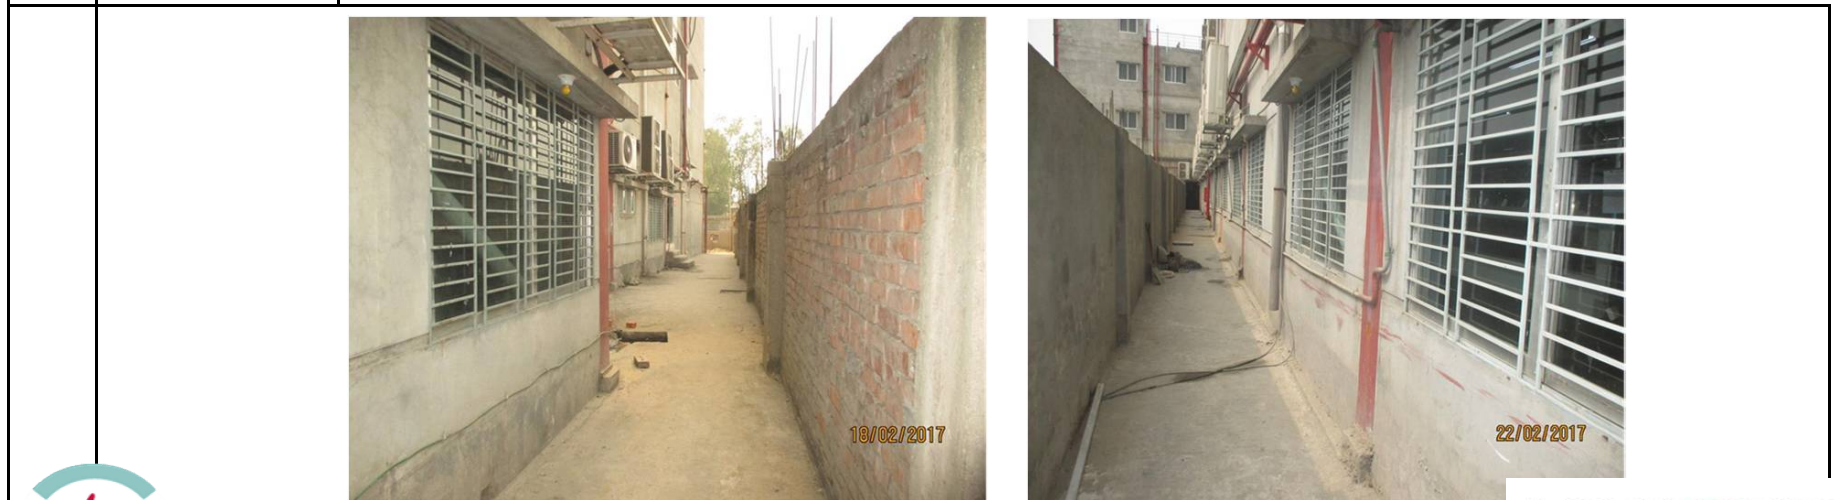
| 6 | Fire Rated Construction | <p>Seal all penetrations and openings to the interior of the building along the discharge paths, up to a height of 10 ft. to provide a minimum 1-hr fire separation.</p> <p>Alternatively, provide a second remote discharge path to the public way (only include this if feasible).</p> <p>Within 2 month</p> |

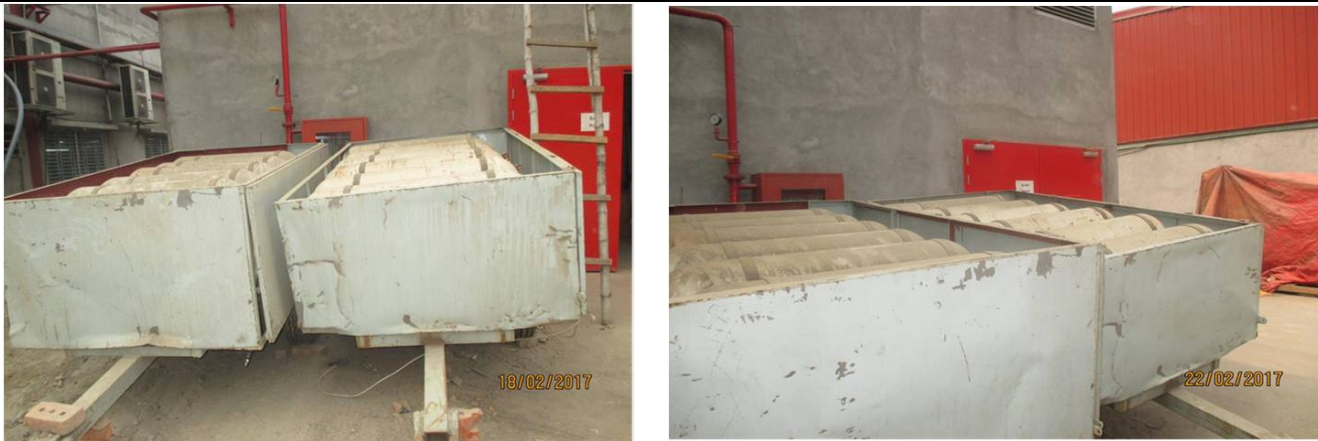
| 7 | Fire Rated Construction | The factory is using/ storing liquefied gas cylinder without any separation. | Remove them from the factory premises.<br>Or,<br>Provide 2-hr rated room for using/ storing liquefied gas cylinder and ensure proper verification of that room.<br>Source of fire such as electrical connection is prohibited. | Immediate |

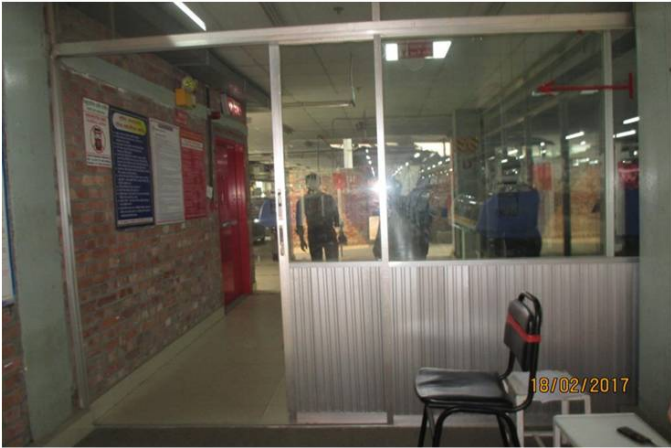
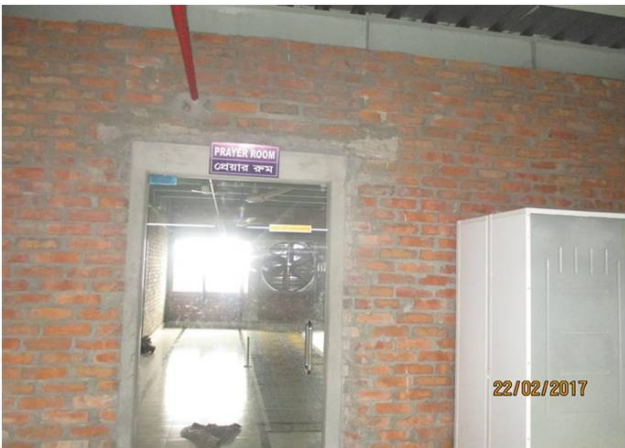
| 8 | Egress | Sliding type doors have been provided along means of egress (building exits, along egress routes, exit discharge). | Replace all collapsible/ sliding type doors & gates by the side-hinged swinging type doors.<br><br>If locks are required for security reasons, utilize special door locking features complying with NFPA 101. | Immediate |

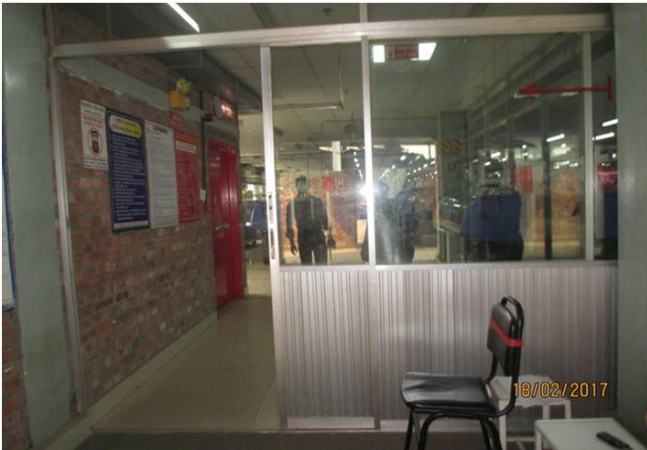
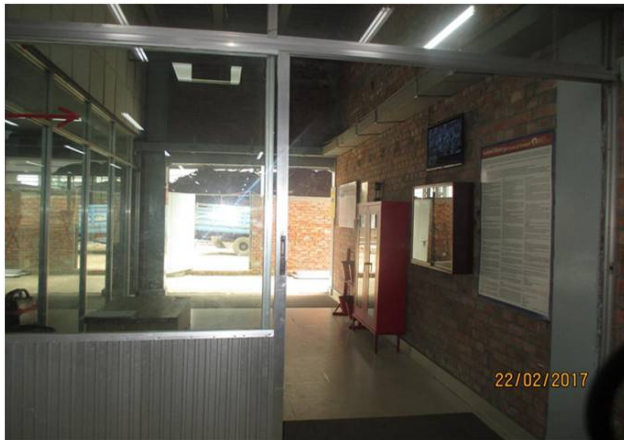
| 9 | Egress | <p>Doors along means of egress are provided with non compliant locking system</p> <ol style="list-style-type: none"> <li>1. Remove all non compliant locking features from egress doors.</li> <li>2. If locks are required for security reasons, utilize special door locking features complying with NFPA 101.</li> </ol> | Immediate |

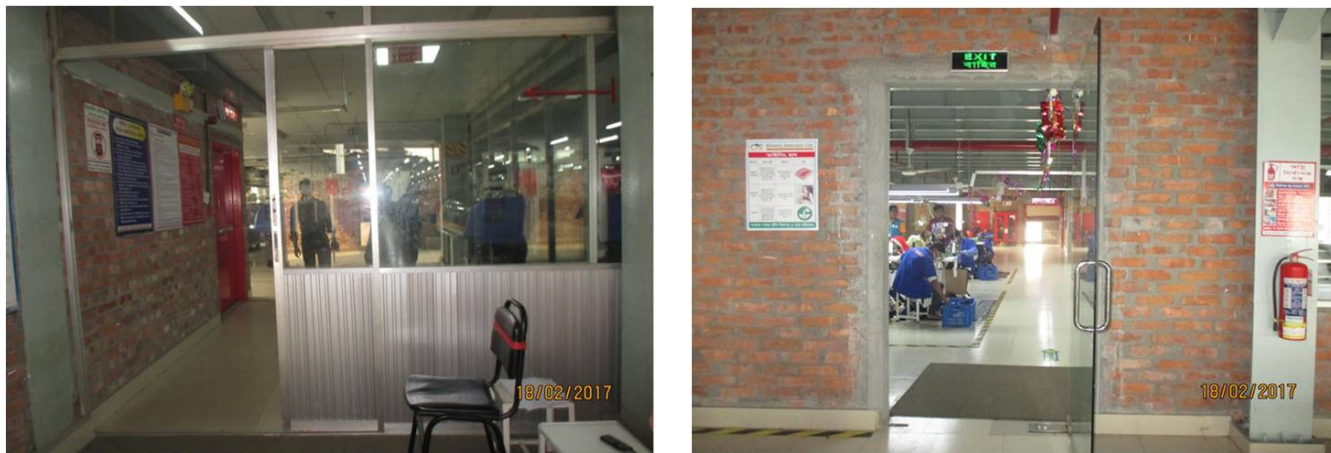
| 10 | Egress | Egress door serving 50 or more occupants but does not swing in the direction of egress travel.<br>Location: Dinning Area & main exit. | Modify swing direction of egress doors to the direction of egress travel. Doors serving an occupant load of more than 50 shall swing in the direction (out-ward) of egress travel . | Within 1 month |

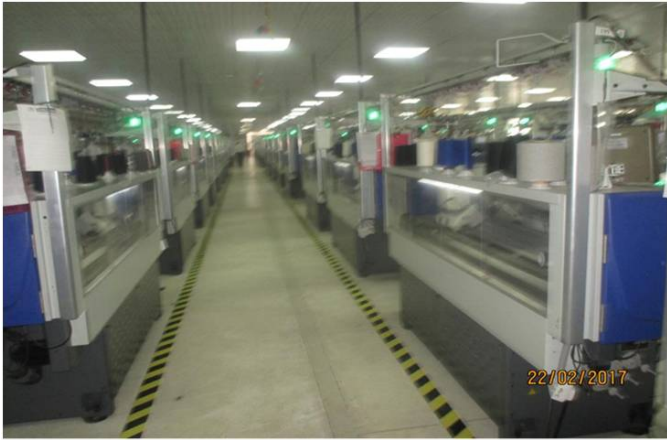
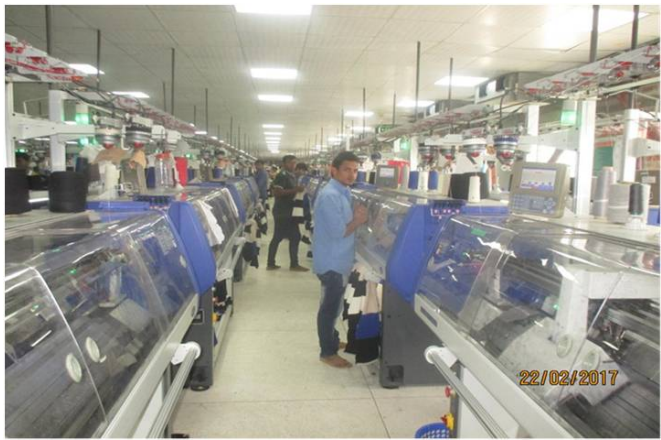
| 11 | Egress | Common path of egress travel exceeds 23 m.<br>Location: Shed Building. | Reconfigure the egress arrangement to reduce the maximum common path of travel to not more than 23 m. | Within 3 months |

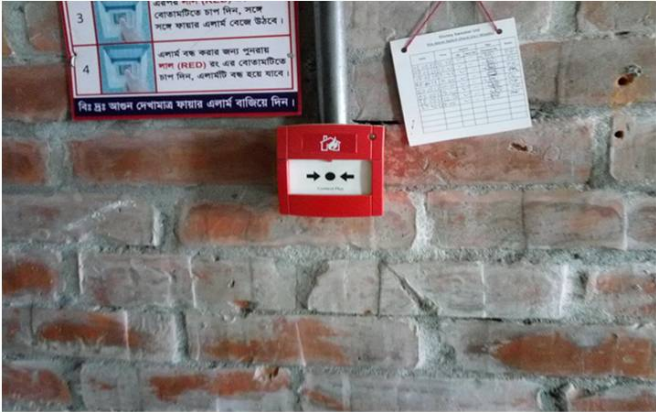
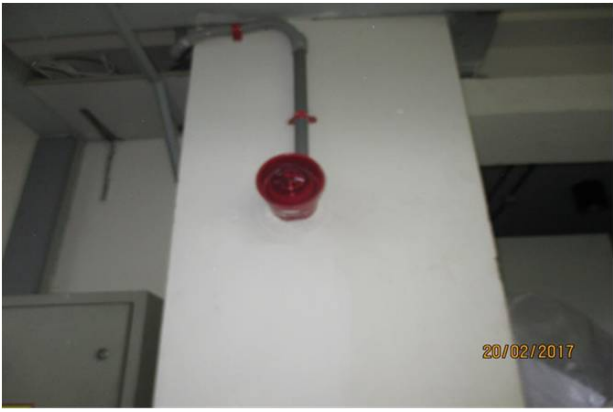
| 12 | Fire Alarm System | <p>The Required Fire Alarm system is not installed in accordance with the ACCORD standard Or NFPA-72.</p> <p>Design of Fire Alarm system should be in accordance with ACCORD standard and NFPA 72.</p> <p>Design Submission 2 months and Installation 4 months.</p> | |

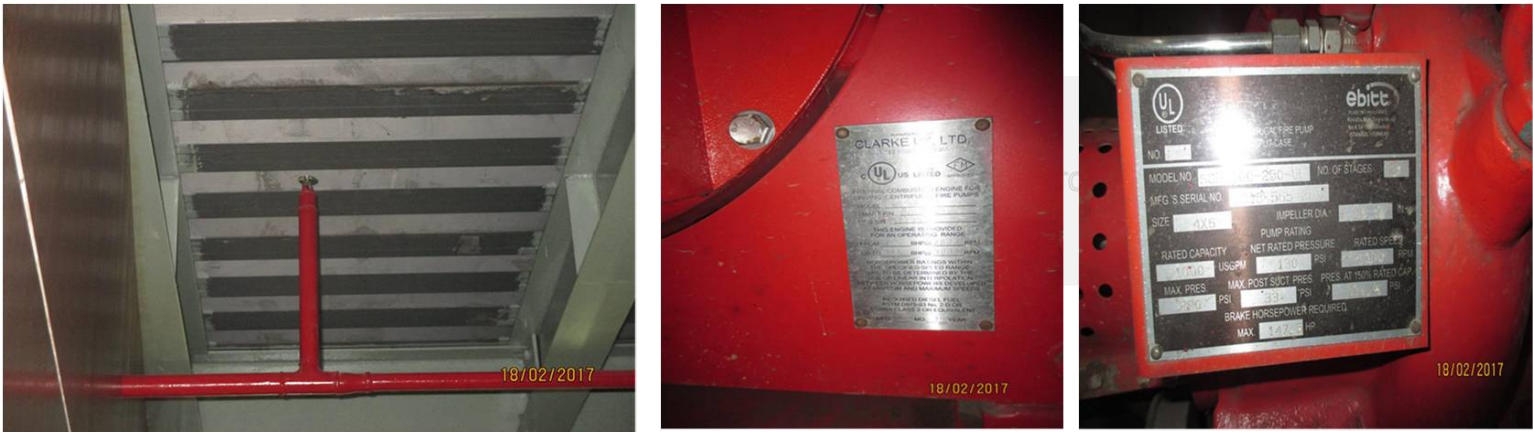
| 14 | Provision of Sprinkler system | Existing 3 storey non-rated building having floor area more than 2000 sqm (22000 sft) is not protected with an approved automatic sprinkler system. | Provide an automatic sprinkler protection throughout the building in accordance with NFPA 13. | Design Submission 2 months and Installation 4 months. |

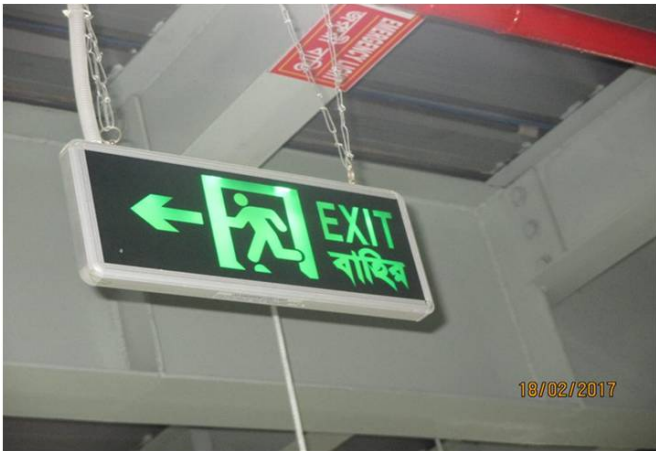
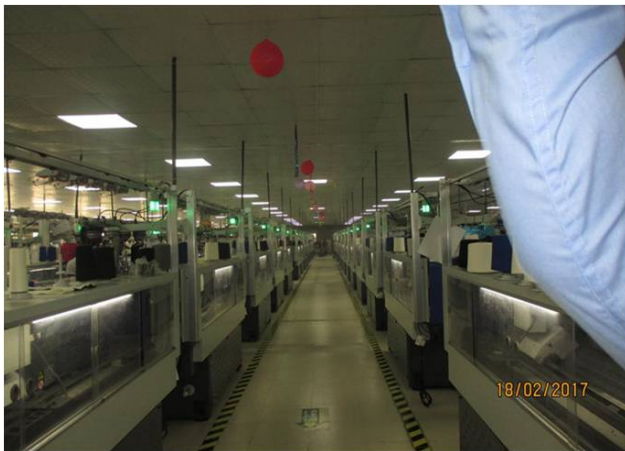
| 15 | Emergency Egress Lighting | Based on the number and location of emergency lights observed, adequate illumination levels are not anticipated along egress routes. | Test the emergency lighting system on each floor and provide additional emergency fixtures to provide adequate illumination along the means of egress. Provide a minimum illumination of 10 lux at the floor level within exit stairs and exit discharge paths and minimum 2.5 lux along exit access aisles. | Within 3 months |
