Dekko Fashions Ltd Dekko Apparels Ltd

Dhaka
(23.819890, 90.363120)
1st April 2014

Observations

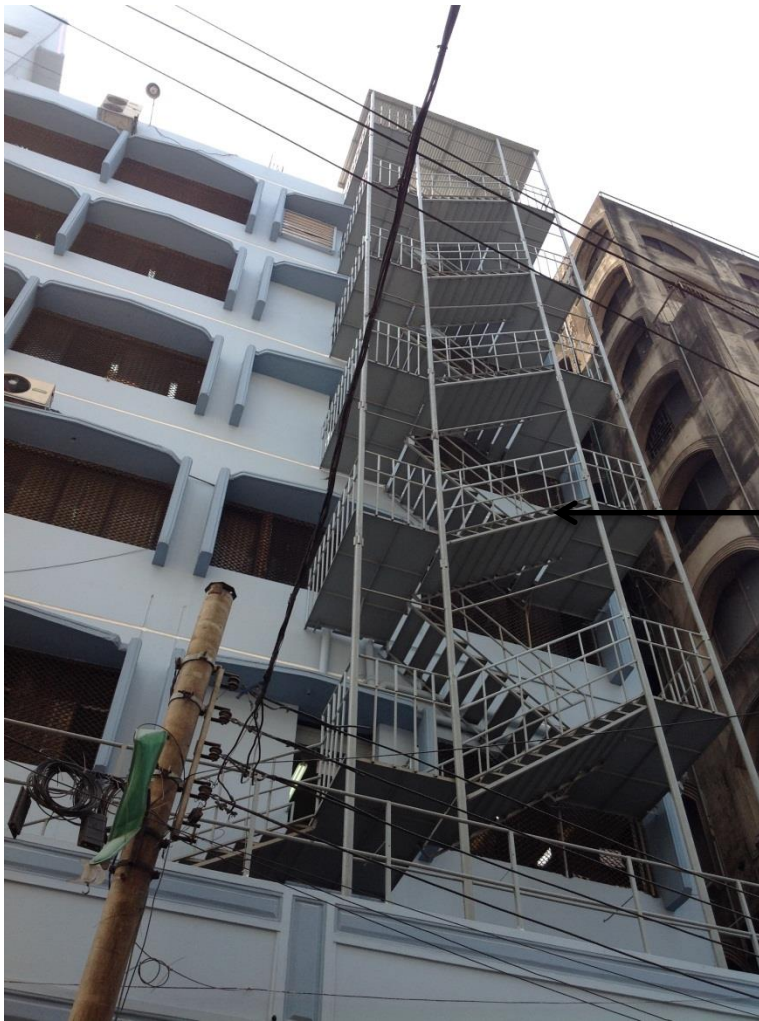
Escape Stair

Escape stair to front elevation which appears to be 'non-engineered' due to the small size of the stair stringer members and support columns. This stair will also apply point loading to the First floor projecting roof slab: it is not clear if this structure has been checked for this additional loading.

ITEM 1: Apparently non-engineered steelwork to escape stairs.

| Item No. | Observation | Recommended Action Plan | Recommended Timeline |
|---|--|---|---|
| 1 | Apparently non-engineered steelwork to escape stairs | Building engineer to check the capacity of the steel stairs and supporting slab under fire escape loading | 6-weeks |
| 2 | Apparently non-engineered steelwork to escape stairs | Carry out any alterations required from the Assessment | 6-months |

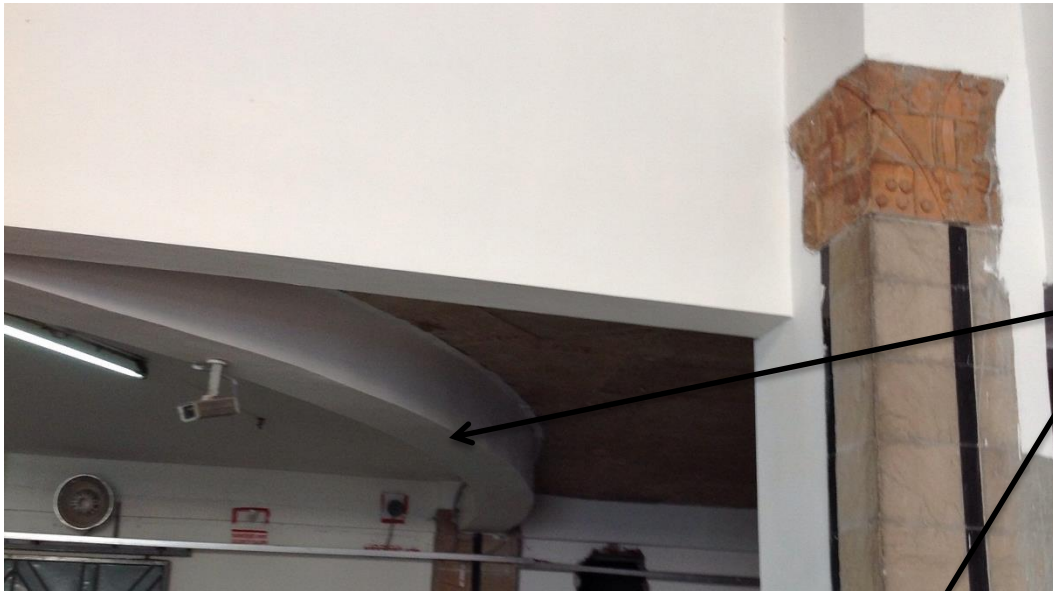
First Floor Curved Beam

The loading on the curved beam at First floor in bay C2/B3 has increased due to the introduction of additional floor slab.

ITEM 2: Additional loading onto original curved beam due to recent infill slab.

| Item No. | Observation | Recommended Action Plan | Recommended Timeline |
|---|--|---|---|
| 3 | Additional loading onto original curved beam due to recent infill slab | Building engineer to check the structures and provide structural drawings and loading plan for the new First floor area | 6-weeks |

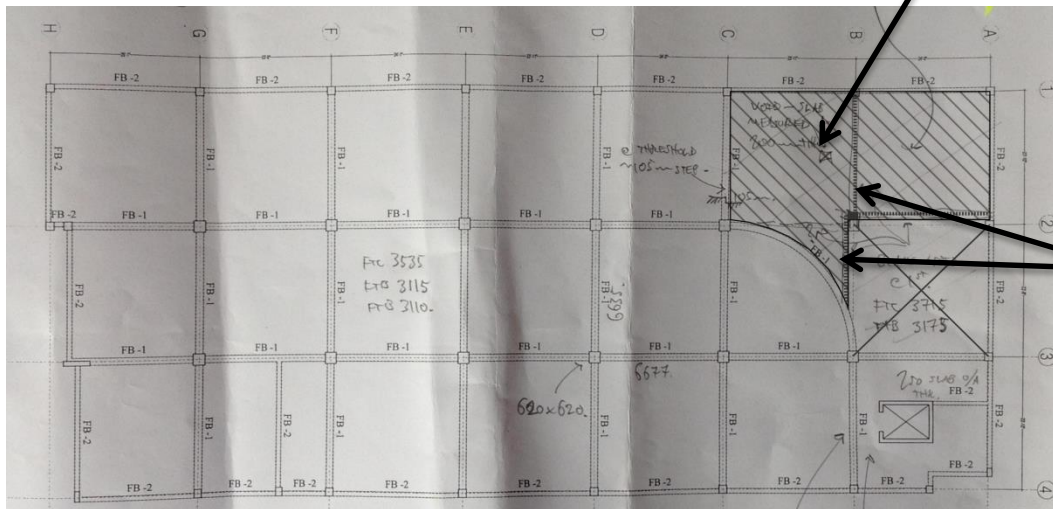
The additional slab area is marked on the plan below, which part-infills the double-height space at the front of the building.

Additional support column and beams (one of which frames into the curved beam). It is unknown if the capacity of the curved beam, nor the surrounding columns and foundations have been checked for the additional forces from the slab infill.

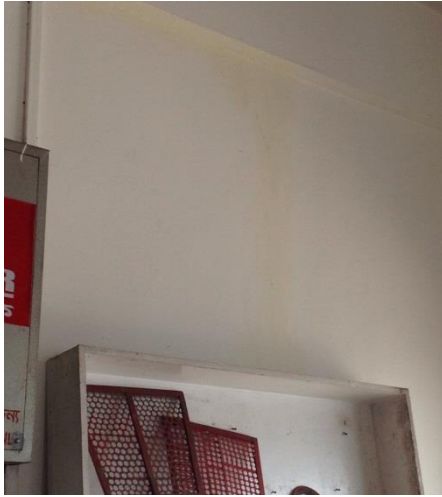
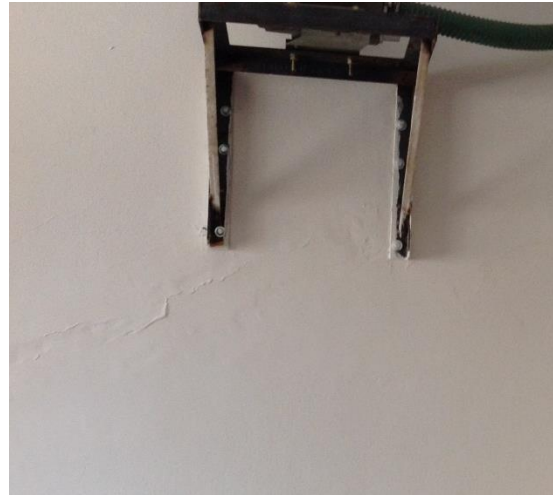
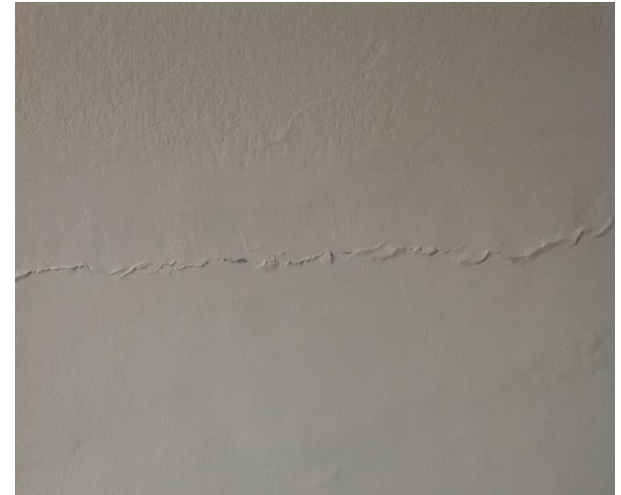
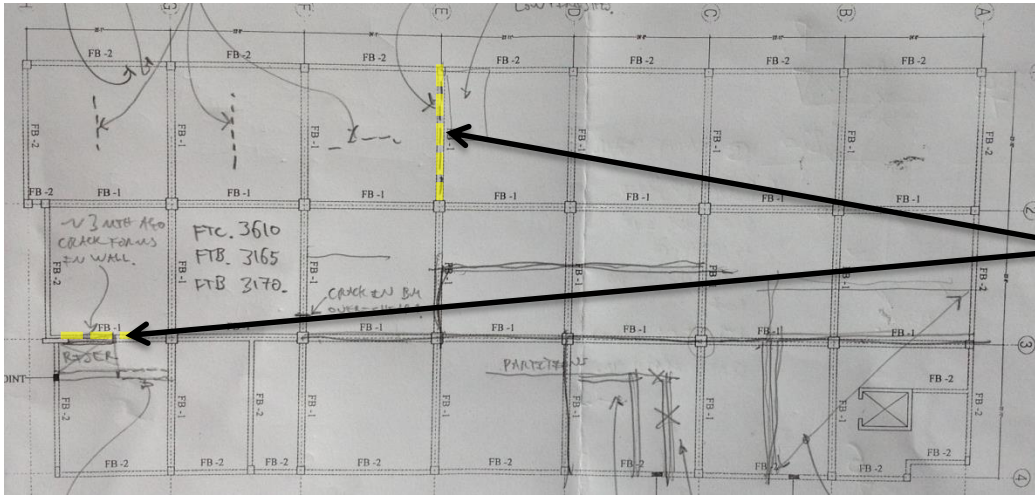
Cracking in Masonry Panels at Level 6

Cracking in masonry panels was observed at Level 6 to two locations as-marked.

ITEM 3: Cracking in masonry panels at Level 6.

| Item No. | Observation | Recommended Action Plan | Recommended Timeline |
|---|--|---|---|
| 4 | Cracking in masonry panels at Level 6 | Engineer to monitor the recent cracking in masonry panels at level 6. Assessment to be made following monitoring and Engineer to specify repairs and strengthening if necessary | 6-months |

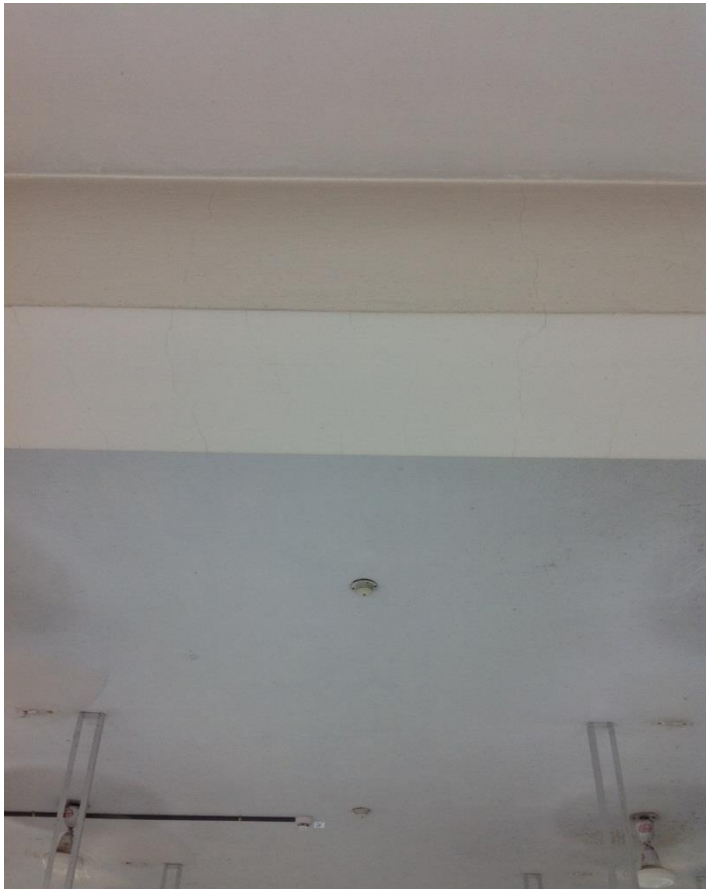
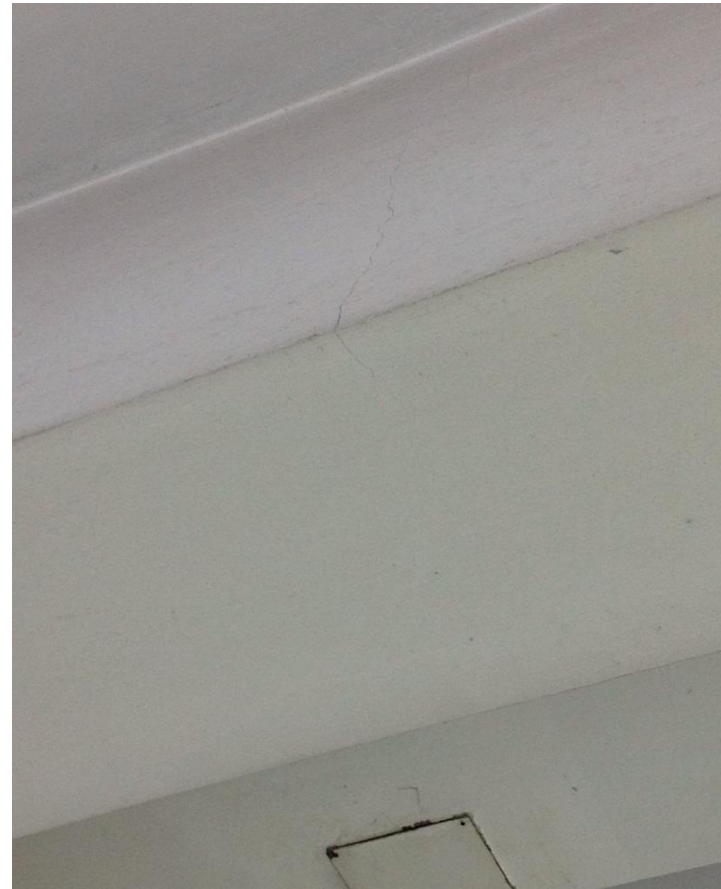
Beam and Slab Cracking

Cracking was observed to the soffit of beams and slabs in numerous locations at many levels . These photos show typical cracking.

ITEM 4: Cracking in beams and slabs at numerous floor levels.

| Item No. | Observation | Recommended Action Plan | Recommended Timeline |
|---|--|---|---|
| 5 | Cracking in beams and slabs at numerous floor levels | Engage an Engineer to investigate if cracks are only in the nominal render finish. Engage an engineer to specify repairs and strengthening if necessary. | 6-months |
