# Tusuka Jeans Ltd. (Unit-2)

Konabari, Neelnagar, Gazipur  
(24.0108529N,90.3245044E)

18<sup>th</sup> January 2017

# Observation

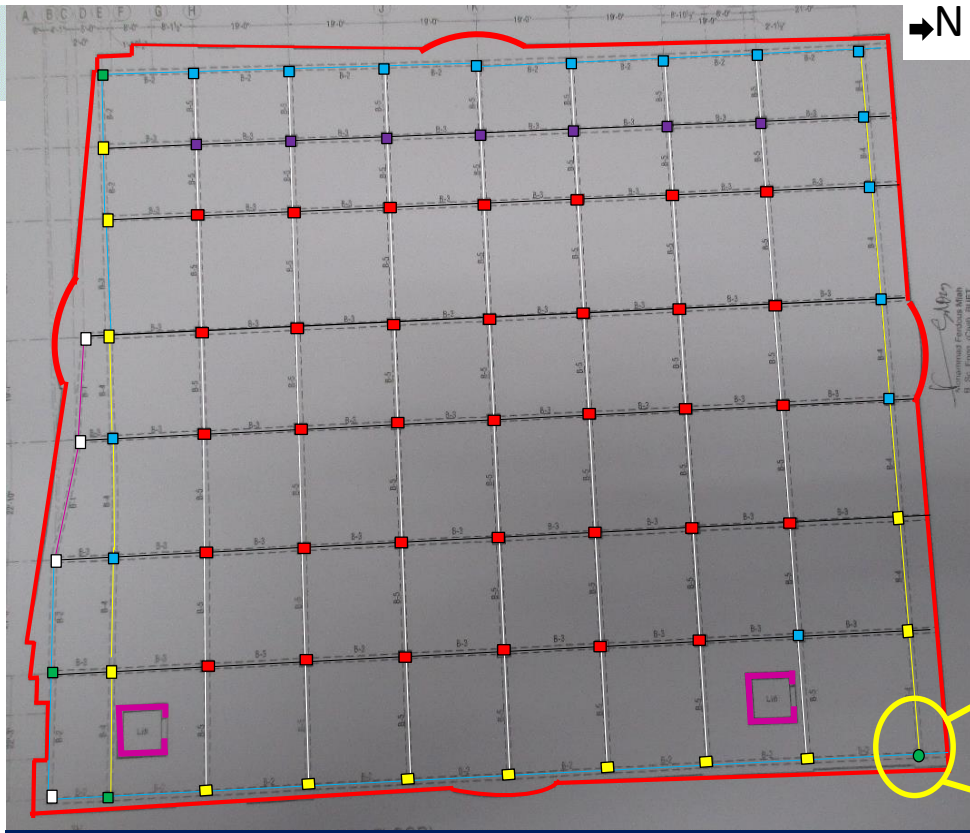
Typical beam Column Layout (Ground floor)

Highlighted column was shown as C-5 (500mmX500mm) at all level in column schedule. However, at Ground floor this column was found as circular column of 700mm diameter. Factory engineer to update as-built drawing reflecting the as constructed condition.

| Item No. | Observation | Recommended Action Plan | Recommended Timeline |
|---|---|---|---|
| 1 | Discrepancy between provided drawing and as constructed condition | Produce accurate as built documentation reflecting existing condition | 6-weeks |

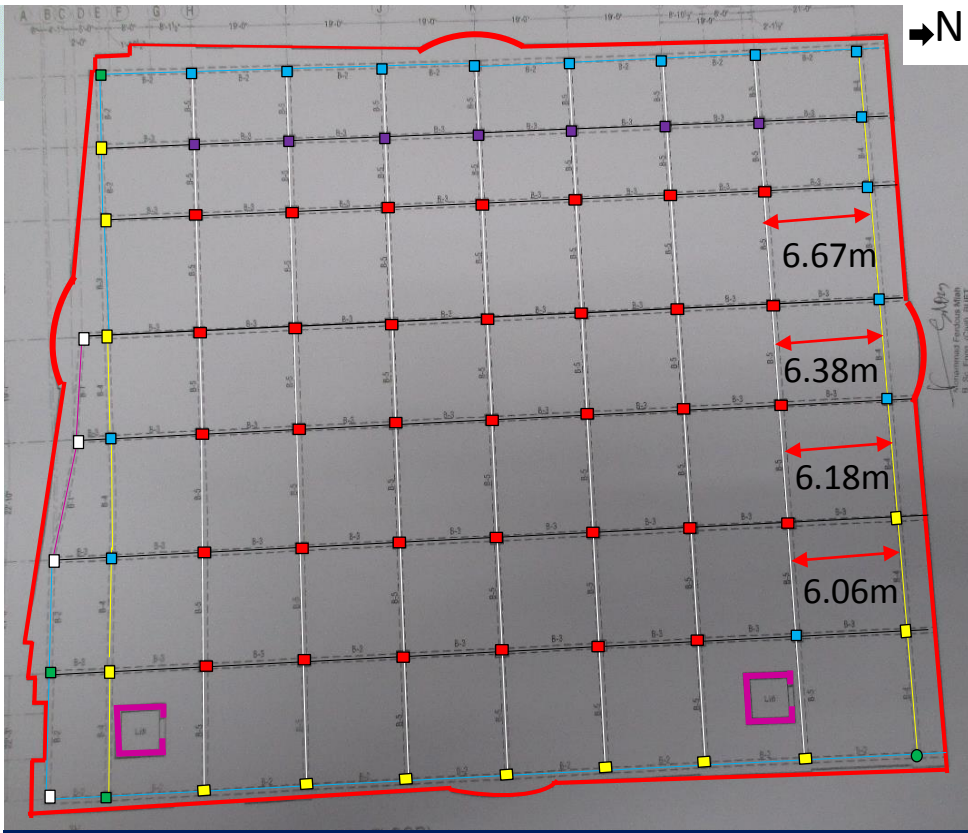
Typical beam Column Layout (1<sup>st</sup> to 8<sup>th</sup> floor)

Grid dimension varies at north most bay. The dimension didn't match with the provided drawing. The length of the grid decreases from west to east direction.

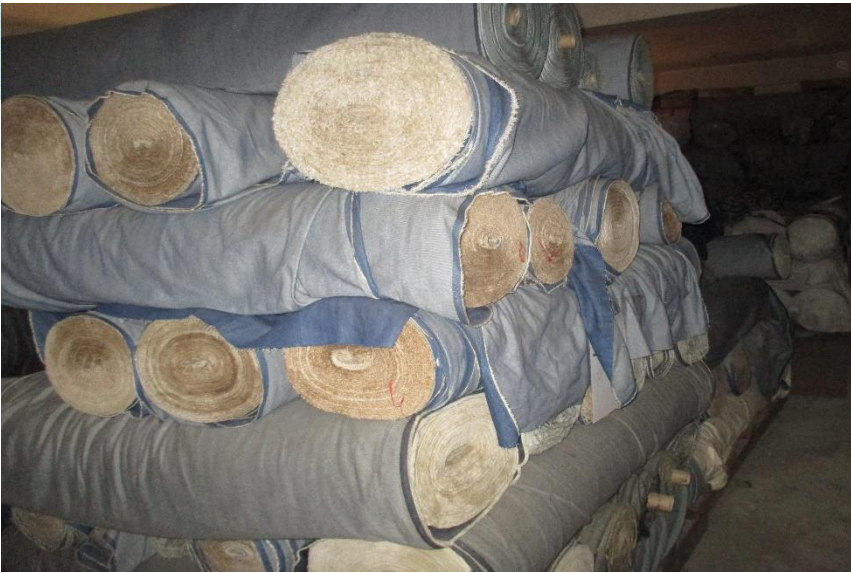
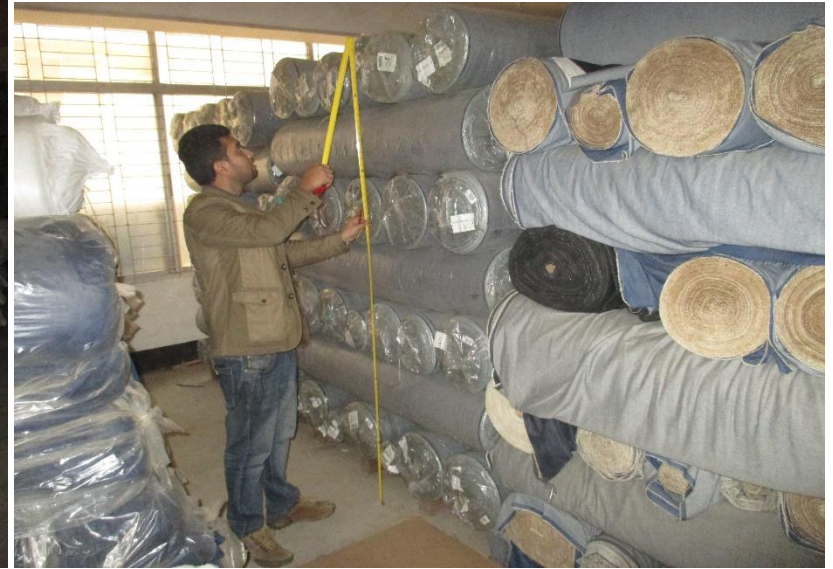
Storage at 1<sup>st</sup> floor

At the time of inspection load plan was posted in every floor plate and typical loading limit was shown as 4 KN/m<sup>2</sup> in the load plan. Load marking was also observed in the storage areas. However, at 1<sup>st</sup> floor storage area live load was observed around 5 KN/m<sup>2</sup> and at 2<sup>nd</sup> floor storage area live load was observed around 4.5 KN/m<sup>2</sup> which exceed the loading limit of existing load plan. Factory management to reduce existing load to 4 KN/m<sup>2</sup> in those area and make sure the existing load plan and height are followed strictly.

| Item No. | Observation | Recommended Action Plan | Recommended Timeline |
|---|---|---|---|
| 2 | Load plan was not followed | Factory management to reduce existing load to 4 KN/m <sup>2</sup> in those area and make sure the existing load plan and height are followed strictly. | 6-weeks |

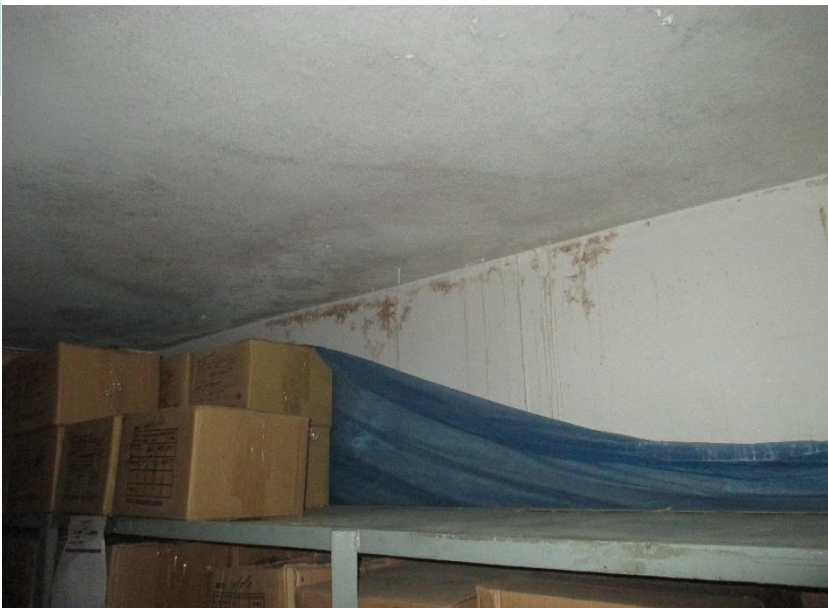
Water ingress at basement through Ground Floor slab

| Item No. | Observation | Recommended Action Plan | Recommended Timeline |
|---|---|---|---|
| 3 | Water ingress through ground floor slab | Factory engineer to investigate the cause of water ingress. | 6-weeks |
| 4 | Water ingress through ground floor slab | Implement any remedial work accordingly. | 6-months |

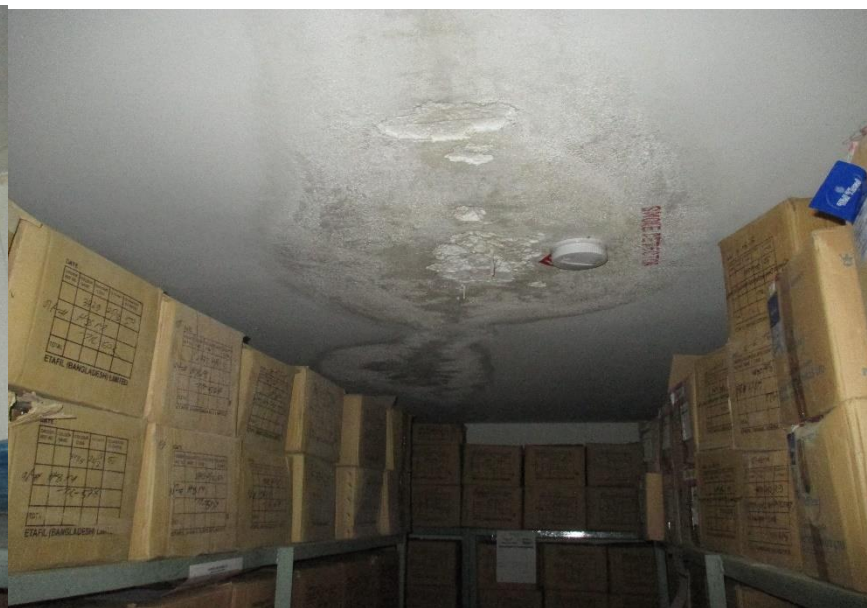
Water ingress at basement through Ground floor slab under washing area of Ground floor. Factory engineer to investigate the cause of water ingress and repair accordingly.

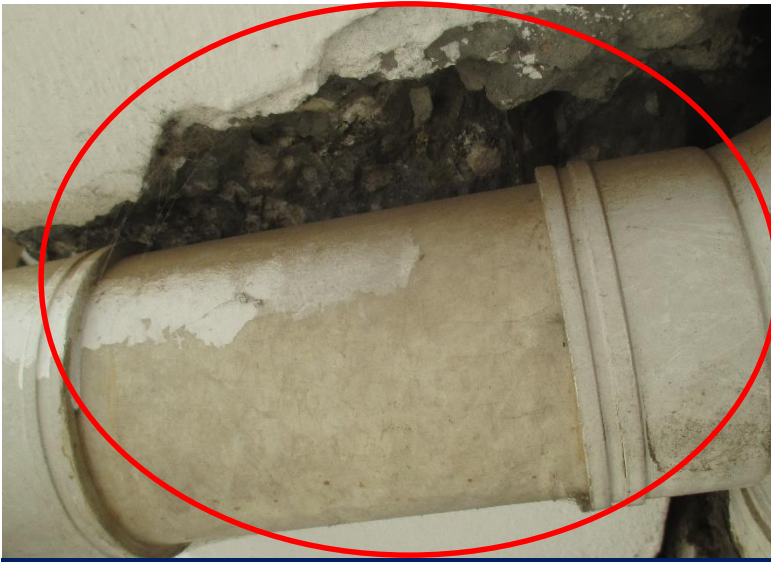
Bottom rebar was found exposed

| Item No. | Observation | Recommended Action Plan | Recommended Timeline |
|---|---|---|---|
| 5 | Damaged beam in toilet area | Factory to take step against possible corrosion according to the suggestion by the factory engineer. | 6-weeks |

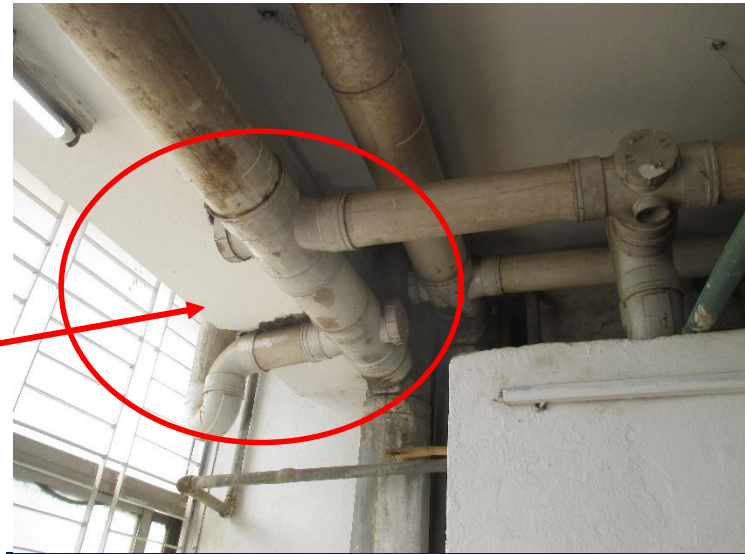
Beam damage at West side Toilet area on 4<sup>th</sup> floor

Damage found under beam at west side toilet area on 4<sup>th</sup> floor which may cause possible corrosion. Factory to take steps to protect possible corrosion according to suggestion given by the factory engineer.

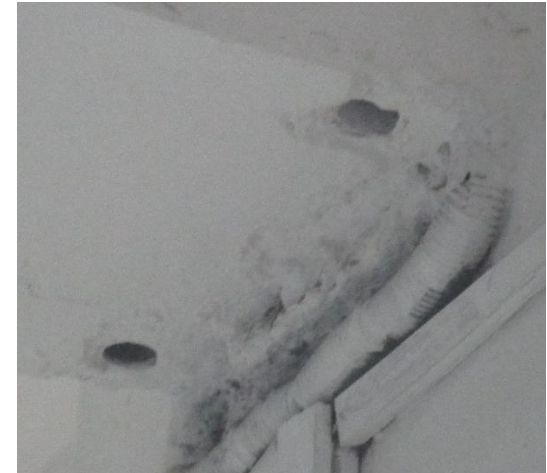
Hole on shear zone at 4<sup>th</sup> floor

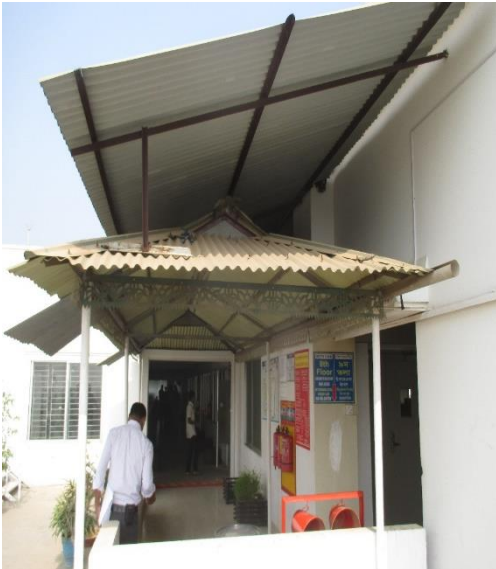
Non engineered canopy at 8<sup>th</sup> floor level

Steel shed at 8<sup>th</sup> floor was appeared to be Non engineered.  
Factory engineer to prepare assessment report for the shed.

| Item No. | Observation | Recommended Action Plan | Recommended Timeline |
|---|---|---|---|
| 6 | Non engineered shed at 8th floor | Factory engineer to prepare assessment report for both non engineered sheds. | 6-weeks |
| 7 | Non engineered shed at 8th floor | Produce accurate as built documentation reflecting existing condition. | 6-weeks |
| 8 | Non engineered shed at 8th floor | Implement any remedial work raised from the assessment. | 6-months |

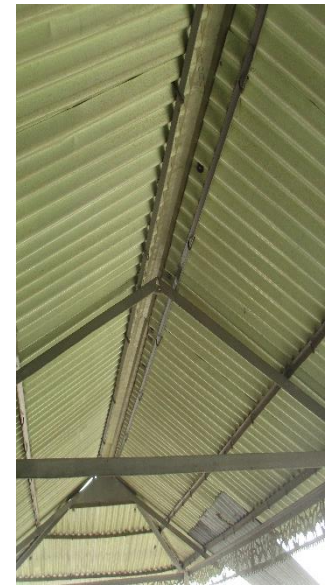
Non engineered connection of shed on 8<sup>th</sup> floor

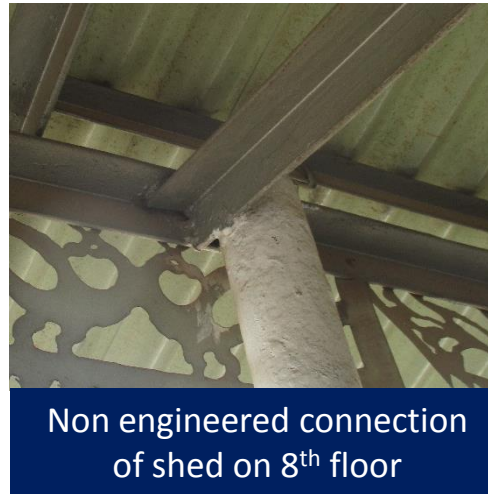
Non engineered connection of shed on 8<sup>th</sup> floor
