# Knit Syndicate

Jalkuri, Siddirganj, Narayanganj-1400, Bangladesh.

5<sup>th</sup> January, 2017

# Observations

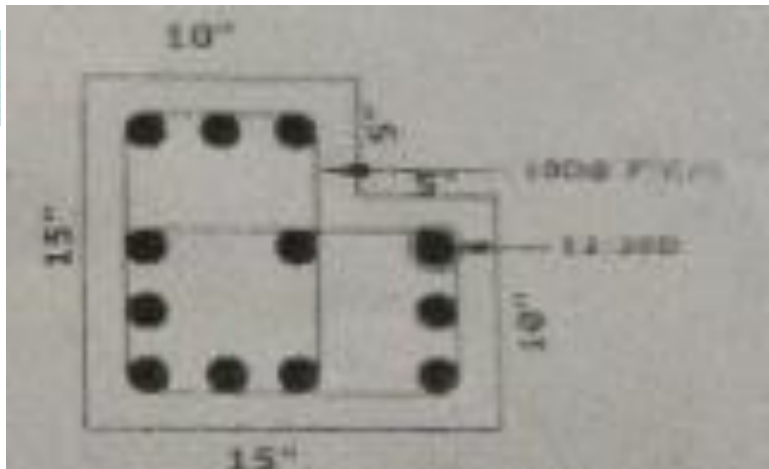
Lift core column detail in column schedule.

Lift core columns are appeared in grade beam layout but not exist in foundation layout. Lift core columns was suspected to be supported on mid portion of grade beam. But no connection detail was found in structural drawings. Factory engineer needs to check the adequacy of Grade beam for the concentrated load from lift core columns.

Item No.	Observation	Recommended Action Plan	Recommended Timeline
1	Columns appear to be stressed in excess of normal design limits	Factory Engineer to review design, loads and columns stresses in area identified above.	6-weeks
2	Columns appear to be stressed in excess of normal design limits	Verify insitu concrete stresses either by 100mm dia. cores or existing cylinder strength data for [the identified columns].	6-weeks
3	Columns appear to be stressed in excess of normal design limits	Factory engineer to investigate the support condition for the lift core columns.	6-weeks
4	Columns appear to be stressed in excess of normal design limits	Check the adequacy of the grade beam on which lift core columns are rested on.	6-weeks
5	Columns appear to be stressed in excess of normal design limits	Produce and actively manage a loading plan for all floor plates within the factory giving consideration to floor capacity and column capacity.	6-months

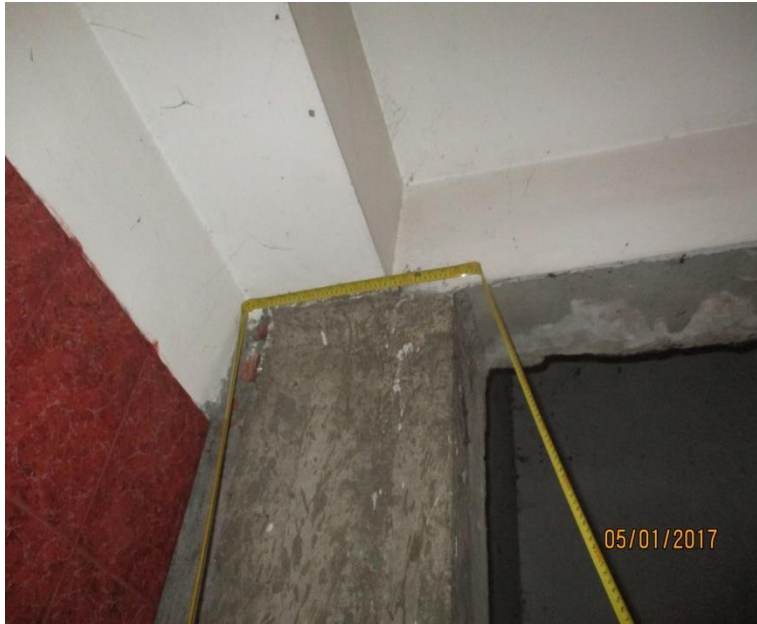
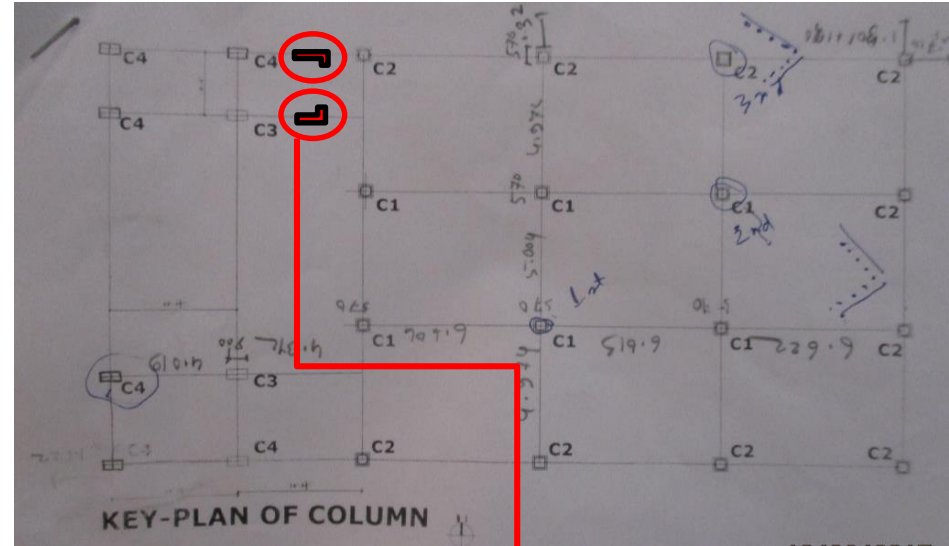
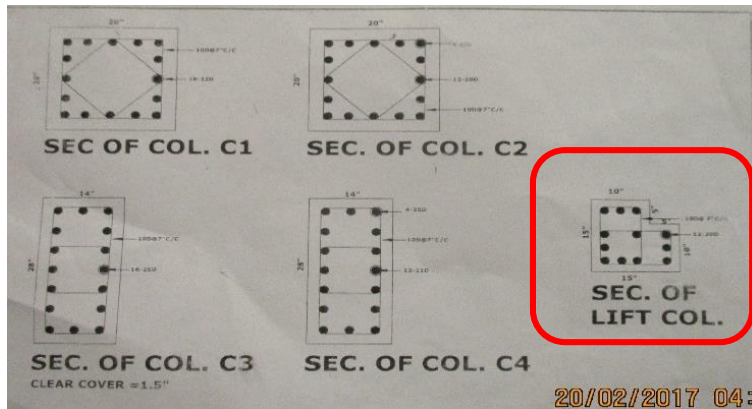
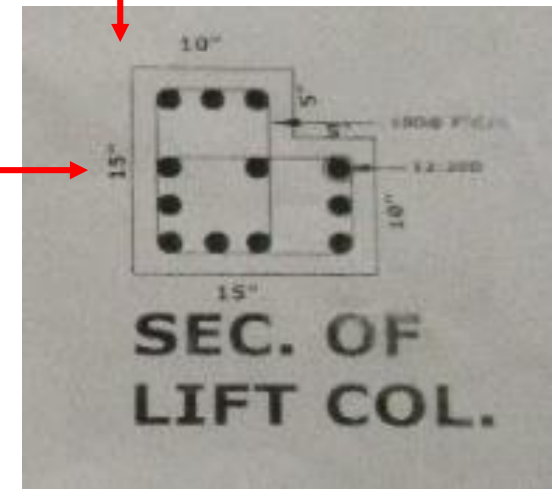
Lift column were shown in the column schedule but not on the column or foundation layout plan. Factory engineer to update the as-built drawings.

6	Discrepancies on the as-built Drawings	Building Engineer to produce a set of as built structural drawing as per as-built condition.	6-weeks
7	Hairline crack observed on beam & slab soffits	Building engineer is required to investigate the extend of cracks.	6-weeks
8	Hairline crack observed on beam & slab soffits	Carry out remedial works if required.	6-months

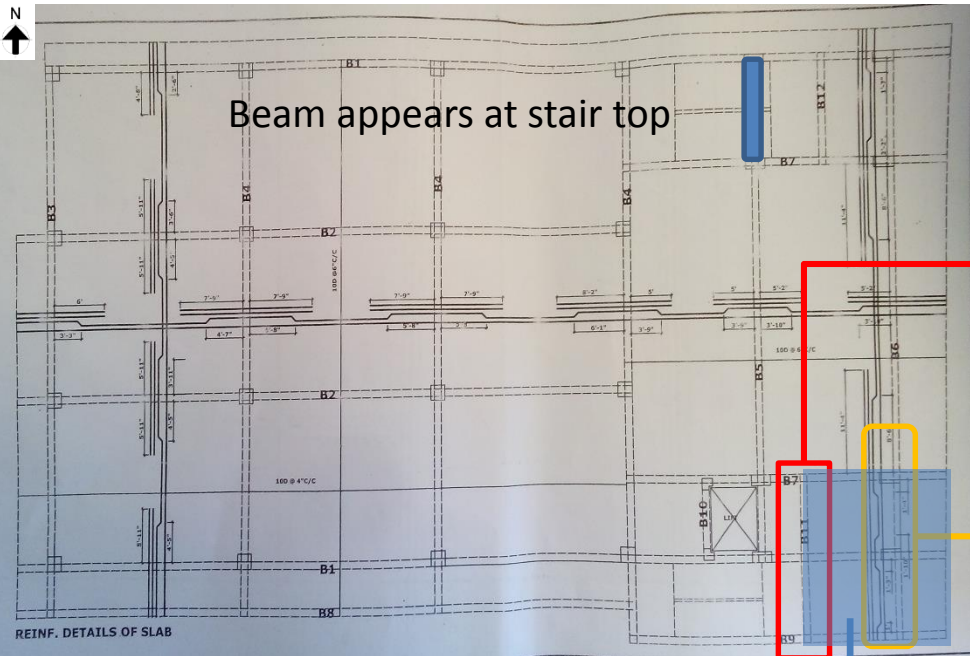
Beam layout

Undocumented mezzanine floor was found at ground floor. Discrepancies in beam size was found at roof.

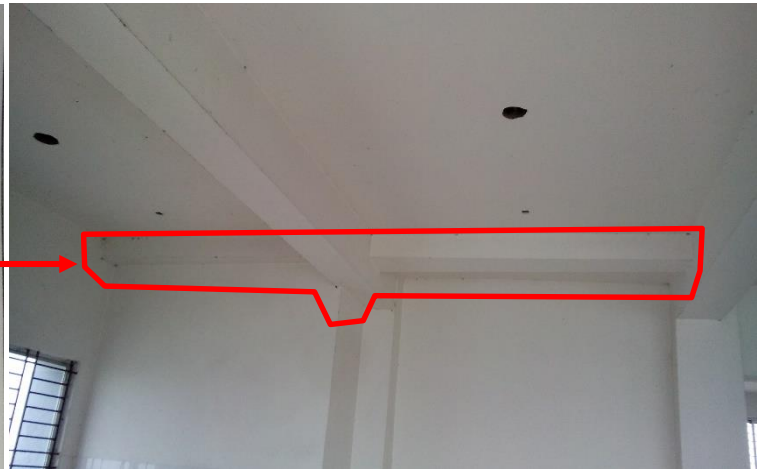
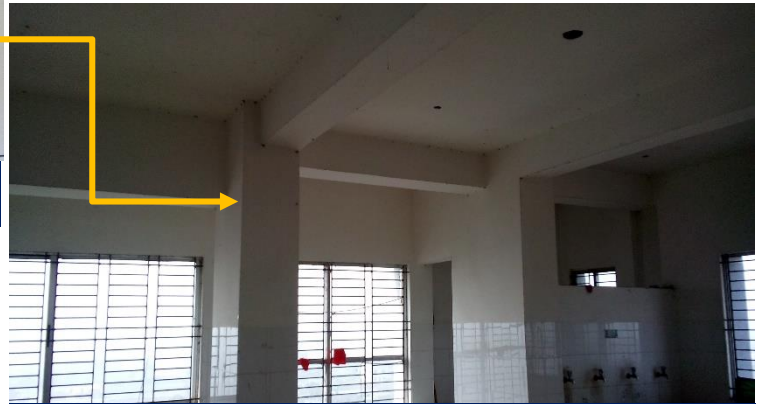
Beam with different size at west side of building

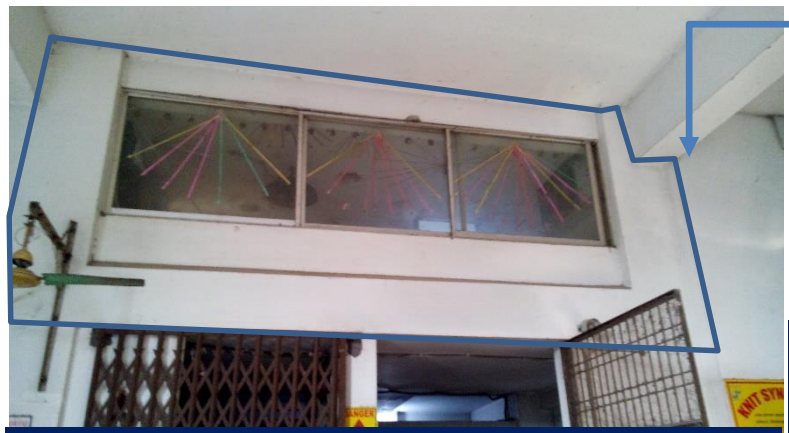
Mezzanine floor at ground level

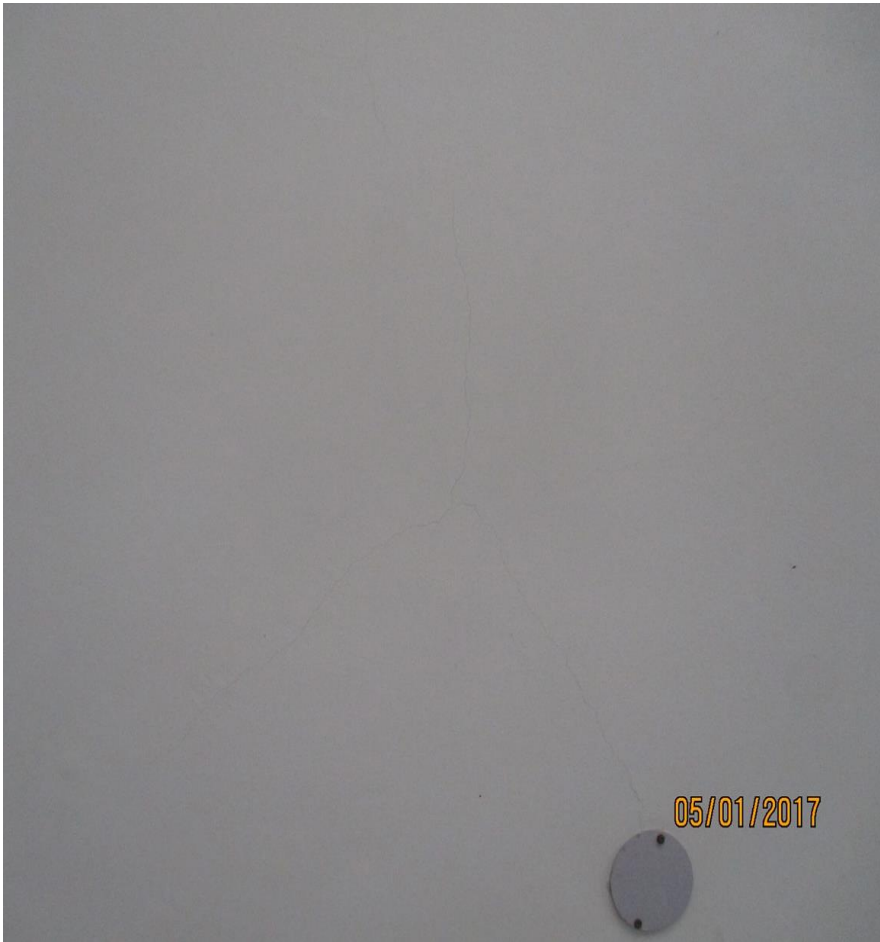
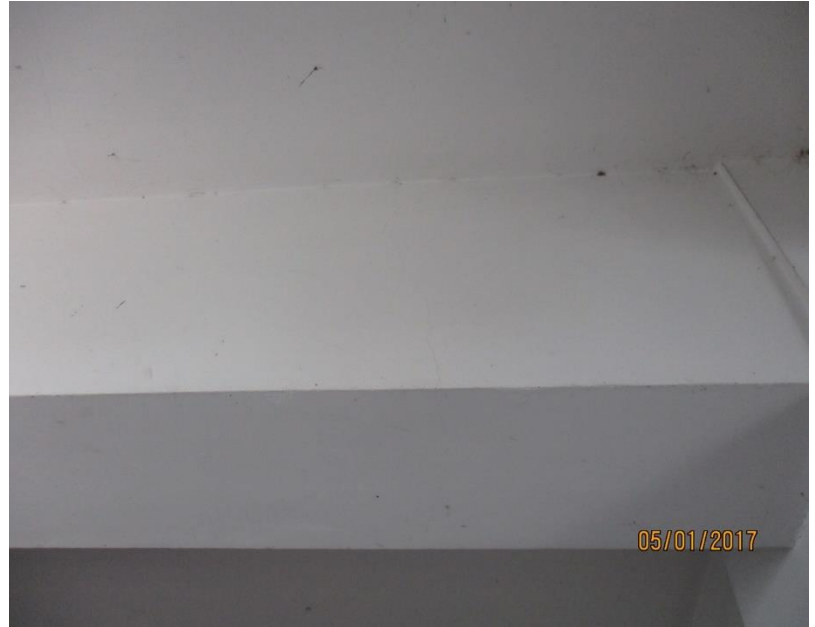
Hairline cracking observed on beam and slab at 5<sup>th</sup> floor level
