# Multifabs Ltd (9450)

Nayapara, Dasimpur, Joydbper, Gazipur

13.APRIL.2014

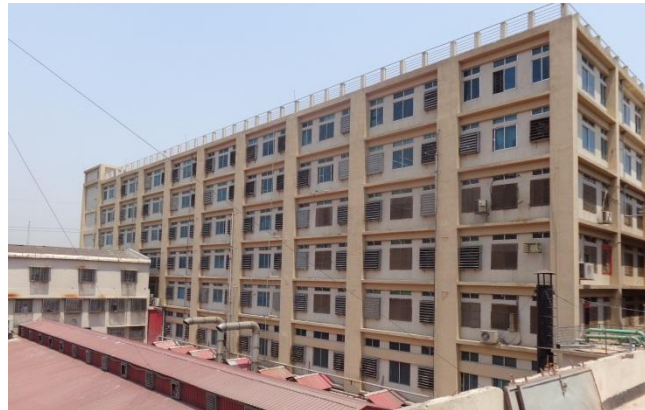
Low Column Safety Factors in Main Factory

Within the main factory, even under minimum allowable live loads, column checks yield lower than desirable safety factors.

- Remove storage loads from main factory floors
- Factory engineer to review design loads and column stresses in main factory building
- Detailed Engineering Assessment of main factory to be commenced.

- Produce and actively manage a loading plan for all floors within the factory complex.
- The Detailed Engineering Assessment is to be completed and acted upon.

- Implement and complete any works deemed necessary by the Detailed Engineering Assessment.

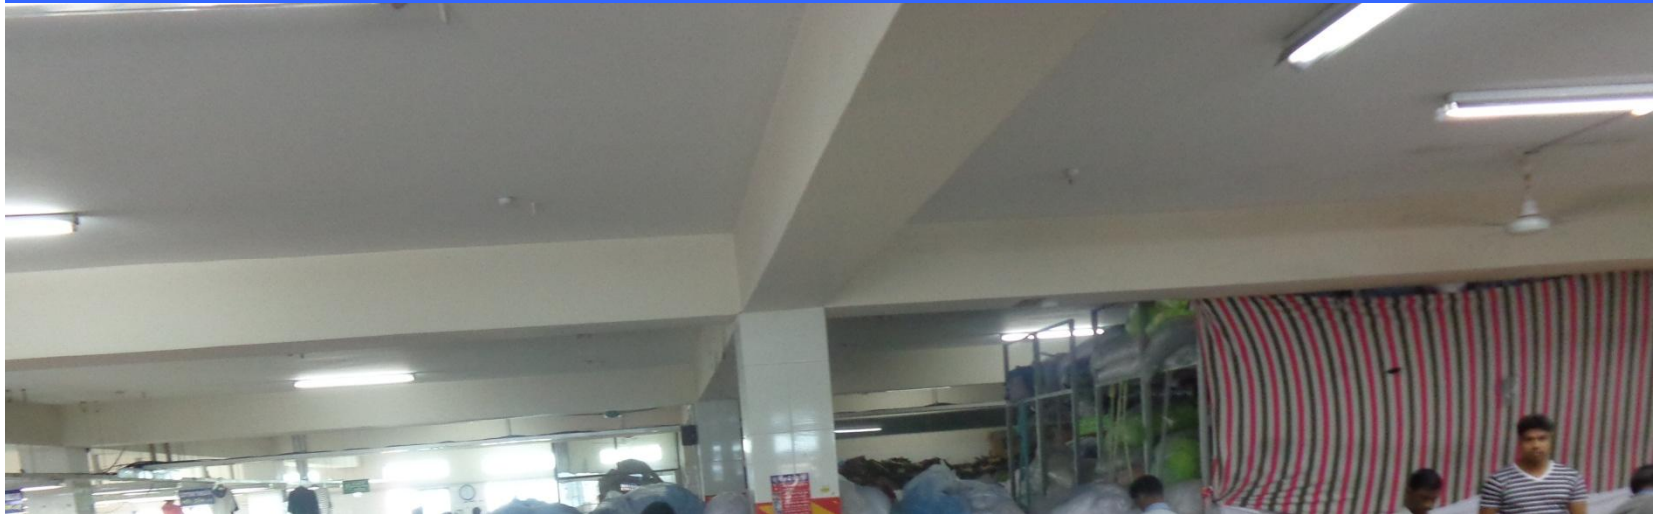
## Lateral Restraint System

All R.C. buildings were constructed with beam/slab arrangements. These arrangements along with brick infill walls compose the only lateral restraint system.

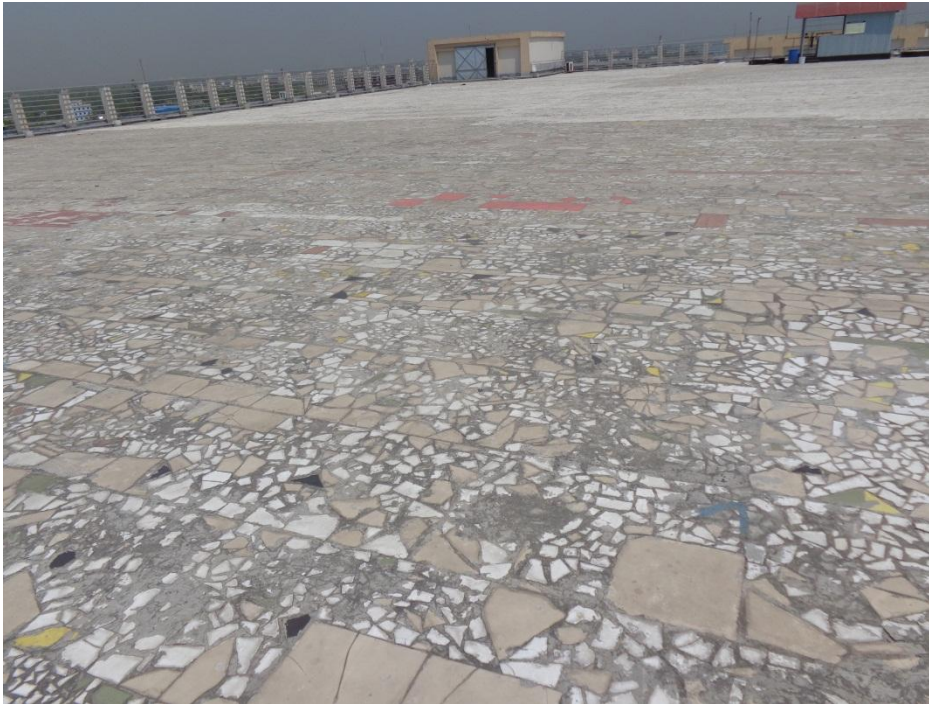
## Water Ingress at Roof Level

There was no waterproofing observed at the rooftop level

There was no evidence of water infiltration at the underside of roof slabs
