Apollo Knit Wear (BD) Ltd.

13.APRIL.2014

ACCORD
on Fire and Building Safety in Bangladesh

Identified Priority 1 Concerns

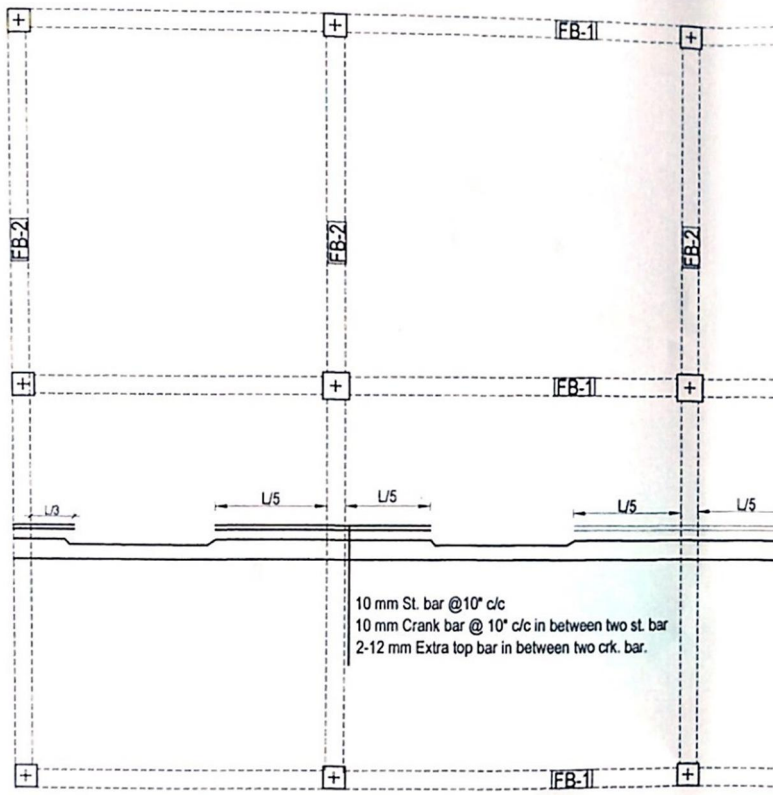
As-built Structural Drawing

The structural as-built drawings provided to us did not match the site conditions and the actual building dimensions, such as:

- Different grid dimensions.
- Cantilevered floor slabs not shown on drawings.
- Brick aggregate used for construction instead of stone aggregate as noted on drawings.

Priority 1 Concern

- Update structural drawings to suit actual site conditions.

- Carry out a DEA as noted in the Item 2 actions; concentrating on dimensional differences, a lack of any recognisable lateral support system and the use of a different concrete aggregate.

- Implement and complete any recommendations resulting from the DEA.

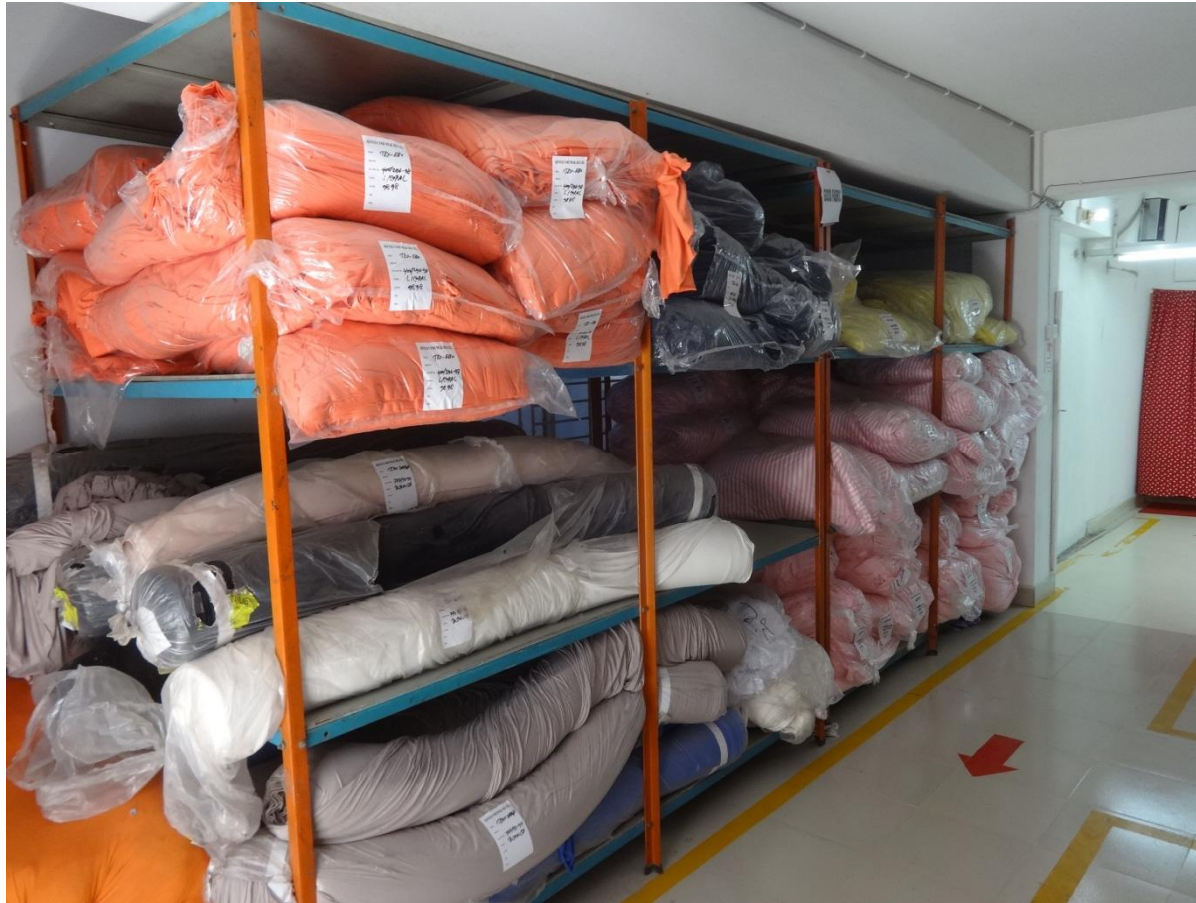
Priority 2 Concern

Rolls of yarn observed stockpiled over cantilevered portion of 4th floor slab at South wall (shown above) and West wall. Additionally, the cantilevered slab is not shown on the as-built structural drawings.

ITEM 2: At the fourth floor, we observed storage of yarn and material over cantilevered sections.

- Carry out a Detailed Engineering Assessment on the cantilevered portion of slab

- Display and enforce loading plans

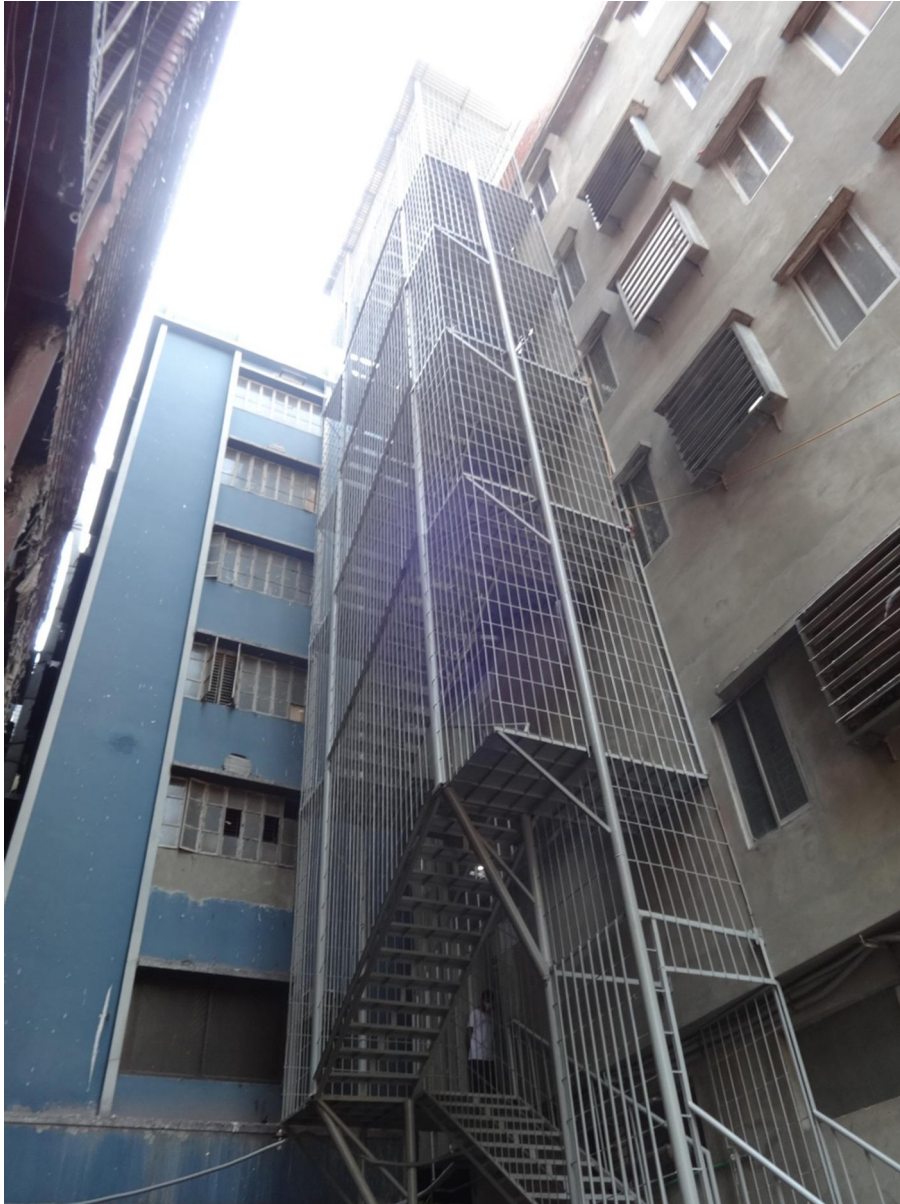
Priority 2 Concern

Steel fire escape staircase at East elevation seems to have been improperly designed and constructed. Columns welded in-situ and are not plumb. Column was interrupted at 6th storey. Bracing and anchorage to building inadequate.

ITEM 3: The steel fire escape staircase seemed to have been improperly designed and constructed.

- Conduct Engineering Assessment on the steel fire escape staircase.

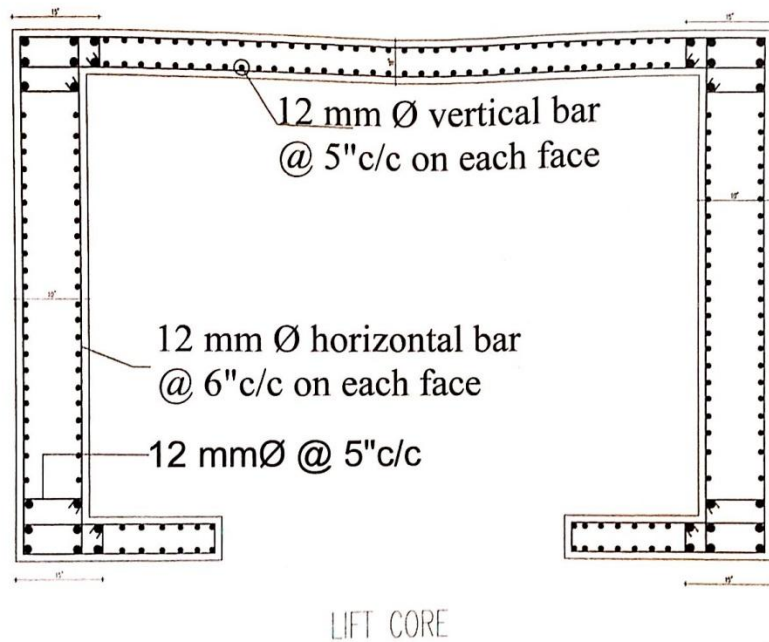
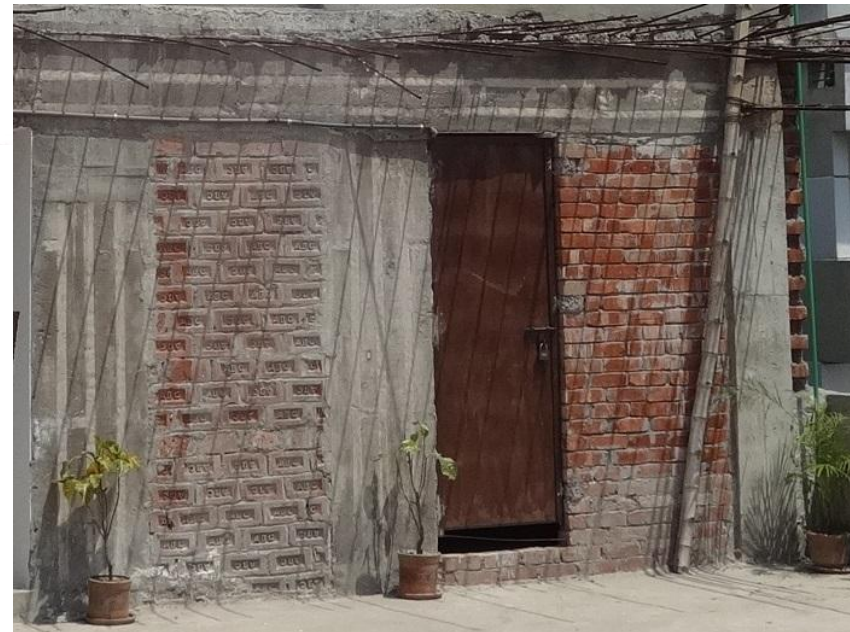
Overall Stability System

Structural as-built drawings detail concrete lift shafts. This shaft would provide overall stability against torsional loading.

Masonry infill on all four sides with concrete corner columns was observed instead.

We require that these items be investigated as part of a Detailed Engineering Assessment

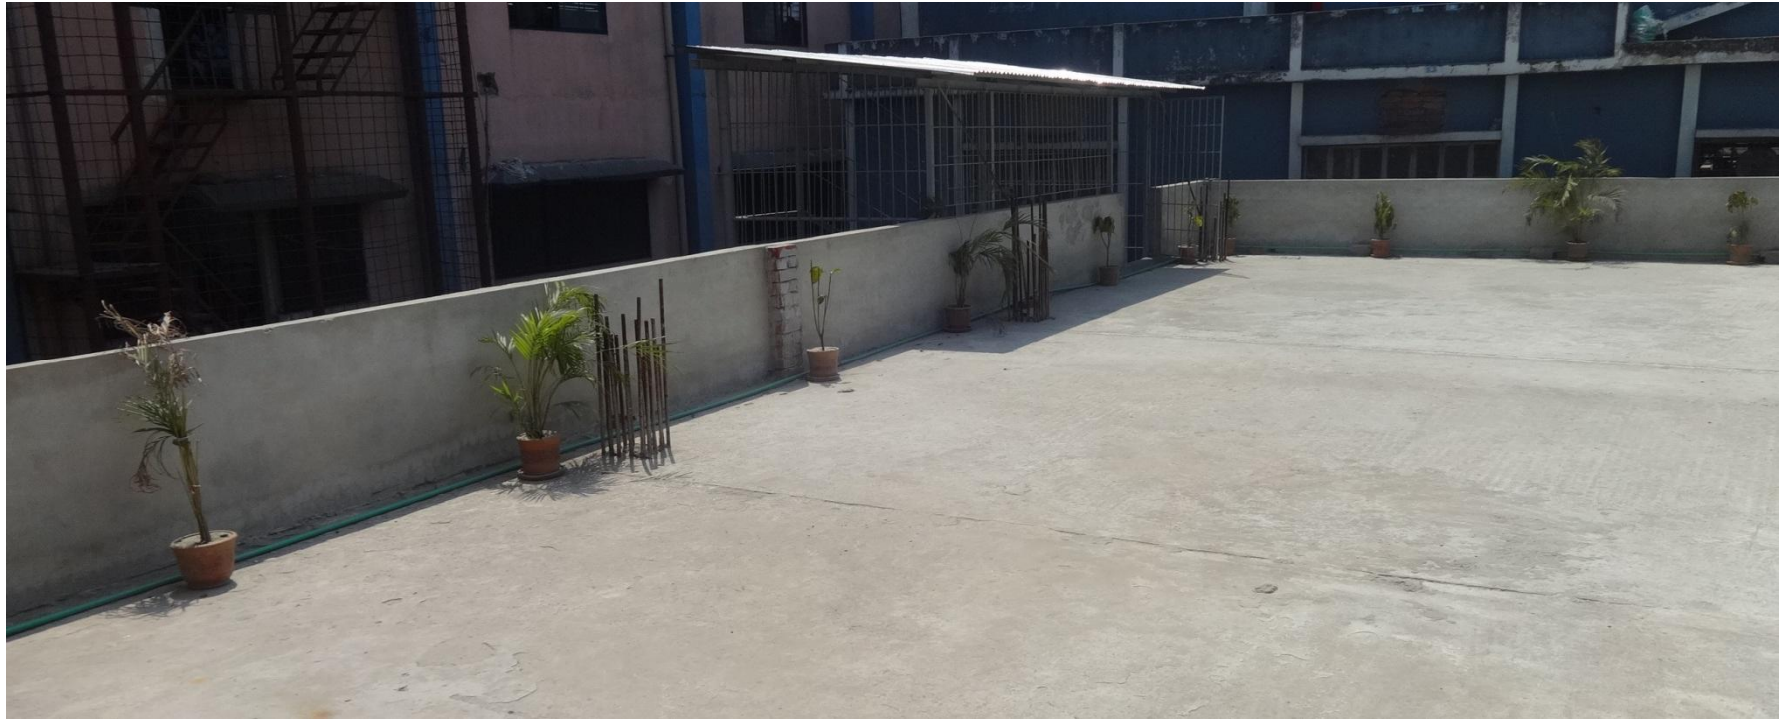
Water Ingress at Roof Level

No waterproofing membrane was visible on the roof of the building. This means that any cracks in the surface finishes on the roof will allow water to seep into the concrete slab beneath the finishes, and cause long-term soaking of the slab. However the existing roof is temporary as an extra story is being built. The new roof should have a membrane.
