# Murad Apparels Ltd. (9798)

15.APRIL.2014

ACCORD  
on Fire and Building Safety in Bangladesh

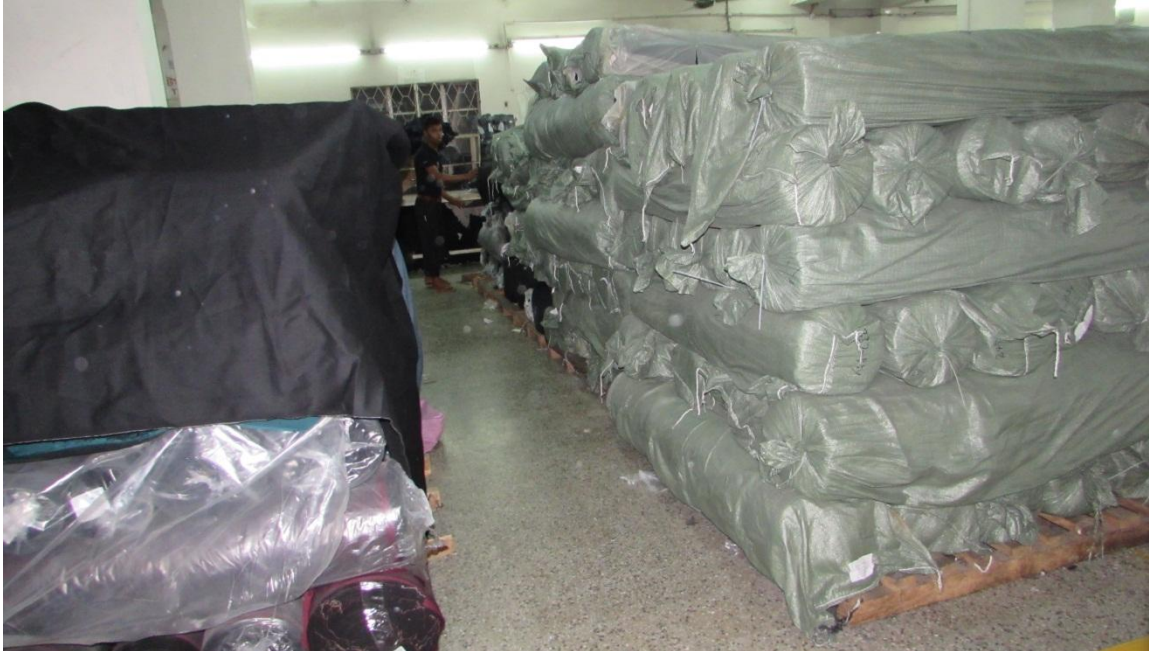
**Excessive Storage Height of Fabric on Level 2**

Each roll of fabric is estimated to weigh approximately 40kg. As they are stacked 6 rolls high, and arranged 6 rolls per layer, the weight of each layer is approximately 240kg, resulting in a total weight of 1,440kg (14.1kN) per stack.

Based on a plan area of 1.4m x 1.4m per stack, the equivalent live load per stack is estimated to be:

$$14.1\text{kN}/(1.4 \times 1.4)\text{m}^2 = 7.1\text{kPa}.$$

The allowable live load should be a max. of 3.0kPa

**ITEM 1: (1<sup>st</sup> Priority 1) Storage heights of fabric in storage rooms on 2<sup>nd</sup> floor appear to be excessive.**

Storage heights of fabric in storage rooms on 2<sup>nd</sup> floor appears to be excessive

- Immediately reduce stacking height of fabric rolls to ensure total load does not exceed 3.0kPa

- Mark the maximum allowable height of fabric stacking to ensure full compliance

- Establish and maintain a set of loading plans for each floor level.

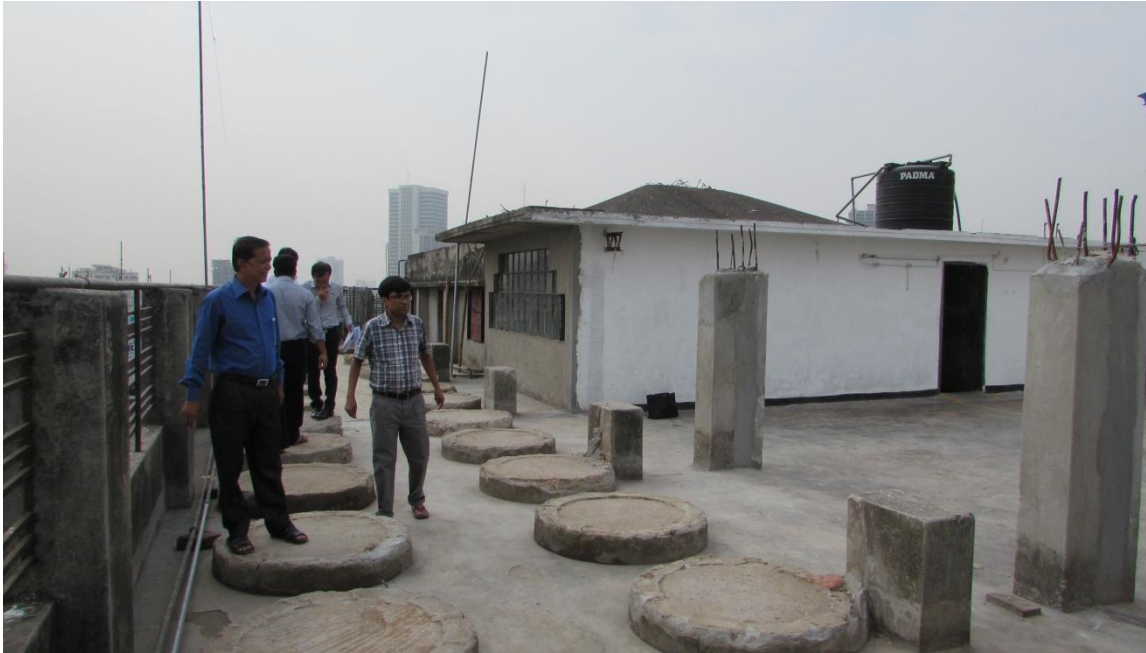
Based on the load rundown analysis of the building the column stress checking analysis gives a YELLOW status result, all floor loadings must be carefully monitored.

The construction of steel framed roof for the dining hall on the roof floor is on the permit drawings.

**The steel roof construction is not on the permit drawings**

**ITEM 2: (1<sup>st</sup> Priority 3) Typical columns have low factors of safety with regard to their loading capacity and the steel roof framed construction is not on the current permit drawings.**

Preliminary load take-down calculations suggest that typical columns have very low factor of safety with regard to their loading capacity. The steel framed roof extension is not on the permit drawings.

- Carry out intrusive testing of structure to determine actual concrete and rebar strengths.
- Carry out a full survey of all structural elements and check the loading capacity of the whole structural system.
- The Factory Engineer to review design, loads and columns stresses in the entire building.

- Consider demolishing the steel framed roof extension.

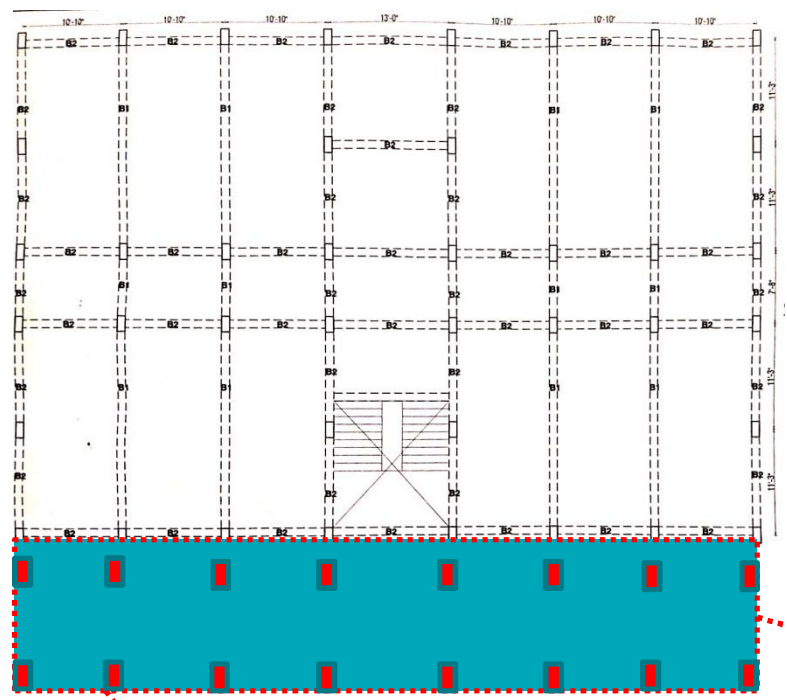
The front extension has been added to the original building. This part of the building has no structural design drawings or as-built drawings, the Factory Engineer is to review and check its structural capacity and stability.

**ITEM 3: (2<sup>nd</sup> Priority 3) There are no design or as-built drawings for the front extension.**

- The Factory Engineer is to carry out thorough load checking of the entire structure, including slabs, beams and columns based on BNBC regulations and produce as-built drawings.

- In conjunction with the building survey, building engineer to produce an accurate set of as-built structural records

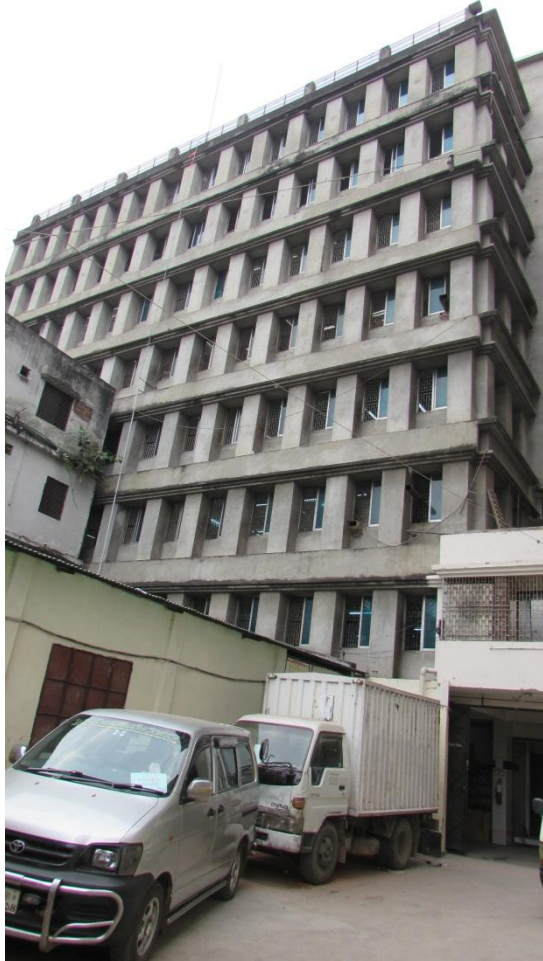
We require that these items be investigated as part of a Detailed Engineering Assessment.

The overall stability of the front extension is our main concern. There is a lack of lateral support system information. No structural drawings show any form of lateral support design.

**ITEM 4: (3<sup>rd</sup> Priority 3) A lack of lateral support system.**

There are no design drawings or as-built drawings for the front extension, there is a lack of any recognisable lateral support system.
