# **FIRE SAFETY INSPECTION REPORT**

**Factory Name: K.C Bottom & Shirt Wear Company**

**ACCORD ID: 12745**

**Date: 12 February, 2017**

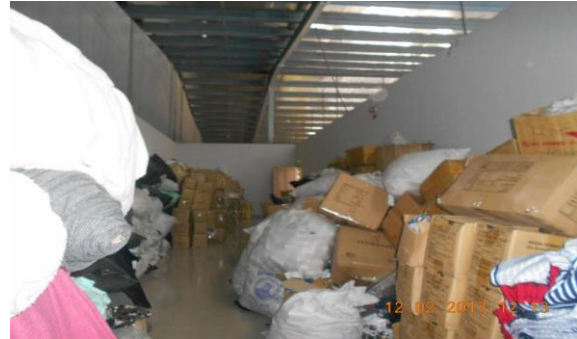
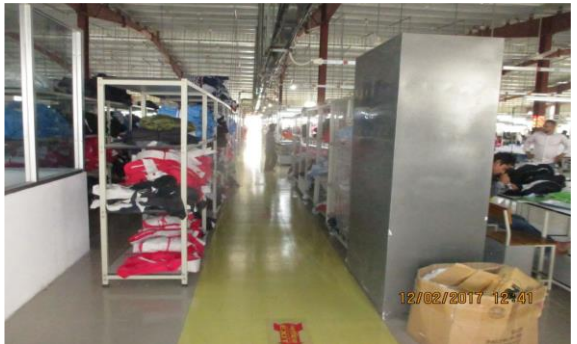
| Sl No. | Category | Findings | Required Action | Remediation Time Frame | Pictorial Evidence |
|---|---|---|---|---|---|
| 1 | Fire rated construction | Areas used for combustible storage are not separated by fire-rated construction. Location: Shed-03 & Shed-05. | Provide dedicated storage rooms separated by minimum 1-hr fire-rated construction. Where separate storage rooms are not feasible, provide defined storage areas and limit the storage arrangement as follows:-<br>Maximum height of 2.4m and maximum area of 23m <sup>2</sup> - If sprinkler protected: maximum height of 3.66m and maximum area of 93m <sup>2</sup> Separate areas of unenclosed combustible storage by a minimum clear distance of 3m. | Within 3 months | |

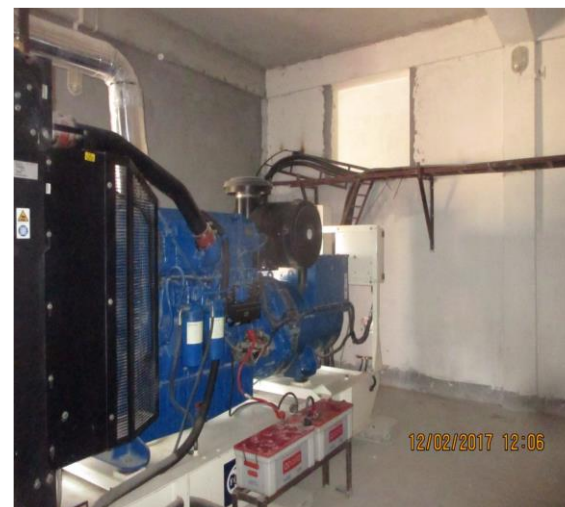
| 2 | Fire rated construction | Generator is not properly separated by fire rated construction with other occupancies/areas due to unprotected opening. | Separate the generator room by a minimum 2-hr fire-rated construction. Seal and/or protected all openings to maintain the required fire separations. | Within 3 months | |

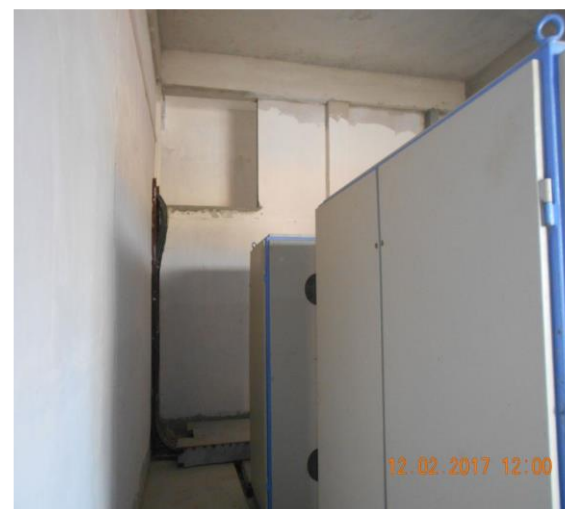
| 3 | Fire rated construction | Transformer is not properly separated by fire rated construction with other occupancies/areas due to unprotected opening. | Separate the transformer room by a minimum 2-hr fire-rated construction. Seal and/or protected all openings to maintain the required fire separations. | Within 3 months | |

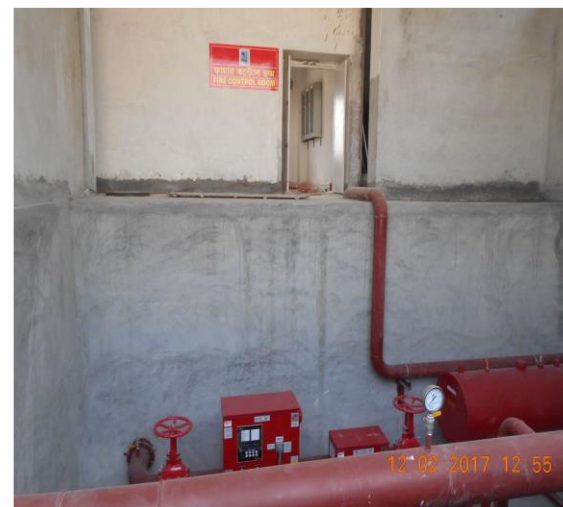
| 4 | Fire rated construction | The fire pump room is not provided with adequate fire separation. | Provide fire pump room with 2 hr rated fire separation when not sprinklered and 1 hr rated fire separation when provided with automatic sprinklers in accordance with NFPA 20.<br>Or,<br>Physically separate the pump room from the protected building by a minimum of 50 ft (15.3 m) in accordance with NFPA 20. | Within 3 months | |

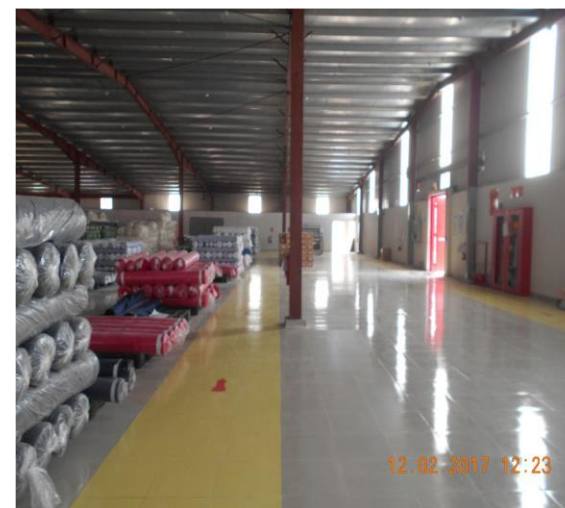
| 5 | Egress | Common path of egress travel exceeds 30 m. | Reconfigure the egress arrangement to reduce the maximum common path of travel to not more than 30 m. | Within 3 months | |

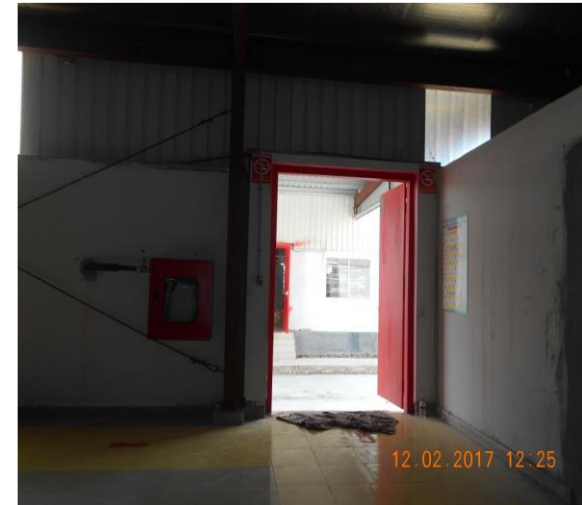
- 6 Egress Lighting Exit sign not provided at exit.  
Location: Shed-04

Lighted exit signs shall be placed at entrance to an exit. Additional exit signs shall be placed throughout the facility anywhere the continuation of the egress is not obvious. Lighted exit signs shall be provided with either battery backup or uninterruptable power supply systems and shall be continuously illuminated.

Within 1 month

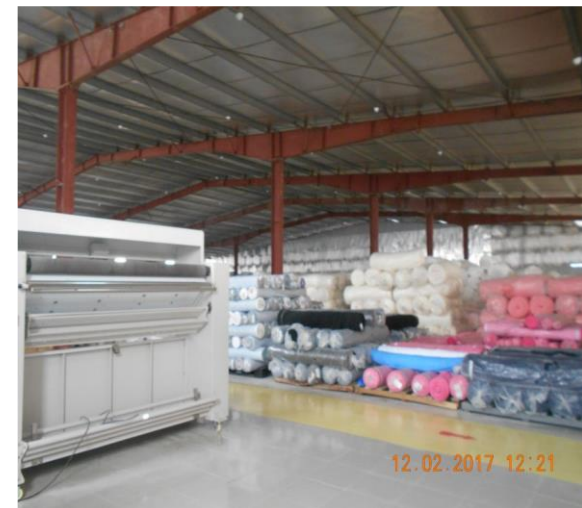
- 7 Egress Lighting Directional signs are not provided where direction of the path of travel to an exit has changed.  
Location: Shed-04

Illuminated directional signs shall be provided where there is a change in the direction for the path of travel and the direction to an exit is not obvious.

Within 1 month

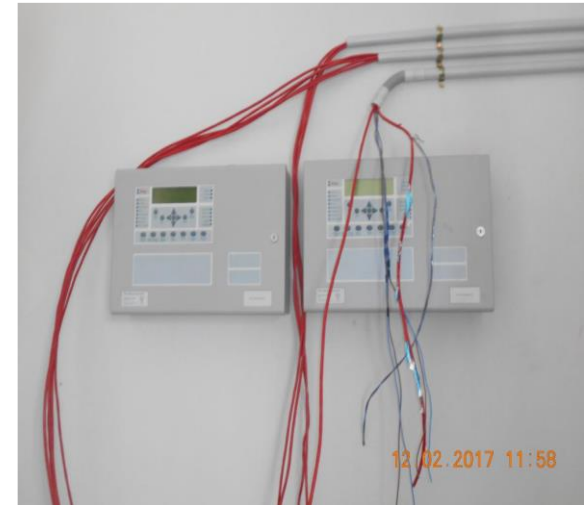
| 8 | Fire Alarm & Detection System | The factory has been designed & installed the addressable fire alarm system without having approval from AHJ (Authorities Having Jurisdiction). | Existing addressable fire alarm & detection system shall be designed & installed as per NFPA 72. Modify the system (if required) after getting approval from AHJ. | Within 6 months |
