# FIRE SAFETY INSPECTION REPORT

**Factory Name: SHANGUTEX LIMITED**

**ACCORD ID: 12626**

**Inspected By: Raju Ahmed & Ashfiq Ur Rahman**  
**Date: March 01, 2017.**

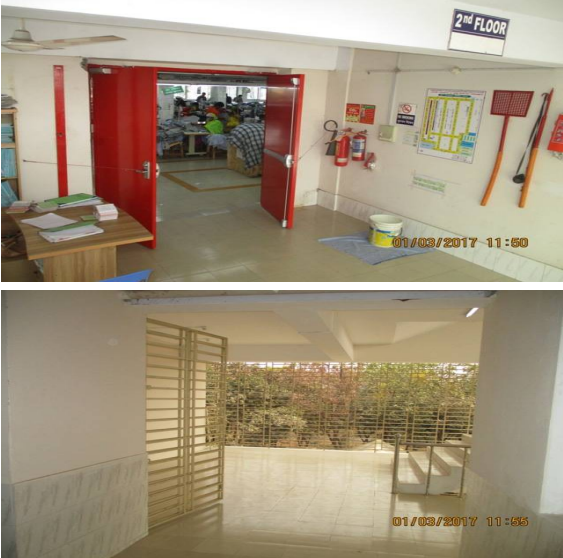
SI No.	Category	Findings	Required Action	Remediation Time Frame	Pictorial Evidence
1	Fire Rated Construction (Building 3)	All exit stairs are not separated from work areas and other spaces on each floor by fire rated construction.	Provide minimum 1.5-hr fire rated doors and seal all unprotected openings to separate the exit stairs from work areas and other building spaces on all floor levels. Ensure that the fire doors are self-closing and positive latching and that they are provided with fire exit (panic) hardware where serving production floors. If fire doors are required to be held open for functional reasons, provide automatic closing devices tied to the fire alarm system.	Within 3 months

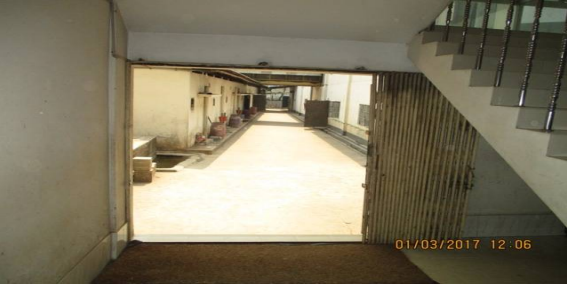
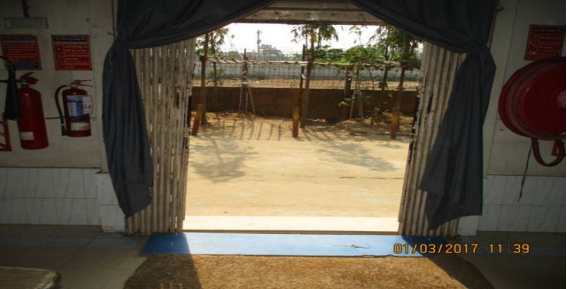
SI No.	Category	Findings	Required Action	Remediation Time Frame	Pictorial Evidence
2	Non complaint gates ( Building 1,2, & 3 )	Collapsible / Sliding doors are provided at overall exit doors & exit stairs.	<p>Replace all collapsible/ sliding type doors &amp; gates by the side-hinged swinging type doors.</p> <p>If locks are required for security reasons, utilize special door locking features complying with NFPA 101.</p>	Immediate

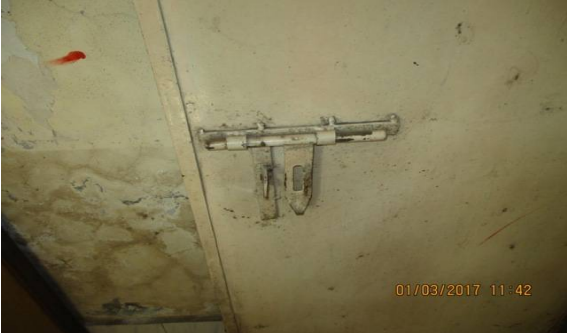
3	Non complaint locking features (Building 1,2 & 3)	Egress doors and gates with locking features are provided at several exit doors & exit stairs.	<p>Remove locking features from all egress doors &amp; gates. If locks are required for security reasons, utilize special door locking features complying with NFPA 101.</p>	Immediate

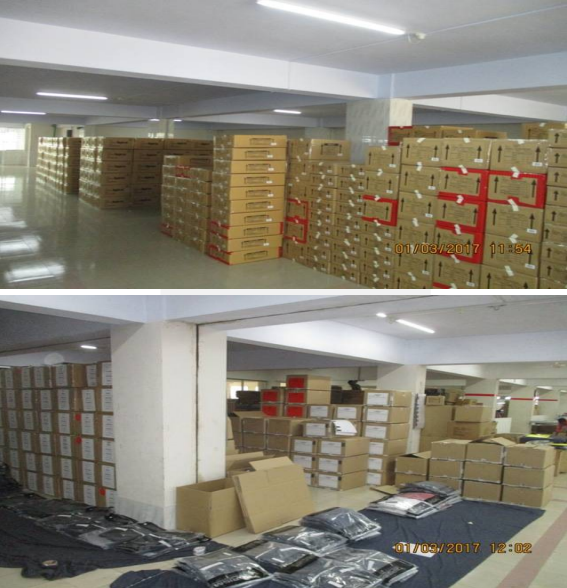
SI No.	Category	Findings	Required Action	Remediation Time Frame	Pictorial Evidence
4	Fire Rated Construction (Building 1,2 & 3)	Areas used for in-process storage (Inspection Goods) of combustible materials are open to the surrounding occupancy. Location: Building A (all floors)	Provide defined storage areas and limit the storage arrangement as: Maximum height of 2.4m and maximum area of 23m <sup>2</sup> . Separate areas of unenclosed combustible storage by a minimum clear distance of 3m	Within 2 months

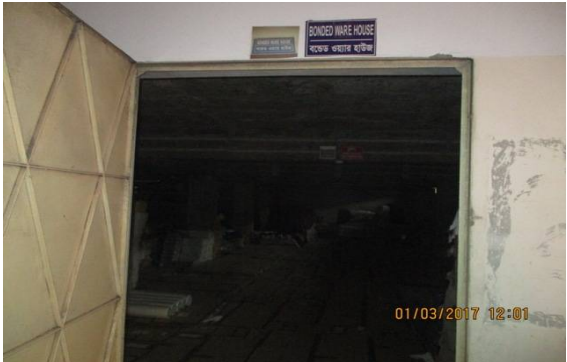
5	Fire Rated Construction ( Building 3 )	Room used for storage of combustible materials (Accessories store & Bonded Ware House) is not separated from the surrounding occupancy. Location: Building 3 (ground floor).	Rooms used for storage of combustible materials shall be separated from the surrounding occupancy with a minimum 1 hour construction.	Within 3 months

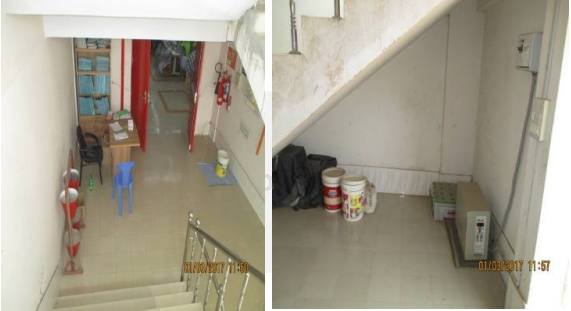
SI No.	Category	Findings	Required Action	Remediation Time Frame	Pictorial Evidence
6	Storage in stair ( Building 3 )	Storage was located in & under the exit stair.	Keep stairs clear of storage.	Immediate

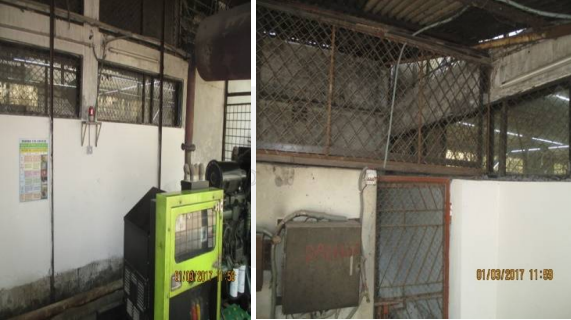
7	Unsealed Floor/Ceiling Penetrations	Unsealed penetrations and openings are located in the Generator & Transformer room. Location: Close to building 1.	Seal all penetrations and openings in floors/ceiling assemblies to maintain the fire separation.	Within 1 month

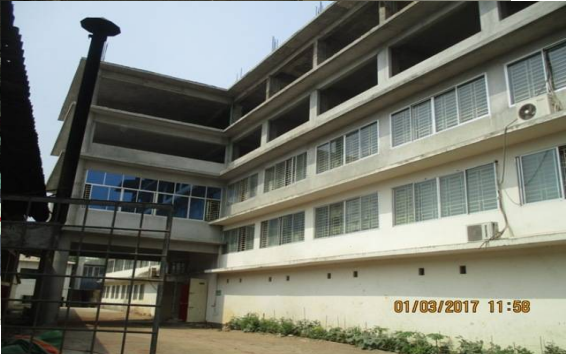
8	Fire Fighting system (Building 3)	The existing building has an occupied floor greater than 10 meter (33 feet) and is not provided with standpipe protection.	Install a new class III standpipe system & fire department connection in accordance with NFPA 14. A class I system shall be permitted in buildings protected throughout by an automatic sprinkler system.	Design within 3 months, Install within 6 months

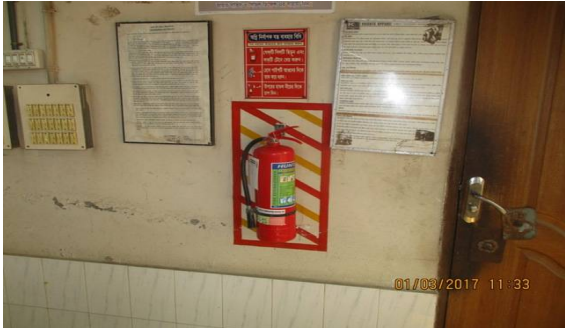
13	Fire Protection	Inspection, testing and maintenance of portable fire extinguishers is not in accordance with NFPA 10.	Inspect, test and maintain the portable fire extinguishers and keep written records on-site, in accordance with NFPA 10 and ACCORD standards.	Within 3 months

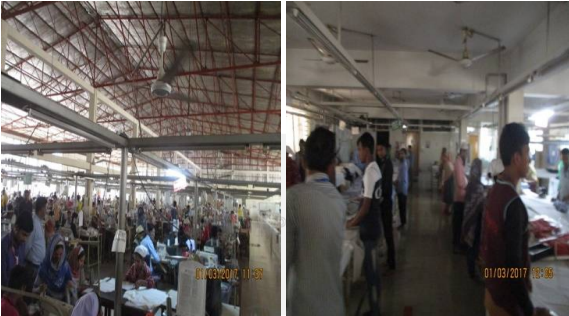
14	Emergency Egress Lighting	Directional signs are not provided where direction of the path of travel to an exit has changed. Location: All over the factory	Illuminated directional signs shall be provided where there is a change in the direction for the path of travel and the direction to an exit is not obvious.	Within 3 months

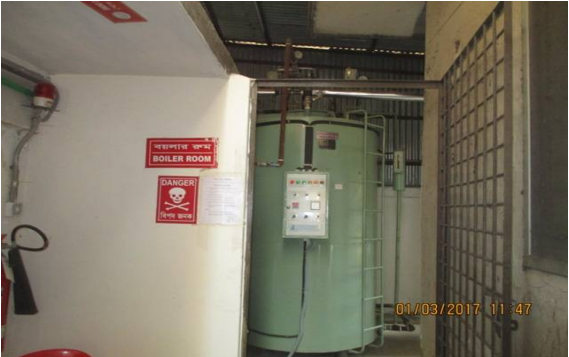
17	Service Room Separation	The Boiler room is not separated by fire rated construction (openings, non-rated doors, penetrations) Location: Between Shed 2 & Building 3.	Separate the boiler room by a minimum 2-hr fire rated construction (for high rise building)/ 1-hr fire rated construction (for low rise building). Seal and/or protected all openings to maintain fire separations.	Within 3 months
