# FIRE SAFETY INSPECTION REPORT

## Mega Washing & Dyeing Ltd.

ACCORD ID: 12640

Date: 06 March, 2017

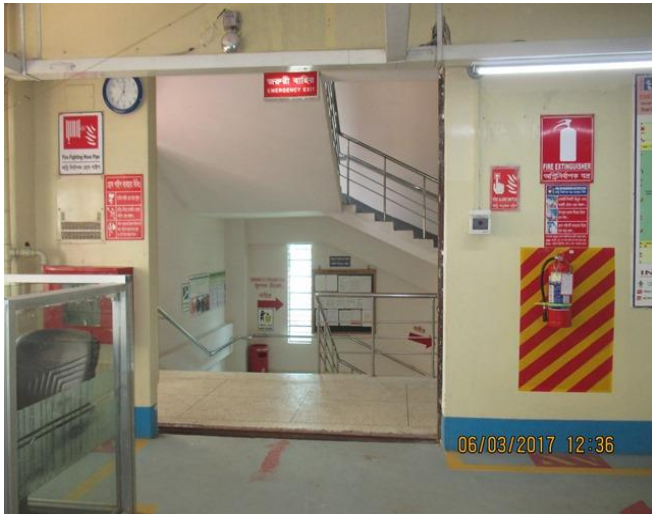
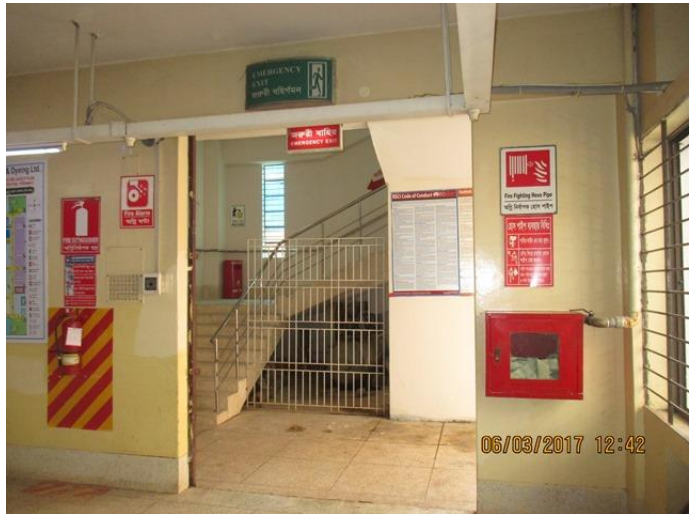
| No. | Category | Finding | Recommendation | Remediation<br>Timeframe |
|---|---|---|---|---|
| F-1 | Fire Rated<br>Construction | Exit stairs are not separated from work areas & other spaces on each floor by fire-rated construction due to unprotected openings and penetrations. | <p>Separate the exit stairs from work areas and other building spaces on all floor levels by minimum 1- hr fire-rated construction. Provide minimum 1- hr fire rated doors and seal all unprotected openings and penetrations to maintain the fire separation.</p> <p>Ensure that all fire doors are self-closing and positive latching, and are provided with fire exit (panic) hardware where serving production floors or assembly occupancies.</p> <p>If fire doors are required to be held open for functional reasons, provide automatic-closing devices tied to the fire alarm system.</p> | Within 3 months |

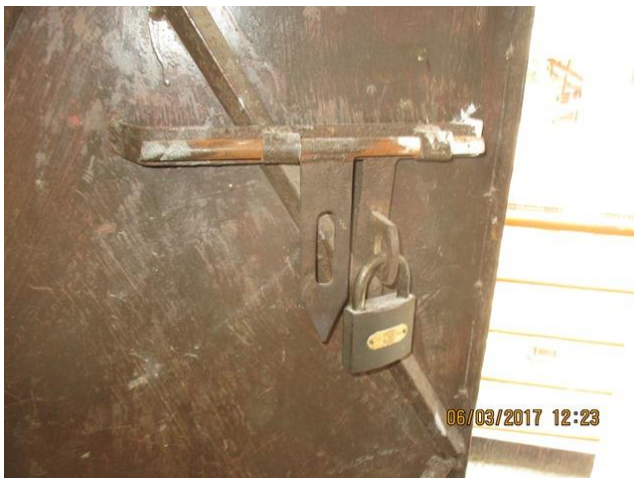
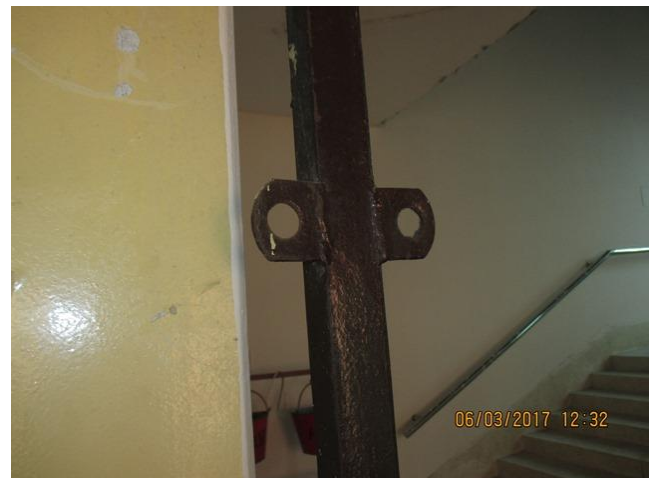
F-2 Egress Egress gates on the all floor with locking features are provided at all exits & exit discharge.

Remove locking features from all egress gates.

If locks are required for security reasons, utilize special door locking features complying with ACCORD standard 6.8.2.

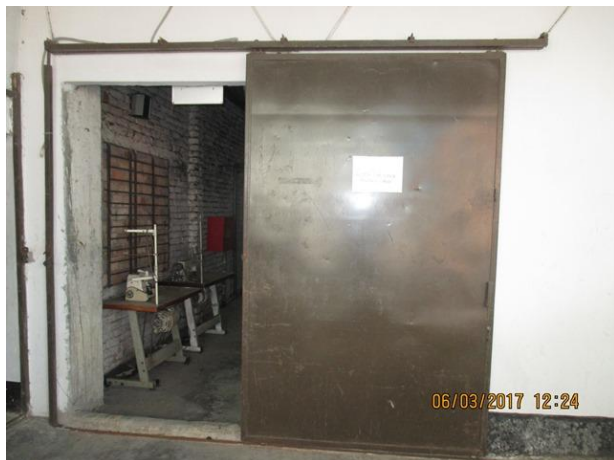
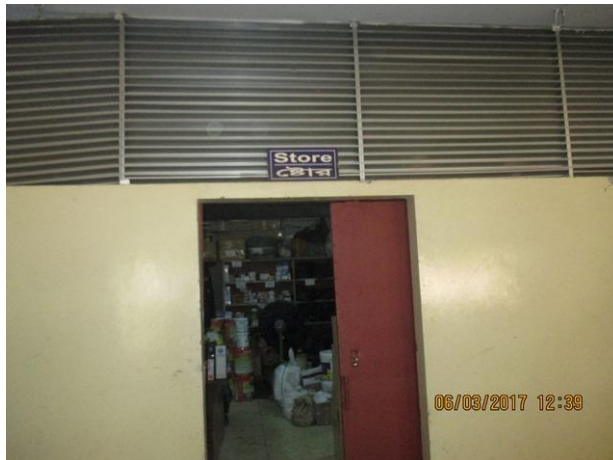
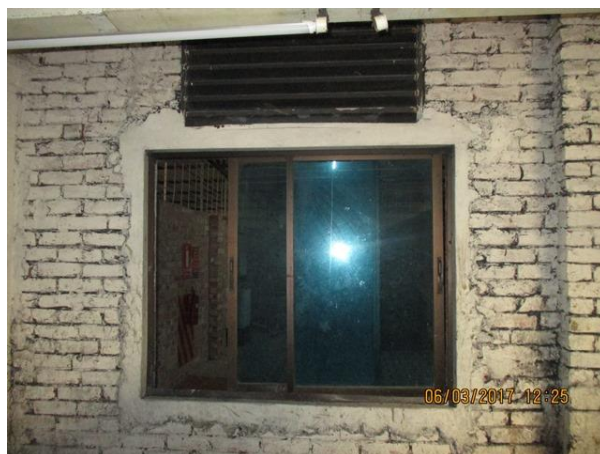
| F-3 | Fire Rated Construction | Room on the ground floor and 2nd floor used for combustible storage is not separated by a minimum 1-hr fire-rated construction. | Provide dedicated storage rooms separated by minimum 1-hr fire-rated construction. | Within 3 months |

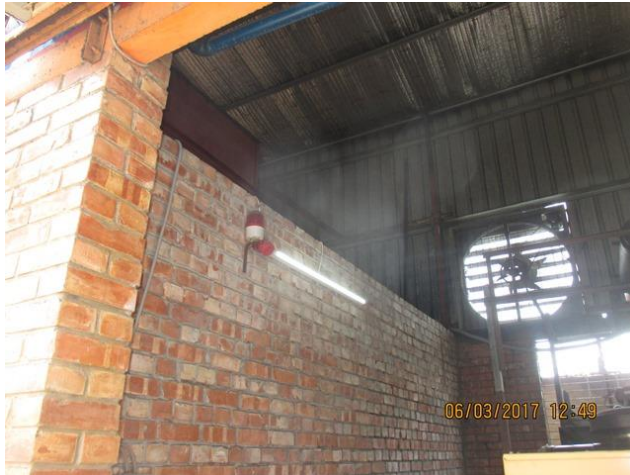
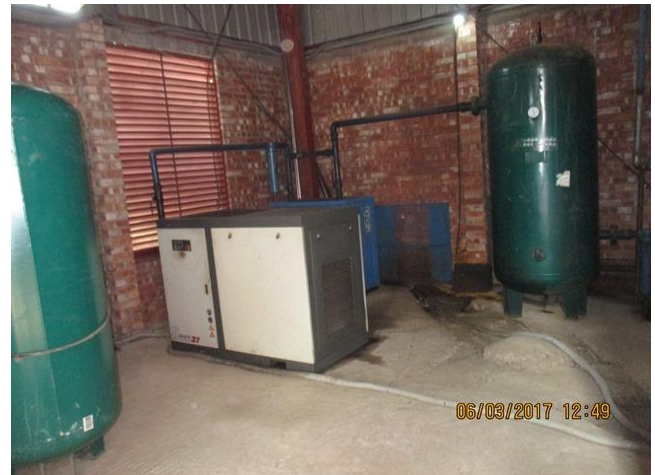
| F-4 | Fire Rated Construction | The boiler, generator and compressor is not properly separated from each other. | Separate the boiler, generator and compressor by fire rated construction. | Within 3 months |

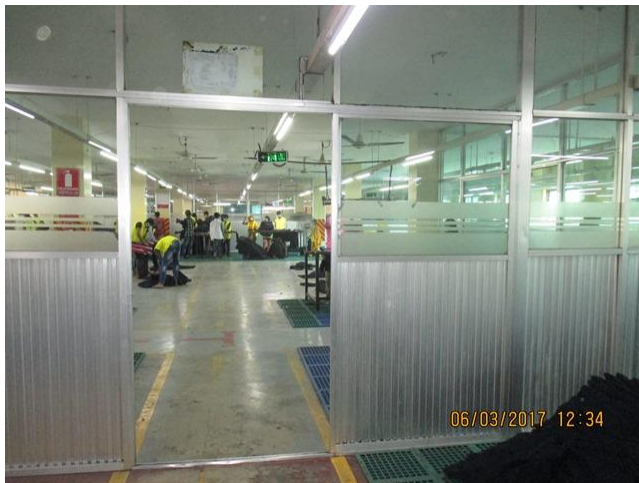
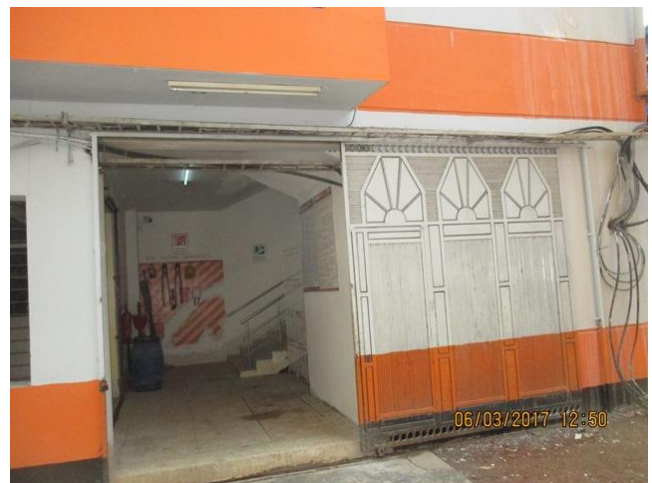
| F-5 | Egress | Sliding doors are provided at the building exits, exit stairs, along egress routes and exit discharge. | Replace all gates, sliding doors and rolling shutters along the means of egress with side-hinged, swinging egress doors.<br><br>If locks are required for security reasons, utilize special door locking features complying with NFPA 101. | Within 1 month |

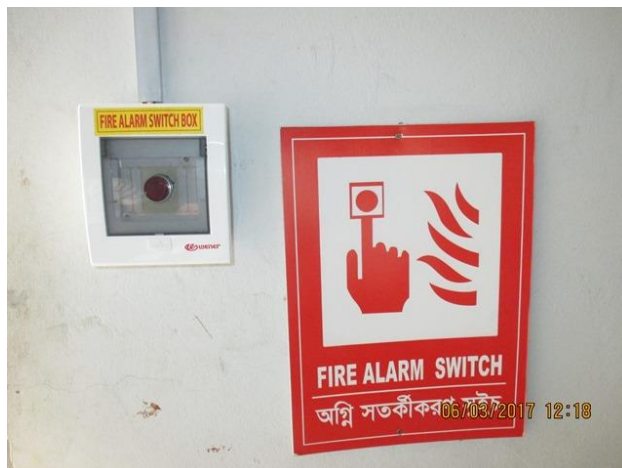
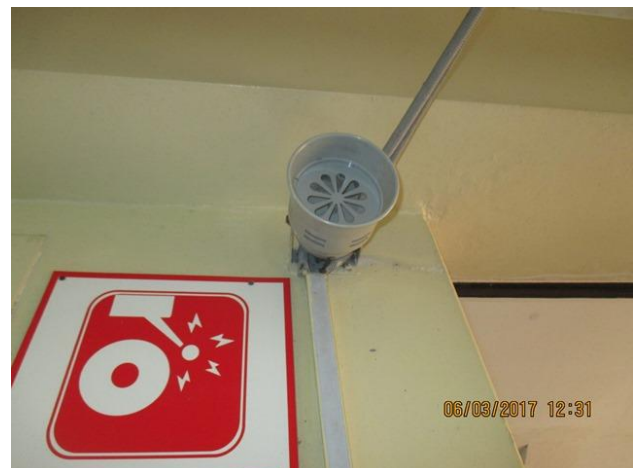
| F-6 | Fire Protection | The fire alarm system is antiquated, not a listed system and does not provide alarm and notification features consistent with acceptable standards. | Replace the fire alarm system with a new, listed automatic fire alarm system in accordance with NFPA 72 and ACCORD standards. | Design within 4 months<br>Install within 9 months |

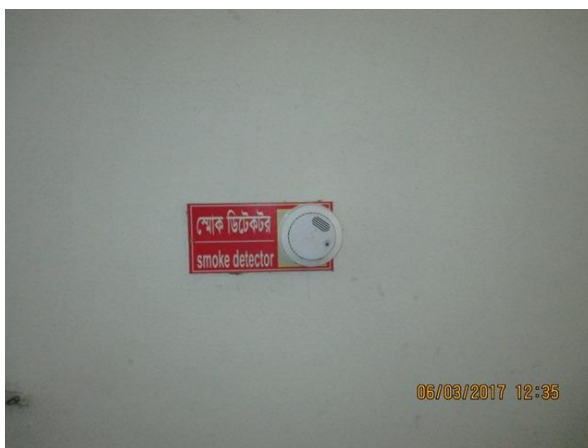
| F-8 | Fire Protection | The building is equipped with single-station smoke alarms. Smoke alarm activation sounds only a local alarm and does not provide automatic fire alarm notification of occupants. | Remove single-station smoke alarms. Provide automatic smoke detection throughout the building, tied into the fire alarm system, in accordance with NFPA 72 and ACCORD standards. | Design within 4 months<br>Install within 9 months |

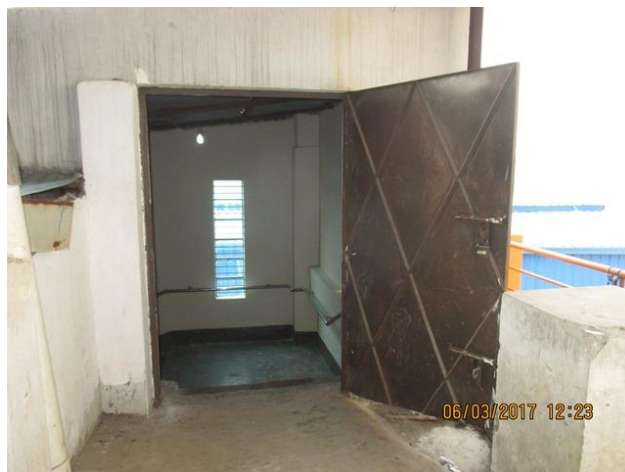
| F-9 | Egress | Egress door serving 50 or more occupants but does not swing in the direction of egress travel.<br><br>Locations: 2nd floor. | Modify swing direction of egress doors to the direction of egress travel. | Within 3 months |

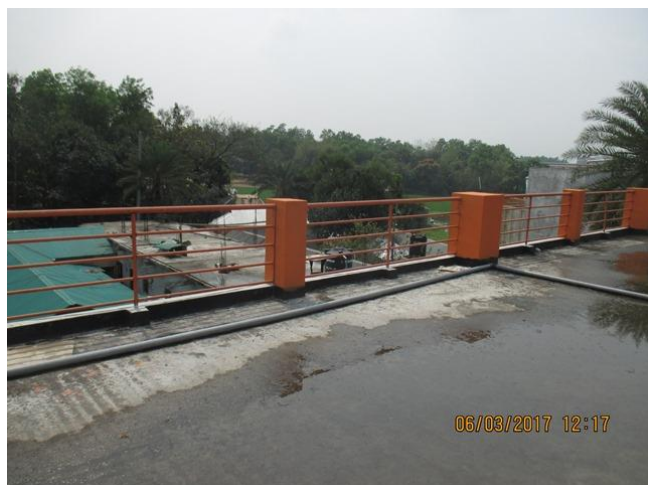
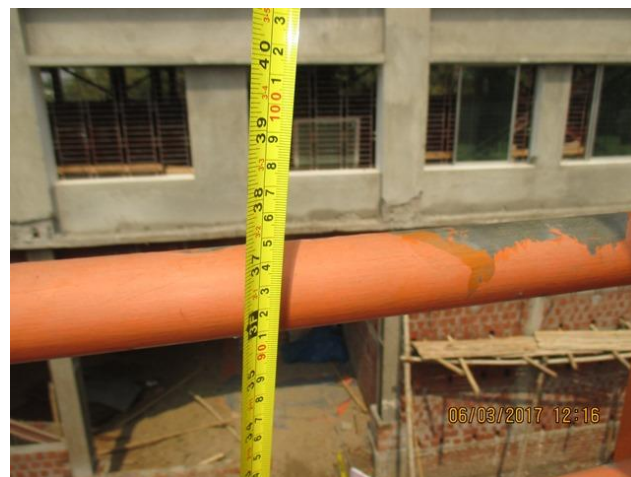
F-10 Egress

Occupiable roof is not provided with an adequate parapet / guard rail.

All occupiable roofs shall be provided with parapets or guards with a minimum height of 1067 mm (42 in.)

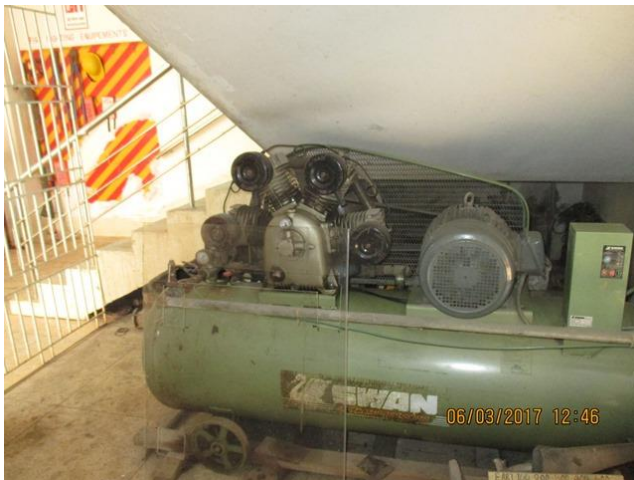
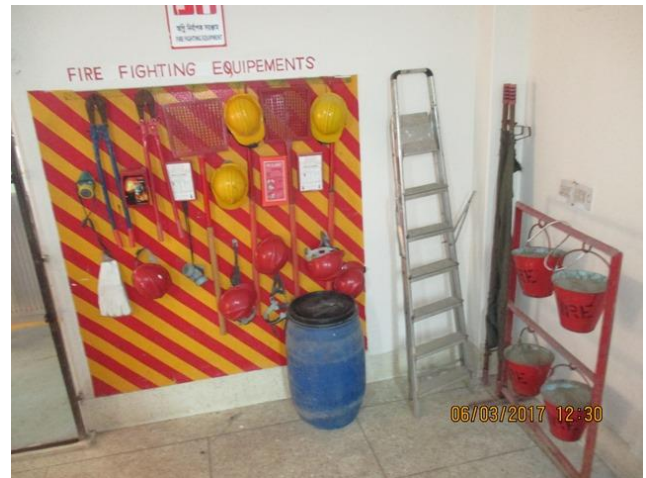
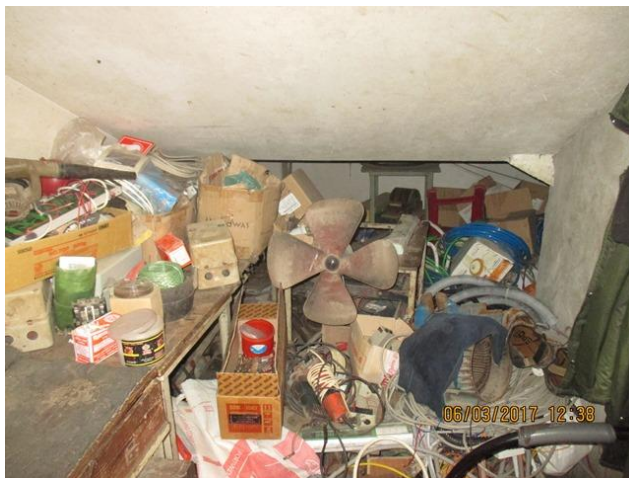
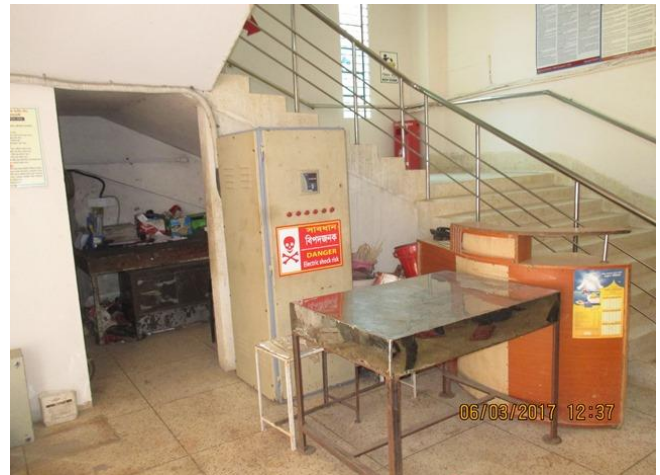
| F-14 | Egress | Storage was located in the all exit stairs. | Remove all storage from exit stairs. | Immediately |

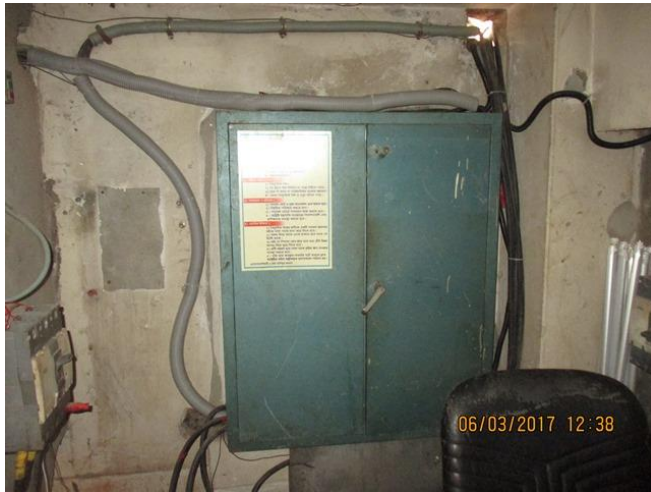
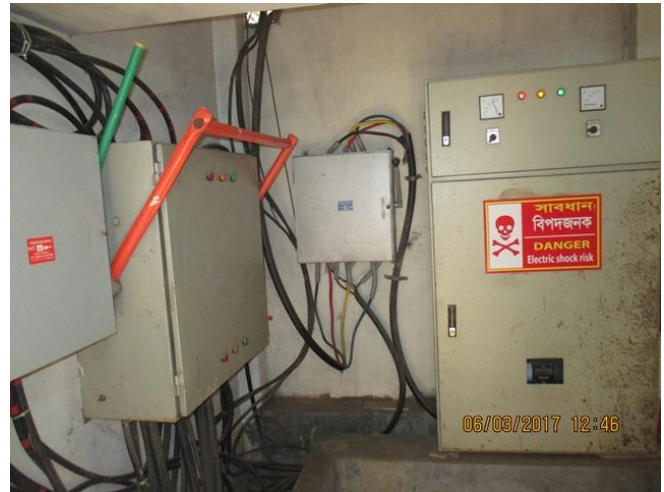
| F-16 | Fire Rated Construction | Electrical panels were located in the exit stair enclosures. | Remove and re-locate all electrical panels from exit stair enclosures. | Within 3 months |

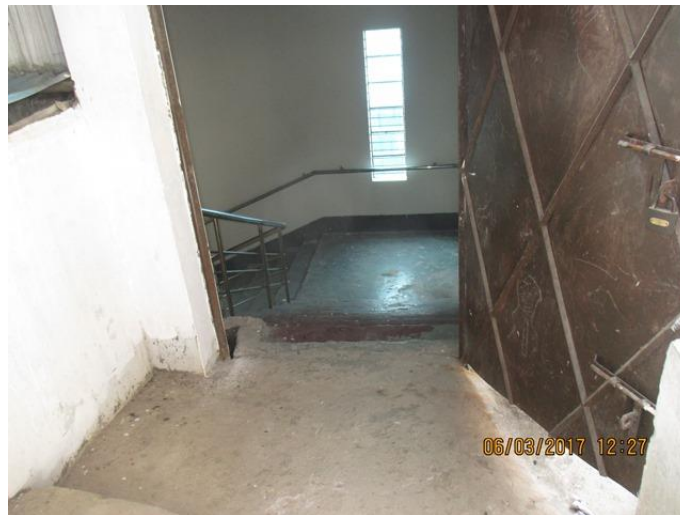
F-17 Egress

Landing is not provided on both side of the door at roof which may cause of tripping hazard.

Provide adequate landing on both side of the door.

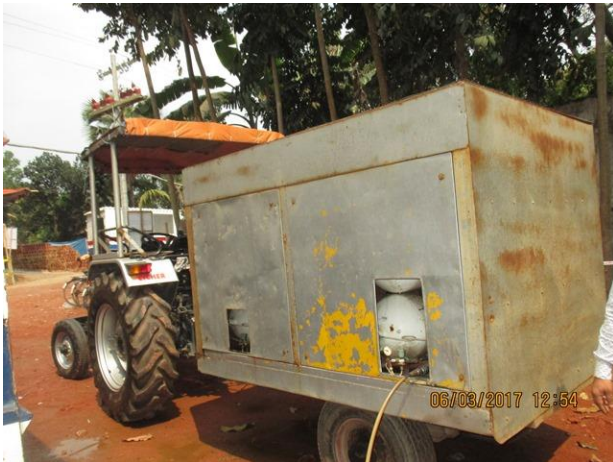
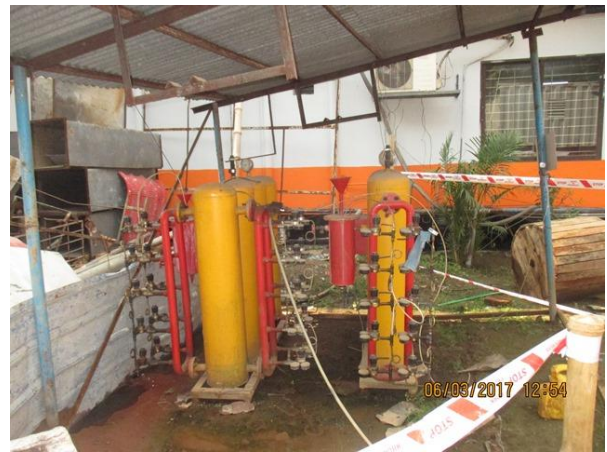
| F-18 | Fire Rated Construction | Liquefied or compressed gas cylinders are located within the factory. | The storage or use of liquefied or compressed flammable gas cylinders shall be prohibited within the factory building. | Immediately |

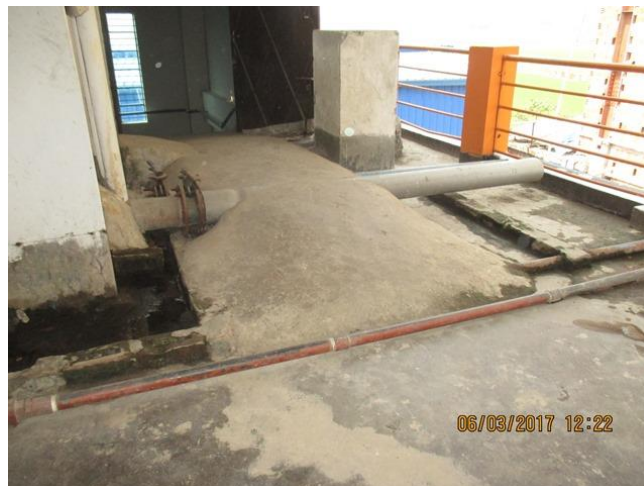
| F-19 | Egress | The running slope at the top floor does not comply with Accord standard. | Reconfigure the slope in a way that comply with Accord standard 6.3.4.2. | Within 3 months |
