# **Esprit Apparel Ltd (Parkzone) Padma Satel Arab Fashions Ltd. P & K Fashion Ltd. Luna Fashion Ltd.**

Luna Complex, Joybangla road, Borobari, Gazipur, Dhaka

29<sup>th</sup> June 2014

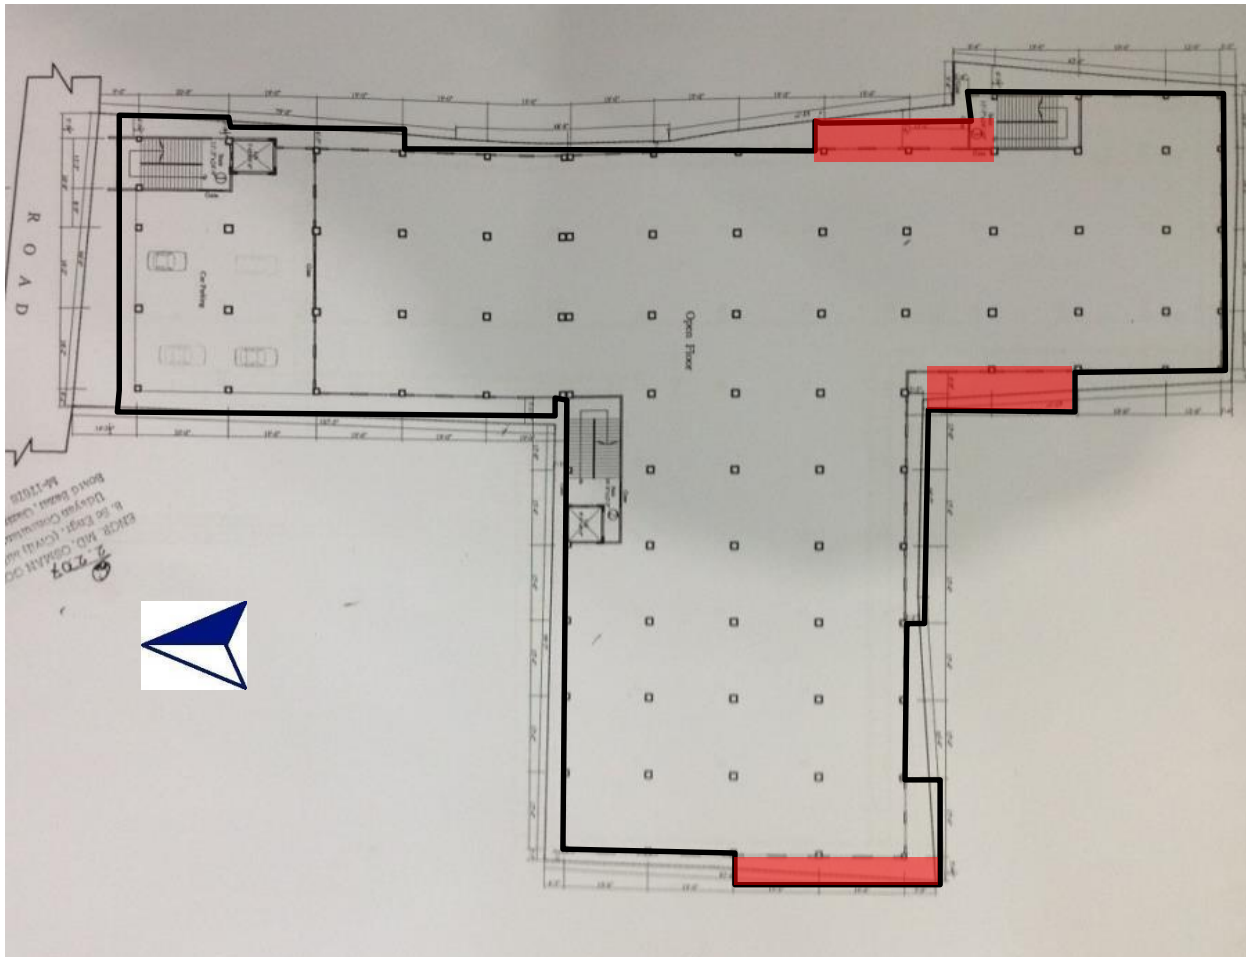
Typical floor layout

**Cursory calculations indicate column stresses are high**

Cursory calculations indicate that stresses are high in all columns. In particular, columns supporting cantilevers with toilet blocks are very highly stressed.

Toilet blocks supported by cantilever slabs

| Item No. | Observation | Recommended Action Plan | Recommended Timeline |
|---|---|---|---|
| 1 | Cursory calculations indicate column stresses are high | Factory Engineer to review design, loads and column stresses for all columns. | Immediate - Now |
| 2 | Cursory calculations indicate column stresses are high | Verify insitu concrete strength using min. 4 no. 100mm dia. Cores taken from the ground floor columns (or existing cylinder strength data if available for 4 column locations). | Immediate - Now |
| 3 | Cursory calculations indicate column stresses are high | Verify existing reinforcement (steel grade, bar diameter and spacing) in columns. | Immediate - Now |
| 4 | Cursory calculations indicate column stresses are high | A Detailed Engineering Assessment of factory to be commenced, see attached scope | Immediate - Now |

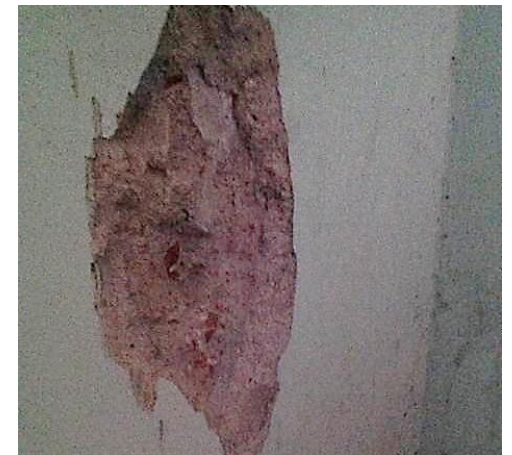
Brick aggregate

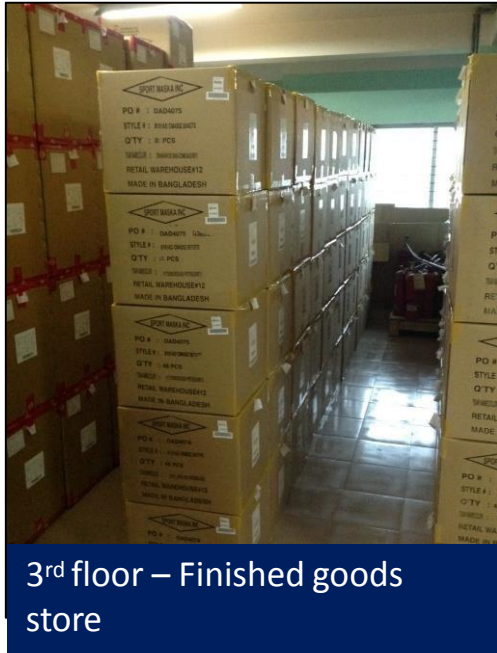
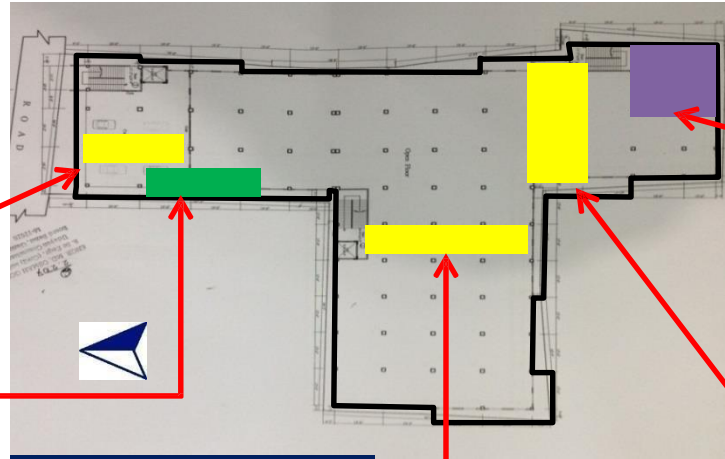
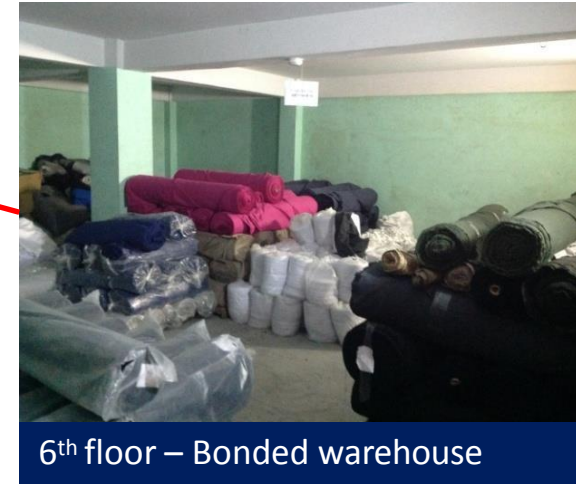
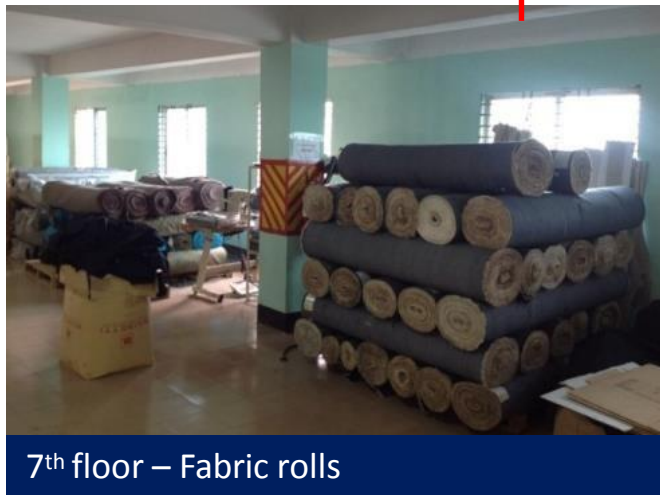
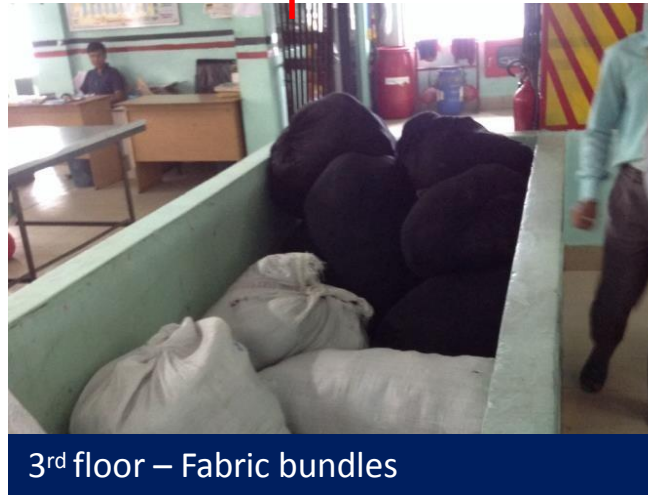
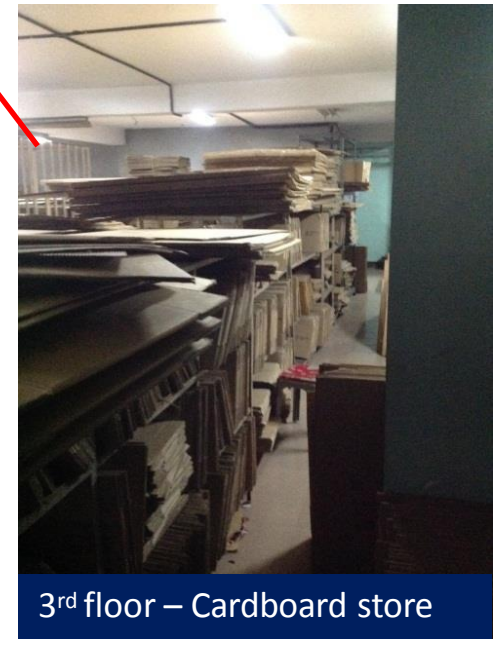
Areas of high loading on structure including cantilevers. No load management plan available for the building.

| Item No. | Observation | Recommended Action Plan | Recommended Timeline |
|---|---|---|---|
| 8 | No floor load management plan | Produce and actively manage a loading plan for all floor plates within the factory giving consideration to floor capacity and column capacity (refer to Item 1). | 6-weeks |
| 9 | No floor load management plan | Continue to implement load management plan. | 6-months |

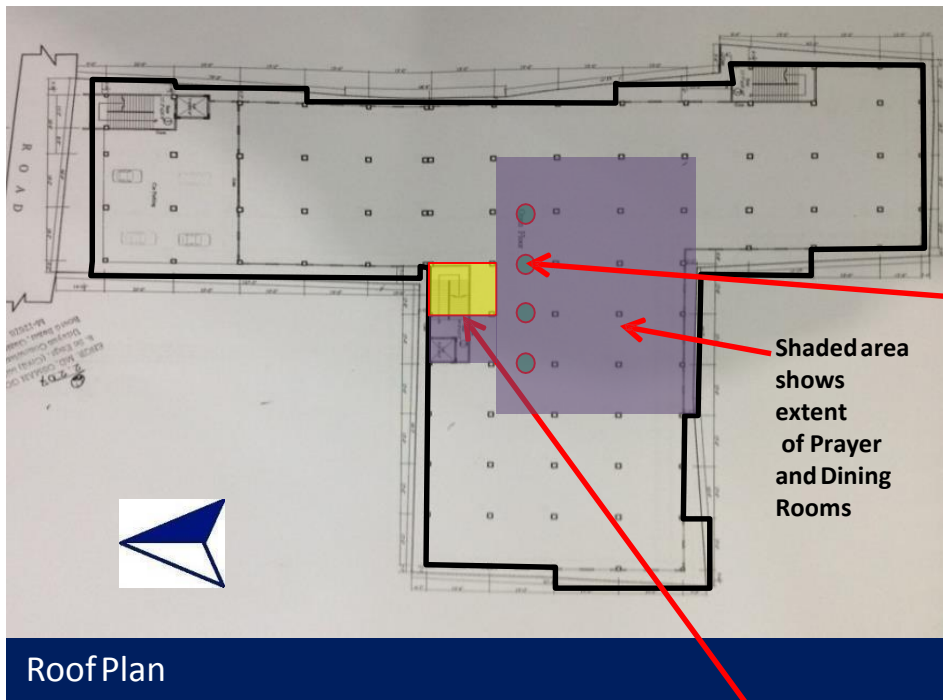
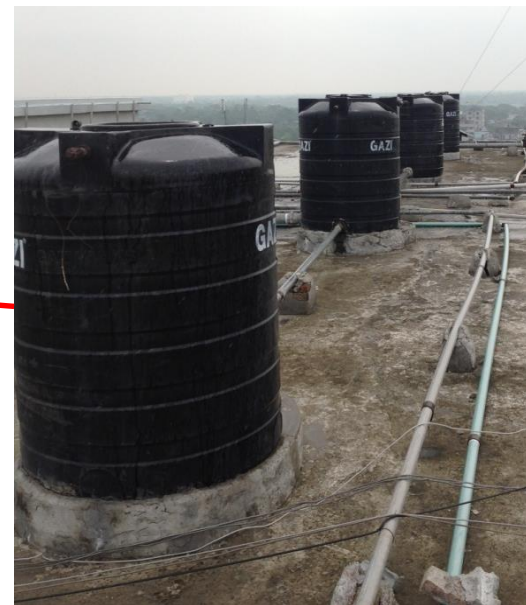
4 no. plastic water tanks

| Item No. | Observation | Recommended Action Plan | Recommended Timeline |
|---|---|---|---|
| 5 | Cursory calculations indicate column stresses are high | Produce and actively manage a loading plan for all floor plates within the factory giving consideration to floor capacity and column capacity. This should include a safe level to which any water tanks can be filled. | 6-weeks |

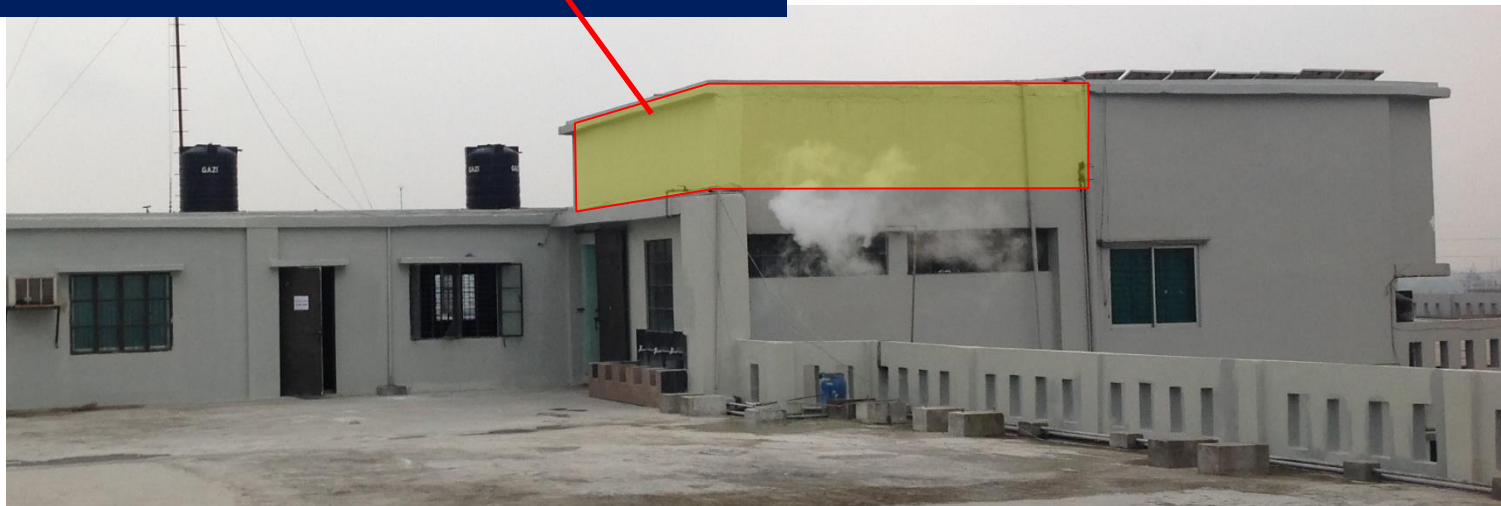
Concrete water tank

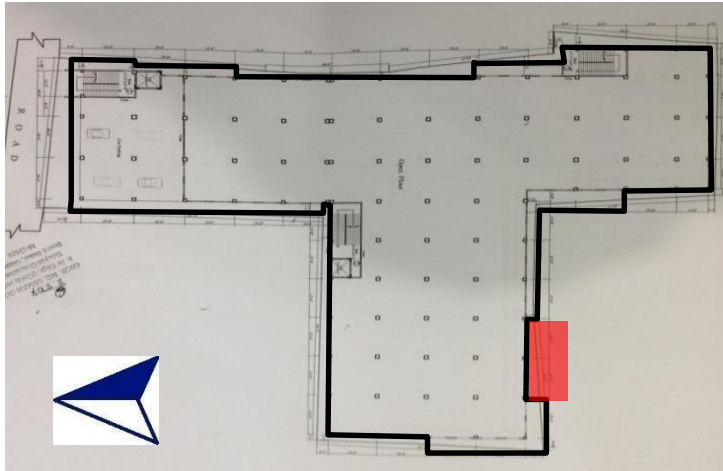
Typical Floor Plan

The steel fire escape stairs appears to be non-engineered. The main issues observed are:

- Overall stability under vertical and horizontal loads does not appear to have been achieved
- Bearing of stair to concrete landing appears inadequate
- Section sizes appear to be slender
- Corrosion of the structure has lead to holes in the tube sections

| Item No. | Observation | Recommended Action Plan | Recommended Timeline |
|---|---|---|---|
| 10 | Apparently non-engineered steel fire escape stairs on southern elevation of the EW building | Building engineer to review capacity of steel stair giving consideration to overall stability, section sizes used, stair bearing details and quality of fabrication | 6-weeks |
| 11 | Apparently non-engineered steel fire escape stairs on southern elevation of the EW building | Building engineer to propose an necessary alterations/strengthening works | 6-weeks |
| 12 | Apparently non-engineered steel fire escape stairs on southern elevation of the EW building | Ensure any necessary remedial works as advised by the Building Engineer are undertaken. | 6-months |

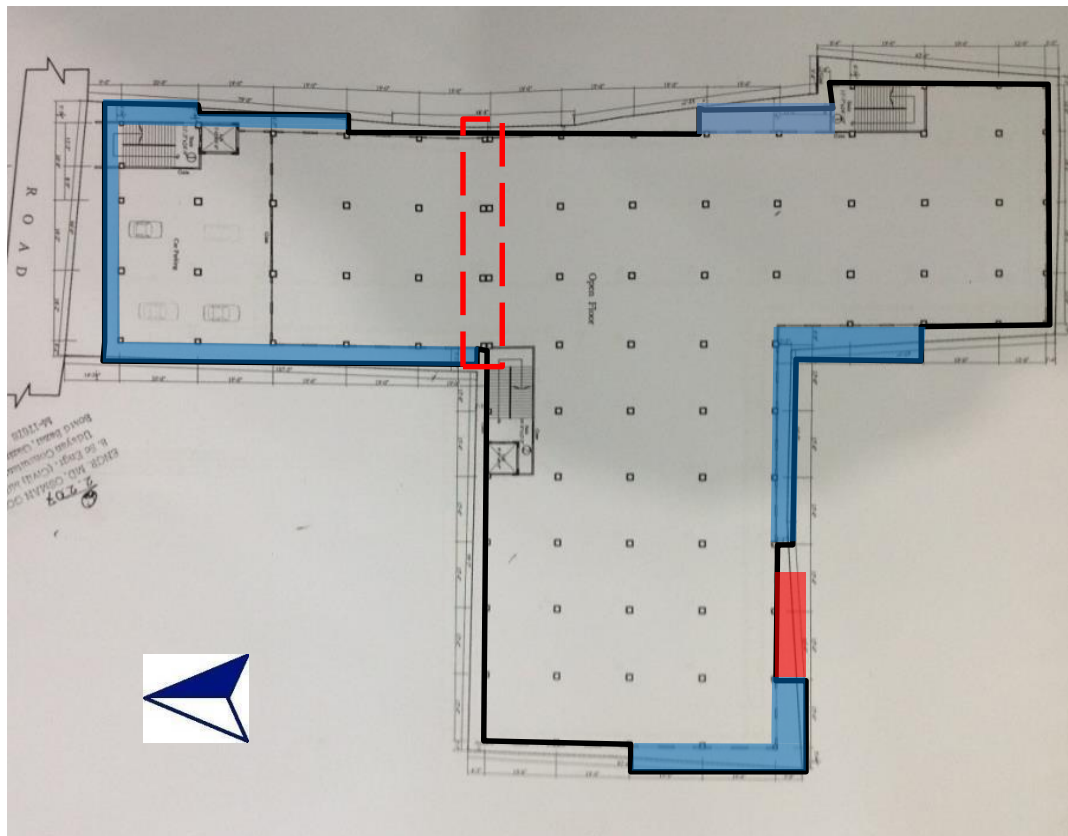
Typical floor Layout

- Double columns shown on drawings, single column built
- Cantilevers not on structural drawings
- Undocumented steel escape stairs
- Observed floor plate layout

| Item No. | Observation | Recommended Action Plan | Recommended Timeline |
|---|---|---|---|
| 13 | Inconsistencies between structural drawings and as built construction | Building engineer to survey building and prepare As-Built drawings as part of the Detail Engineering Assessment (refer to Item 1). | 6-weeks |
| 14 | Inconsistencies between structural drawings and as built construction | Building engineer to identify “as built” cantilever slab and supporting column reinforcement and confirm adequacy of the structural sections. | 6-weeks |

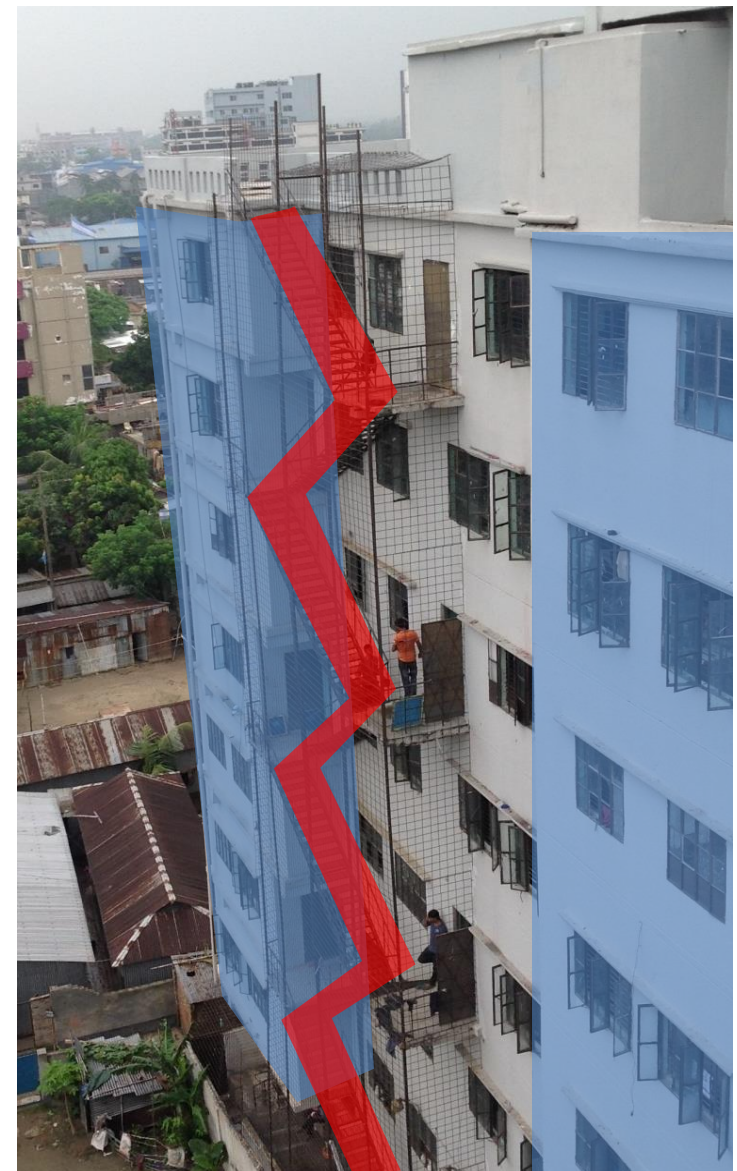
Steel escape stairs and cantilever structure to the south of E-W Building

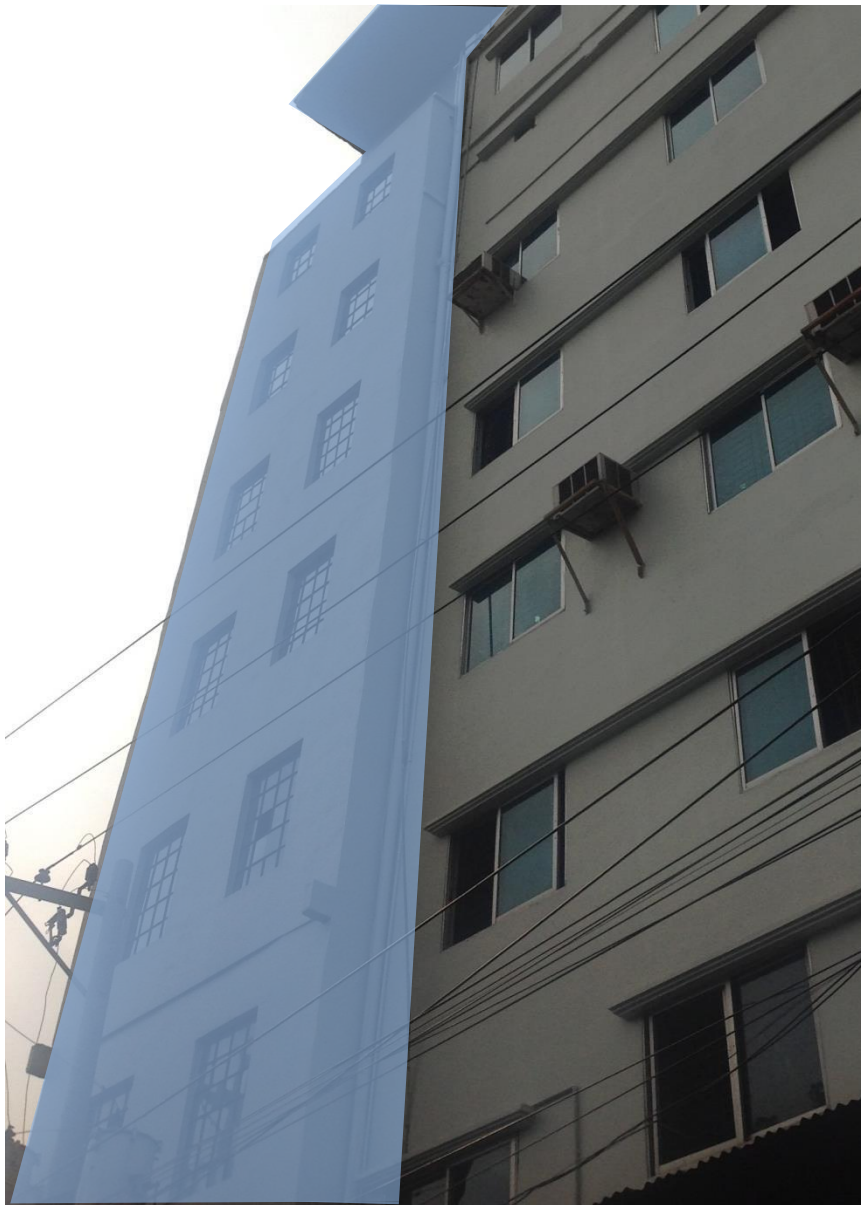
Cantilever structure to North of N-S Building

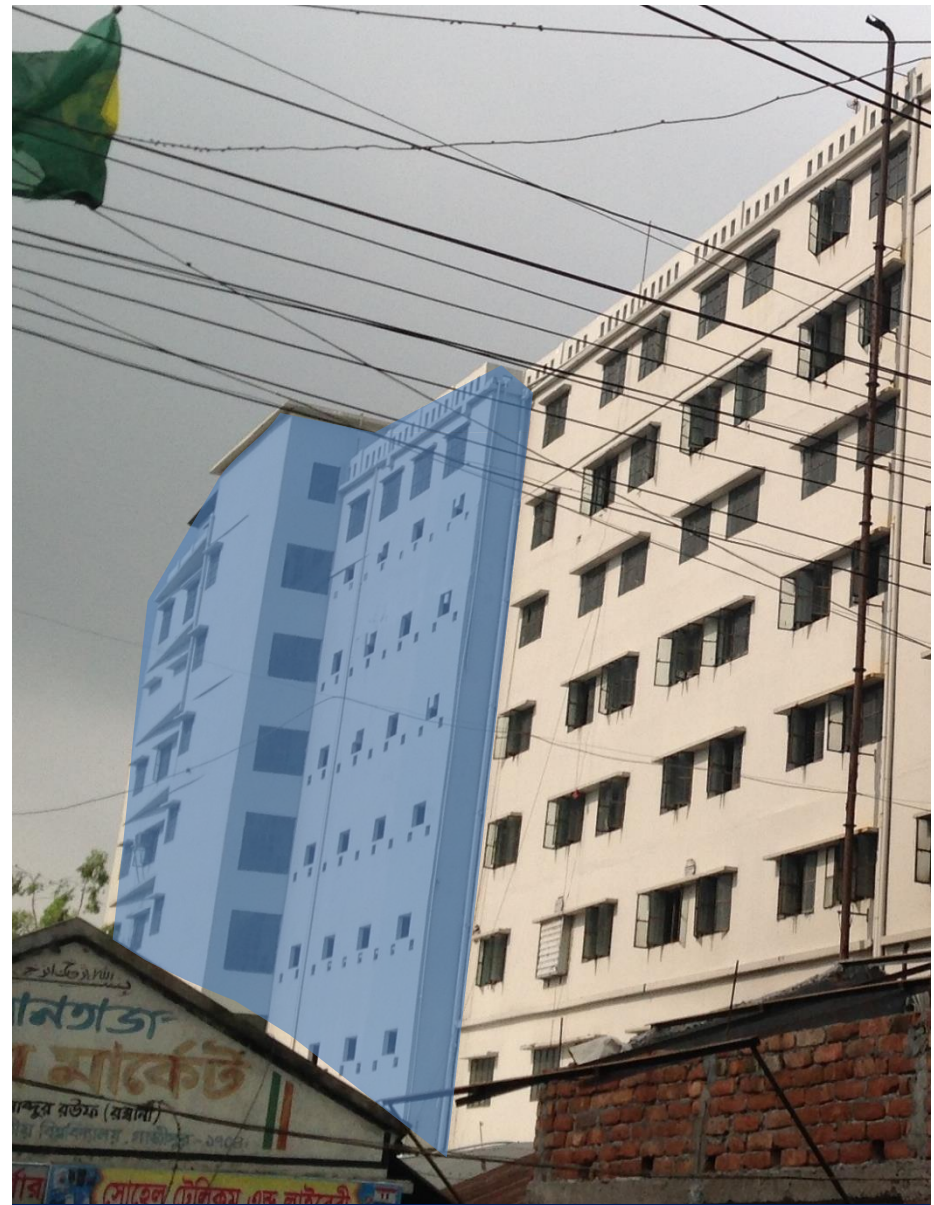
Cantilever structure to the Southwest of the N-S Building

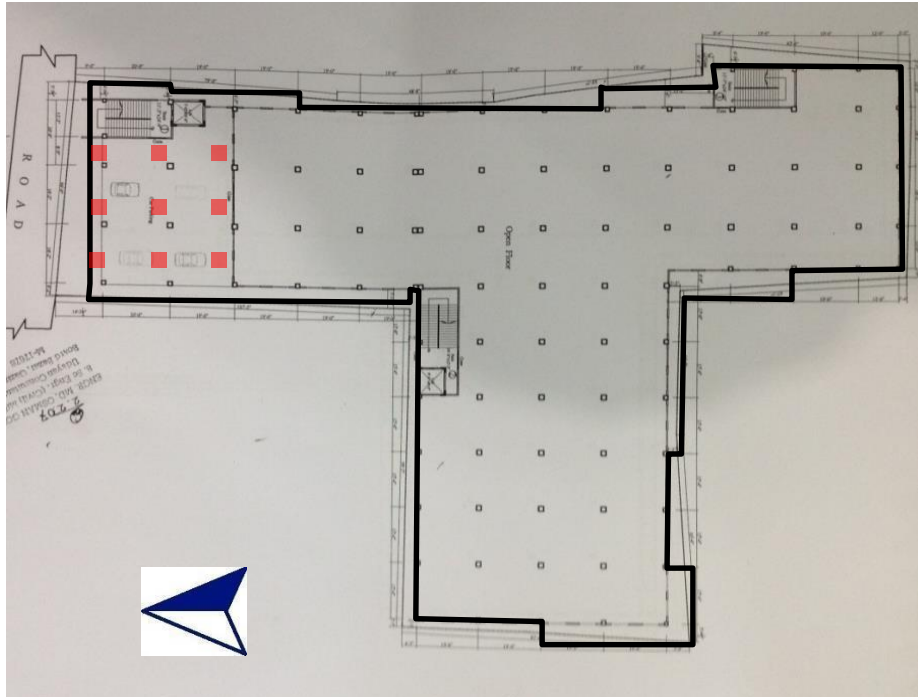
Typical floor Layout

The ground floor columns in the parking/delivery area were partially surrounded by a metal angle frame. These frames appeared light and may provide little protection to the column if struck by a vehicle.

Ground floor columns with steel angle protections

| Item No. | Observation | Recommended Action Plan | Recommended Timeline |
|---|---|---|---|
| 15 | Column protection at ground floor delivery area | Building engineer to review capacity of column protection to vehicular impact and propose strengthening works if required | 6-weeks |

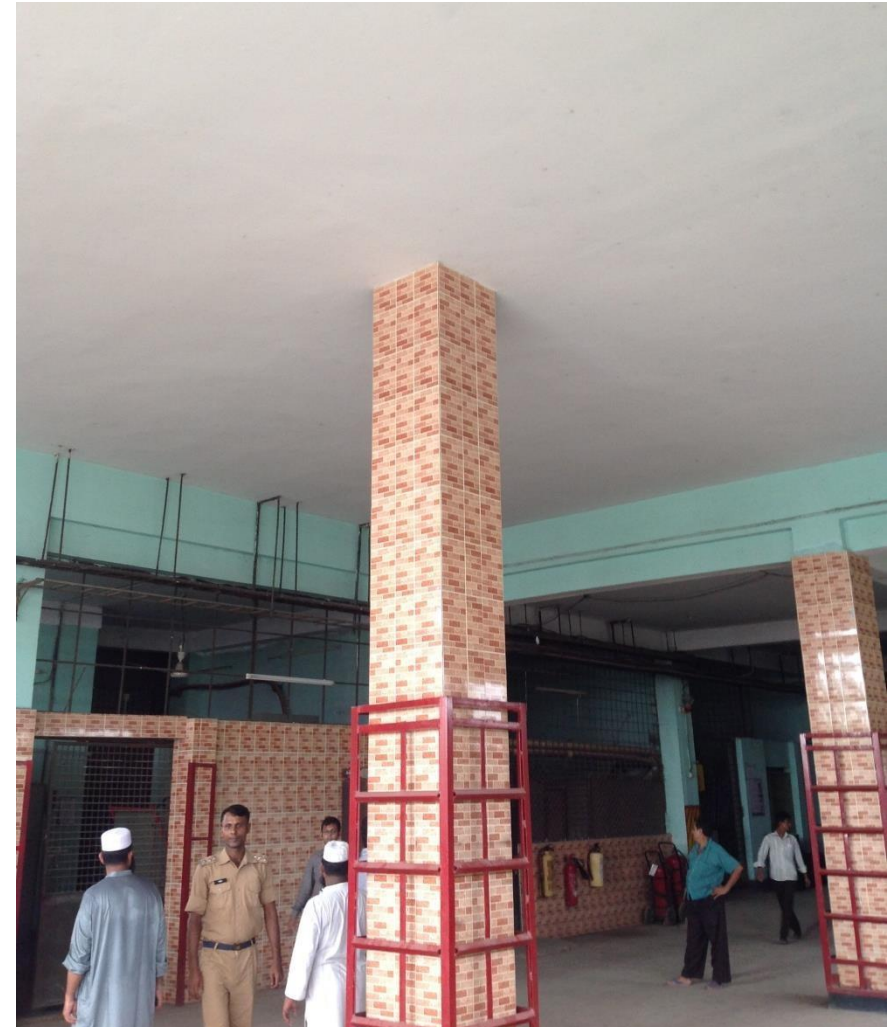
Angle steel frames at columns
