# **FIRE SAFETY INSPECTION REPORT**

**NABA KNIT COMPOSITE**  
**JAMGORA, EPZ ROAD, ASHULIA, DHAKA 1344**

April 17, 2014

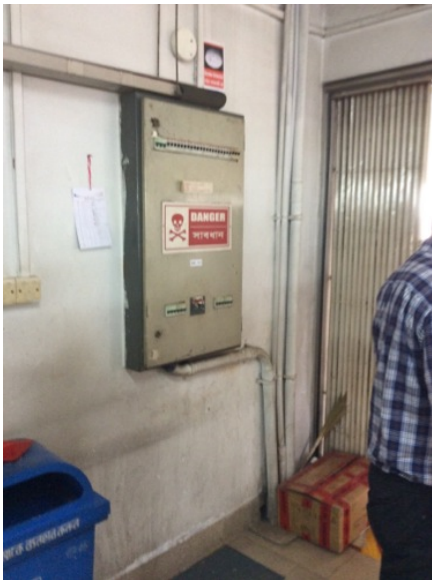
No.	Category	Finding	Recommendation	Remediation Timeframe
F-1	Fire Rated Construction	Unsealed penetrations, electrical conduit at electrical panels.	Seal all penetrations and openings in floor/ceiling assemblies to maintain the fire separation.	Within 3 months

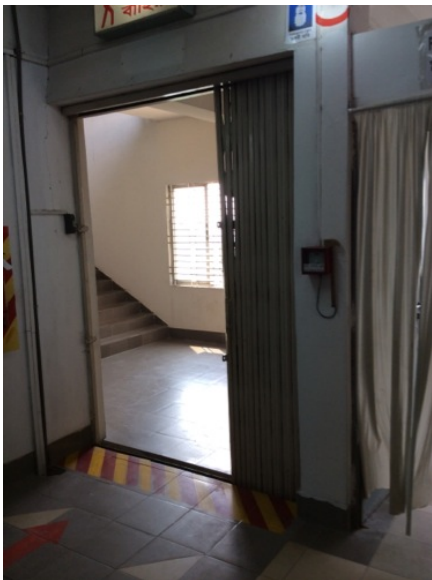
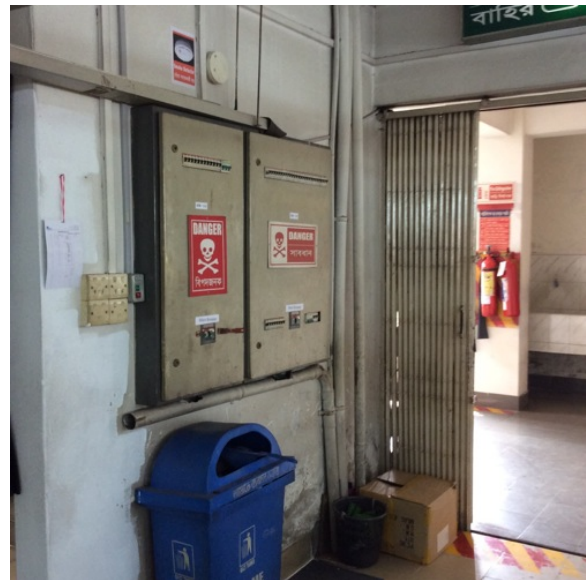
F-2	Fire Rated Construction	The exit stairs are not separated from production areas on each floor by fire-rated construction.	Provide minimum 1.5-hr fire rated doors and seal all unprotected openings to separate the exit stairs from work areas and other building spaces on all floor levels. Ensure that the fire doors are self-closing and positive latching and that they are provided with fire exit (panic) hardware where serving production floors.  If fire doors are required to be held open for functional reasons, provide automatic-closing devices tied to the fire alarm system.	Within 3 months
-----	-------------------------	---	---	-----------------

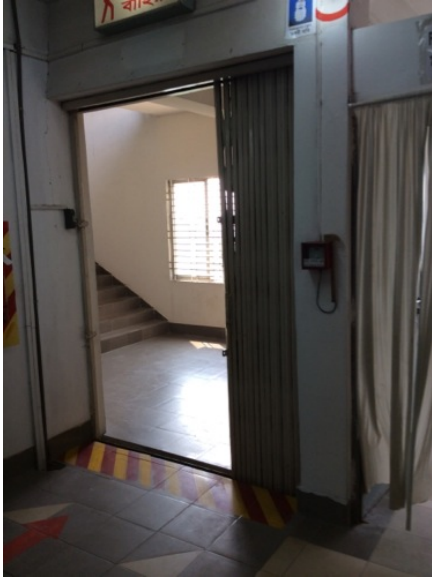
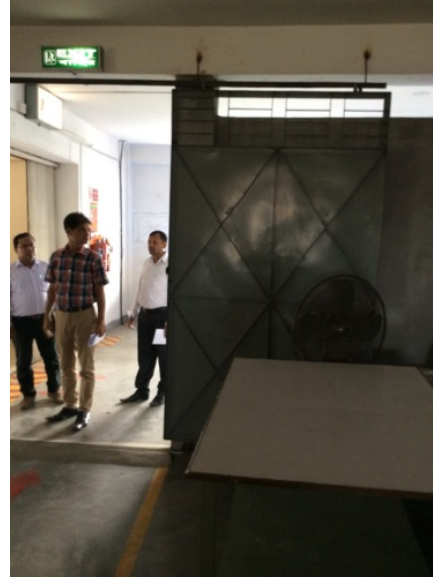
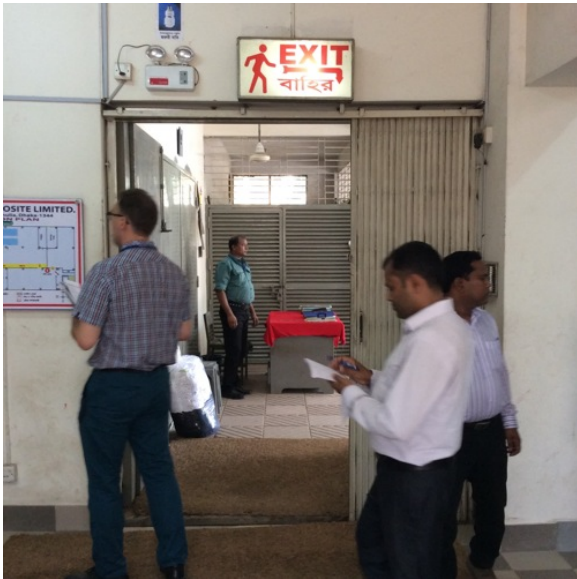
F-3	Egress	Egress doors / gates with locking features are provided at building exits from the production and storage areas to interior exit stairs and at building exit discharge. These were unlocked during inspection.	Remove locking features from all egress doors / gates.  If locks are required for security reasons, utilize special door locking features complying with NFPA 101.	Immediate
-----	--------	--	--	-----------

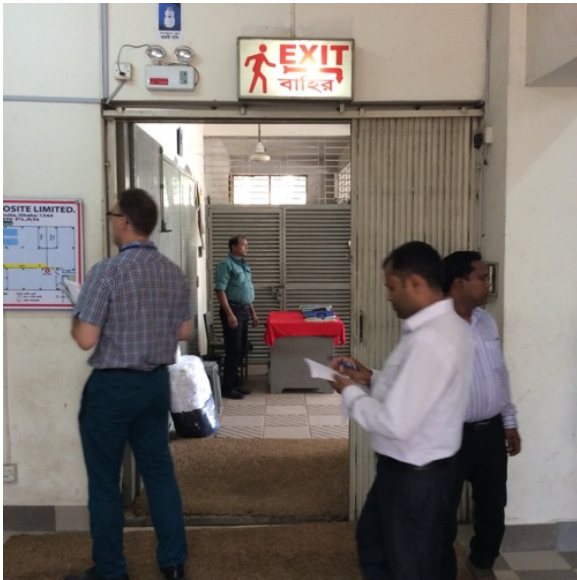
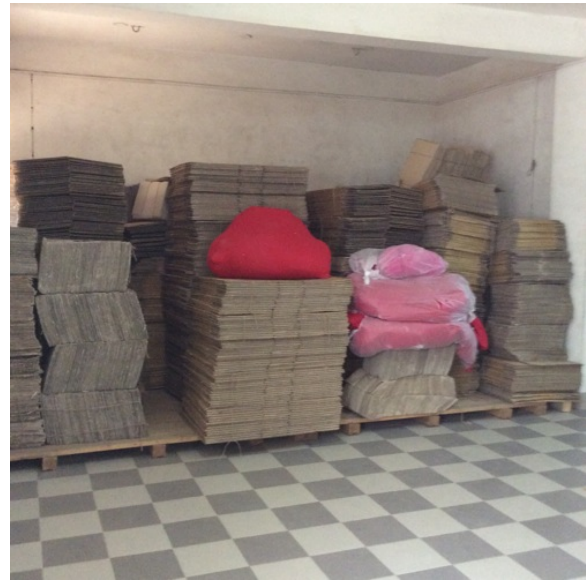
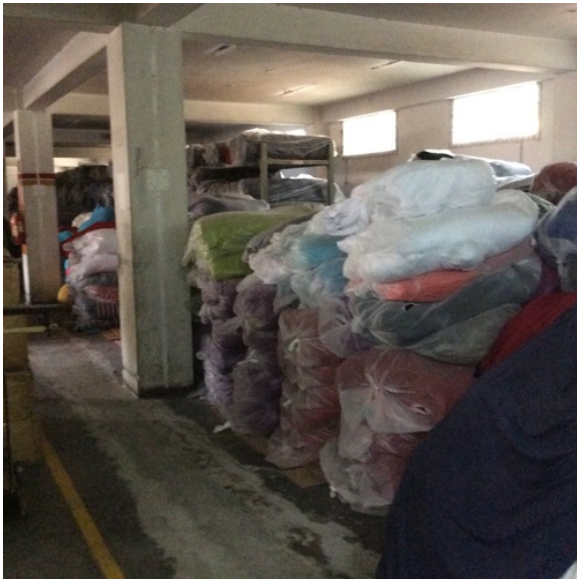
F-4	Egress	Main exit stair at building main entry discharges inside the building and is open to storage.	Provide 2-hr fire-rated separation from the storage area and add exit passageway leading directly outside.	Within 6 months
-----	--------	---	--	-----------------

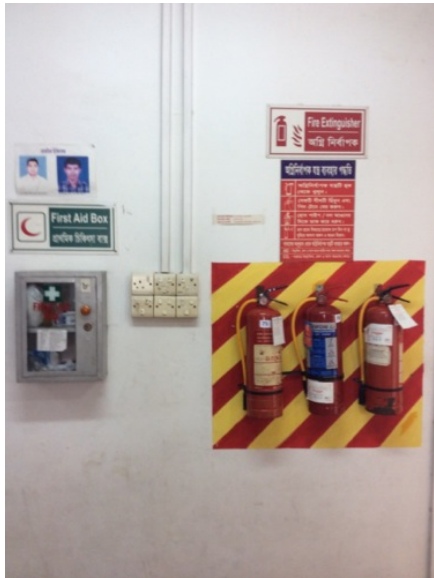
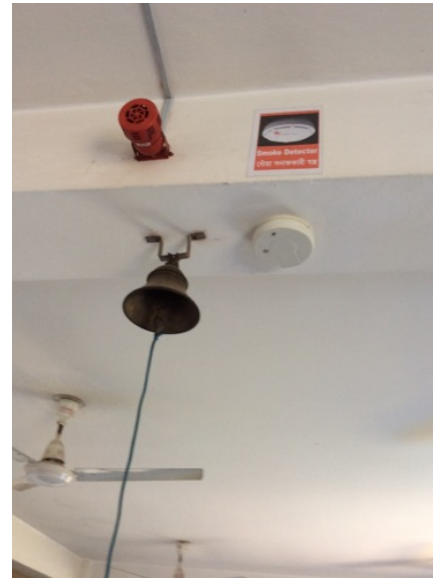
F-5	Fire Protection	The fire alarm system is antiquated, not a listed system, and does not provide alarm and notification features consistent with acceptable standards.	Replace the fire alarm system with a new, listed addressable fire alarm system in accordance with NFPA 72.	Design within 4 months, install within 9 months
-----	-----------------	--	--	---

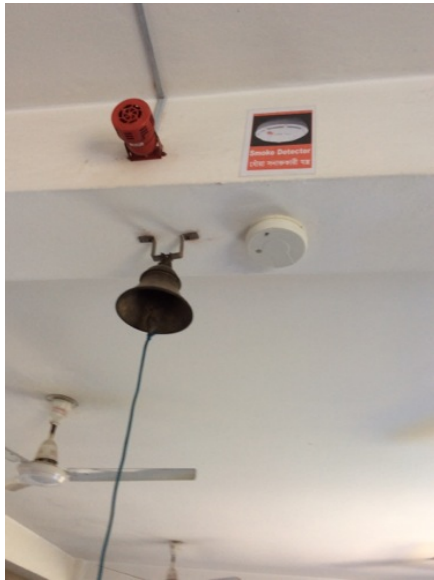
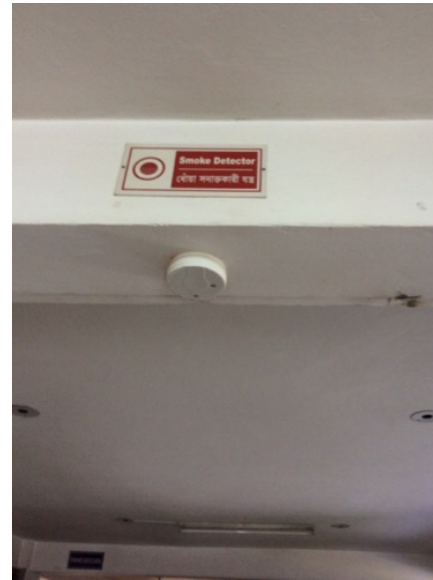
F-6	Fire Protection	Inspection, testing, and maintenance records for the fire alarm system were not per NFPA 72.	Inspect, test and maintain the fire alarm system, and keep written records on-site, in accordance with NFPA 72.	Within 3 months
F-7	Fire Protection	The building is equipped with single-station smoke alarms. Smoke alarm activation sounds only a local alarm and does not provide automatic fire alarm notification of occupants.	Replace the single-station smoke alarms with automatic smoke detectors tied into the fire alarm system. Configure the fire alarm system to initiate occupant notification upon activation of any two smoke detectors in addition to the manual fire alarm stations.	Within 6 months

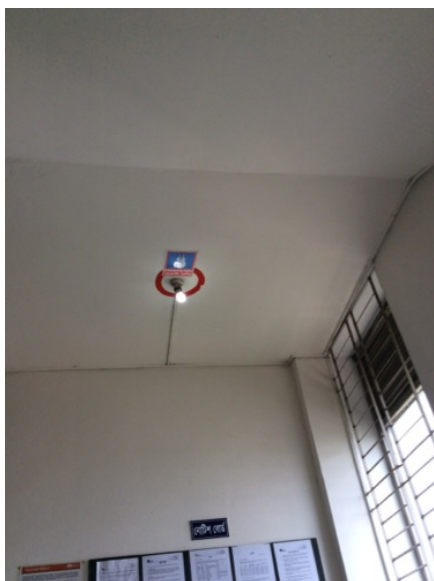
F-8 Egress Lighting

Based on the number and location of emergency lights observed, adequate illumination levels are not anticipated along all egress routes.

Test the emergency lighting system on each floor and provide additional emergency fixtures to provide adequate illumination along the means of egress. Provide a minimum illumination of 10 lux at the floor level within exit stairs and exit discharge paths and minimum 2.5 lux along exit access aisles.
