# **FIRE SAFETY INSPECTION REPORT**

## **AMEX KNITTING & DYEING INDUSTRIES LTD.**

**SUFIA PLAZA, 327/3/B, SOUTH JATTRABARI**

July 7, 2014

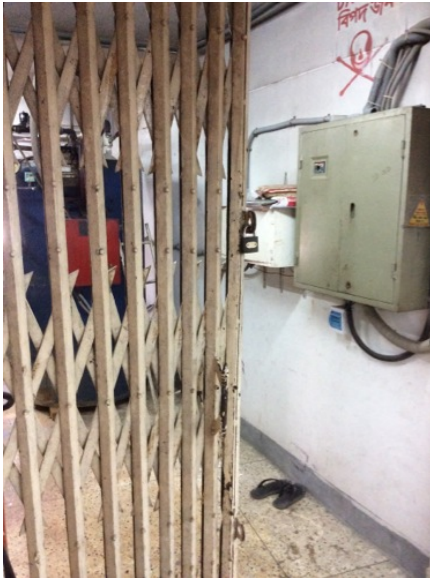
| No. | Category | Finding | Recommendation | Remediation Timeframe |
|---|---|---|---|---|
| F-1 | Fire Rated Construction | The boiler and ground floor generator rooms are not separated by fire-rated construction. | Separate the boiler / and ground floor generator rooms by a minimum 2-hr fire-rated construction. Seal and/or protected all openings to maintain the required fire separations | Within 3 months |

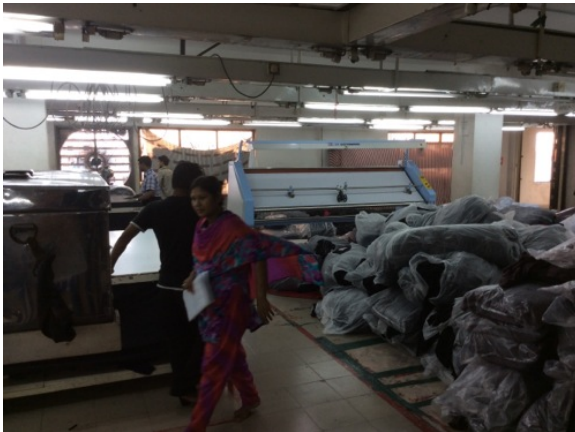
| F-2 | Fire Rated Construction | <p>Areas on floor 2 and 6 used for combustible storage are not separated by fire-rated construction.</p> <p>Rooms on floor 1, 3, and 6 used for combustible storage are not separated by fire-rated construction.</p> | <p>Provide dedicated storage rooms separated by minimum 1-hr fire-rated construction.</p> <p>Where separate storage rooms are not feasible, provide defined storage areas and limit the storage arrangement as follows:</p> <ul style="list-style-type: none"><li>- Maximum height of 2.4m and maximum area of 23m<sup>2</sup></li><li>- If sprinkler protected: maximum height of 3.66m and maximum area of 93m<sup>2</sup></li></ul> <p>Separate areas of unenclosed combustible storage by a minimum clear distance of 3m.</p> | Within 3 months |

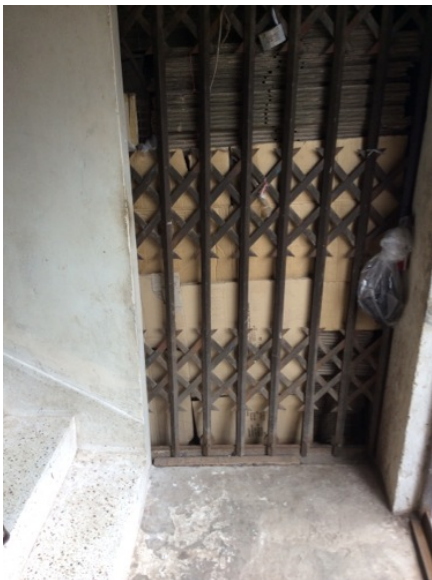
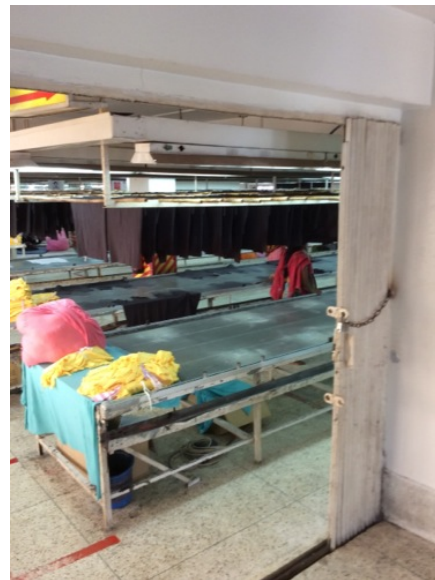
| F-3 | Fire Rated Construction | The exit stairs are not separated from work areas on each floor by fire-rated construction. | <p>Provide minimum 1.5-hr fire rated doors and seal all unprotected openings to separate the exit stairs from work areas and other building spaces on all floor levels. Ensure that the fire doors are self-closing and positive latching and that they are provided with fire exit (panic) hardware where serving production floors.</p> <p>If fire doors are required to be held open for functional reasons, provide automatic-closing devices tied to the fire alarm system.</p> | Within 3 months |

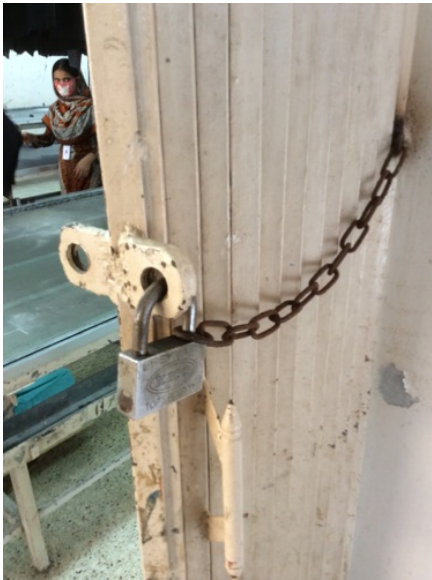
| F-4 | Egress | Egress gates with locking features are provided at all building exits, exit stairs, and exit discharges. | <p>Remove locking features from all egress gates.</p> <p>If locks are required for security reasons, utilize special door locking features complying with NFPA 101.</p> | Immediate |

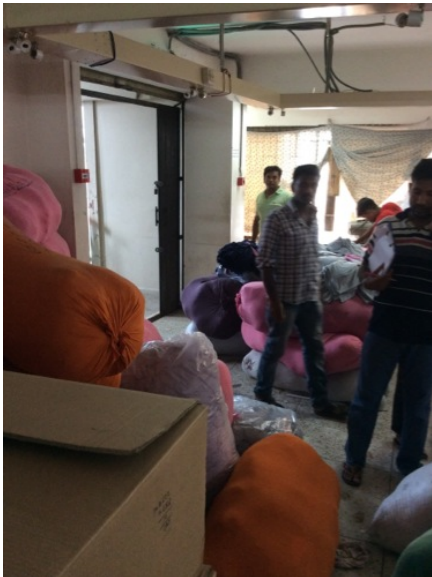
| F-5 | Egress | Storage was located in the egress path on floors 1 and 6. | Keep egress paths and stairs clear of storage. | Immediate |

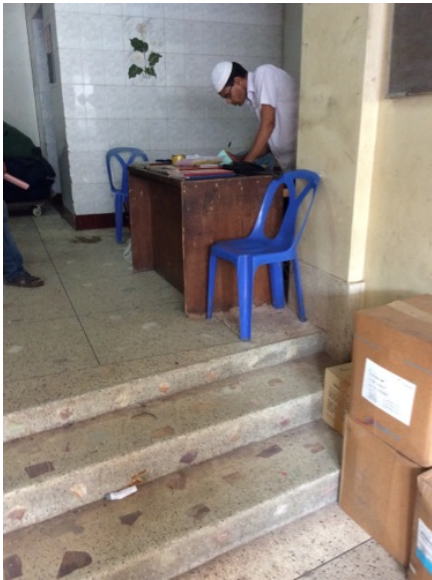
| F-6 | Egress | Storage was located in Stair 2 at the ground floor. | Remove all storage from exit stairs and egress paths. | Immediate |

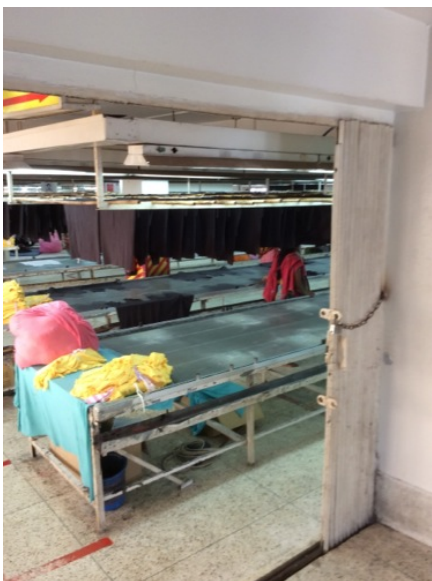
| F-7 | Egress | Collapsible gates provided at all building exits, exit stairs, and exit discharges. | Replace all gates along the means of egress with side-hinged, swinging egress doors. | Within 1 month |

| | | | If locks are required for security reasons, utilize special door locking features complying with NFPA 101. | |

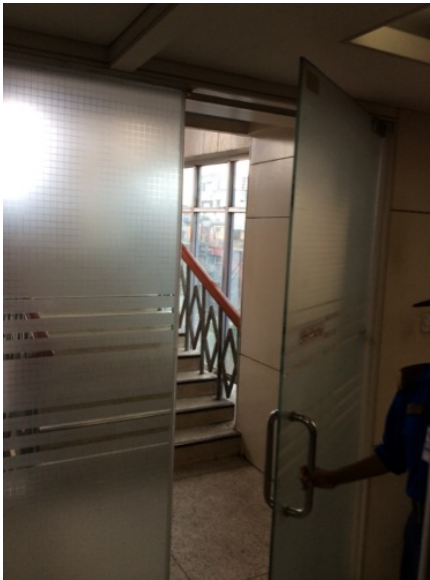
| F-8 | Egress | Evacuation plans were not provided at Stair 4. | Provide Evacuation plans at each stair on each floor. | Within 1 month |

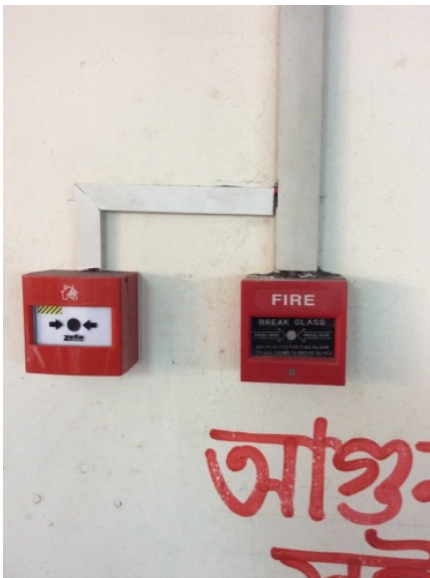
| F-11 | Fire Protection | The fire alarm system is antiquated, not a listed system, and does not provide alarm and notification features consistent with acceptable standards. | Replace the fire alarm system with a new, listed addressable fire alarm system in accordance with NFPA 72. | Design within 4 months, install within 9 months |

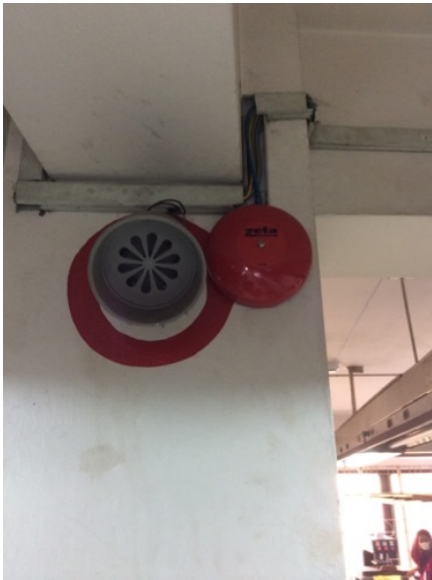
| F-12 | Fire Protection | Inspection, testing, and maintenance of the fire alarm system is not in accordance with NFPA 72. | Inspect, test and maintain the fire alarm system, and keep written records on-site, in accordance with NFPA 72. | Within 3 months |

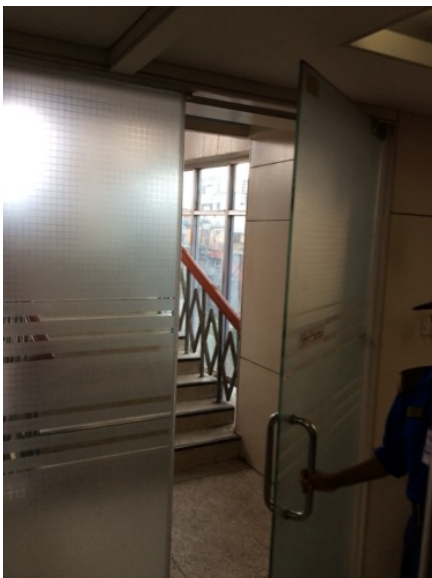
| F-14 | Egress Lighting | Exit sign not provided at exits from sewing area on floor 1 and office areas on floor 2. | Provide exit signs above all exits to the exterior and all doors to the exit stairs. | Within 1 month |

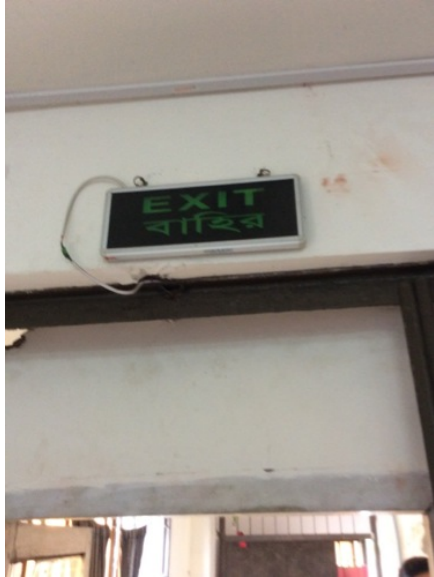
| F-15 | Egress Lighting | Exit signage not illuminated on floor 1. | Regularly inspect all exit signage and replace/install lights as needed to illuminate signs. | Within 1 month |

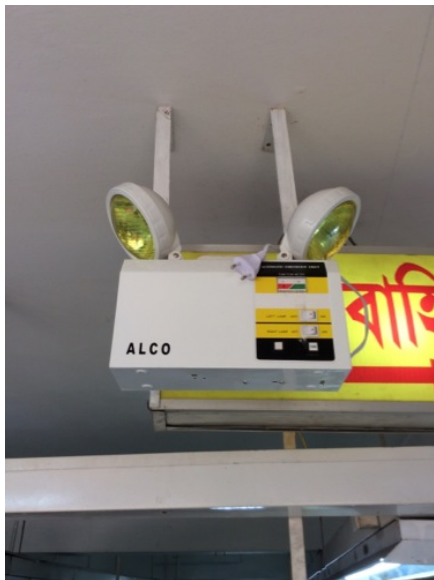
| F-16 | Egress Lighting | Emergency lighting throughout the factory did not function in test mode. | Regularly test the emergency lighting system on each floor and replace/repair lights as needed. | Within 1 month |

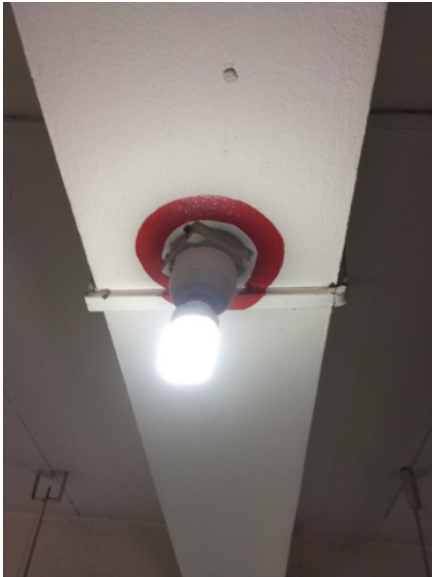
| F-17 | Egress Lighting | Inspection, testing, and maintenance for the emergency lighting system was not in accordance with The ACCORD standard. | Inspect, test and maintain the emergency lighting system in accordance with The ACCORD standard. Keep written records on-site. | Within 3 months |
