Century Apparels Ltd - Unit 2

Holding # 01, Block-B D.N. Road, West Masdair, Fatullah, Narayanganj-1400

19th March, 2017

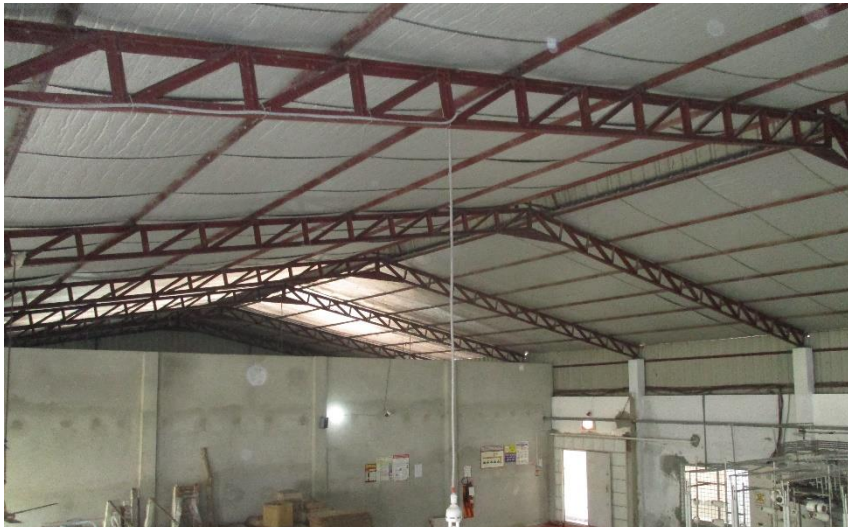
No lateral system were observed to resist lateral loading.(Shed#1)

Item No.	Observation	Recommended Action Plan	Recommended Timeline
1	Apparently no obvious lateral stability of any sheds	Building engineer is required to check the stability system, connection adequacy of all sheds against lateral loading.	6-weeks
2	Apparently no obvious lateral stability of any sheds	Carry out Engineering Assessment for all sheds.	6-weeks
3	Apparently no obvious lateral stability of any sheds	Carry out remedial works arise from Engineering Assessment.	6-months
4	No drawings were available on site	Building engineer is required to produce the as built drawings for all sheds as part of Engineering Assessment.	6-weeks

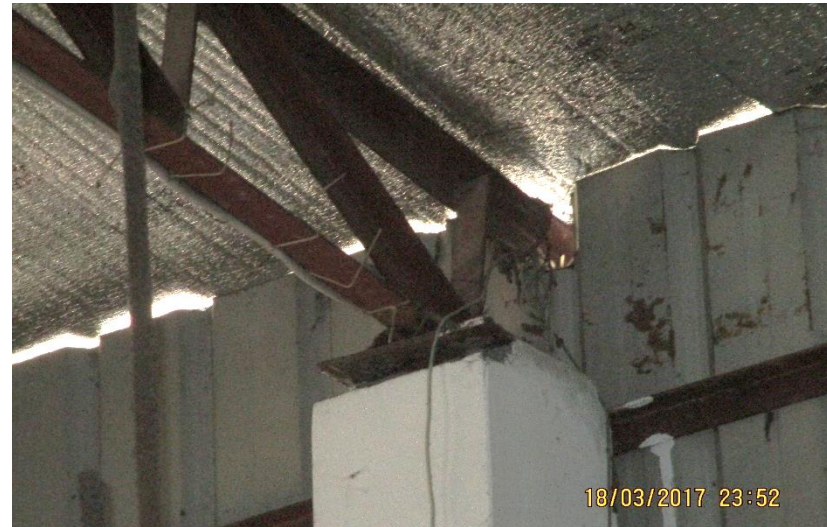
Poor Connection between RCC column support and truss connections(Shed#1)

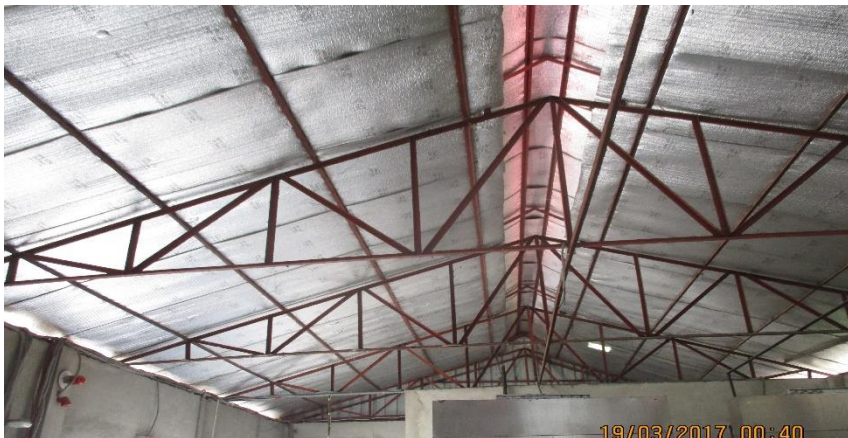
No lateral system were observed to resist lateral loading (Shed#2)

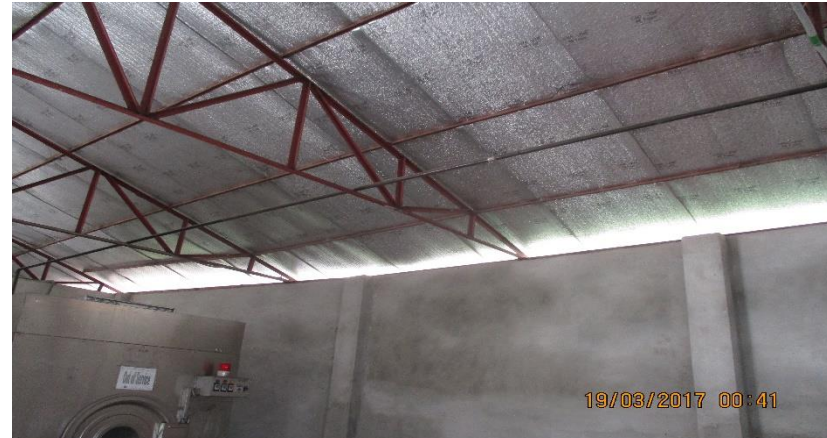
Inadequate connection between truss and brick walls (Shed#2)

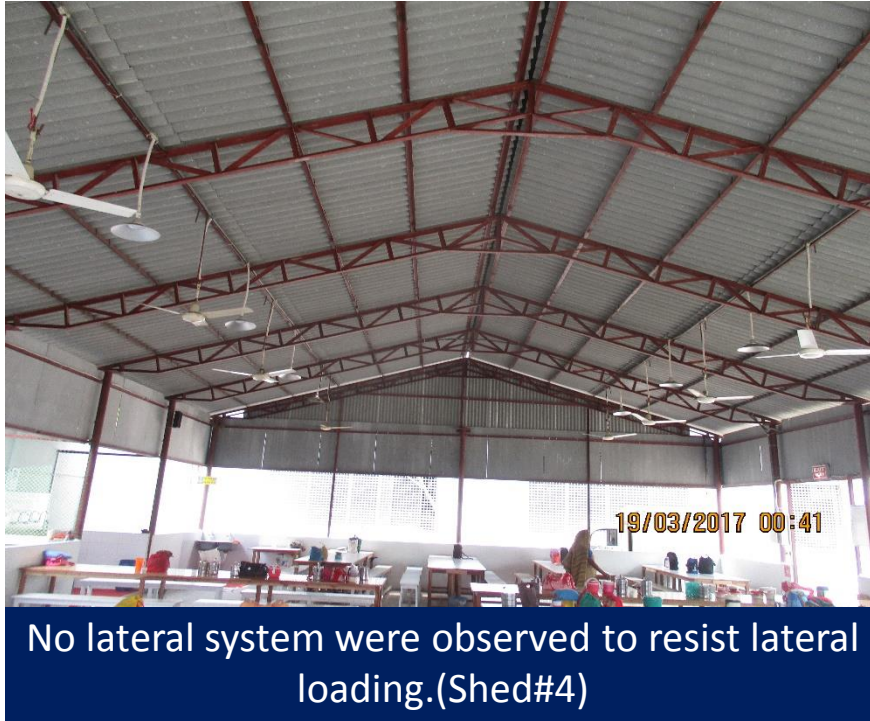
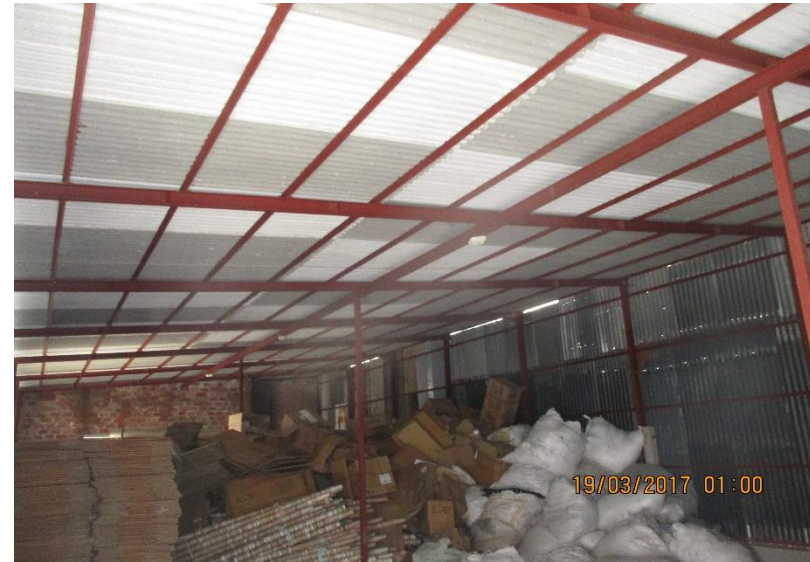
Apparently Non engineered (Shed#3)

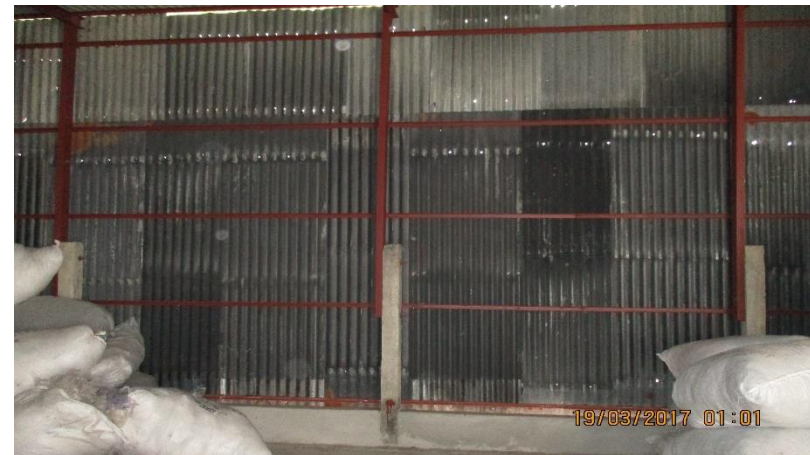
Non engineered connections (Shed#3)

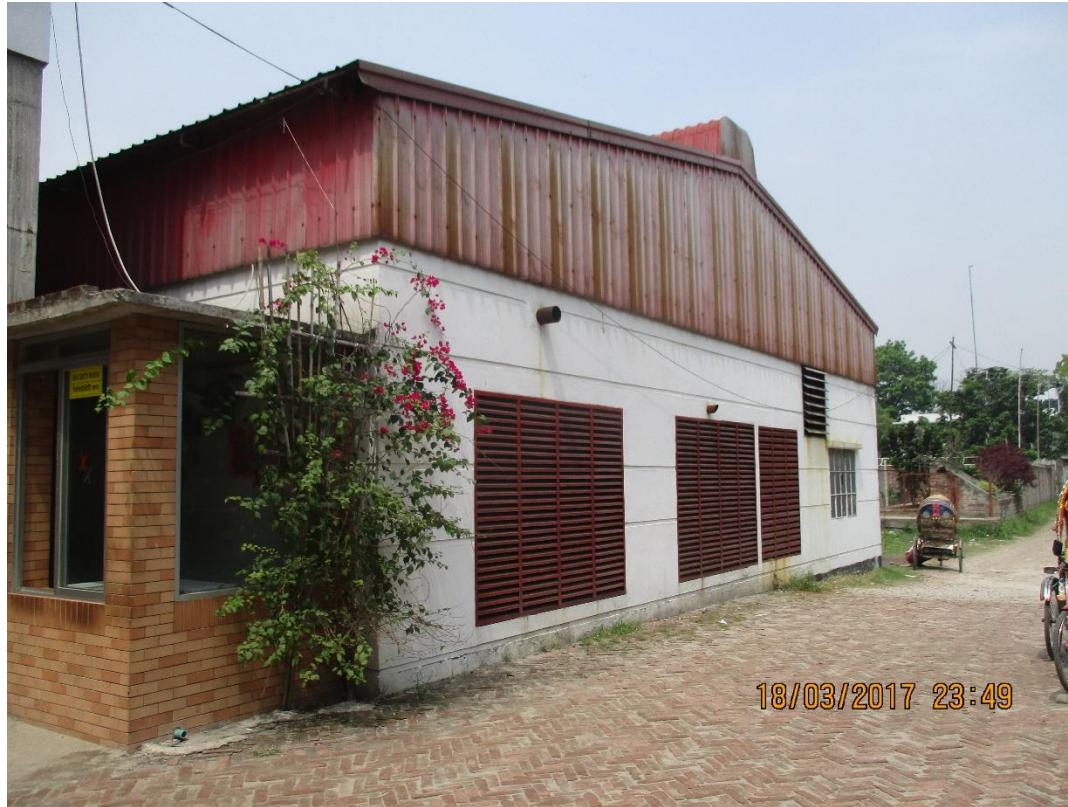
No drawings(Permits and As built) were available on site for any structure. Building engineer is required to produce as built drawings.
