# Hams Garments Ltd (extension)

South Vangnahati, Chapilapara, Sreepur  
(24.194313N, 90.452568E)

11<sup>th</sup> January, 2017

# **Discrepancy between drawing and as-built condition**

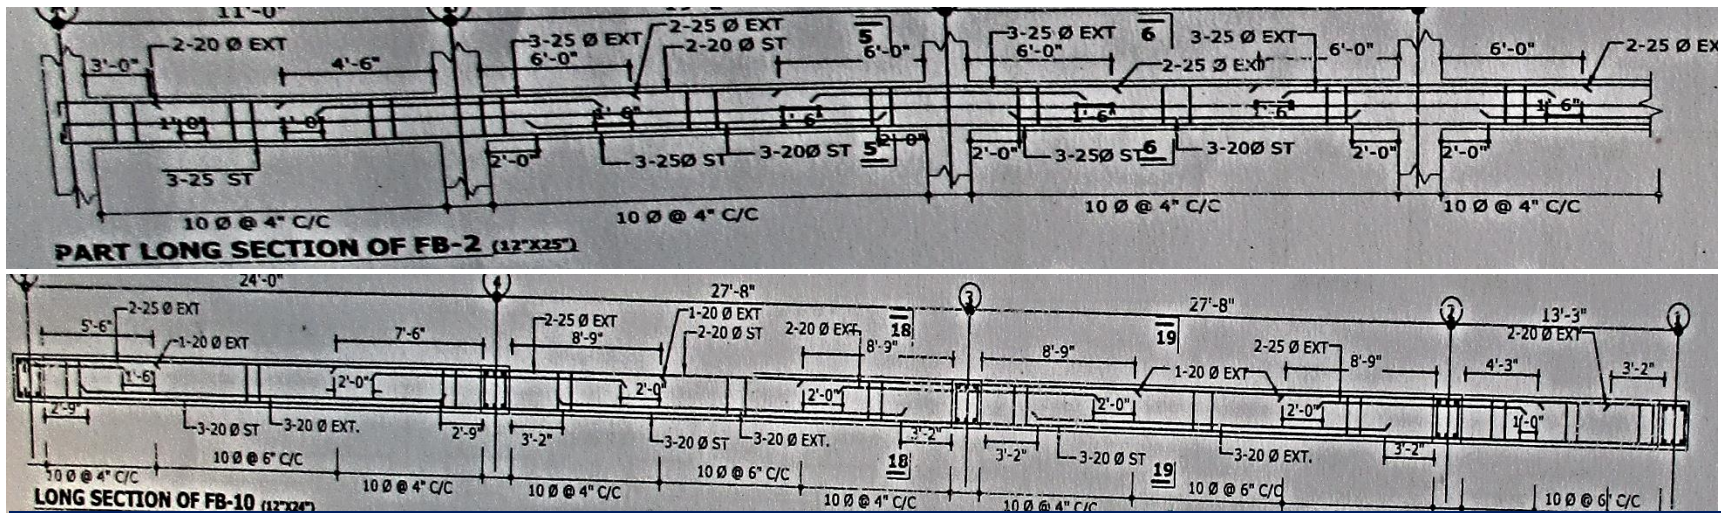
Floor beam detail from provided structural drawings

During inspection, roof floor concrete pouring was going on and all rebar's were placed. Discrepancies' was found in rebar placement of beams and construction drawings. 5-20mm dia rebar was found instead of 6-20 mm dia rebar in FB1 & FB10. More over 6-20mm dia rebar was found instead of 3-25mm & 3-20mm in bottom of Fb2 which indicate that the structural design has not been followed properly for construction.

| Item No. | Observation | Recommended Action Plan | Recommended Timeline |
|---|---|---|---|
| 1 | Discrepancy between drawings and as-built condition | Factory engineer to investigate the whole building and review the design for missing reinforcement of beam and all other existing condition. | 6-weeks |

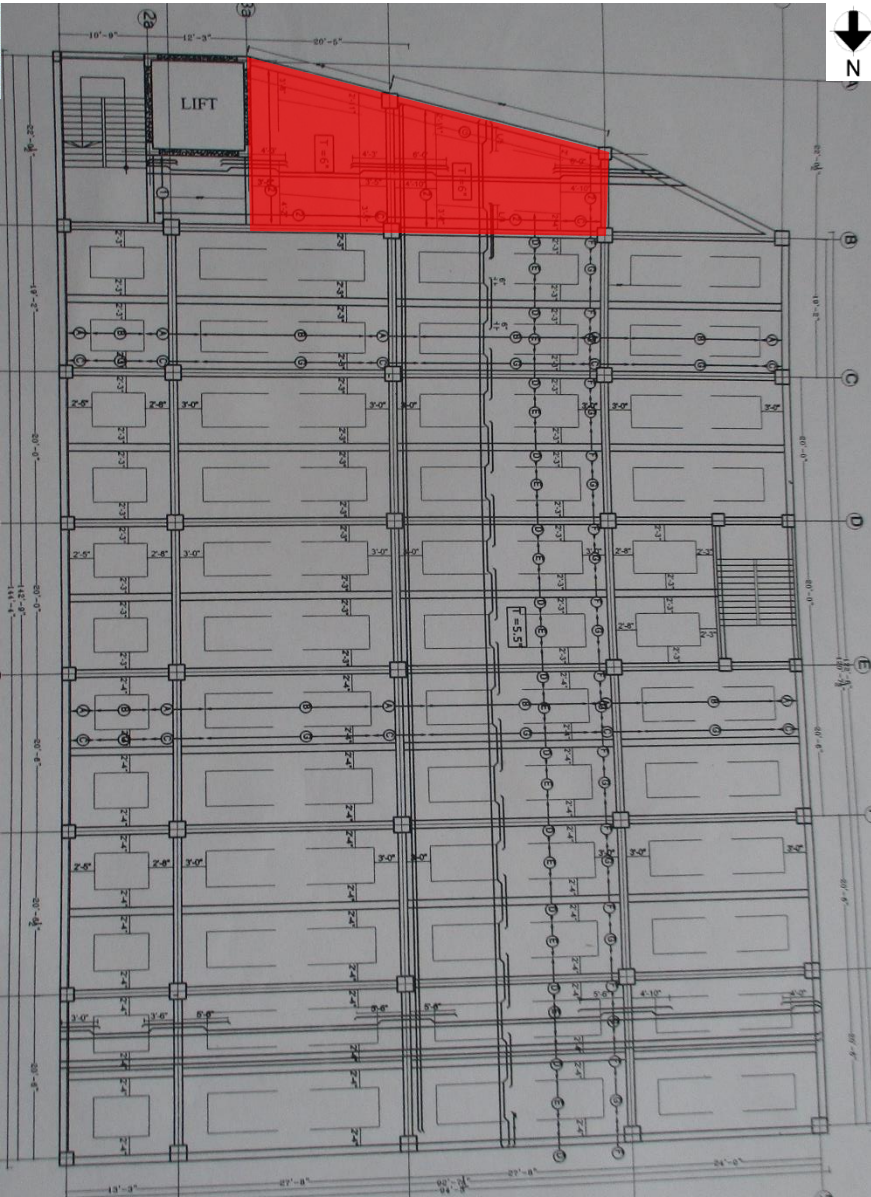
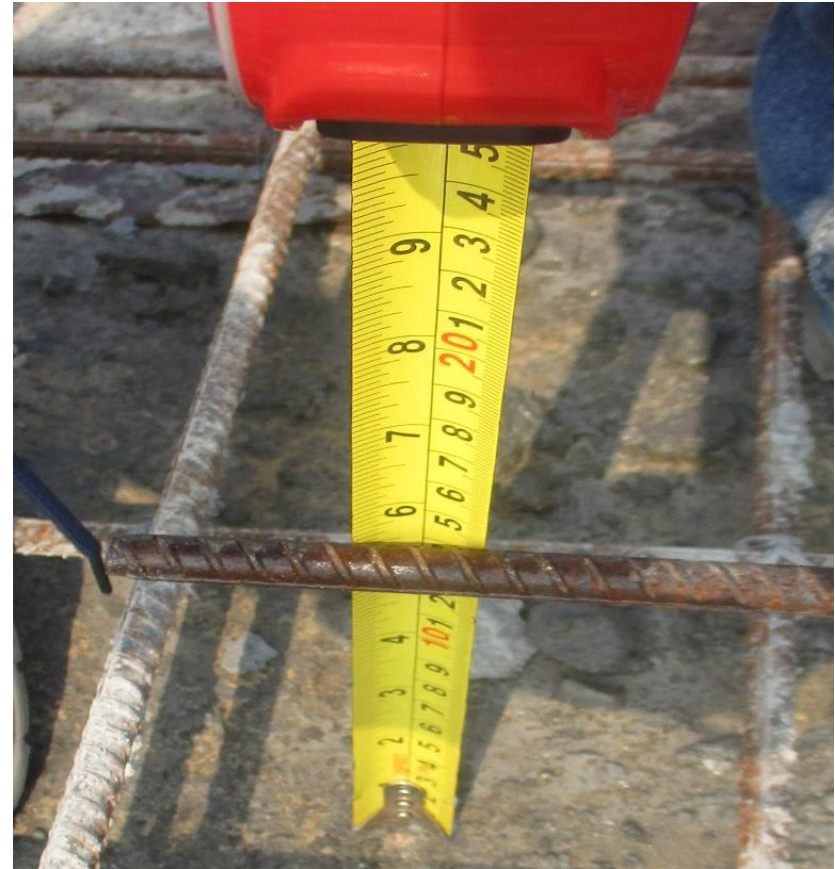
Typical slab layout

According to the working drawings slab thickness of the highlighted area is mentioned 150mm and 140mm in other portion. Construction work was ongoing at the time of inspection. Slab thickness was found more than 150mm.

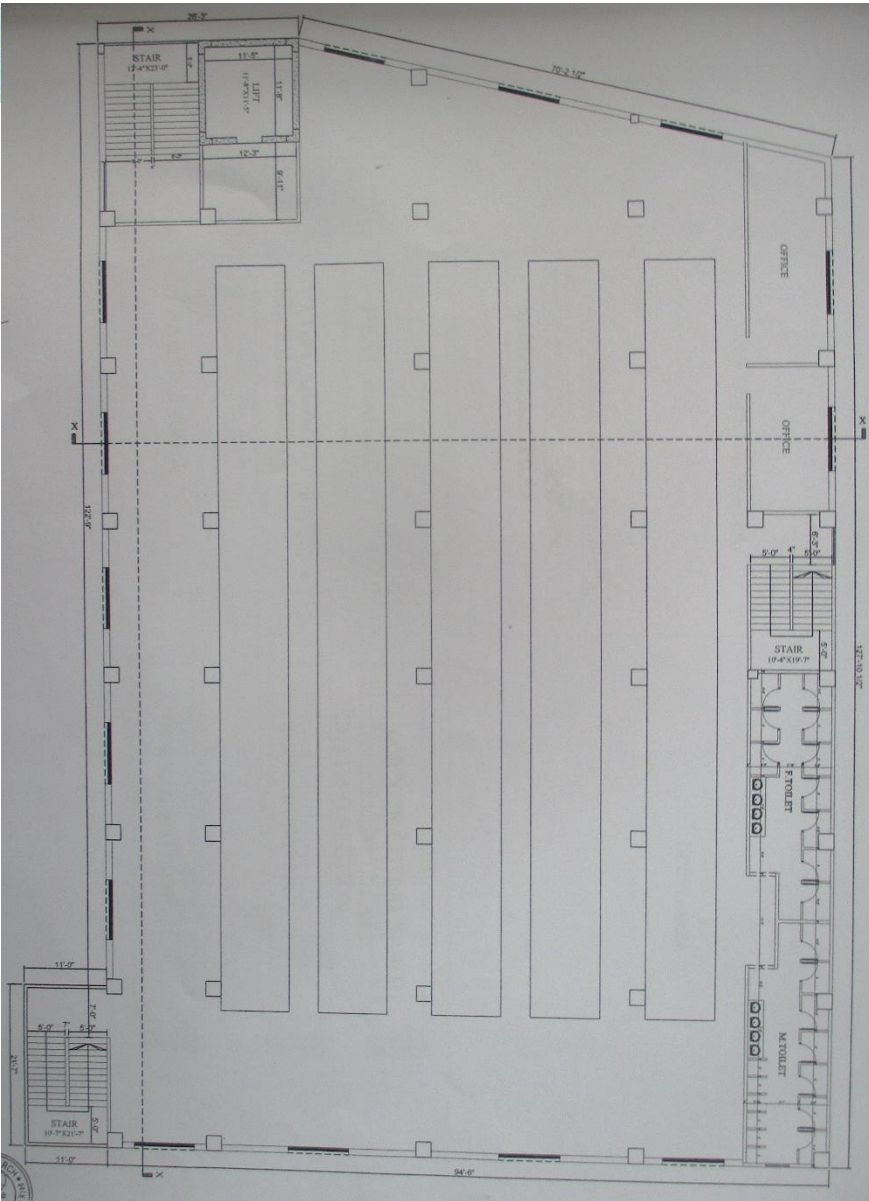
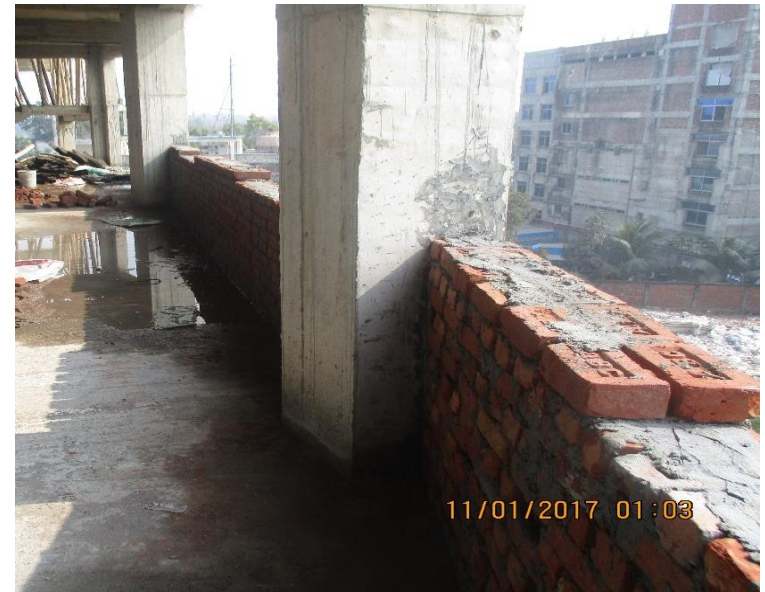
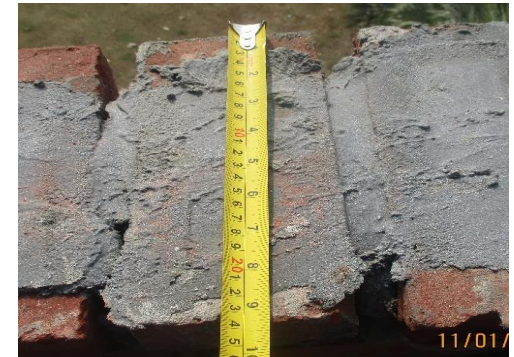
Floor layout of 3<sup>rd</sup> floor

In floor plan the peripheral walls are shown as 125mm but 250mm thick wall was being constructed at the time of inspection as a result additional load should be considered for column capacity check

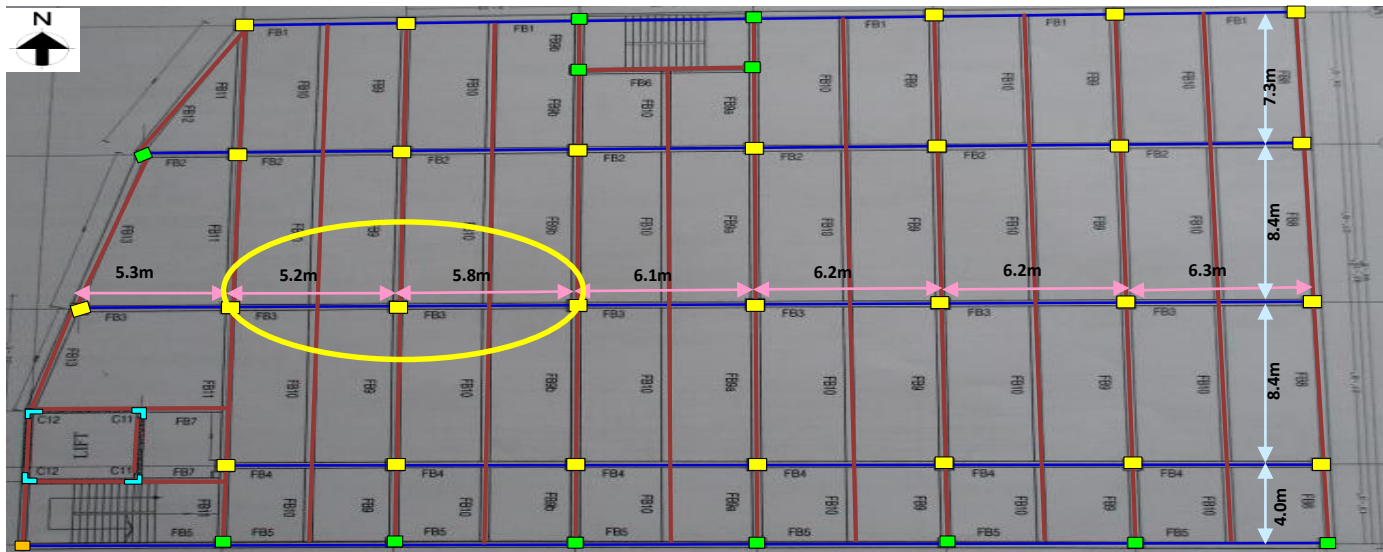
Typical grid dimensions measured on site from Gr floor to top floor

During inspection, column centre to centre distance was found around 0.9m less than provided drawing along 'X' direction

| Item No. | Observation | Recommended Action Plan | Recommended Timeline |
|---|---|---|---|
| 2 | Discrepancy between drawings and as-built condition | Factory engineer to investigate the whole building and review the design considering the rotated columns, missing reinforcement of beam and all other existing condition | 6-weeks |

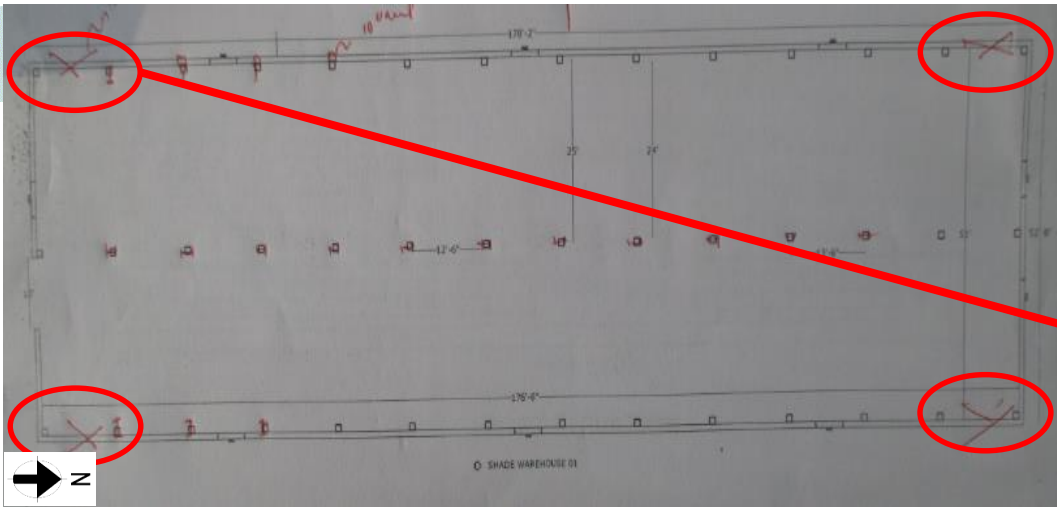
Vertical bracing point at two end bay

Connection in column-rafter joint and bracing-column joint appeared to be inadequate. Lateral stability in the long direction is provided by vertical bracing in the two end bay (red circle in the layout) which is appeared to be inadequate. Moreover, no horizontal bracing was observed in roof. Factory engineer has to check the lateral stability and adequacy of the connections.

| Item No. | Observation | Recommended Action Plan | Recommended Timeline |
|---|---|---|---|
| 5 | Sheds appeared to be non engineered | Factory engineer to check the lateral stability of two sheds against heavy wind load. | 6-weeks |

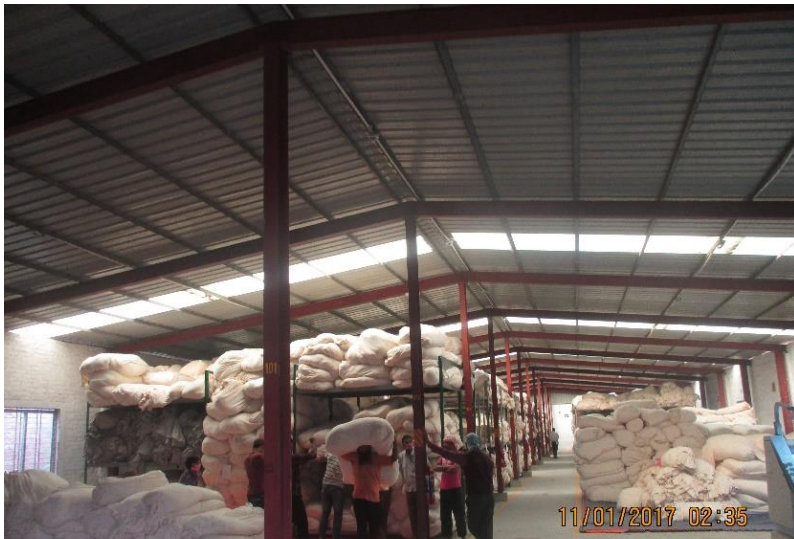
Shed-1

At the time of inspection only typical column layout and architectural drawings were made available but no structural drawings were available for both sheds. Factory engineer has to produce as-built structural drawings for both sheds.

| Item No. | Observation | Recommended Action Plan | Recommended Timeline |
|---|---|---|---|
| 8 | Insufficient documents of two sheds | Factory engineer to produce as built documentation (both structural and architectural drawing) of two sheds. | 6-weeks |
